NOTICE TO BUYER: SELLER-PROCURED INSPECTION REPORT

The following notice is given with respect to the Purchase and Sale Agreement dated _____ between _____ (“Buyer”) and Neil Ross Jennifer Palau (“Seller”) concerning 15410 134th PINE #26C Woodinville WA 98072 (“the Property”).

At your request, a visual inspection of the above referenced property was conducted on 03/03/2021. We have inspected the major structural components, plumbing, heating and electrical systems for signs of significant non-performance, excessive or unusual wear and general state of repair.

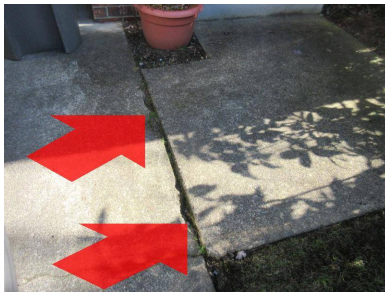
2.5 WALKWAY

The walkway has cracked and settled differentially. The walkway remains functional despite this condition. However, the raised edges of the concrete can be a trip hazard for some people. Grinding down the raised edges of the concrete will mitigate the hazard. Repairs should be made as necessary.

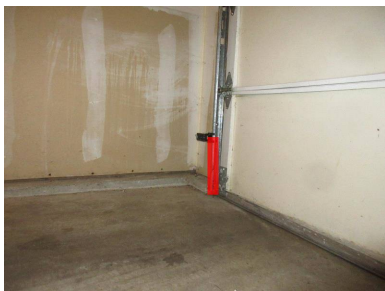
6.3 GARAGE DOOR OPENER

The Photo-eye beam was installed too high above the floor of the garage to adequately offer protection for small children and/or pets. We recommend that the photo-eye be lowered to within 4-6" of the floor.

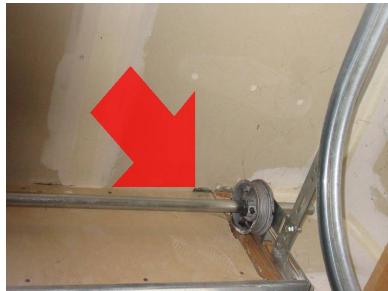
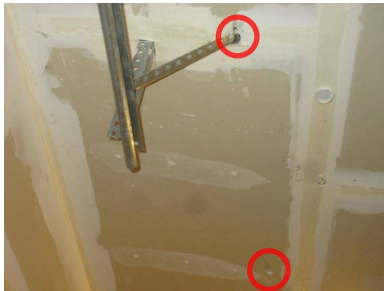
6.4 FIRE SEPARATION

There are voids in the fire resistive barrier between the living space and garage that will allow flames to penetrate. The gypsum barrier slows the spread of a fire from the garage to the structure and/or living space. Patching the voids with a fire retardant caulk is recommended.

- Page 3, Fire Separation (6.4) – Owner will patch holes with fire retardant caulk
- Page 3, Luminaries (7.15) – Owner will address

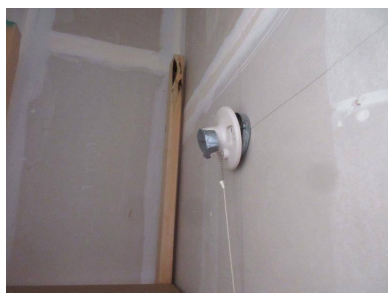
7.15 LUMINARIES

The luminaires in the exterior closet is detached and is hanging from its wires. This is a hazard. The luminaires should be reattached and secured to the ceiling.

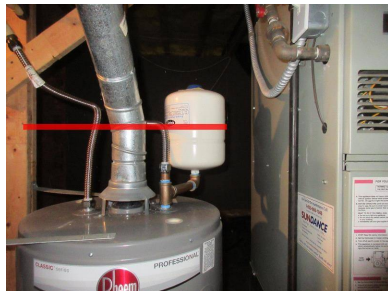
9.6 EXPANSION TANK

The expansion tank is not adequately secured to the wall. This could result in damage to the water pipe and leakage during an earth quake. A seismic restraint should be installed to secure the expansion tank.

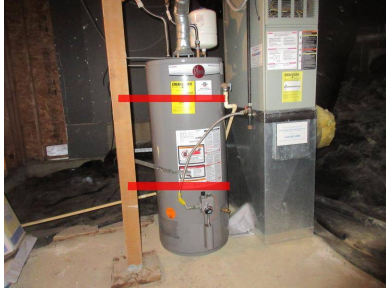
9.12 SEISMIC RESTRAINT

The seismic restraint for the water heater was minimal. Proper strapping is recommended to adequately secure the tank and provide potable water in the event of an earthquake.

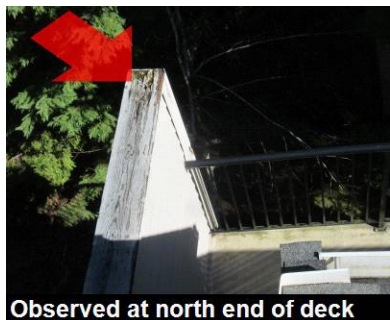
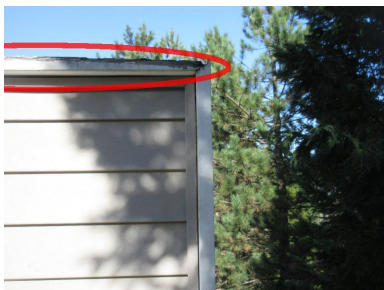
3.1 PRIMARY EXTERIOR WALL CLADDING

The wing wall cap boards at the east side of the building are rotted where they have had chronic contact with moisture. Rot damaged material should be replaced and protected from chronic contact with moisture. We recommend covering the wall cap board with a metal cap flashing.

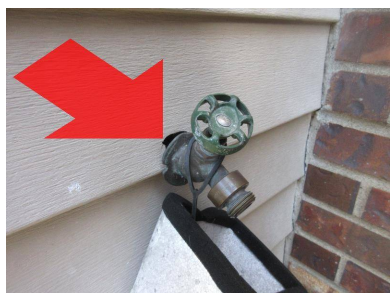
3.2 PEST CONTROL

There are openings adjacent the hose bib through which insects and rodents can enter into the structure. These openings should be covered or filled with aerosol foam.

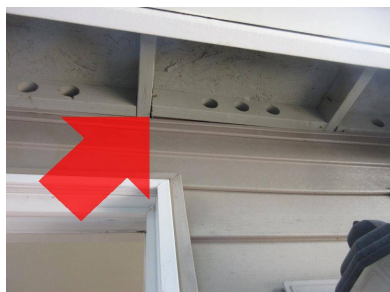
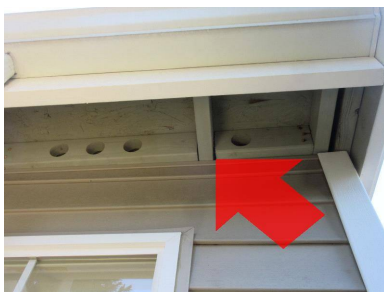
3.3 SOFFITS AND OVERHANGS

There are large gaps over 1/4" in size adjacent the soffit vent blocks. These gaps allow insects and rodents to enter the attic. Covering the gaps with screening, a strip of wood and/or caulking is recommended.

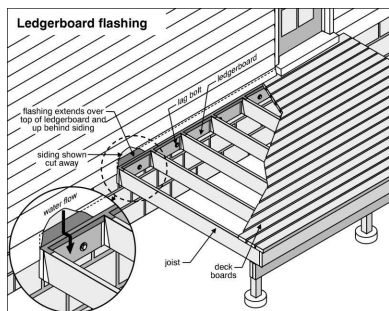
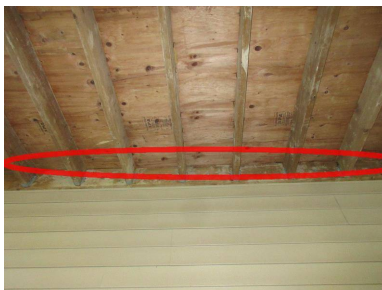
3.6 DECK

There is no flashing at the intersection between the deck and house. This will allow water to enter behind the siding. The installation of flashing in this area is recommended.

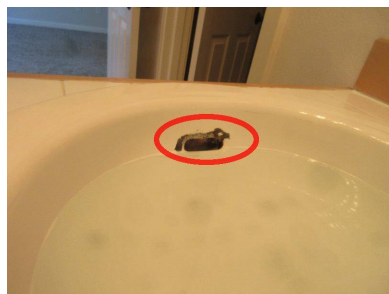
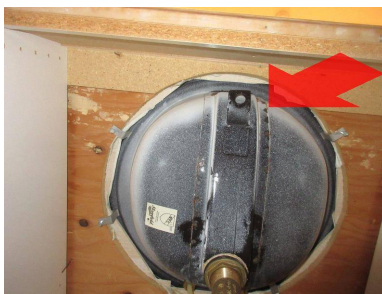
11.27 SINK

The overflow portion of the sinks are rusted. This will cause the sinks to leak. Replacement of the sinks is recommended.

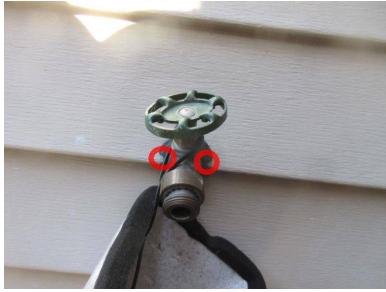
13.9 HOSE BIBBS AND EXTERIOR SUPPLY PIPES

The hose bibb on the front of the building is loose. This could result in damage to the water pipe and leakage. The bibb should be securely fastened to the wall.

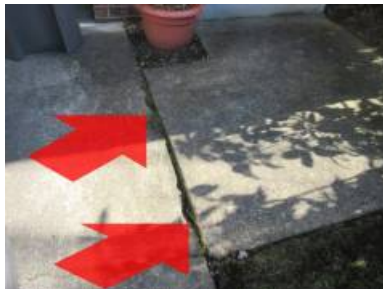
The walkway has cracked and settled differentially. The walkway remains functional despite this condition. However, the raised edges of the concrete can be a trip hazard for some people. Grinding down the raised edges of the concrete will mitigate the hazard. Repairs should be made as necessary.

Many legal and public works departments have defined a trip hazard as an irregularity in a walking surface exceeding one inch (1") in height. All walking surfaces should maintain, free of a vertical surface change of 3/4" or more, in the interest of public and personal safety.

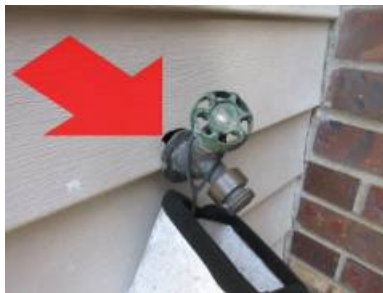
3.2 PEST CONTROL

There are openings adjacent the hose bib through which insects and rodents can enter into the structure. These openings should be covered or filled with aerosol foam.

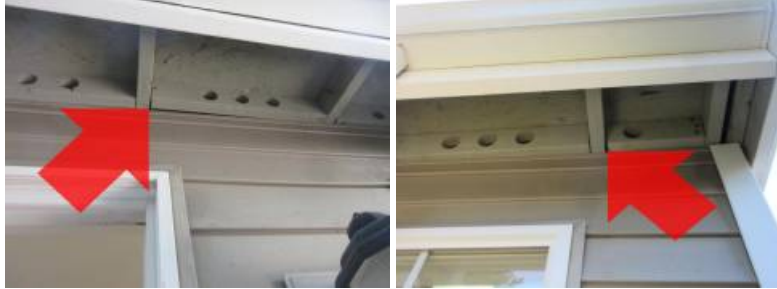
3.3 SOFFITS AND OVERHANGS

There are large gaps over 1/4" in size adjacent the soffit vent blocks. These gaps allow insects and rodents to enter the attic. Covering the gaps with screening, a strip of wood and/or caulking is recommended.

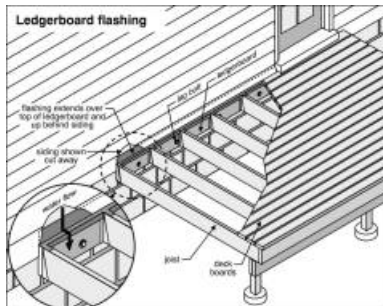
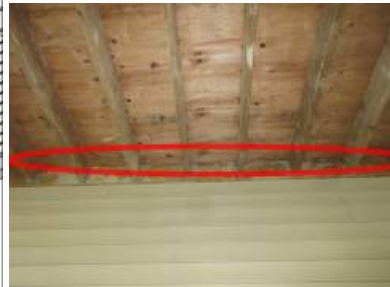
There is no flashing at the intersection between the deck and house. This will allow water to enter behind the siding. The installation of flashing in this area is recommended.

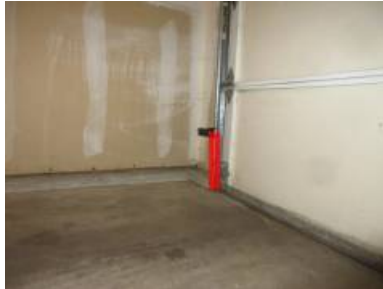
The Photo-eye beam was installed too high above the floor of the garage to adequately offer protection for small children and/or pets. We recommend that the photo-eye be lowered to within 4-6" of the floor.

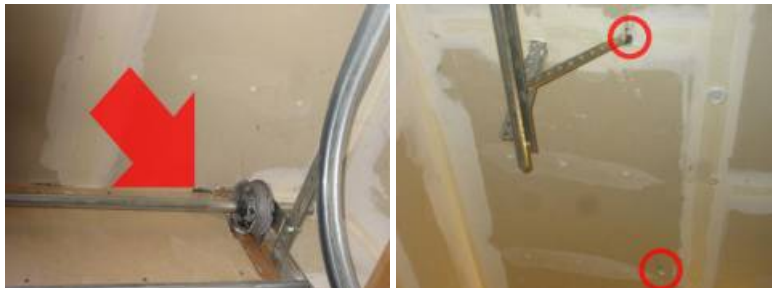
6.4 FIRE SEPARATION

There are voids in the fire resistive barrier between the living space and garage that will allow flames to penetrate. The gypsum barrier slows the spread of a fire from the garage to the structure and/or living space. Patching the voids with a fire retardant caulk is recommended.

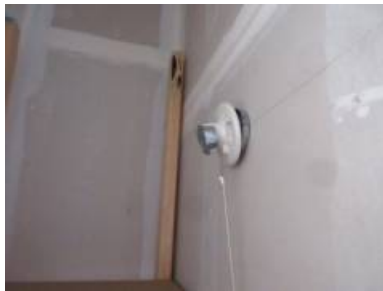
The luminaires in the exterior closet is detached and is hanging from its wires. This is a hazard. The luminaires should be reattached and secured to the ceiling.

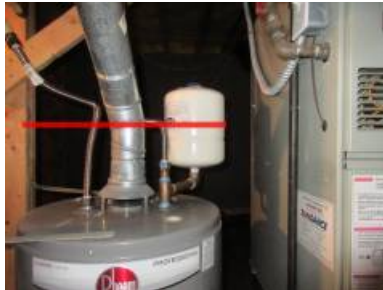
The expansion tank is not adequately secured to the wall. This could result in damage to the water pipe and leakage during an earth quake. A seismic restraint should be installed to secure the expansion tank.

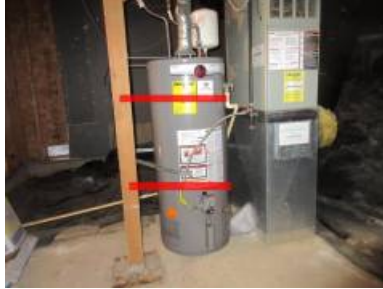
9.12 SEISMIC RESTRAINT

The seismic restraint for the water heater was minimal. Proper strapping is recommended to adequately secure the tank and provide potable water in the event of an earthquake.

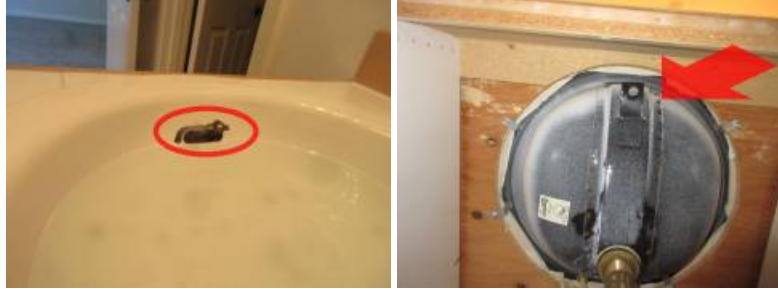
11.27 SINK

The overflow portion of the sinks are rusted. This will cause the sinks to leak. Replacement of the sinks is recommended.

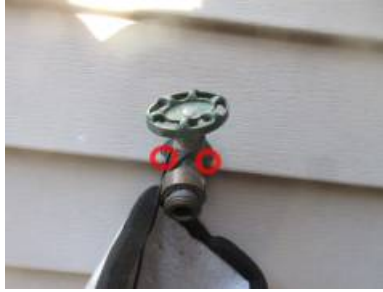
The hose bibb on the front of the building is loose. This could result in damage to the water pipe and leakage. The bibb should

be securely fastened to the wall.
