**NOTICE TO BUYER: SELLER-PROCURED INSPECTION REPORT**

The following notice is given with respect to the Purchase and Sale Agreement dated \_\_\_\_\_ between \_\_\_\_\_ (“Buyer”) and **Justin Stobb** **Deedee Stobb** (“Seller”) concerning **20026 105th Ave SE** **Snohomish** **WA 98296** (“the Property”).

March 12, 2021

At your request, a visual inspection of the above referenced property was conducted on 03/11/2021. We have inspected the major structural components, plumbing, heating and electrical systems for signs of significant non-performance, excessive or unusual wear and general state of repair.

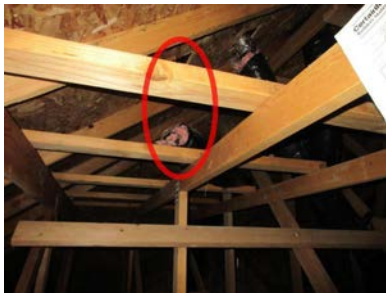
##### 5.3 MECHANICAL VENTILATION SYSTEMS

The bathroom vent fan discharges in the attic rather than outside. This is an undesirable condition that causes excessive moisture in the attic and can result in mold or fungus growth. A 4" smooth-wall sheet metal duct should be installed to direct the moisture laden air discharged from the fan out of the attic.

- 5.3 Valentine Roofing came out and corrected bathroom fan venting
- 6.4 Screw holes in sheetrock from garage to living area have been filled
- 6.17 A GFI Outlet was installed for the Hot Water Heater in the shop

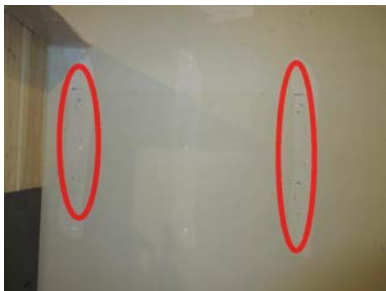
##### 6.4 FIRE SEPARATION

There are voids (nail holes) in the fire resistive barrier between the living space and garage that will allow flames to penetrate. The gypsum barrier slows the spread of a fire from the garage to the structure and/or living space. Patching the voids with a fire retardant caulk is recommended.

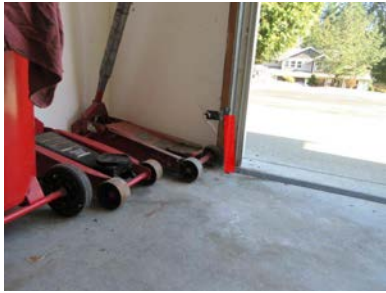
#### 6.14 GARAGE DOOR OPENER

The Photo-eye beam was installed to high above the floor of the garage to adequately offer protection for small children and/or pets. We recommend that the photo-eye be lowered to within 4-6" of the floor.

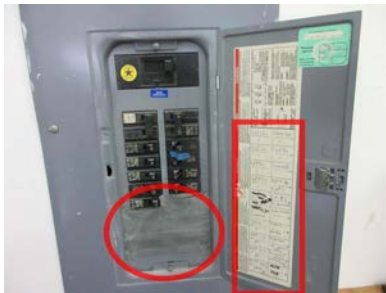
Twist-outs are missing from the subpanel cover. This exposes live conductors and is a shock hazard. The installation of snap-in replacement blanks is recommended.

The circuits are not properly labeled. Each circuit breaker should be labeled to allow servicing and repair of electrical circuits and equipment without having to shut off power to all electrical circuits. The services of a qualified electrician should be retained to perform this service.

- 7.10 Snap in replacement blanks have been installed, the circuit to the shop comes off of the main house panel and is protected by a smaller breaker there, The wire ran to the shop was sized for the amount of service being provided to the shop, the panel in the shop while not permitted was professionally installed.

- 7.10 Relabeled the shop subpanel circuits
- 7.13 Corrected all outlets discovered labeled as loose
- 10.17 A CPVC drain was installed on the pressure relief valve in the shop hot water heater

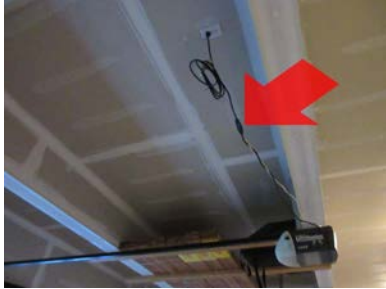
#### 7.12 WIRING

An extension cord is used as a temporary power source for the garage door opener. An extension cord is not suitable as a permanent wiring method. The installation of a receptacle within cords length of the motor is recommended.

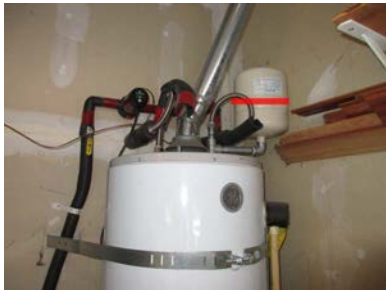
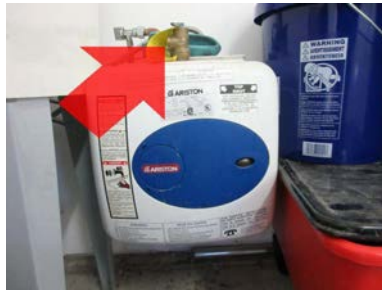
##### 10.6 EXPANSION TANK

The expansion tank is not adequately secured to the wall. This could result in damage to the water pipe and leakage during an earth quake. A seismic restraint should be installed to secure the expansion tank.

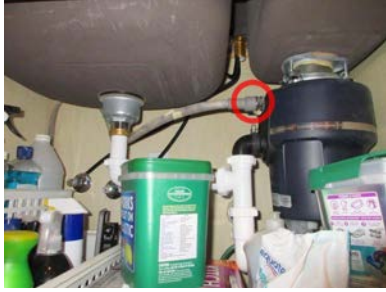
##### 11.8 AIR GAP

The dishwasher drain lacks an air gap. The dishwasher will function without one, but there is a risk of contamination of the inside of the dishwasher by waste water. The installation of an air gap is recommended.

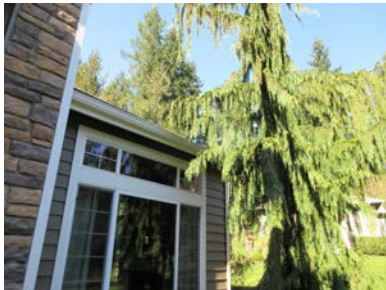
### 2.3 VEGETATION

Trees are nearly touching the building on the east side. Low hanging tree branches can damage the roof, siding, doors and windows. Tree branches should be trimmed back where necessary.

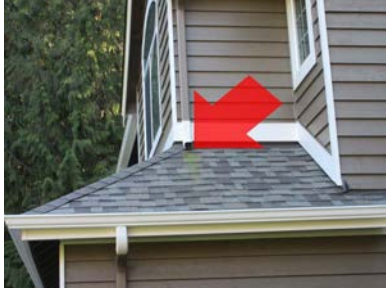
### 3.4 GUTTERS AND DOWNSPOUTS

Downspouts draining directly onto the asphalt shingle surface causes excessive wear of the roofing material. Downspout extensions to the lower gutters should be installed to prevent excessive wear and tear of the roofing.

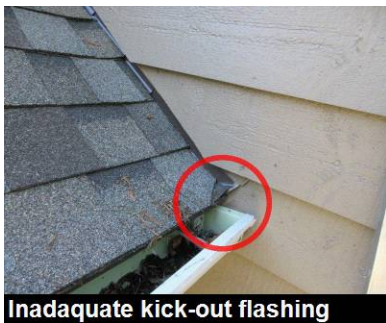
### 4.5 FLASHINGS

There is no kick out flashing at the roof edge to wall intersection above the gutter. This will allow water to enter the wall behind the siding. The installation of a kick-out flashing is recommended.

Inadaquate kick-out flashing

- 4.5 Valentine roofing came out and corrected the missing kick-out flashing
- 6.22 Shop sink was attached to the South wall
- 12.29 Drain Stops function as they should after tightening

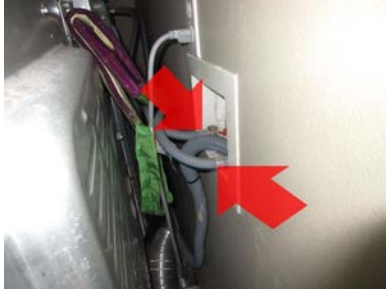
### 13.8 APPLIANCES

Upgrading the washer connections to high pressure (steel braided) lines is recommended.

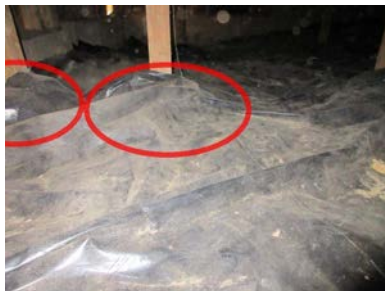
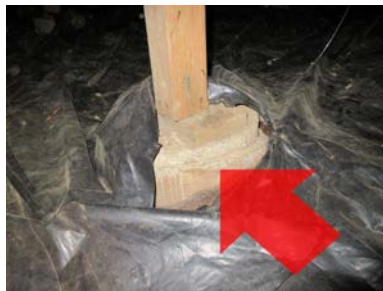
### 20.4 VAPOR RETARDER

The support post concrete piers are covered with the plastic vapor retarder. This allows the transmission of water vapor from the soil up and into the floor framing. The plastic vapor retarder should be removed from the pier so that it covers at least 85% of the entire surface of the soil only.

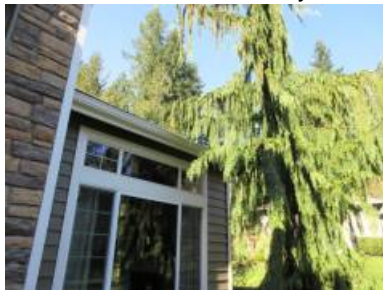
Trees are nearly touching the building on the east side. Low hanging tree branches can damage the roof, siding, doors and windows. Tree branches should be trimmed back where necessary.

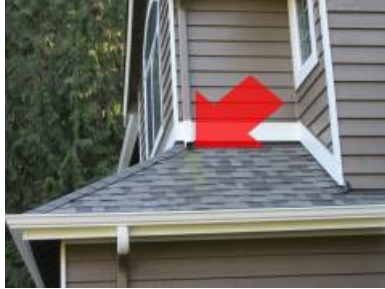
Downspouts draining directly onto the asphalt shingle surface causes excessive wear of the roofing material. Downspout extensions to the lower gutters should be installed to prevent excessive wear and tear of the roofing.

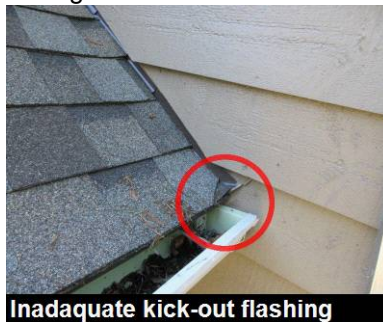
There is no kick out flashing at the roof edge to wall intersection above the gutter. This will allow water to enter the wall behind the siding. The installation of a kick-out flashing is recommended.

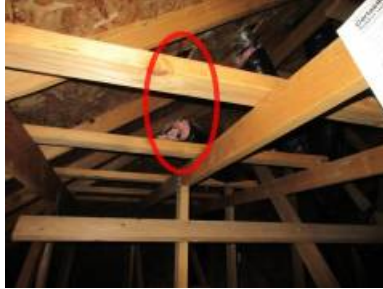
#### 5.3 MECHANICAL VENTILATION SYSTEMS

The bathroom vent fan discharges in the attic rather than outside. This is an undesirable condition that causes excessive moisture in the attic and can result in mold or fungus growth. A 4" smooth-wall sheet metal duct should be installed to direct the moisture laden air discharged from the fan out of the attic.

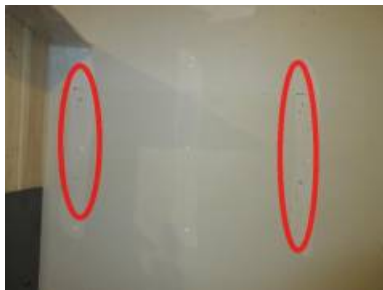
#### 6.4 FIRE SEPARATION

There are voids (nail holes) in the fire resistive barrier between the living space and garage that will allow flames to penetrate. The gypsum barrier slows the spread of a fire from the garage to the structure and/or living space. Patching the voids with a fire retardant caulk is recommended.

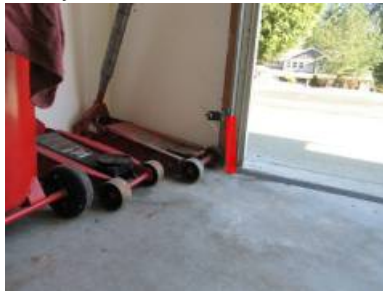
The Photo-eye beam was installed to high above the floor of the garage to adequately offer protection for small children and/or pets. We recommend that the photo-eye be lowered to within 4-6" of the floor.

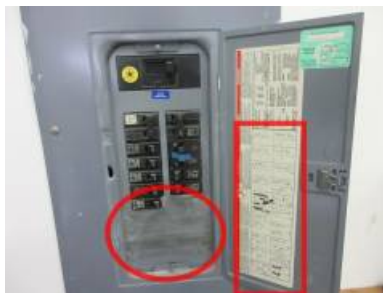
Twist-outs are missing from the subpanel cover. This exposes live conductors and is a shock hazard. The installation of snap-in replacement blanks is recommended.

The circuits are not properly labeled. Each circuit breaker should be labeled to allow servicing and repair of electrical circuits and equipment without having to shut off power to all electrical circuits. The services of a qualified electrician should be retained to perform this service.

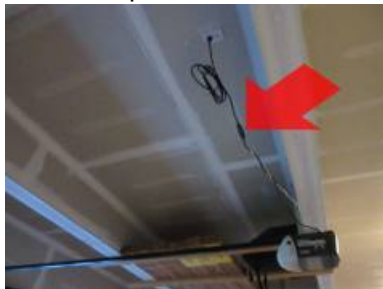
An extension cord is used as a temporary power source for the garage door opener. An extension cord is not suitable as a permanent wiring method. The installation of a receptacle within cords length of the motor is recommended.

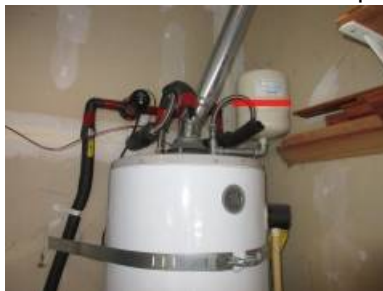
The expansion tank is not adequately secured to the wall. This could result in damage to the water pipe and leakage during an earth quake. A seismic restraint should be installed to secure the expansion tank.

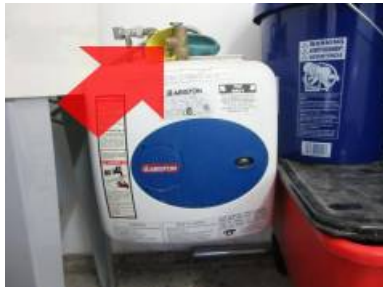
#### **10.17 PRESSURE RELIEF VALVE**

The pressure relief valve lacks a drain pipe. This is a scald hazard. The installation of a 3/4" copper, CPVC plastic or galvanized steel drain pipe is recommended. Ideally, the drain should be routed to the exterior. However, running the pipe straight down to the floor eliminates the scald hazard.

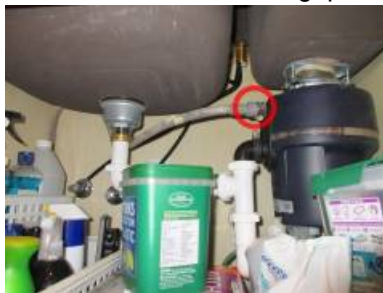
#### 11.8 AIR GAP

The dishwasher drain lacks an air gap. The dishwasher will function without one, but there is a risk of contamination of the inside of the dishwasher by waste water. The installation of an air gap is recommended.

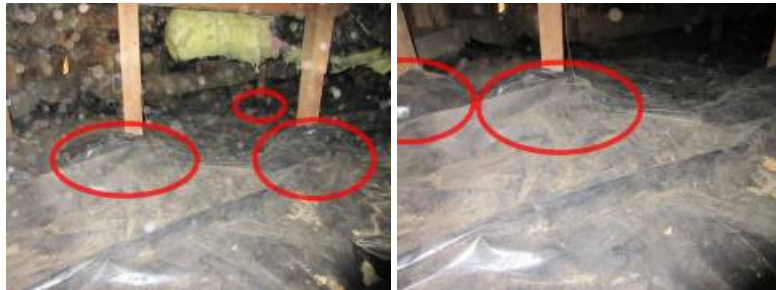
The support post concrete piers are covered with the plastic vapor retarder. This allows the transmission of water vapor from the soil up and into the floor framing. The plastic vapor retarder should be removed from the pier so that it covers at least 85% of the entire surface of the soil only.

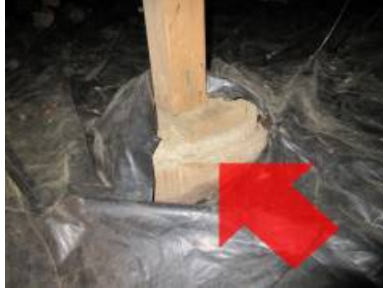
Good building practice requires that foundation walls or pier footings supporting wood frame construction, should extend at least 8" above the finish grade with at least a 6" clearance between the top of the soil and the bottom of the wood finish materials. Untreated wood should be raised 1-2" above surrounding flatwork and should have a moisture barrier such as 30 lb. asphalt impregnated felt installed between the concrete and wood. For additional information and treatment options, you should retain the services of a qualified pest control operator.
