**NOTICE TO BUYER: SELLER-PROCURED INSPECTION REPORT**

**Zeinab Birjandian, Omid Mola  
13626 179th Ave NE  
Redmond, WA, 98052**

**Per the seller, the following items listed on the pre-sale inspection summary dated 10/7/2021, are being corrected by the seller as part of preparation for sale in good faith.**

13626 179th Ave. NE  
Redmond WA.

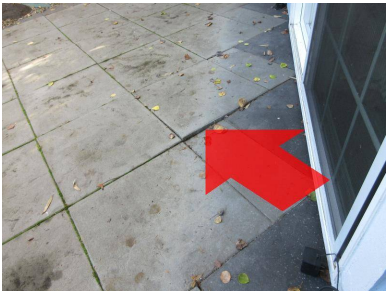
**2.5 PATIO**

The walking surface was not even and trip hazards were present. We recommend all walking surfaces be maintained free of trip hazards.

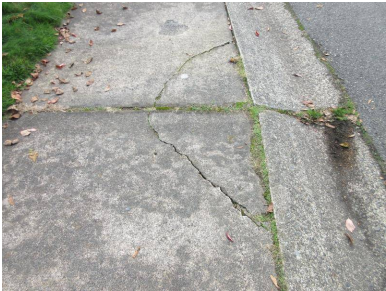
**2.6 WALKWAY**

The front walkway has cracked and settled differentially. This was probably caused by inadequate preparation of the soil prior to the placement of the concrete. This condition can be repaired by pressure grouting the sunken portion of the walkway or by removing and replacing it. Grinding down the raised edges of the concrete will also mitigate the hazard. The walkway remains functional despite this condition. However, the raised edges of the concrete can be a trip hazard for some people. Repairs should be made as necessary.

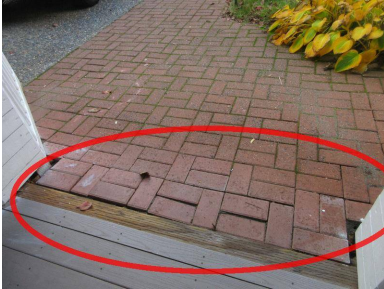
The walkway pavers adjacent the front porch have settled differentially. This was probably caused by inadequate preparation of the soil prior to the placement of the masonry. This condition can be repaired by

removing and replacing them. The walkway remains functional despite this condition. However, the raised edges of the concrete pavers can be a trip hazard for some people. Repairs should be made as necessary.

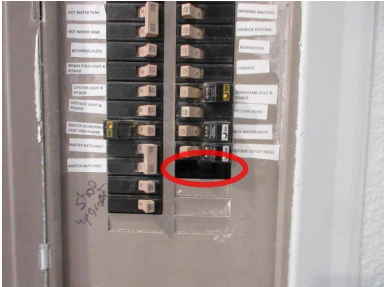
**6.8 SERVICE PANEL**

Twist-outs are missing from the service panel cover. This exposes live conductors and is a shock hazard. The installation of snap-in replacement blanks is recommended.

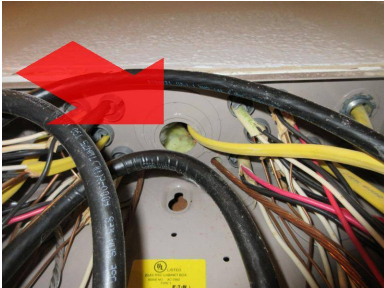
There is an electrical cable emanating from the service panel that is not clamped. The sharp edge of the panel box could cut through the wire insulation and cause a short circuit or fire. Clamping the cable to the panel box using an approved cable clamp is recommended.

- 6.8 Service panel- clamped the cable
- 6.11 Receptacles- Loose panels fixed
- 10.13 Garbage disposal- cord is clamped
- 11.2 Bathtub- stoppers placed
- 11.8 Bathroom cabinet door repaired
- 11.31 Countertop- caulking repaired

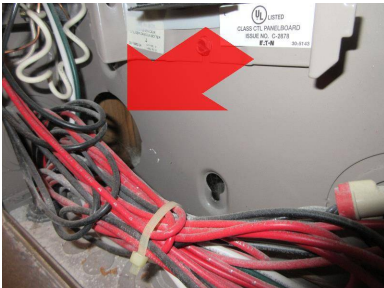
There are openings in the panel box where knock-outs have been removed. Missing knock-outs should be replaced with snap in metal plugs.

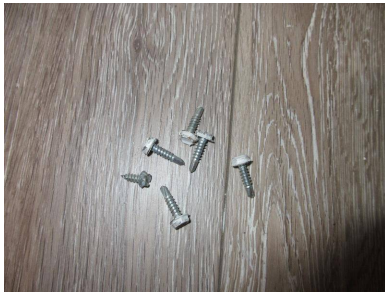
Screws that secure the panel cover to the panel box are the wrong type. This is a potential hazard. Screws should be replaced with the original style blunt end screws.

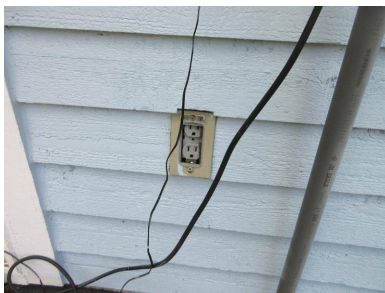
### 6.11 RECEPTACLES

There are numerous loose receptacles throughout the home. This is a potential shock and a fire hazard. All loose receptacles should be repaired as necessary.

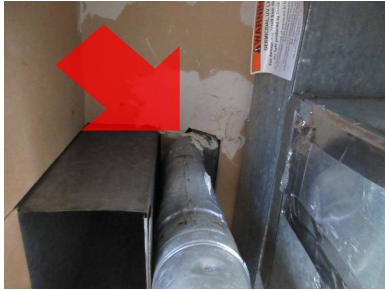
The furnace vent connector is too close to a combustible material. This is a hazard. A minimum clearance of 6" is required between the single wall vent connector and the combustible material. The double wall type B vent requires only 1" of clearance. Repairs are recommended.

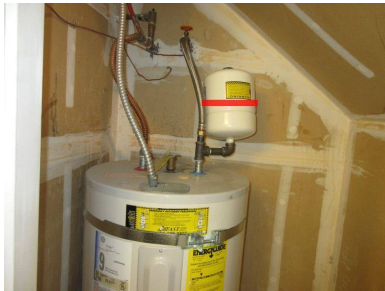
### **9.6 EXPANSION TANK**

The expansion tank is not adequately secured to the wall. As code requirements start to call for engineered expansion tank supports we recommend the installation of seismic restraints to secure the expansion tank instead of allowing it to simply depend on piping connections that could result in damage to the water pipe and leakage during an earthquake.

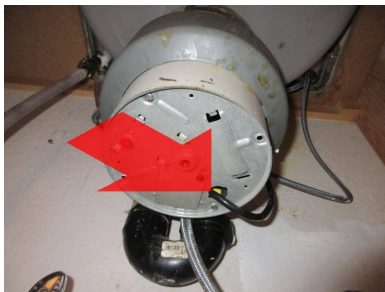
The cord is not clamped where it enters the disposal. This could damage the wires or cause a ground fault. The cord should be clamped in accordance with industry standards.

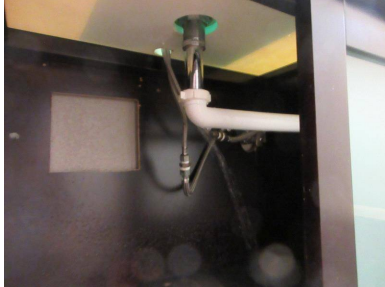
The left sink drain pipe connection is leaking. This will damage the cabinet. The leak should be repaired.

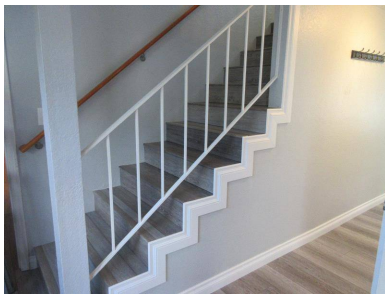
***14.2 STAIRS***

The stair railing baluster spacing is too wide. This is a hazard for small children. The baluster spacing should be reduced as a safety upgrade. Current standards require that a 4" sphere not pass through the railing.

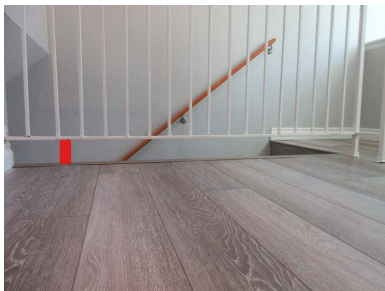
***14.3 GUARD RAILINGS***

The spacing under the railings is too wide. This is a hazard to small children. The railing should be spaced close enough to the deck surface so that a 4" sphere cannot pass through. Upgrading the deck railing is recommended if small children are present.

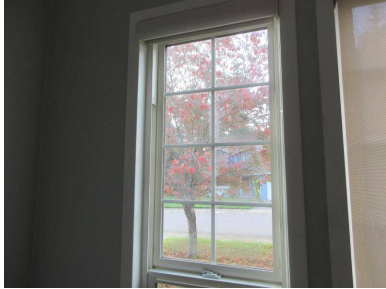
***14.7 WINDOWS***

There is condensation or mineral deposits between the panes of glass in one of the insulated glass window panes. This indicates a failed seal. The glass assembly should be replaced, which is the only method for correcting this deficiency.

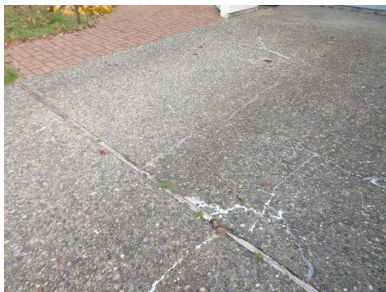
One or more of the wooden dividers separating the concrete driveway sections were infested by wood destroying organisms and have deteriorated to a point where they are becoming a trip hazard. Replacement with mortar is recommended.

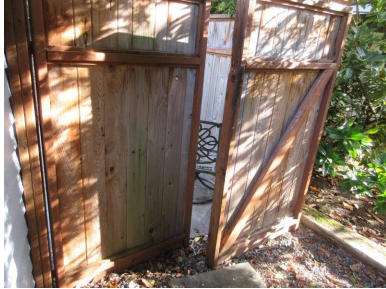
##### **2.7 FENCES AND GATES**

The east gate needs repair, hardware should be adjusted or replaced as necessary to restore full function.

- 2.7 Restore East gate to working order. (Clarification - The East Gate is actually the South Gate next to the converted garage.)
- 6.11 Cover plate of the exterior receptacle
- 14.7 Windows- One master bedroom window does not close and the other has a failed sealed glass unit. These windows are under warranty. Warranty claim is filled and repair requested.  
Living room window - failed sealed glass- ordered replacement.

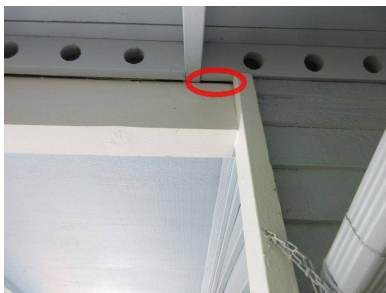
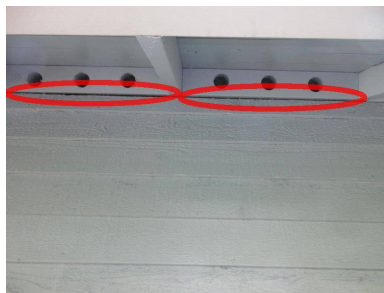
### 3.4 SOFFITS AND OVERHANGS

There are large gaps over 1/4" in size adjacent the soffit vent blocks. These gaps allow insects and rodents to enter the attic. Covering the gaps with screening, a strip of wood and/or caulking is recommended.

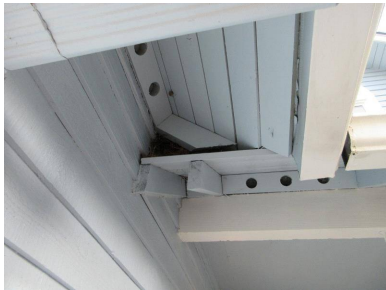
There are openings at the intersection between the overhang and the roof through which birds and rodents can enter into the attic. These openings should be covered with wood, wire mesh or filled with aerosol foam.

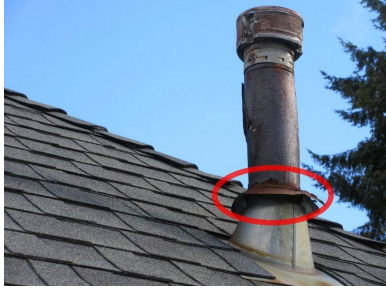
### 4.5 GAS APPLIANCE VENTS

The outer portion of the gas appliance vent above the roof is deteriorated. This will allow leakage to occur. This section of vent should be replaced.

The storm collar is damaged. This will allow leakage to occur. The installation of a storm collar is recommended.

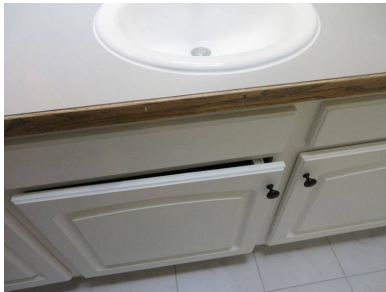
The bathroom cabinet door hardware is damaged and in need of repair. The cabinet is otherwise in serviceable condition.

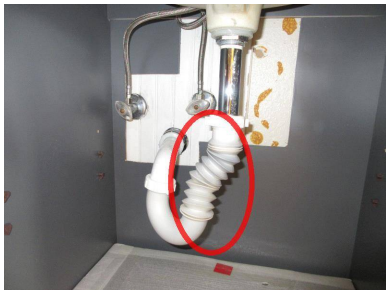
Improper, non-conforming material has been used for the drain pipe fitting. This material will not function reliably. Replacement with industry standard fittings is recommended.

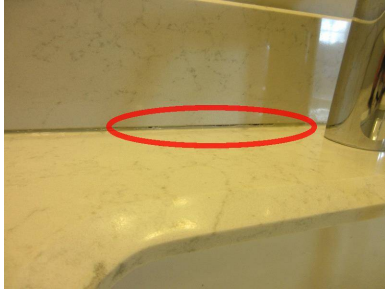
**11.31 COUNTERTOP**

The backsplash caulking is cracked. Cracking of the caulk allows water to enter the gap and is difficult to clean. Caulking the cracks and/or gaps is recommended.

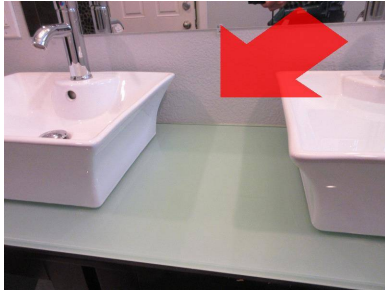
**11.42 COUNTERTOP**

The backsplash is missing. The installation of a backsplash is recommended.

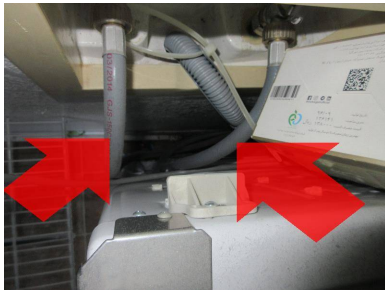
**12.1 APPLIANCES**

High pressure (steel braided) washer line connections is recommended.

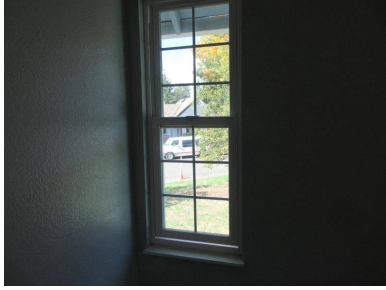
One of the master bedroom windows is stuck. They should be adjusted or repaired as necessary to restore proper operation.

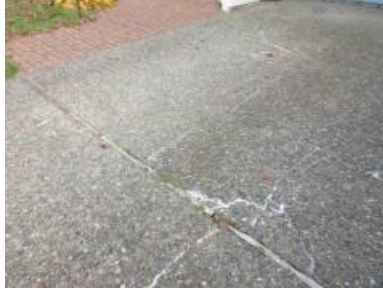
One or more of the wooden dividers separating the concrete driveway sections were infested by wood destroying organisms and have deteriorated to a point where they are becoming a trip hazard. Replacement with mortar is recommended.

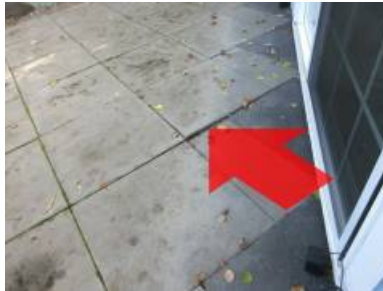
## 2.5 PATIO

The walking surface was not even and trip hazards were present. We recommend all walking surfaces be maintained free of trip hazards.

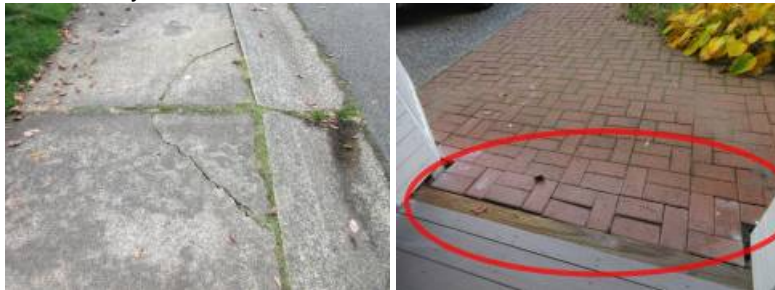
## 2.6 WALKWAY

The front walkway has cracked and settled differentially. This was probably caused by inadequate preparation of the soil prior to the placement of the concrete. This condition can be repaired by pressure grouting the sunken portion of the walkway or by removing and replacing it. Grinding down the raised edges of the concrete will also mitigate the hazard. The walkway remains functional despite this condition. However, the raised edges of the concrete can be a trip hazard for some people. Repairs should be made as necessary.

The walkway pavers adjacent the front porch have settled differentially. This was probably caused by inadequate preparation of the soil prior to the placement of the masonry. This condition can be repaired by removing and replacing them. The walkway remains functional despite this condition. However, the raised edges of the concrete pavers can be a trip hazard for some people. Repairs should be made as necessary.

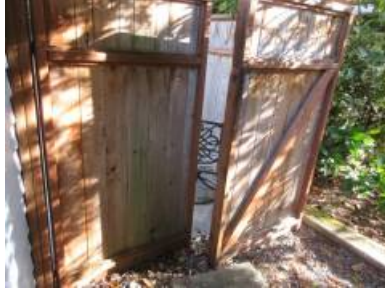
## 2.7 FENCES AND GATES

The east gate needs repair, hardware should be adjusted or replaced as necessary to restore full function.

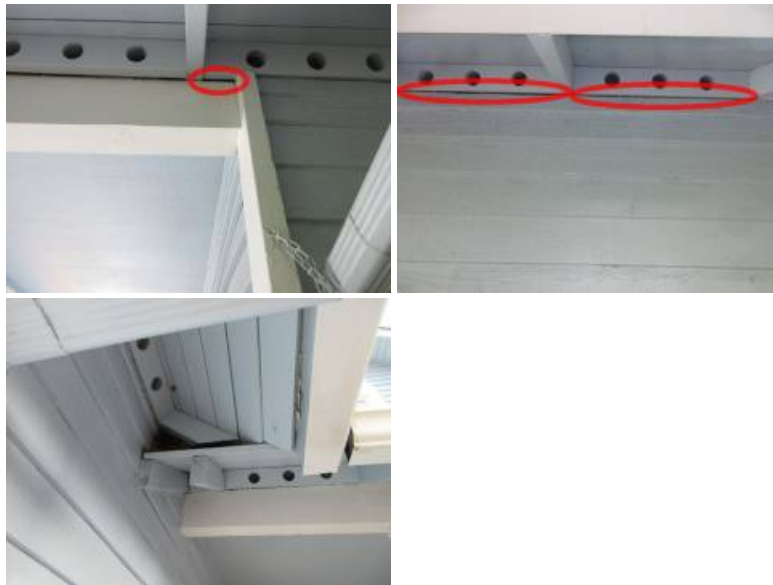
There are openings at the intersection between the overhang and the roof through which birds and rodents can enter into the attic. These openings should be covered with wood, wire mesh or filled with aerosol foam.

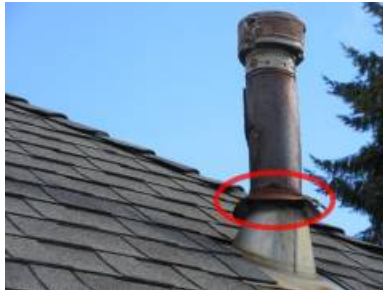
The storm collar is damaged. This will allow leakage to occur. The installation of a storm collar is recommended.

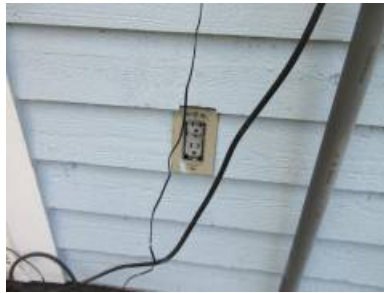
There are numerous loose receptacles throughout the home. This is a potential shock and a fire hazard. All loose receptacles should be repaired as necessary.

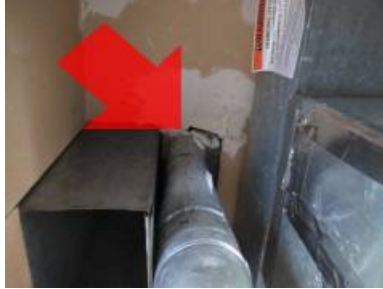
The furnace vent connector is too close to a combustible material. This is a hazard. A minimum clearance of 6" is required between the single wall vent connector and the combustible material. The double wall type B vent requires only 1" of clearance. Repairs are recommended.

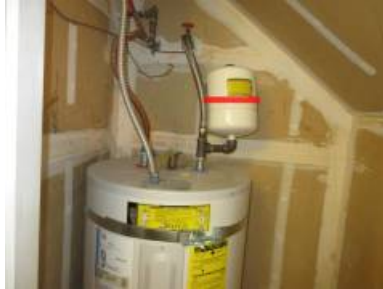
The expansion tank is not adequately secured to the wall. As code requirements start to call for engineered expansion tank supports we recommend the installation of seismic restraints to secure the expansion tank instead of allowing it to simply depend on piping connections that could result in damage to the water pipe and leakage during an earthquake.

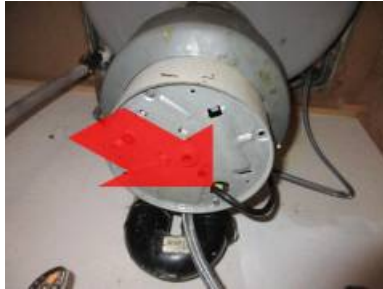
The cord is not clamped where it enters the disposal. This could damage the wires or cause a ground fault. The cord should be clamped in accordance with industry standards.

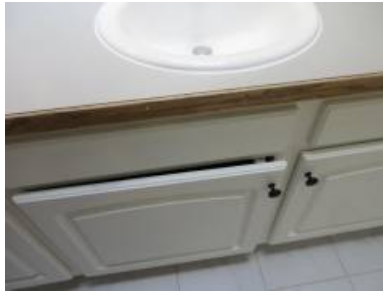
The bathroom cabinet door hardware is damaged and in need of repair. The cabinet is otherwise in serviceable condition.

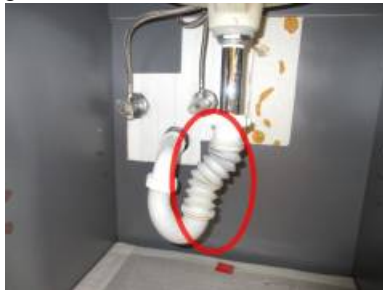
Improper, non-conforming material has been used for the drain pipe fitting. This material will not function reliably. Replacement with industry standard fittings is recommended.

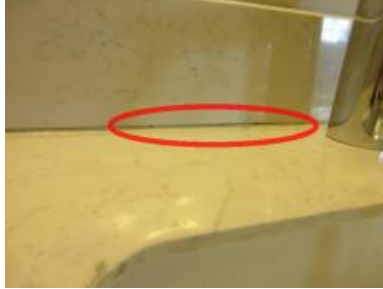
The backsplash caulking is cracked. Cracking of the caulk allows water to enter the gap and is difficult to clean. Caulking the cracks and/or gaps is recommended.

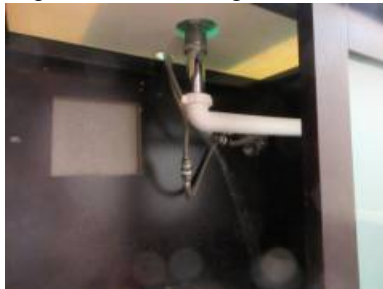
The left sink drain pipe connection is leaking. This will damage the cabinet. The leak should be repaired.

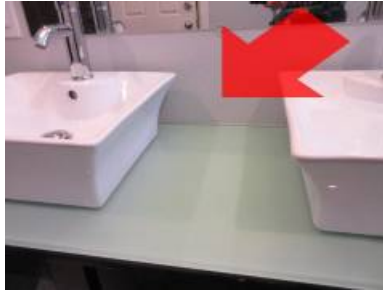
The backsplash is missing. The installation of a backsplash is recommended.

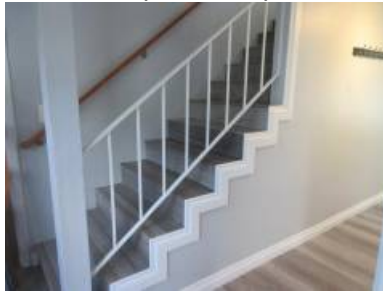
The stair railing baluster spacing is too wide. This is a hazard for small children. The baluster spacing should be reduced as a safety upgrade. Current standards require that a 4" sphere not pass through the railing.

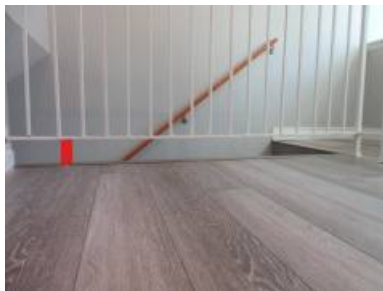
### 14.3 GUARD RAILINGS

The spacing under the railings is too wide. This is a hazard to small children. The railing should be spaced close enough to the deck surface so that a 4" sphere cannot pass through. Upgrading the deck railing is recommended if small children are present.

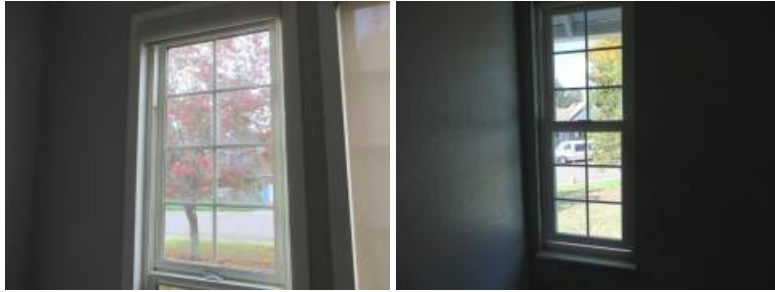
One of the master bedroom windows is stuck. They should be adjusted or repaired as necessary to restore proper operation.
