### NOTICE TO BUYER: SELLER-PROCURED INSPECTION REPORT

The following notice is given with respect to the Purchase and Sale Agreement dated \_\_\_\_\_  
between \_\_\_\_\_ ("Buyer")  
and Robin Shelley ("Seller")  
concerning 1520 NE 75th St. Seattle WA 98115 ("the Property").

June 15, 2022

**Re: 1520 NE 175th St.  
Seattle, WA.**

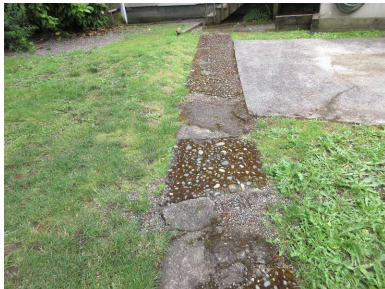
The walkway has cracked and settled differentially. This was probably caused by inadequate preparation of the soil prior to the placement of the concrete. This condition can be repaired by pressure grouting the sunken portion of the walkway or by removing and replacing it. Grinding down the raised edges of the concrete will also mitigate the hazard. The walkway remains functional despite this condition. However, the raised edges of the concrete can be a trip hazard for some people. Repairs should be made as necessary.

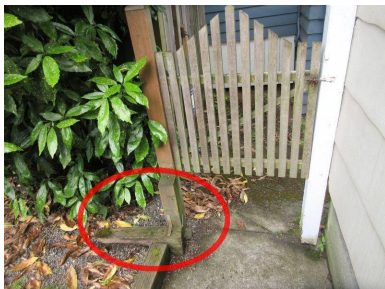
The gate needs repair, gate posts should be replaced as necessary to restore function.

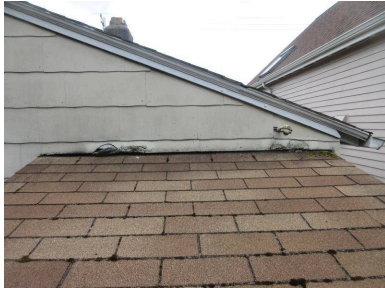
The siding is vulnerable to damage where it has been close to or in contact with the roofing material. The siding should be modified and a minimum of a 2" clearance should be maintained between the top of the roofing and bottom of the siding.

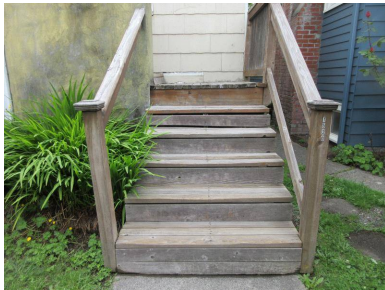
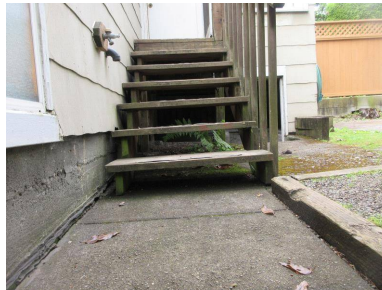
### 3.7 PORCH STEPS

The steps are non-conforming due to the variable and/or excessive rise. Stair design standards require that step risers do not exceed 8" and that the variation in rise not exceed 3/8" in order to reduce falls from tripping. To increase the margin of safety, consideration should be given to reconfiguring the steps so that rise and run do not vary by more than 3/8". If this proves to be too impractical or expensive, then we recommend exercising caution when using.

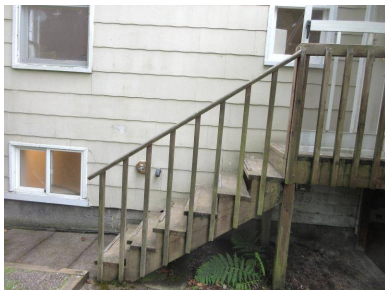
### 3.8 PORCH RAILING

The spacing between the balusters is too wide. This is a hazard to small children. The balusters should be spaced close enough together so that a 4" sphere cannot pass through. Upgrading the porch railing is recommended if small children are present.

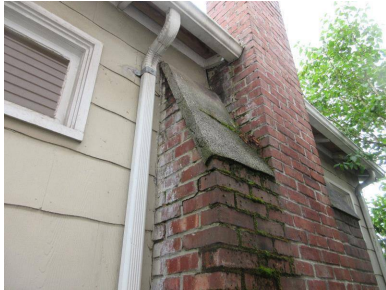
Mortar deteriorated in the corbeled areas adjacent the chimney. This has led to accelerated deterioration of the brick masonry. Damaged areas can be repaired by filling in cutout or defective mortar joints with fresh mortar. (Tuck pointing)

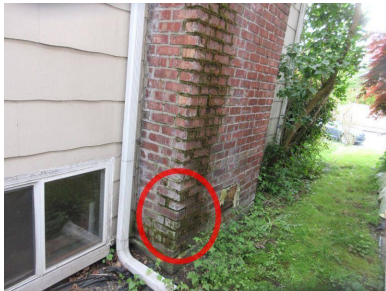
Moss/vegetation was observed in several areas around the chimney. This will lead to accelerated deterioration of the brick masonry mortar. We recommend removal of all organic growth. Damaged areas can be repaired by filling in cutout or defective mortar joints with fresh mortar. (Tuck pointing)

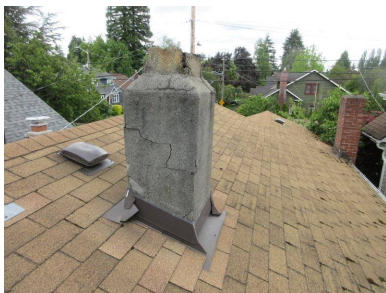
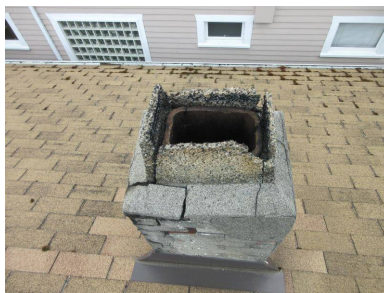
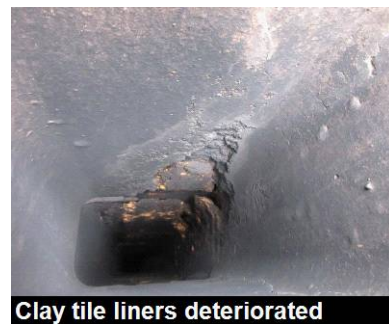
The utility chimney is deteriorated above the roof line. This is a safety concern. Rebuilding the chimney is recommended.

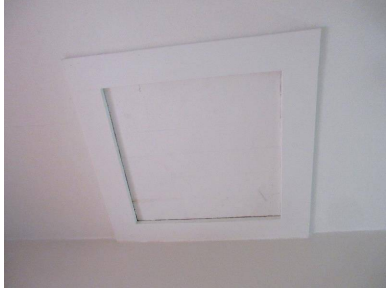
### 5.1 ACCESS

The access opening to the attic is too small by today's standards. The rough framed opening should not be less than 22 inches by 30 inches. Modification of the access opening is recommended for inspection and servicing of components in the attic.

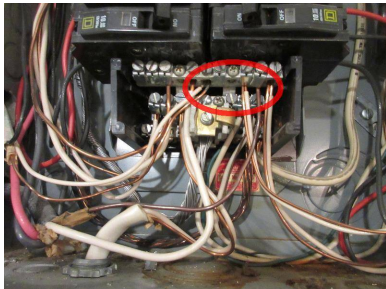
Neutral (white wire) and equipment grounding conductors (bare wire) terminate under the same lug. An individual terminal should be provided for the connection of each branch-circuit neutral conductor. When the neutral is disconnected, the objective is to still have the equipment ground connected. If both the neutral and grounded conductor is under the same terminal, this cannot be accomplished. The services of a qualified electrical contractor should be retained to repair the circuit(s).

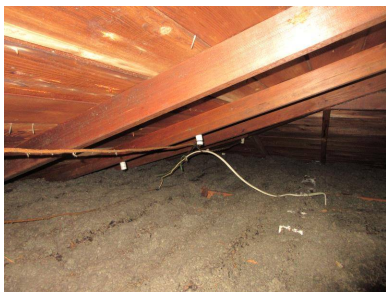
Improperly modified knob and tube wiring was observed in the attic. This is a fire hazard. The services of a qualified electrical contractor should be retained for repairs.

Splices in cable made outside of a junction box were observed in the attic. This is a fire hazard. The splices should be made inside an approved box with a cover.

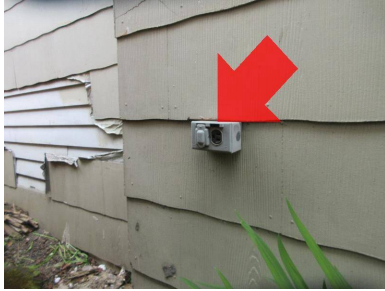
The cover plate is damaged at the exterior receptacle. This is a shock and fire hazard. The installation of a weather tight cover plate is recommended.

There is a minimum number of receptacles in this house. The number of receptacles may be inadequate for your particular needs. Consideration should be given to adding additional electrical receptacles.

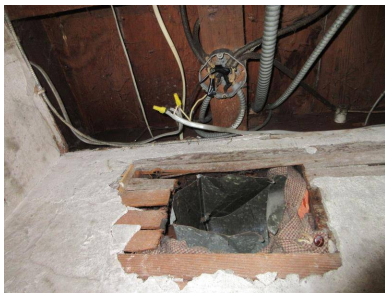
There is a junction box with a missing cover in the basement. This is a fire/shock hazard. Covers should be installed on all junction boxes.

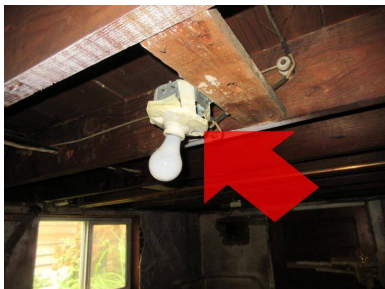
The light fixtures in the closet and one in the basement are detached and are hanging from their wires. This is a hazard. The fixtures should be reattached and secured to the ceiling.

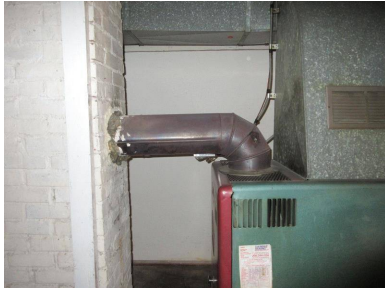
The pitch of the vent connector is inadequate. This can result in spillage of combustion gases. The vent connector should be reconfigured so that it slopes 1/4" per foot up towards the outlet.

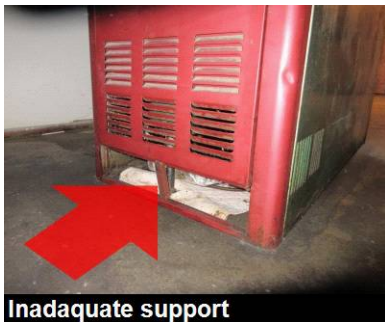
The oil burner motor cover is not fitted properly and the piece of wood is inadequate support. The vestibule cover should be modified or replaced.

The furnace responded to the thermostats call for heat and all major components were functional however, the furnace is 60 years old and is nearing the end of its service life. The need for furnace replacement should be anticipated. This type of furnace should be serviced annually.

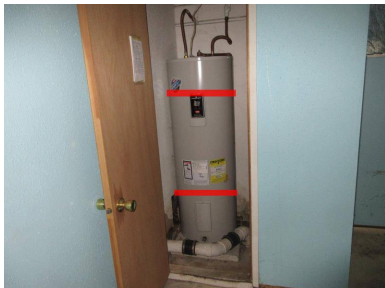
The water heater is not secured to the wall. A seismic restraint should be installed to secure the water heater and prevent it from falling over during an earthquake. This prevents the gas and water lines from rupturing.

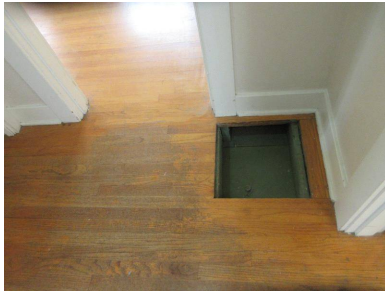
The large hole in the flooring is a hazard. We recommend the installation of a floor grate or other suitable cover.

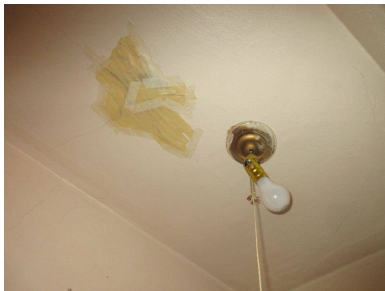
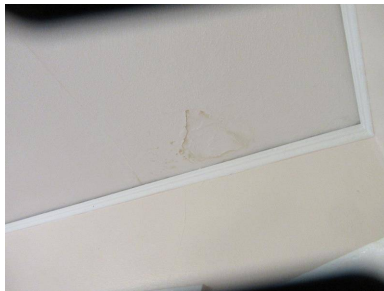
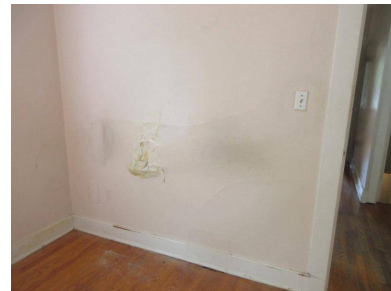
We observed damage to the surfaces of the ceilings in several areas of the home. Testing the observed areas with a moisture meter revealed no moisture present at the time of the inspection. The damages to the surfaces appear to be from old roof leaks. Damages are cosmetic and repairs are optional.

There are notable signs of damage on the walls. This is a cosmetic condition with this type of construction and does not indicate a structural deficiency. The cracks should be repaired, nails reset, seams repaired and painted over.

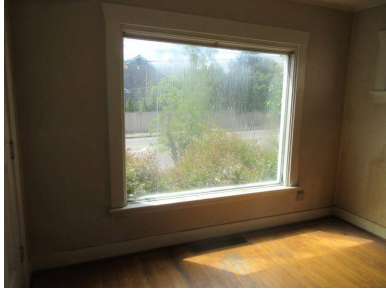
There is condensation or mineral deposits between the panes of glass in one of the insulated glass window panes located in the living room. This indicates a failed seal. The glass assembly should be replaced, which is the only method for correcting this deficiency.

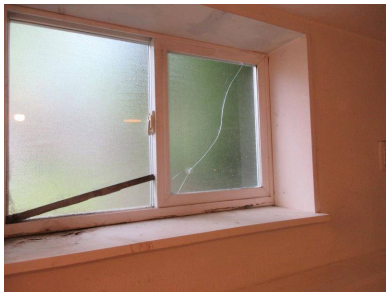
Glass in the basement bathroom window is cracked. This is a safety concern. Broken glass should be replaced.

Several of the windows are stuck. They should be adjusted or repaired as necessary to restore proper operation.

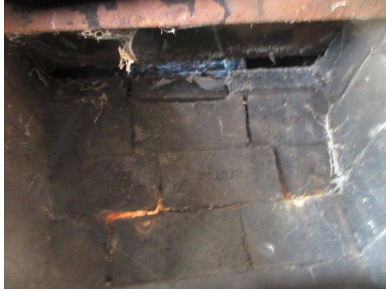
Deterioration of the fire brick was observed inside the firebox. Loose bricks should be reset, cracks and voids should be filled with refractory cement.

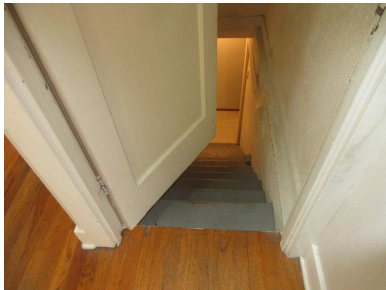
The landing for the steps is missing. This creates a potential trip hazard. Stair landings should be 36" square. Consideration should be given to modifying the steps. If this proves to be too impractical or expensive, then you should reverse the door swing.

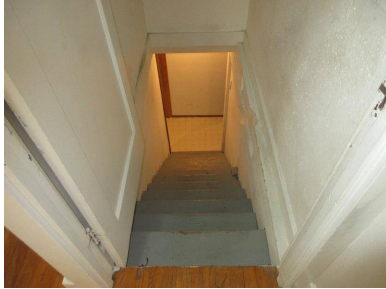
There is no handrail in the stairwell. This is a safety hazard. The installation of a graspable handrail that conforms to present industry standards is recommended.

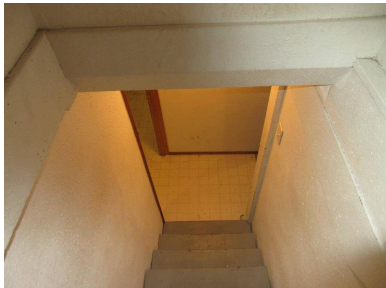
The head clearance above the stairs is less than the normal 6'- 8" presently required. This could result in head injuries. To reduce the risk of head injuries, padding should be installed at low points and/or care should be exercised when using these stairs.

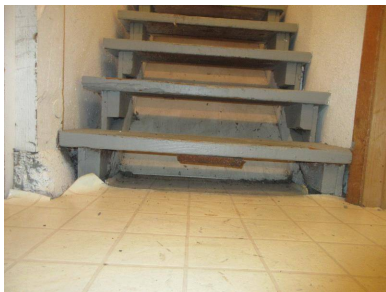
The stairs are non-conforming due to the variable and/or excessive rise. Stair design standards require that stair risers do not exceed 8" and that the variation in rise not exceed 3/8" in order to reduce falls from tripping. To increase the margin of safety, consideration should be given to reconfiguring the stairs so that rise and run do not vary by more than 3/8". If this proves to be too impractical or expensive, then we recommend exercising caution when using these stairs.

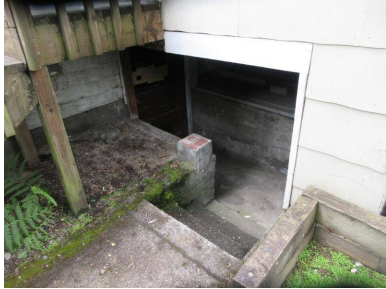
#### **18.4 BASEMENT WALKOUT**

The basement walkout stairs are non-conforming due to the variable and/or excessive rise and head clearances. Stair design standards require that stair risers do not exceed 8" and that the variation in rise not exceed 3/8" in order to reduce falls from tripping. To increase the margin of safety, consideration should be given to reconfiguring the stairs so that rise and run do not vary by more than 3/8". If this proves to be too impractical or expensive, then we recommend exercising caution when using these stairs.

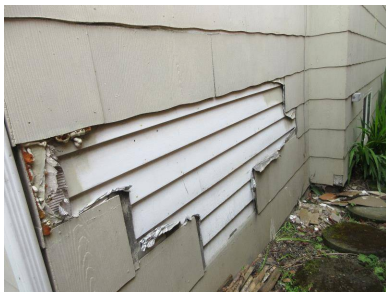
Sections of siding are cracked or missing. Consideration should be given to replacing the damaged siding or installing flashing and/or caulk to prevent moisture or pest entry into these areas.

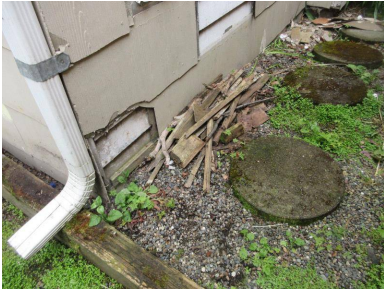
#### **3.2 PEST CONTROL**

Soil is close to or in contact with siding in some areas around the building exterior. Good building practice requires that foundation walls or pier footings supporting wood frame construction, extend at least 8" above the finish grade with at least a 6" clearance between the top of the soil and the bottom of the wood finish materials. Soil in direct contact with wood creates a hospitable environment for wood destroying organisms. Establishing these minimum clearances is recommended.

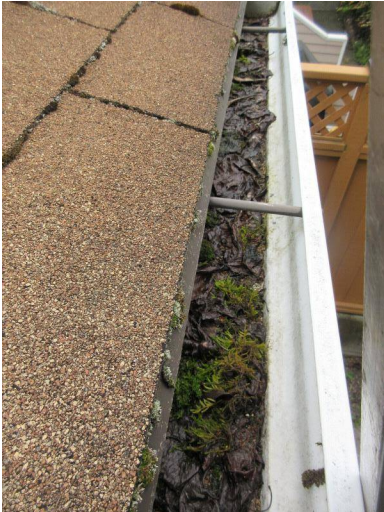
### 3.4 GUTTERS AND DOWNSPOUTS

There is a build-up of organic debris inside the gutters. Proper maintenance of gutters and downspouts is essential and should be performed routinely in order to prevent clogging. Maintenance consists primarily of keeping leaves and other organic debris out of the system. Failure to clean the gutters will result in water splash on the building when they overflow. Gutters can be damaged under the weight of the water and organic matter inside the gutter. Gutters should be cleaned as necessary to maintain a free flow of water into the downspouts.

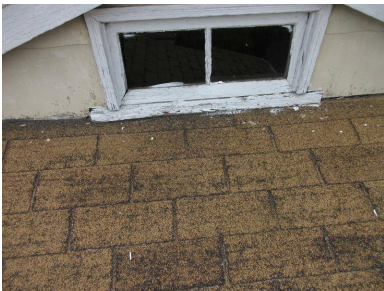
### 3.5 PAINT

Localized areas of peeling paint were noted on numerous trim boards. Paint protects the wood from cupping, checking, warping and rot. These areas should be scraped, primed and repainted.

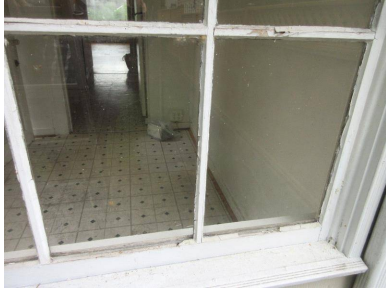
The window glazing is cracked and deteriorated. Glazing helps secure the glass pane and prevents water intrusion into the window frame. Removing and replacing deteriorated glazing is recommended.

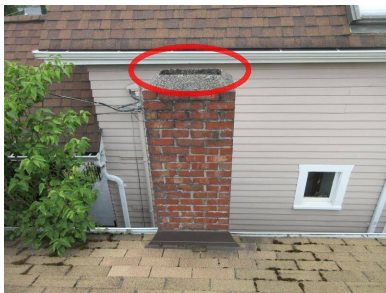
The top of the masonry chimney does not have a spark arrestor/rain cap. The installation of a spark arrestor/rain cap is recommended as a safety upgrade and to prevent moisture damage to the inside of the chimney and fireplace. An additional benefit of a rain cap is that it will keep birds and rodents from entering the house when the damper is left open.

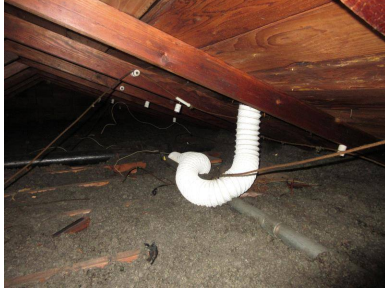
Flexible plastic duct is used to direct air from the vent fan to the exterior. This type of material is unreliable. Replacing the plastic duct with 4" smooth-wall sheet metal duct is recommended.

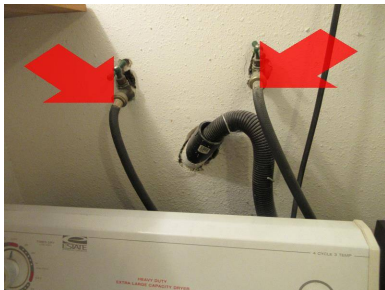
High pressure (steel braided) washer line connections is recommended.

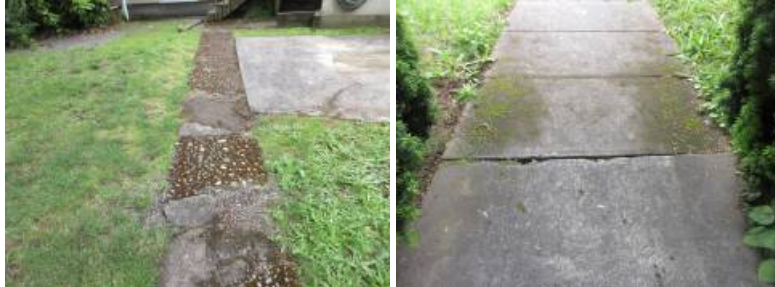
The gaps separating the concrete walkway sections are a trip hazard. Replacement with mortar is recommended.

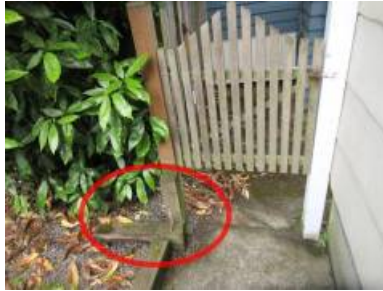
## 2.8 FENCES AND GATES

The gate needs repair, gate posts should be replaced as necessary to restore function.

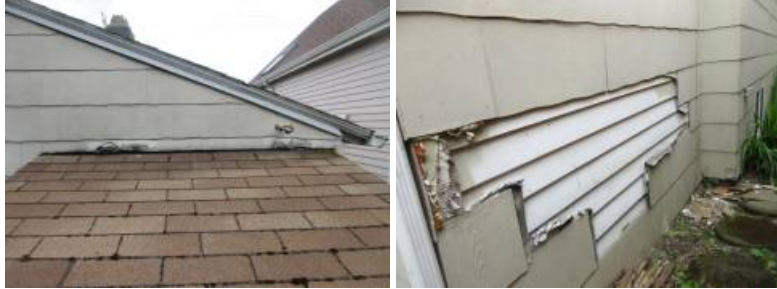
Sections of siding are cracked or missing. Consideration should be given to replacing the damaged siding or installing flashing and/or caulk to prevent moisture or pest entry into these areas.

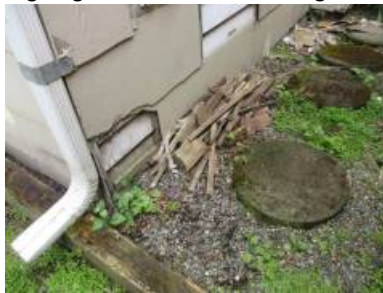
### 3.2 PEST CONTROL

Soil is close to or in contact with siding in some areas around the building exterior. Good building practice requires that foundation walls or pier footings supporting wood frame construction, extend at least 8" above the finish grade with at least a 6" clearance between the top of the soil and the bottom of the wood finish materials. Soil in direct contact with wood creates a hospitable environment for wood destroying organisms. Establishing these minimum clearances is recommended.

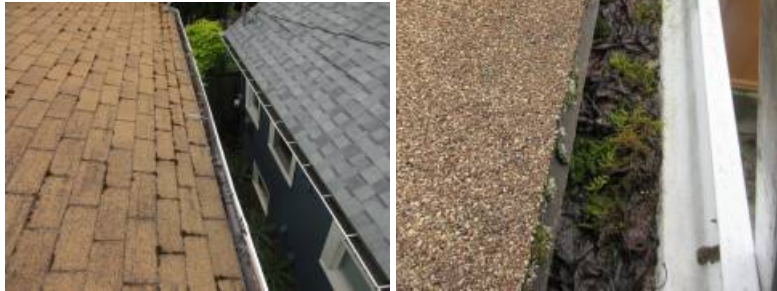
There is a build-up of organic debris inside the gutters. Proper maintenance of gutters and downspouts is essential and should be performed routinely in order to prevent clogging. Maintenance consists primarily of keeping leaves and other organic debris out of the system. Failure to clean the gutters will result in water splash on the building when they overflow. Gutters can be damaged under the weight of the water and organic matter inside the gutter. Gutters should be cleaned as necessary to maintain a free flow of water into the downspouts.

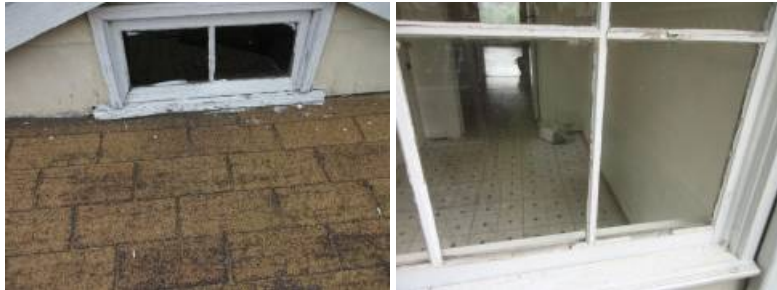
The window glazing is cracked and deteriorated. Glazing helps secure the glass pane and prevents water intrusion into the window frame. Removing and replacing deteriorated glazing is recommended.

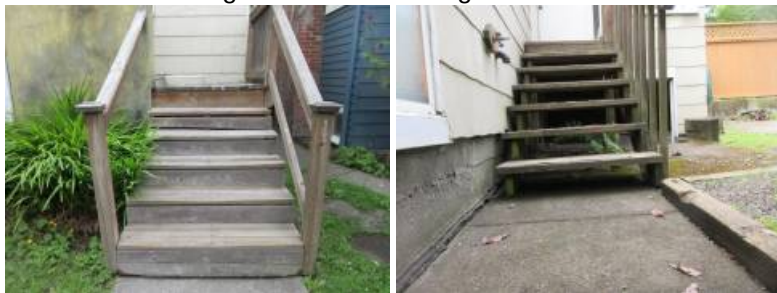
The steps are non-conforming due to the variable and/or excessive rise. Stair design standards require that step risers do not exceed 8" and that the variation in rise not exceed  $\frac{3}{8}$ " in order to reduce falls from tripping. To increase the margin of safety, consideration should be given to reconfiguring the steps so that rise and run do not vary by more than  $\frac{3}{8}$ ". If this proves to be too impractical or expensive, then we recommend exercising caution when using.

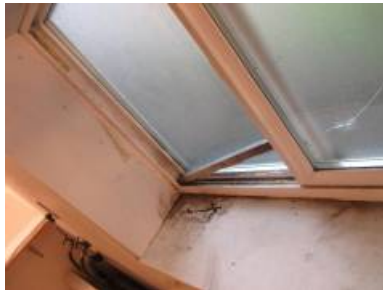
One of the lower bathroom window sills is water damaged. Repair or replacement of the damaged window sills is recommended.

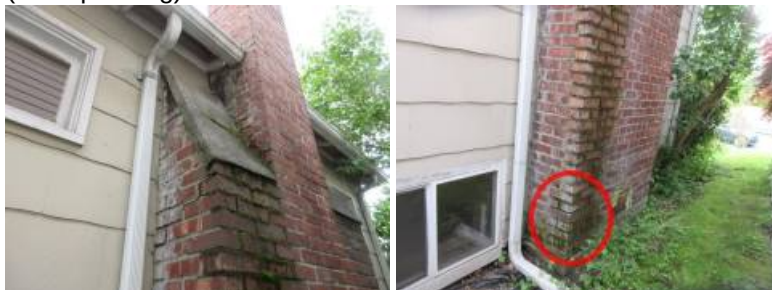
Moss/vegetation was observed in several areas around the chimney. This will lead to accelerated deterioration of the brick masonry mortar. We recommend removal of all organic growth. Damaged areas can be repaired by filling in cutout or defective mortar joints with fresh mortar. (Tuck pointing)

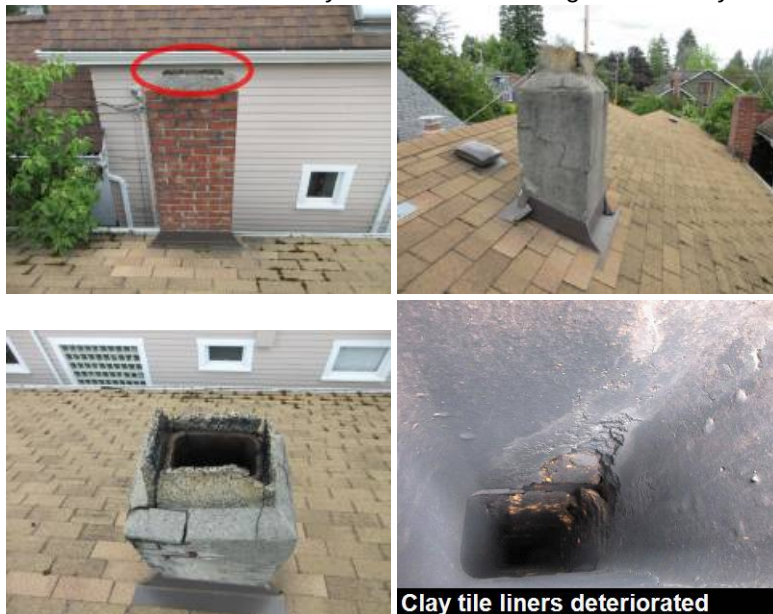
The utility chimney is deteriorated above the roof line. This is a safety concern. Rebuilding the chimney is recommended.

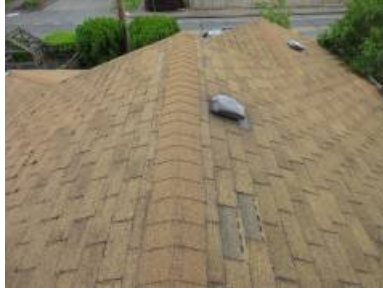
The roof is nearing the end of its service life. Significant wear and deterioration was observed. The need for replacement should be anticipated within 1-3 years.

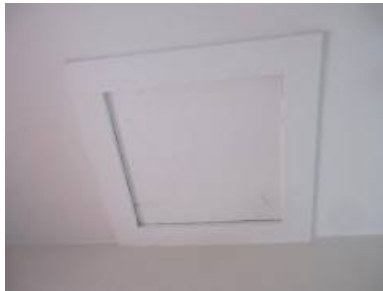
The access opening to the attic is too small by today's standards. The rough framed opening should not be less than 22 inches by 30 inches. Modification of the access opening is recommended for inspection and servicing of components in the attic.

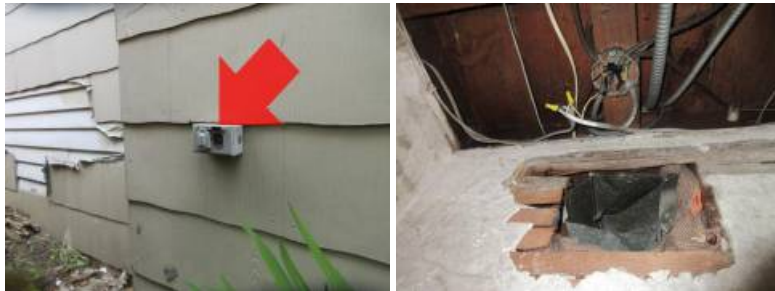
There is a junction box with a missing cover in the basement. This is a fire/shock hazard. Covers should be installed on all junction boxes.
