NOTICE TO BUYER: SELLER-PROCURED INSPECTION REPORT

Ralph & Debbie Kappelhoff
13327 157th Ave NE
Redmond, WA, 98052

At your request, a visual inspection of the above referenced property was conducted on 02/20/2023. We have inspected the major structural components, plumbing, heating and electrical systems for signs of significant non-performance, excessive or unusual wear and general state of repair.

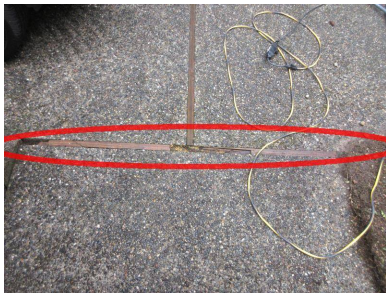
One or more of the wooden dividers separating the concrete walkway sections were infested by wood destroying organisms and have deteriorated to a point where they are becoming a trip hazard. Replacement with mortar is recommended.

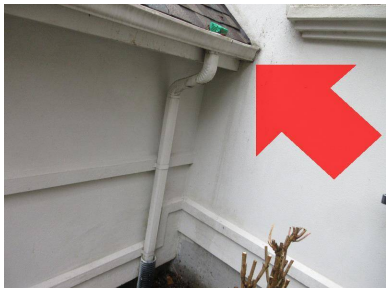
There is a build-up of organic debris inside the gutters. Proper maintenance of gutters and downspouts is essential and should be performed routinely in order to prevent clogging. Maintenance consists primarily of keeping leaves and other organic debris out of the system. Failure to clean the gutters will result in water splash on the building when they overflow. Gutters can be damaged under the weight of the water and organic matter inside the gutter. Gutters should be cleaned as necessary to maintain a free flow of water into the downspouts.

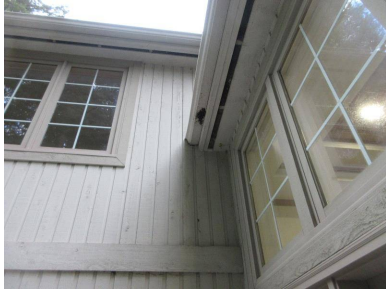
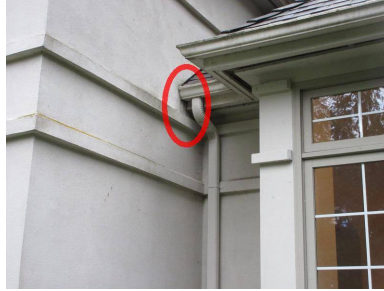
The gutters are corroded and beginning to leak. Replacement of the gutters will be required in the near future.

- 2.5 Walkway Cracks – filled with sealing compound as request by inspector
- 2.5 Walkway Wood Separator – repaired
- 3.5 Gutters and Downspouts – replaced by Rock Roofing on Feb 27, 2023

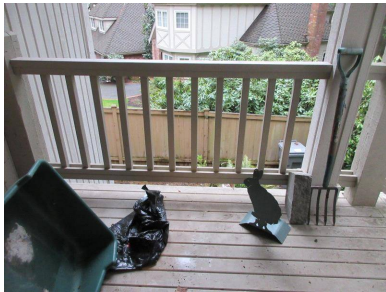
The spacing between the balusters is too wide. This is a hazard to small children. The balusters should be spaced close enough together so that a 4" sphere cannot pass through. Upgrading the porch railing is recommended if small children are present.

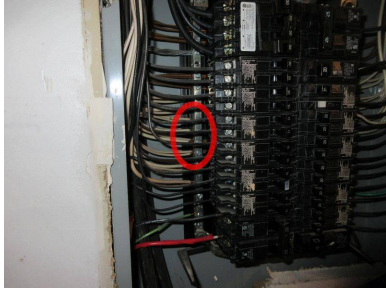
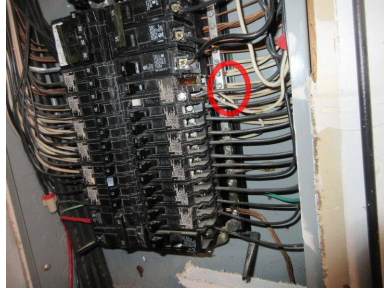
Several of the neutral wires are double tapped on the buss bar. Double tapping means that two conductors share a single terminal. Double tapped terminals can loosen and overheat and therefore are not permitted unless the terminal is specifically listed for multiple wires. This defect is easily repaired by connecting the two wires to a "pig tail", securing them with a wire cap, and then inserting the pig tail conductor under the terminal.

- 7.8 Service Panel – seller disagrees that this is an issue but will implement the recommendation if the buyer feels it is needed

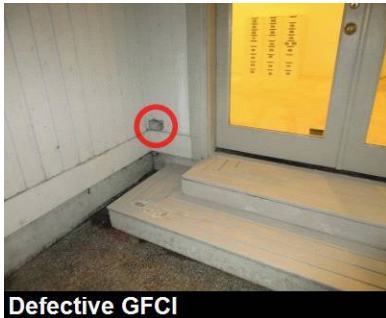
The GFCI receptacle in the lower level northwest entry does not trip when a ground fault is introduced. This is caused by an improperly wired or defective GFCI. Repair or replacement of this GFCI is recommended.

The installation of additional GFCI protection in the laundry room receptacle is recommended.

- 7.12 Receptacles – all receptacles pointed out as lose by the inspector have been corrected
- 7.13 GFCI in Laundry Room – a GFCI has been added and tested

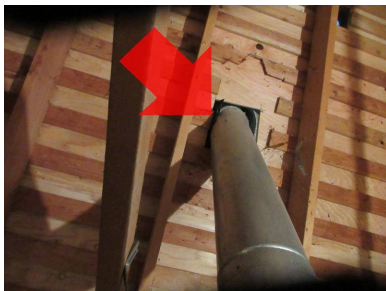
The furnace vent connector is too close to a combustible material. This is a hazard. A minimum clearance of 6" is required between the single wall vent connector and the combustible material. The double wall type B vent requires only 1" of clearance. Repairs are recommended.

- 7.13 GFCI on Lower Deck – this GFCI tested OK before the inspector left
- 7.15 Luminaries in Basement Bathroom – bulb has been replaced and works
- 8.8 Forced Air Vent Air Gap – added additional bracing to the vent to center it

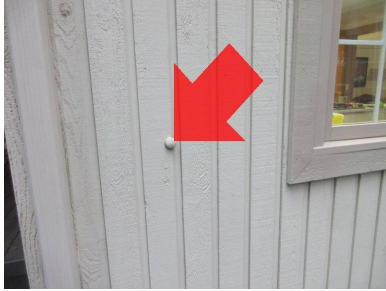
An air gap called a Johnson Tee is installed in the kitchen wall. This air gap protects the dishwasher from contamination caused by a backflow of waste water. The cap protruding on the exterior wall opposite the dishwasher is not drilled. This renders the air gap non-functional. Drilling a 1/4" hole in the end of the cap will restore its function. The remaining visible portions of the Johnson Tee were properly installed and functioning as intended.

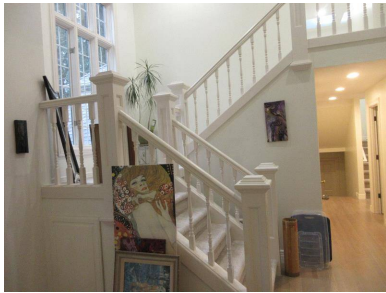
The stair railing baluster spacing is too wide. This is a hazard for small children. The baluster spacing should be reduced as a safety upgrade. Current standards require that a 4-3/8" sphere not pass through the railing.

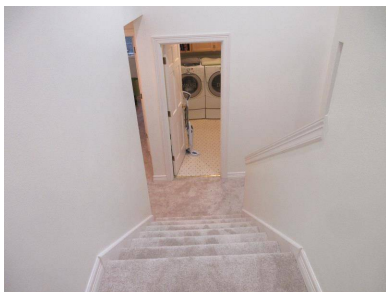
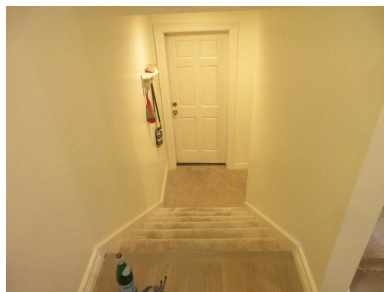
There is no handrail in the stairwells. This is a safety hazard. The installation of a graspable handrail that conforms to present industry standards is recommended.

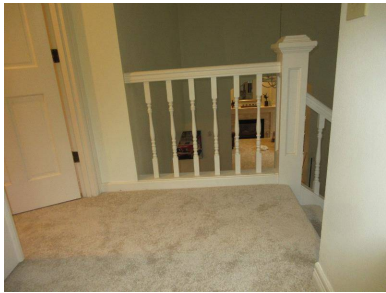
15.3 GUARD RAILINGS

The spacing between the balusters is too wide. This is a hazard to small children. The balusters should be spaced close enough together so that a 4" sphere cannot pass through. Upgrading the guard railing is recommended if small children are present.

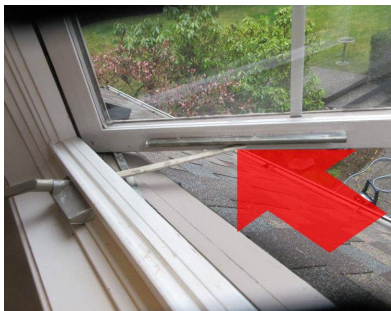
15.7 WINDOWS

Several of the windows do not operate smoothly which makes it difficult to close completely. We recommend repairs as necessary to restore the windows proper operation.

The latch/locking mechanism for one of the guest bedroom windows does not operate properly. We recommend repairs or replacement as necessary.

- 12.34 East Guest Bedroom Bathroom Ventilation – repaired
- 15.7 Window in Guest Room – the opening mechanism has been repaired
- 15.8 Smoke Detectors – additional smoke detector added in the basement bedroom

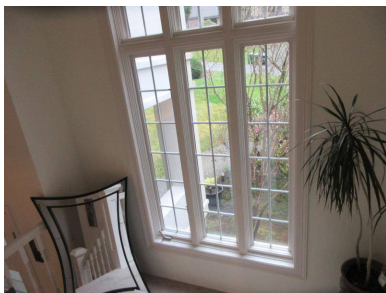
The stairway landing window glass is not labeled as tempered safety glass. The existing glass is nonconforming by current building standards and would be hazardous if broken. The installation of safety glass is recommended as a safety upgrade.

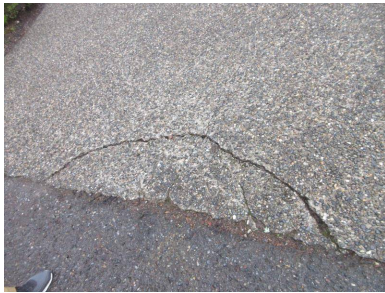
The driveway has cracked and settled differentially. This was probably caused by inadequate preparation of the soil prior to the placement of the concrete. This condition can be repaired by removing and replacing it. The driveway remains functional despite this condition.

One or more of the wooden dividers separating the concrete driveway sections were infested by wood destroying organisms and have deteriorated to a point where they are becoming a trip hazard. Replacement with mortar is recommended.

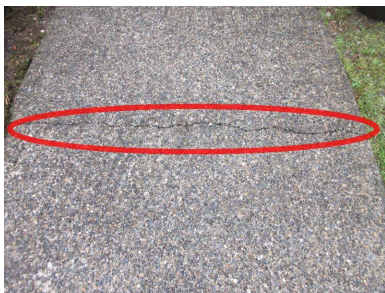
2.5 WALKWAY

Cracks were observed in the concrete surface of the walkway. Minor cracks can be sealed to minimize moisture entry and further settlement of the concrete.

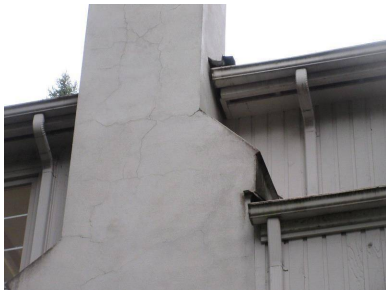
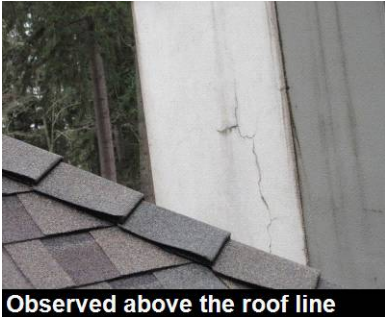
Excessive cracking was observed adjacent the west chimney chase. There is no way to determine, without invasive inspection, if water has leaked past the building paper into the chimney chase framing. Therefore, it is possible that water intrusion has damaged the floor, wall and/or ceiling-roof structure even though there is no evidence of such damage. We recommend the services of a qualified siding contractor for the repair and/or replacement as needed.

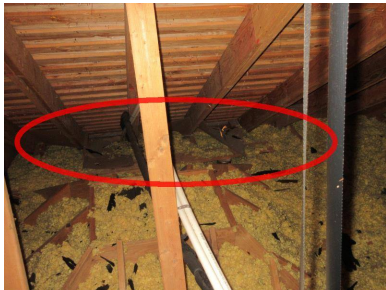
Wind baffles locations are compromised in some areas of the attic. The proper placement of wind baffles in front of all soffit vents is recommended.

- 5.3 Attic Baffles – all baffles reconnected using screws instead of staples
- 6.4 Garage Fire Separation – repaired with non-combustible calc
- 6.5 Garage Passage Door – 2 new spring returns added to close door properly

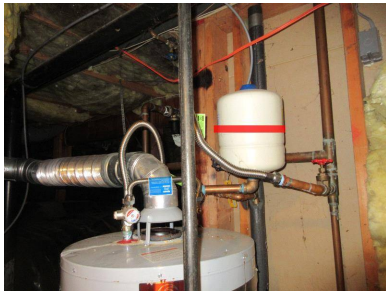
The expansion tank is not adequately secured to the wall. As code requirements start to call for engineered expansion tank supports we recommend the installation of seismic restraints to secure the expansion tank instead of allowing it to simply depend on piping connections that could result in damage to the water pipe and leakage during an earthquake.

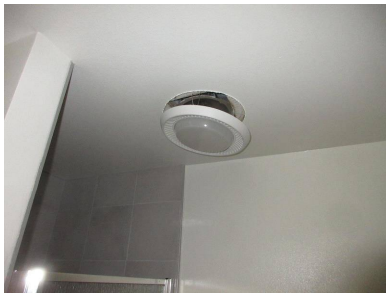
The luminaries/fan diffuser in the southeast guest bedroom bathroom is loose. Loose and/or damaged luminaries covers/diffusers should be replaced or repaired as necessary.

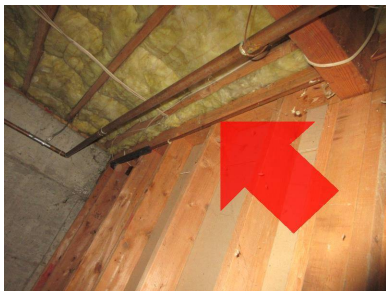
There are water pipes in the crawlspace that are not adequately insulated and could freeze. The installation of foam pipe insulation on all exposed water pipes is recommended.

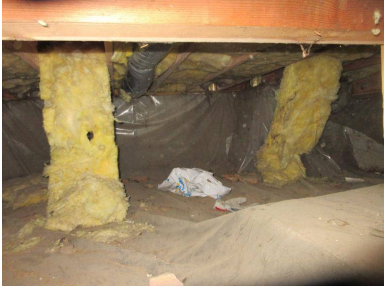
Some of the insulation batts were not properly secured and have falling down. The fallen batts should be reinstalled and secured.

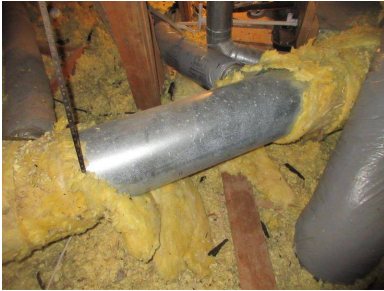
18.5 DUCT INSULATION

Some of the duct insulation is missing or has fallen off the ducts. This increases the amount of heat loss. The installation of new duct insulation is recommended in areas where insulation is missing.

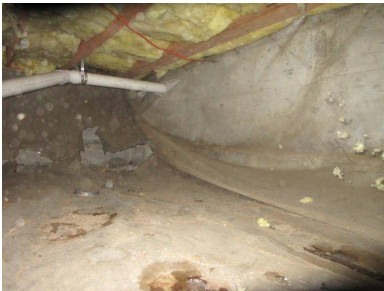
The foundation walls are covered with the plastic vapor retarder. This allows the transmission of water vapor from the soil up and into the exterior wall framing. The plastic vapor retarder should be removed from the foundation.

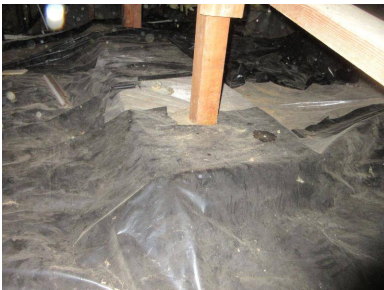
The support post concrete piers are covered with the plastic vapor retarder. This allows the transmission of water vapor from the soil up and into the floor framing. The plastic vapor retarder should be removed from the piers.

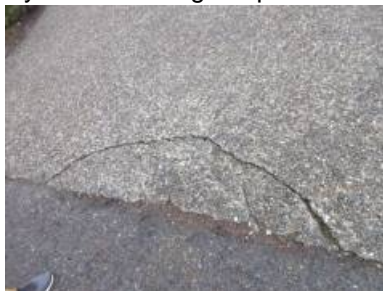
One or more of the wooden dividers separating the concrete driveway sections were infested by wood destroying organisms and have deteriorated to a point where they are becoming a trip hazard. Replacement with mortar is recommended.

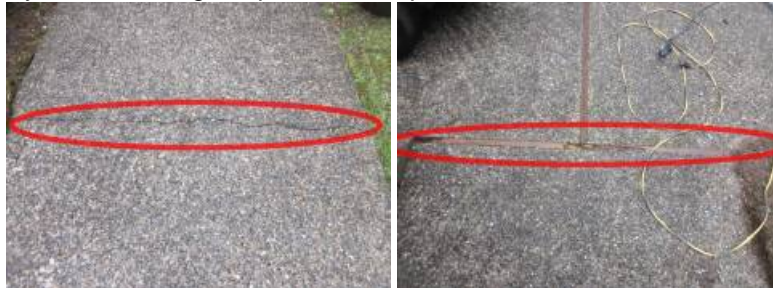
One or more of the wooden dividers separating the concrete walkway sections were infested by wood destroying organisms and have deteriorated to a point where they are becoming a trip hazard. Replacement with mortar is recommended.

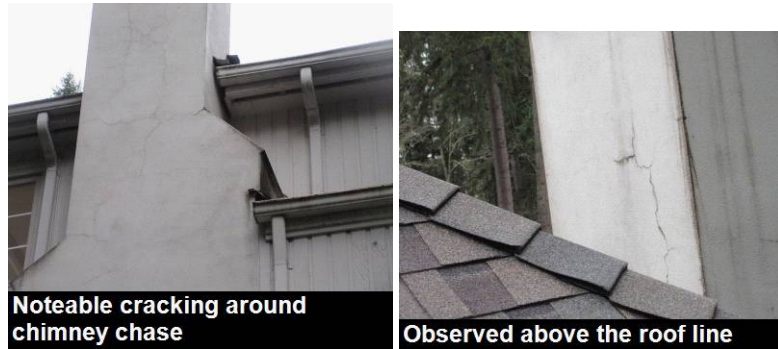
Excessive cracking was observed adjacent the west chimney chase. There is no way to determine, without invasive inspection, if water has leaked past the building paper into the chimney chase framing. Therefore, it is possible that water intrusion has damaged the floor, wall and/or ceiling-roof structure even though there is no evidence of such damage. We recommend the services of a qualified siding contractor for the repair and/or replacement as needed.

Noteable cracking around chimney chase

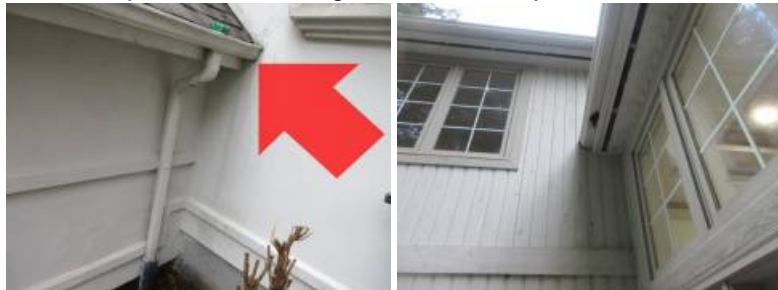
The gutters are corroded and beginning to leak. Replacement of the gutters will be required in the near future.

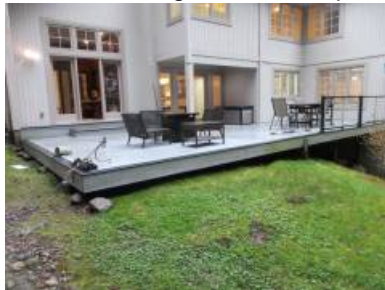
The lower deck is installed close to the ground making it more vulnerable to deterioration. The proximity of the deck to the ground also prevented an inspection of the deck framing. The visible portions of the deck are in good condition.

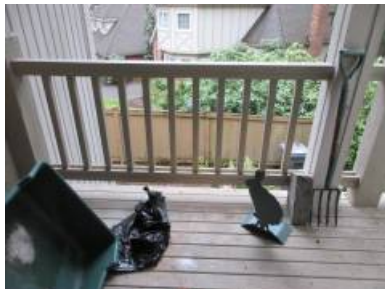
The spacing between the balusters is too wide. This is a hazard to small children. The balusters should be spaced close enough together so that a 4" sphere cannot pass through. Upgrading the porch railing is recommended if small children are present.

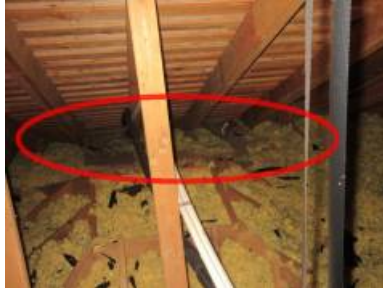
Wind baffles locations are compromised in some areas of the attic. The proper placement of wind baffles in front of all soffit vents is recommended.

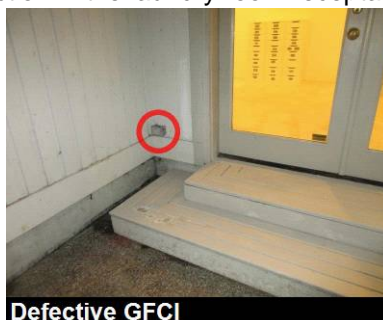
The installation of additional GFCI protection in the laundry room receptacle is recommended.

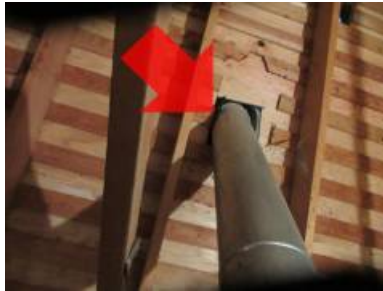
The furnace vent connector is too close to a combustible material. This is a hazard. A minimum clearance of 6" is required between the single wall vent connector and the combustible material. The double wall type B vent requires only 1" of clearance. Repairs are recommended.

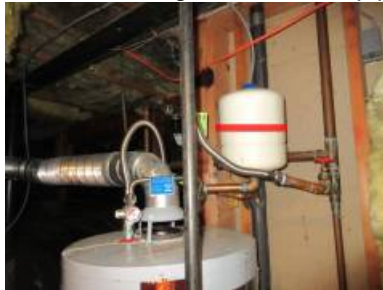
The expansion tank is not adequately secured to the wall. As code requirements start to call for engineered expansion tank supports we recommend the installation of seismic restraints to secure the expansion tank instead of allowing it to simply depend on piping connections that could result in damage to the water pipe and leakage during an earthquake.

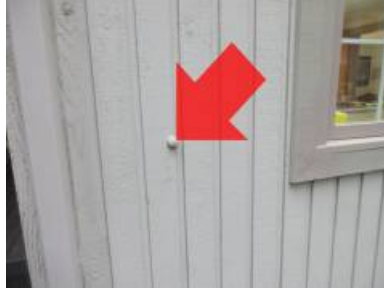
An air gap called a Johnson Tee is installed in the kitchen wall. This air gap protects the dishwasher from contamination caused by a backflow of waste water. The cap protruding on the exterior wall opposite the dishwasher is not drilled. This renders the air gap non-functional. Drilling a 1/4" hole in the end of the cap will restore its function. The remaining visible portions of the Johnson Tee were properly installed and functioning as intended.

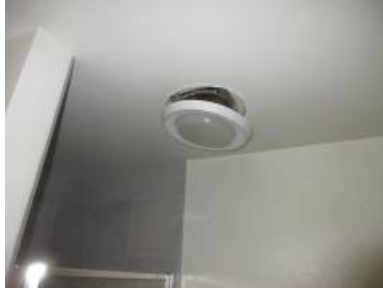
The luminaries/fan diffuser in the southeast guest bedroom bathroom is loose. Loose and/or damaged luminaries covers/diffusers should be replaced or repaired as necessary.

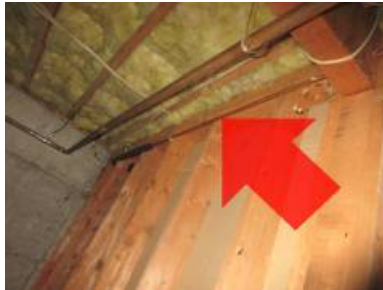
There are water pipes in the crawlspace that are not adequately insulated and could freeze. The installation of foam pipe insulation on all exposed water pipes is recommended.

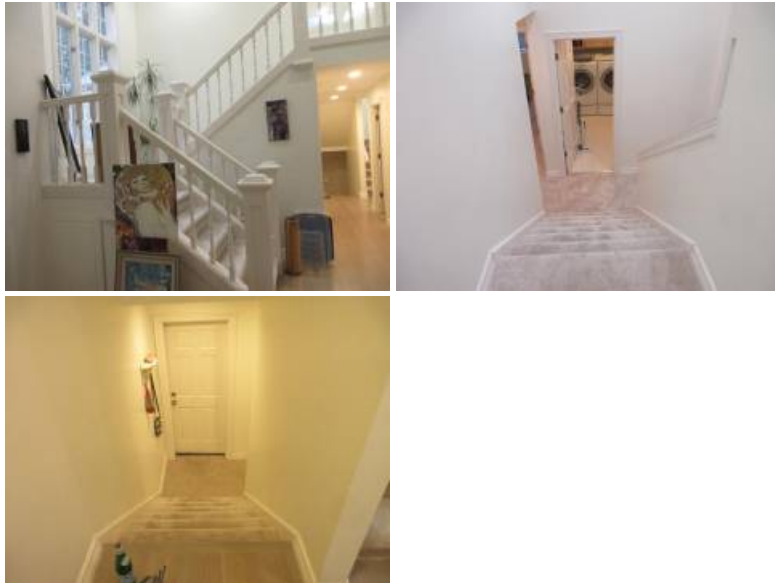
There is no handrail in the stairwells. This is a safety hazard. The installation of a graspable handrail that conforms to present industry standards is recommended.

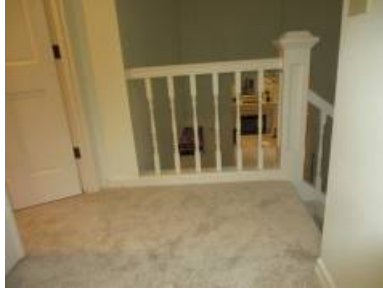
15.3 GUARD RAILINGS

The spacing between the balusters is too wide. This is a hazard to small children. The balusters should be spaced close enough together so that a 4" sphere cannot pass through. Upgrading the guard railing is recommended if small children are present.
