NOTICE TO BUYER: SELLER-PROCURED INSPECTION REPORT

The following notice is given with respect to the Purchase and Sale Agreement dated _____ between _____ (“Buyer”) and **Christine Carrell** _____ (“Seller”) concerning **17405 Ne 139th Pl Redmond WA 98052** (“the Property”).

Christine Carrell 17405 NE 139th Pl, Redmond WA 98052

Per the seller as of July 14th, 2020, the following items listed on the inspection summary, dated June 29th, 2020, have been addressed by the seller:

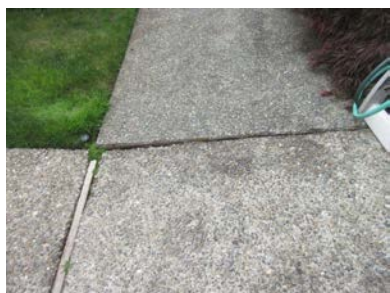
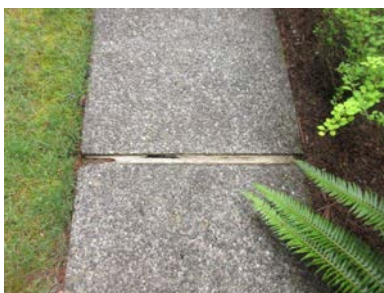
2.5 WALKWAY

One or more of the wooden dividers separating the concrete walkway sections were infested by wood destroying organisms and have deteriorated to a point where they are becoming a trip hazard. Replacement with mortar is recommended.

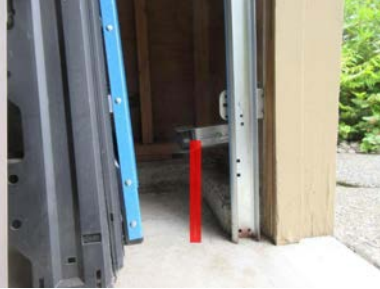
The Photo-eye beam was installed too high above the floor of the garage to adequately offer protection for small children and/or pets. We recommend that the photo-eye be lowered to within 4-6" of the floor.

6.3 Garage door openers: photo-eye beam lowered to within 4-6" of floor

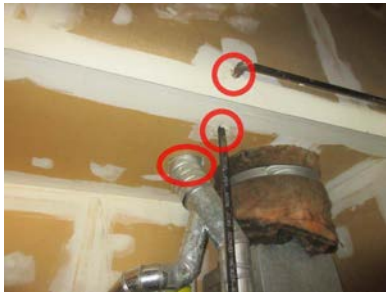
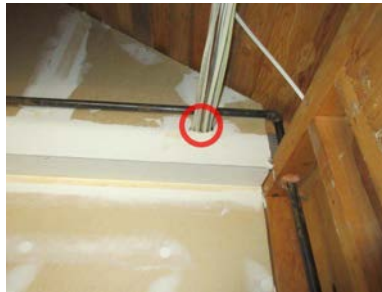
6.4 FIRE SEPARATION

There are voids in the fire resistive barrier between the attic and garage that will allow flames to penetrate. The gypsum barrier slows the spread of a fire from the garage to the structure and/or living space. Patching the voids with a fire retardant caulk is recommended.

The installation of a furnace vent thimble is recommended to prevent flames to spread to the structure.

6.4 Fire Separation: Voids filled with fire retardant foam seal

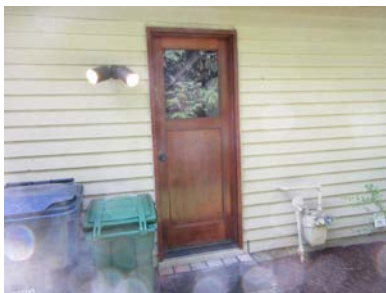
The glass in the garage door is not tempered safety glass. Tempered glass can be identified by the etched emblem in one corner of each pane. A higher margin of safety could be achieved if the glass was approved safety glass. Consideration should be given to replacing the glass as a safety upgrade.

6.6 Exterior door: Please note that the glass is in fact tempered safety glass

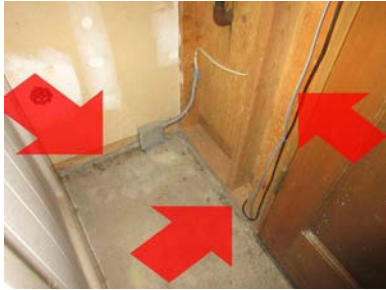
There is Romex cable in the garage that is run over the surface of the wall framing. This cable is vulnerable to damage. The cable should be relocated or protected in conduit.

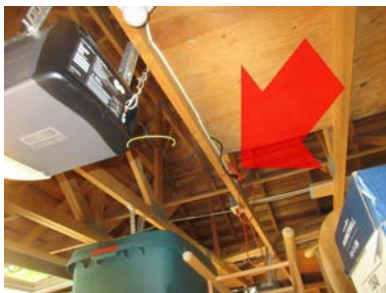
An extension cord is used as a temporary power source for the garage door openers. An extension cord is not suitable as a permanent wiring method. The installation of a receptacle within cords length of the motors is recommended.

7.10: Wiring: Electrician added receptacles for each garage door opener

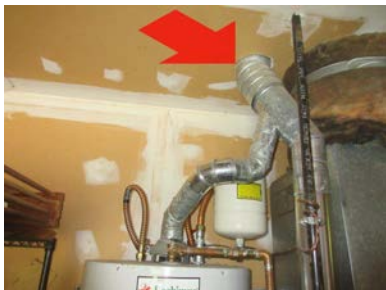
The furnace type B vent is in contact with combustible materials in the garage and attic. This is a fire hazard. A minimum clearance of 1" is required between the type B vent and the combustible material. Repairs are recommended.

8.10: Vent: 2 long-term contractors state this is not a fire hazard for multiple reasons and because of double wall pipe

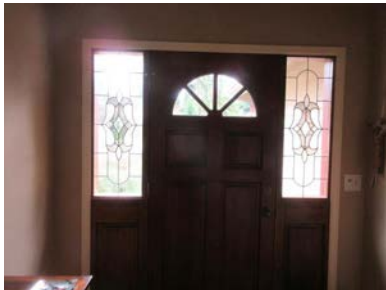
The glass adjacent the front door is not tempered safety glass. Tempered glass can be identified by the etched emblem in one corner of each pane. A higher margin of safety could be achieved if the glass was approved safety glass. Consideration should be given to replacing the glass as a safety upgrade.

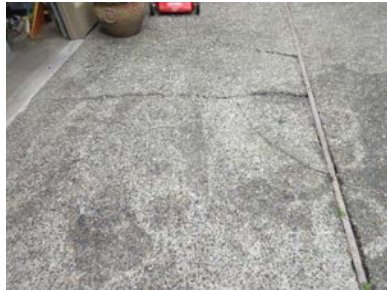
One or more of the wooden dividers separating the concrete driveway sections were infested by wood destroying organisms and have deteriorated to a point where they are becoming a trip hazard. Replacement with mortar is recommended.

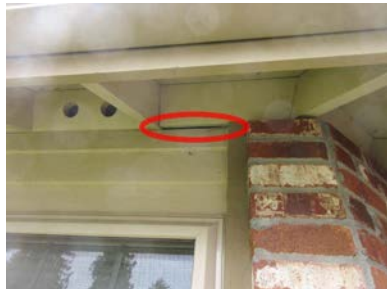
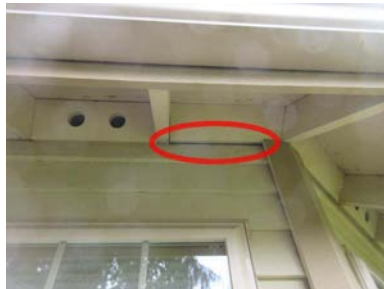
3.5 SOFFITS AND OVERHANGS

There are large gaps over 1/4" in size adjacent the soffit vent blocks. These gaps allow insects and rodents to enter the attic. Covering the gaps with screening, a strip of wood and/or caulking is recommended.

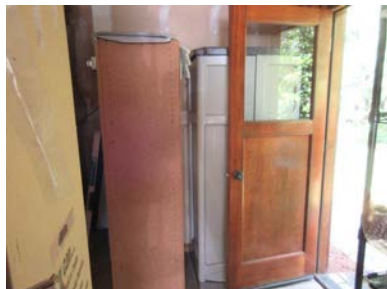
Wood doors are undesirable for use at any location that has chronic exposure to rainfall or water splash. Consideration should be given to upgrading the exposed wood doors to aluminum or vinyl clad doors.

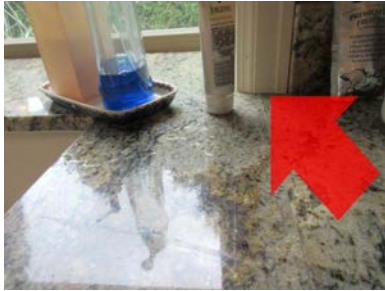
10.1 COUNTERTOPS

The backsplash is not caulked. This allows water and food to enter the gap between the back splash and counter and is difficult to clean. Caulking should be installed at this location.

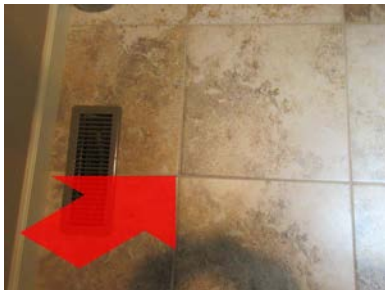
Grout is cracked between some of the ceramic tiles and one of the tiles are loose. This can allow water to enter under the tile and can damage the substrate. Repair of the grouting and loose tile(s) is recommended.

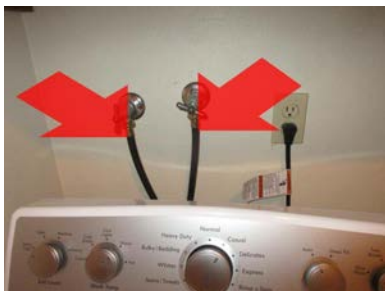
Upgrading the washer connections to high pressure (steel braided) lines is recommended.

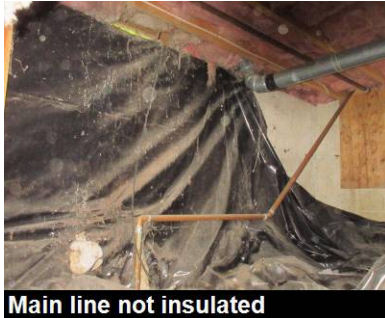
13.4 INTERIOR WATER SUPPLY PIPES

There are water pipes in the crawlspace that are not adequately insulated and could freeze. The installation of foam pipe insulation on all exposed water pipes is recommended.

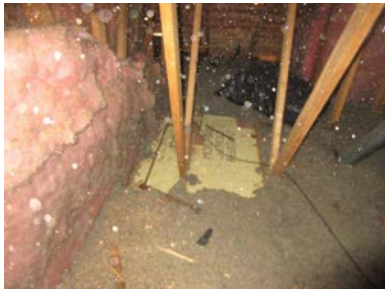
17.1 ATTIC INSULATION

There is a large thermal bypasses in the attic over the master bathroom. A thermal bypass is an opening between an insulated and uninsulated part of the house through which heated air can escape. As air is heated, it rises and pulls cool air in to the space to replace it. This condition will result in significant heat loss. Sealing up all thermal bypass routes is recommended.

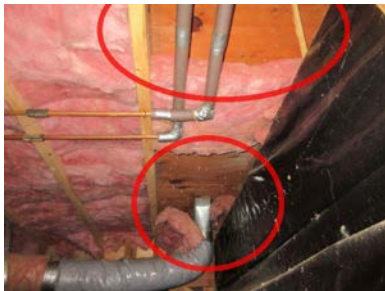
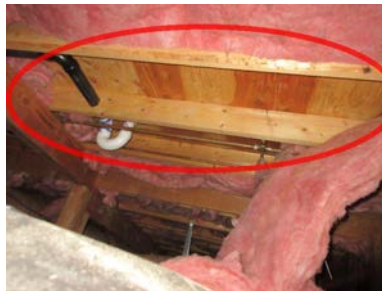
17.4 FLOOR INSULATION

Some of the insulation batts are missing and several were not properly secured and have falling down. The fallen batts should be reinstated and secured. The missing batts should be replaced.

17.4: Floor insulation: Fallen and or missing batts installed and/or secured

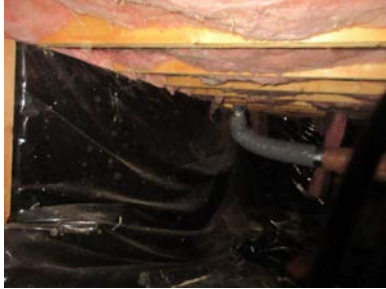
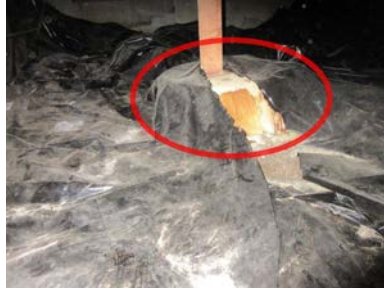
19.4 VAPOR RETARDER

The foundation walls are covered with the plastic vapor retarder. This allows the transmission of water vapor from the soil up and into the exterior wall framing. The plastic vapor retarder should be removed from the foundation so that it covers at least 85% of the entire surface of the soil only.

The support post concrete piers are covered with the plastic vapor retarder. This allows the transmission of water vapor from the soil up and into the floor framing. The plastic vapor retarder should be removed from the pier so that it covers at least 85% of the entire surface of the soil only.

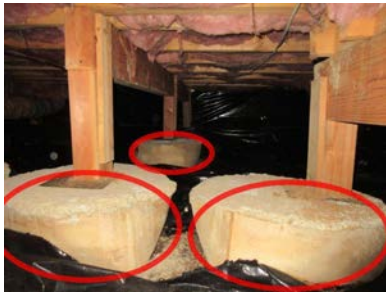
19.5 PEST CONTROL

Scrap-wood and other cellulose debris was observed on the crawl floor. This wood debris creates conducive conditions for wood boring insects. The removal of all cellulose debris is recommended.

Cellulose forms were left in place on the pier footings. This cellulose is conducive to the infestation of various wood destroying organisms. The removal of the cellulose is recommended.

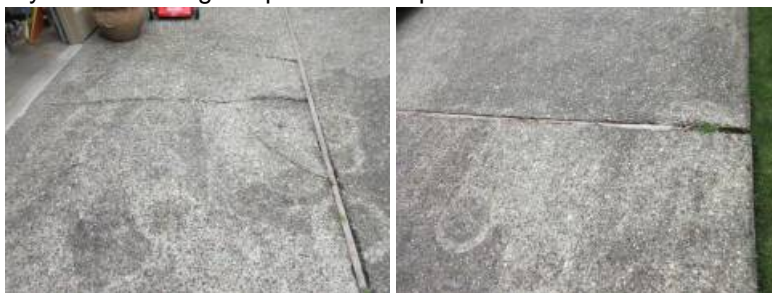
One or more of the wooden dividers separating the concrete driveway sections were infested by wood destroying organisms and have deteriorated to a point where they are becoming a trip hazard. Replacement with mortar is recommended.

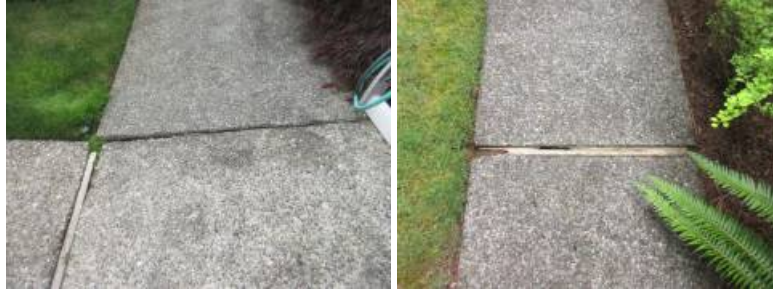
Many legal and public works departments have defined a trip hazard as an irregularity in a walking surface exceeding one inch (1") in height. All walking surfaces should maintain, free of a vertical surface change of 3/4" or more, in the interest of public and personal safety.

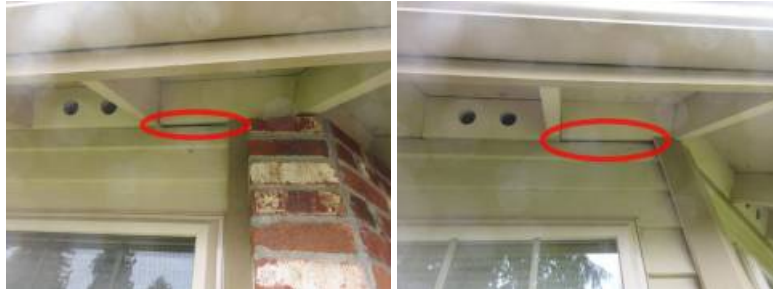
There are large gaps over 1/4" in size adjacent the soffit vent blocks. These gaps allow insects and rodents to enter the attic. Covering the gaps with screening, a strip of wood and/or caulking is recommended.

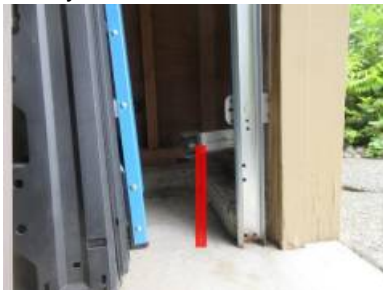
The Photo-eye beam was installed too high above the floor of the garage to adequately offer protection for small children and/or pets. We recommend that the photo-eye be lowered to within 4-6" of the floor.

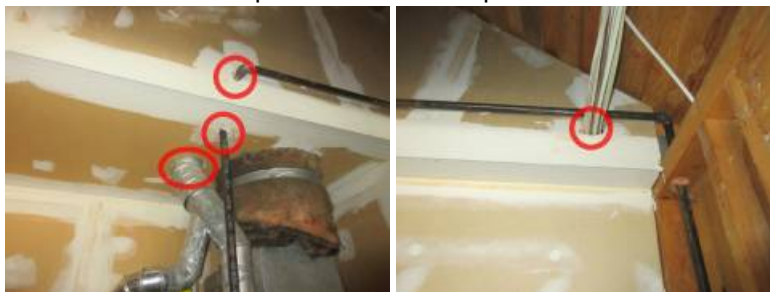
6.4 FIRE SEPARATION

The installation of a furnace vent thimble is recommended to prevent flames to spread to the structure.

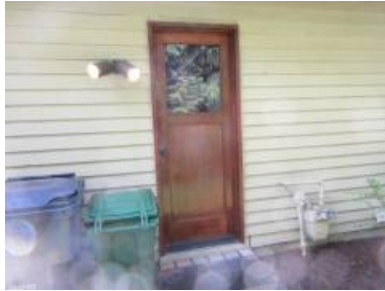
The glass in the garage door is not tempered safety glass. Tempered glass can be identified by the etched emblem in one corner of each pane. A higher margin of safety could be achieved if the glass was approved safety glass. Consideration should be given to replacing the glass as a safety upgrade.

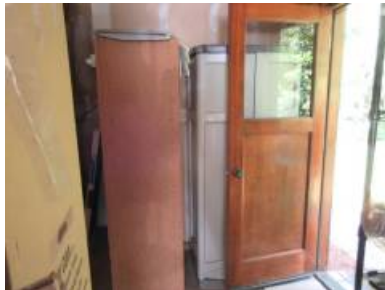
Wood doors are undesirable for use at any location that has chronic exposure to rainfall or water splash. Consideration should be given to upgrading the exposed wood doors to aluminum or vinyl clad doors.

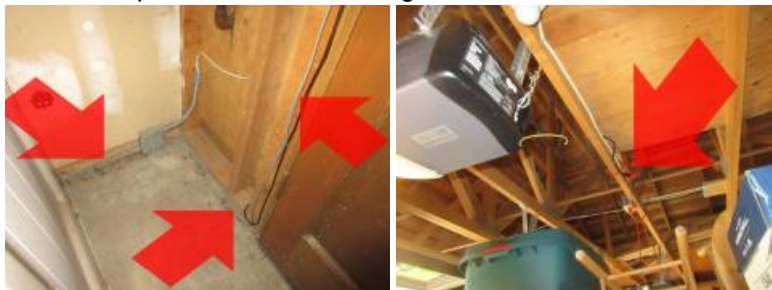
An extension cord is used as a temporary power source for the garage door openers. An extension cord is not suitable as a permanent wiring method. The installation of a receptacle within cords length of the motors is recommended.

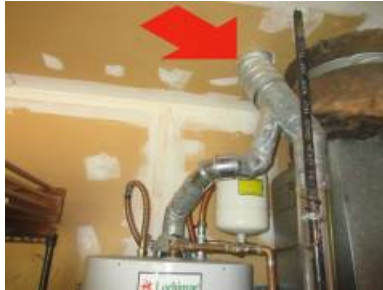
The furnace type B vent is in contact with combustible materials in the garage and attic. This is a fire hazard. A minimum clearance of 1" is required between the type B vent and the combustible material. Repairs are recommended.

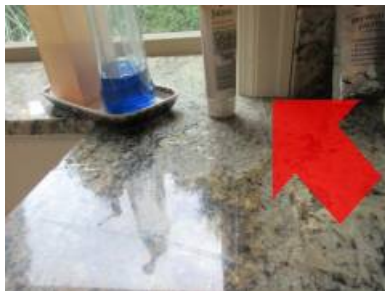
The backsplash is not caulked. This allows water and food to enter the gap between the back splash and counter and is difficult to clean. Caulking should be installed at this location.

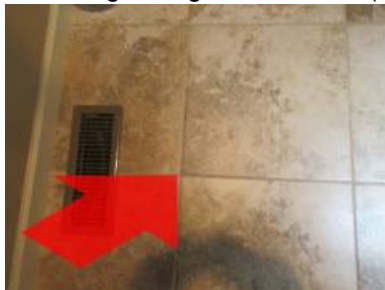
Grout is cracked between some of the ceramic tiles and one of the tiles are loose. This can allow water to enter under the tile and can damage the substrate. Repair of the grouting and loose tile(s) is recommended.

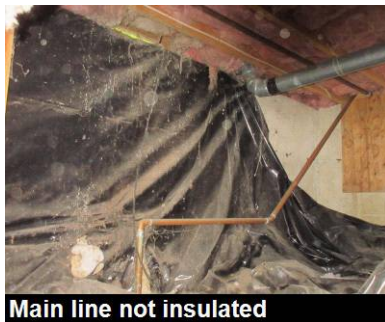
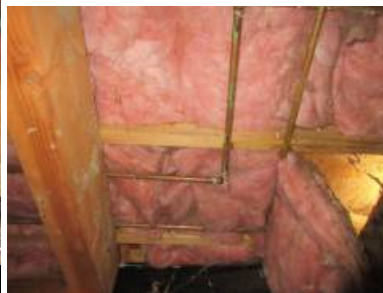
There are water pipes in the crawlspace that are not adequately insulated and could freeze. The installation of foam pipe insulation on all exposed water pipes is recommended.

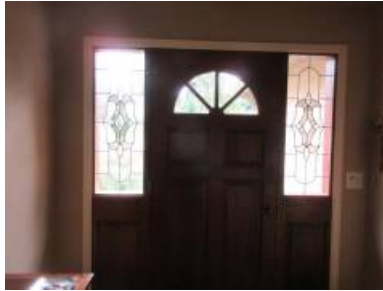
The glass adjacent the front door is not tempered safety glass. Tempered glass can be identified by the etched emblem in one corner of each pane. A higher margin of safety could be achieved if the glass was approved safety glass. Consideration should be given to replacing the glass as a safety upgrade.

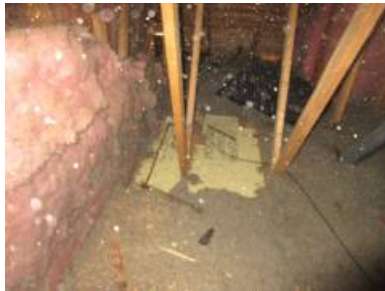
There is a large thermal bypasses in the attic over the master bathroom. A thermal bypass is an opening between an insulated and uninsulated part of the house through which heated air can escape. As air is heated, it rises and pulls cool air in to the space to replace it. This condition will result in significant heat loss. Sealing up all thermal bypass routes is recommended.

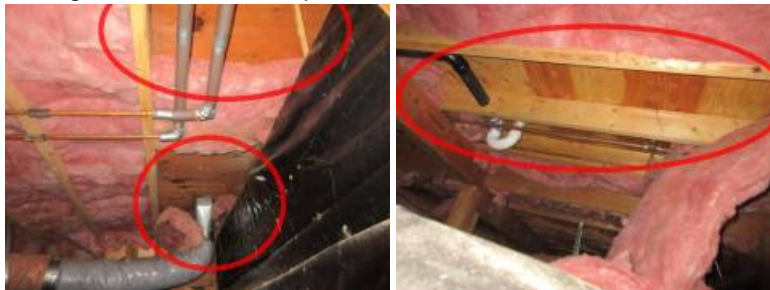
Some of the insulation batts are missing and several were not properly secured and have falling down. The fallen batts should be reinstalled and secured. The missing batts should be replaced.

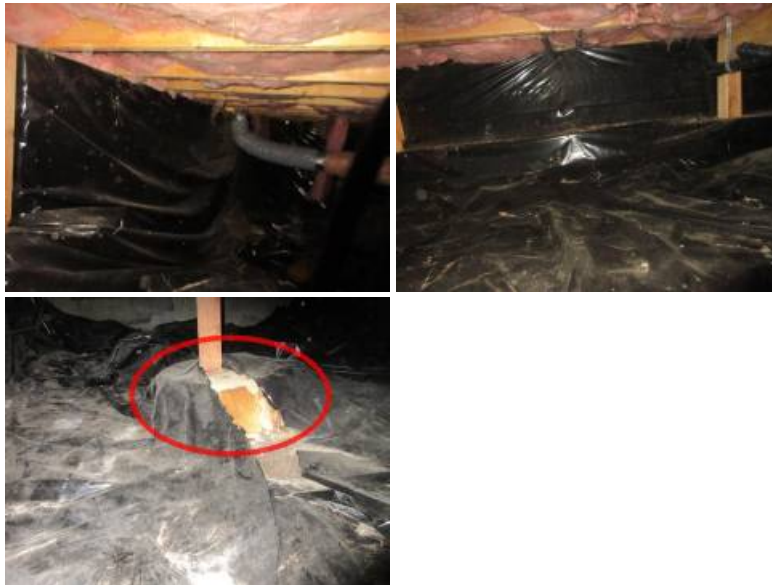
The support post concrete piers are covered with the plastic vapor retarder. This allows the transmission of water vapor from the soil up and into the floor framing. The plastic vapor retarder should be removed from the pier so that it covers at least 85% of the entire surface of the soil only.

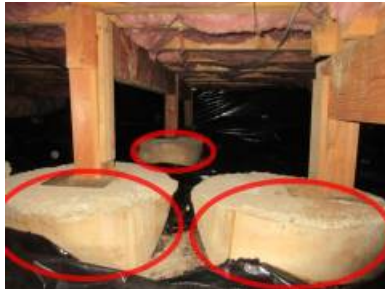
Good building practice requires that foundation walls or pier footings supporting wood frame construction, should extend at least 8" above the finish grade with at least a 6" clearance between the top of the soil and the bottom of the wood finish materials. Untreated wood should be raised 1-2" above surrounding flatwork and should have a moisture barrier such as 30 lb. asphalt impregnated felt installed between the concrete and wood. For additional information and treatment options, you should retain the services of a qualified pest control operator.
