NOTICE TO BUYER: SELLER-PROCURED INSPECTION REPORT

The following notice is given with respect to the Purchase and Sale Agreement dated _____ between _____ (“Buyer”) and Colleen Colley (“Seller”) concerning 17709 NE 137th Ct Redmond WA 98052 (“the Property”).

**Colleen Colley
17709 NE 137th Ct
Redmond, WA 98052**

DATE OF INSPECTION: 1/30/2024.
 INSPECTOR'S NAME: Terry Clark.
 CLIENT NAME: Mr. & Mrs. Adam Stone & Colleen Colley.
 MAILING ADDRESS: 17709 NE 137th Ct.
 Redmond WA.
 CLIENT E-MAIL ADDRESS: adam@adamstone.net colleencolley@hotmail.com.
 ADDRESS OF PROPERTY INSPECTED: 17709 NE 137th Ct.
 Redmond, WA.

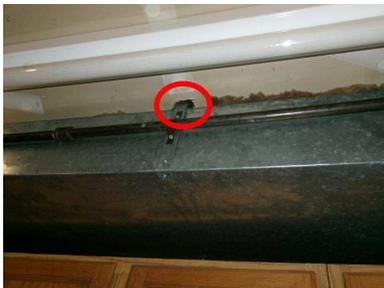
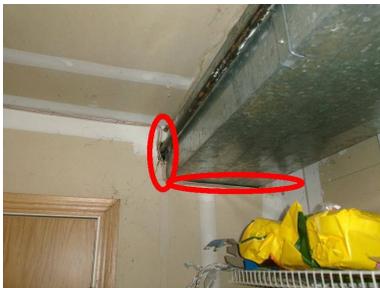
FIRE SEPARATION

There are voids in the fire resistive barrier between the living space and garage that will allow flames to penetrate. The gypsum barrier slows the spread of a fire from the garage to the structure and/or living space. Patching the voids with a fire retardant caulk is recommended.

- Added fire stop foam to penetrations.

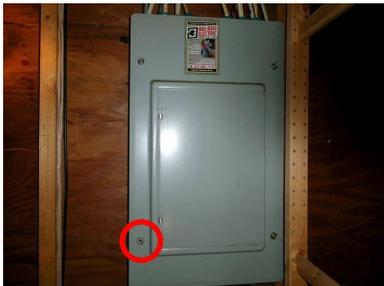
SERVICE PANEL

One of the screws that secure the panel cover to the panel box is missing. This is a potential hazard. Missing screws should be replaced with the original style blunt end screws.

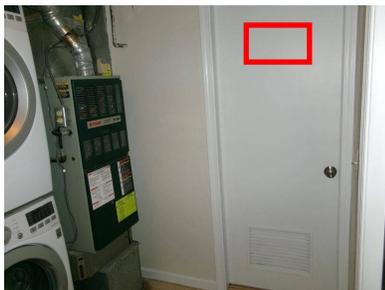
The combustion supply is inadequate. Most appliance manufacturers and municipalities require that there be at least two openings of 100 square inches. The upper opening should be within 12" of the ceiling. The lower opening should be within 12" of the floor. A louvered closet door is also adequate. The supply of combustion air can come from outside, or can come from inside the house, providing that the area it is being drawn from communicates freely with the rest of the house.

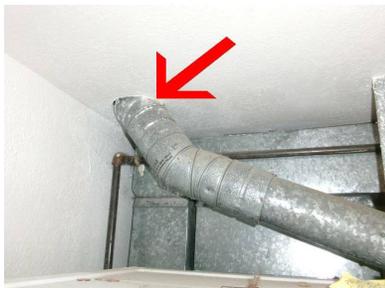
VENT

The furnace type B vent is in contact with combustible materials in the garage. This is a fire hazard. A minimum clearance of 1" is required between the type B vent and the combustible material. Repairs are recommended.

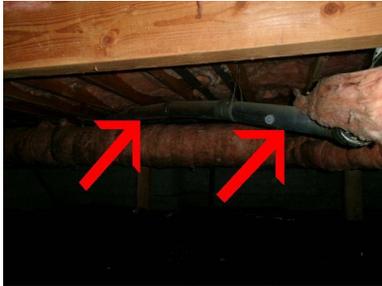
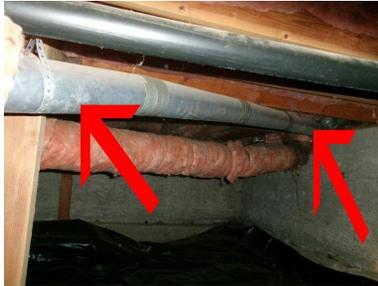
Present standards for dryer vents require a 4 inch, smooth wall duct, no longer than 35 feet, with a hooded damper at the exterior termination. A flexible duct (6 ft max) can only be used between the dryer and floor or wall inlet.

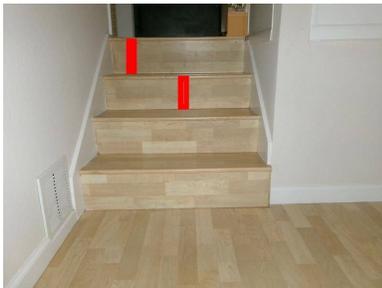
STAIRS

The lower stairs are non-conforming due to the variable and/or excessive rise. Stair design standards require that stair risers do not exceed 8" and that the variation in rise not exceed 3/8" in order to reduce falls from tripping. To increase the margin of safety, consideration should be given to reconfiguring the stairs so that rise and run do not vary by more than 3/8". If this proves to be too impractical or expensive, then we recommend exercising caution when using these stairs.

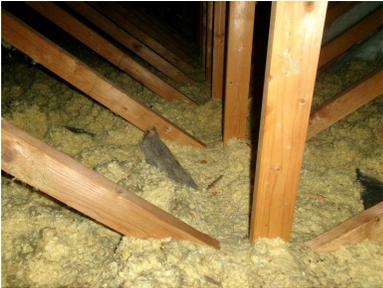
Rodents have tunneled underneath the insulation and created runways on the surface. Over time, this has caused the insulation to collapse from underneath, compress, and loose it's R-value. Also the insulation acts like a sponge and absorbs rodent urine. We recommend the damaged insulation be replaced.

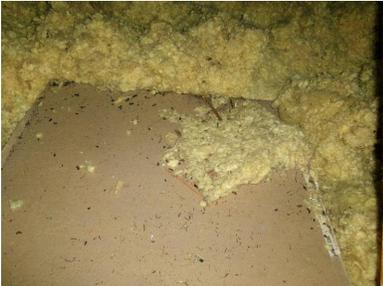
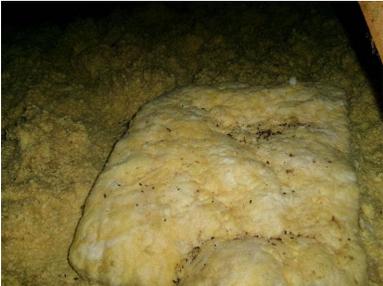
Rodent feces observed within the attic.

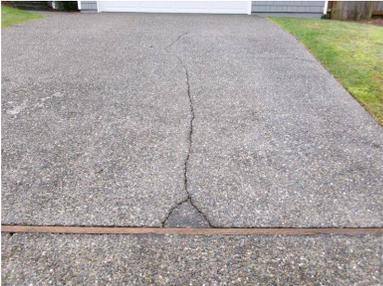
Cracks were observed in the concrete surface of the driveway. These cracks should be sealed to minimize moisture entry and further settlement of the concrete. Minor cracks are common and do not affect the serviceability of the concrete.

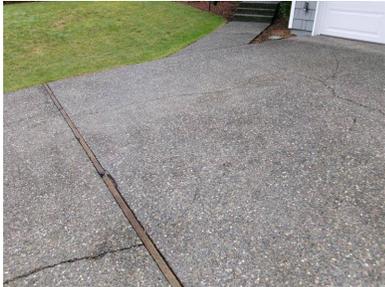
The wooden divider separating the concrete driveway sections has deteriorated to a point where it is a trip hazard. Replacement with mortar is recommended.

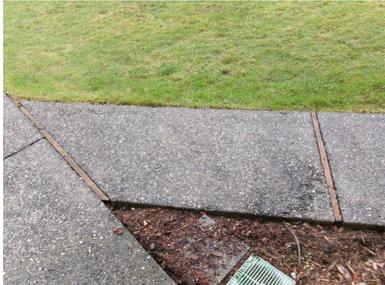
WALKWAY

When the wooden dividers separating the concrete walkway sections have deteriorated to a point where they become a trip hazard. Replacement with mortar is recommended.

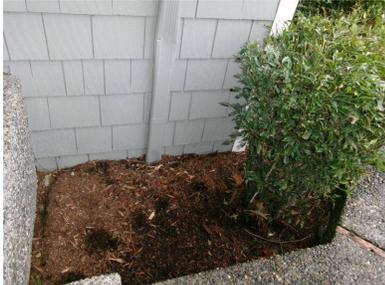
Soil is close to or in contact with siding adjacent the front porch. Good building practice requires that foundation walls or pier footings supporting wood frame construction, extend at least 8" above the finish grade with at least a 6" clearance between the top of the soil and the bottom of the wood finish materials. Soil in direct contact with wood creates a hospitable environment for wood destroying organisms. Establishing these minimum clearances is recommended.

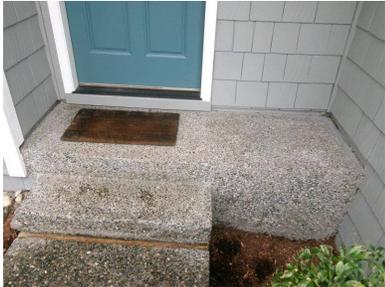
Untreated wood in direct contact with concrete was observed along the stoop. Untreated wood should be raised 1-2" above the concrete. Treating the wood with a preservative sometimes will prevent wood destroy organism damage.

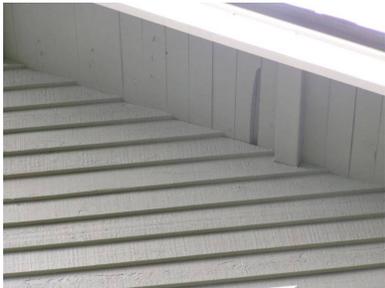
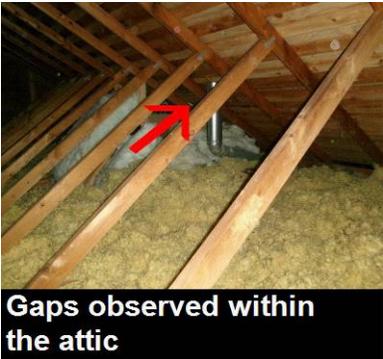
SOFFITS AND OVERHANGS

There are openings between the ends of the skip sheathing boards under the overhang through which rodents can enter into the attic. These openings should be covered with wood, wire mesh or filled with aerosol foam.

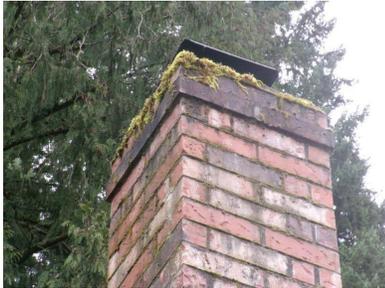
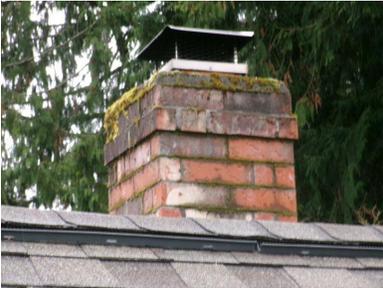
CHIMNEYS

Moss/vegetation was observed in several areas around the upper portion of the chimney. This will lead to accelerated deterioration of the brick masonry mortar. We recommend removal of all organic growth. Damaged areas can be repaired by filling in cutout or defective mortar joints with fresh mortar. (Tuck pointing)

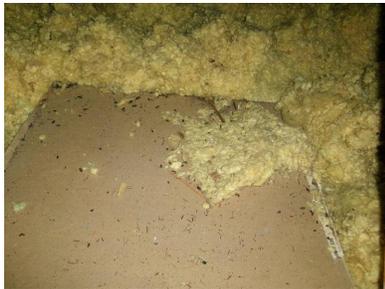
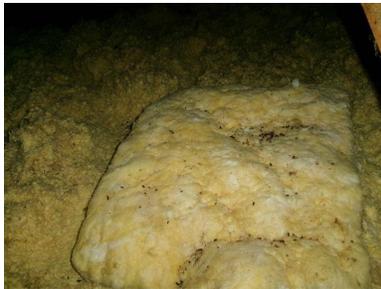
There is evidence of rodent activity in the attic. The first step in eliminating rodents from the attic is to seal all possible entry points using wire mesh, caulking, wood, stainless steel wool, or aerosol foam. Careful work sealing cracks, holes and gaps over 1/4" in size will discourage further activity. Once this work is completed, snap traps baited with peanut butter should be installed and monitored. The absence of rodents in the traps typically means that the rodents have been excluded from the area.

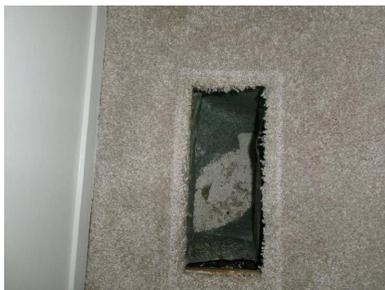
The visible portion of the duct in the primary bedroom contains construction debris. Ducts should be cleaned as necessary.

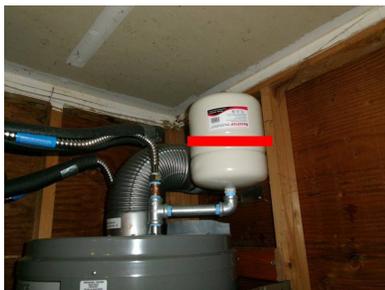
EXPANSION TANK

The expansion tank is not adequately secured to the wall. As code requirements start to call for engineered expansion tank supports we recommend the installation of seismic restraints to secure the expansion tank instead of allowing it to simply depend on piping connections that could result in damage to the water pipe and leakage during an earthquake.

- Secured expansion tank

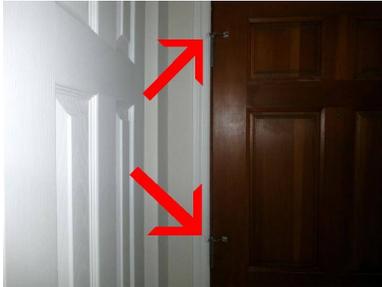
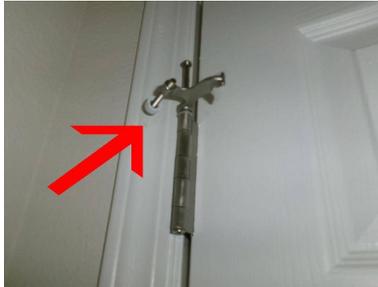
Several of the doors are equipped with hinge mounted door stops. This type of door stop can damage the door skin, tear out hinge screws, and damage the door trim and frame. The removal and replacement with wall or floor mounted door stops is recommended.

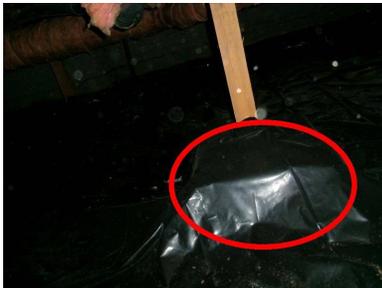
The support post concrete piers are covered with the plastic vapor retarder. This allows the transmission of water vapor from the soil up and into the floor framing. The plastic vapor retarder should be removed from the pier so that it covers at least 85% of the entire surface of the soil only.

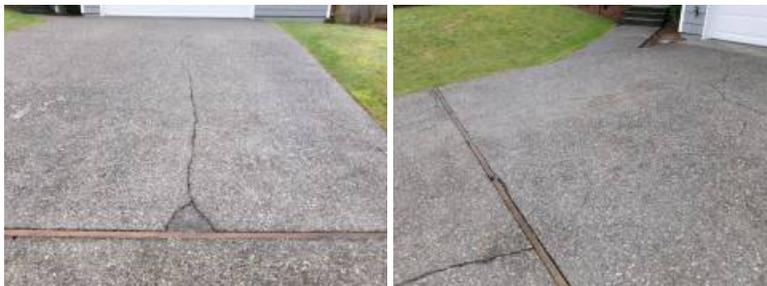
The wooden divider separating the concrete driveway sections has deteriorated to a point where it is a trip hazard. Replacement with mortar is recommended.

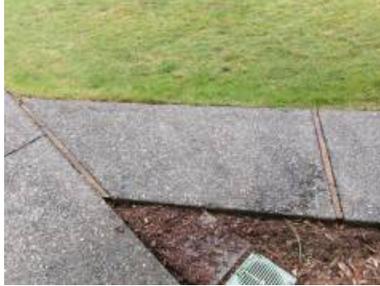
Many legal and public works departments have defined a trip hazard as an irregularity in a walking surface exceeding one inch (1") in height. All walking surfaces should maintain, free of a vertical surface change of 3/4" or more, in the interest of public and personal safety.

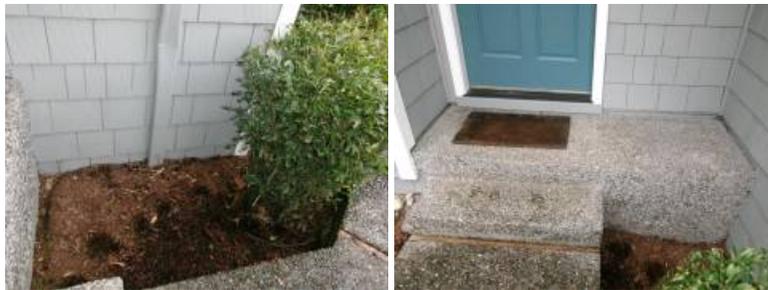
Untreated wood in direct contact with concrete was observed along the stoop. Untreated wood should be raised 1-2" above the concrete. Treating the wood with a preservative sometimes will prevent wood destroy organism damage.

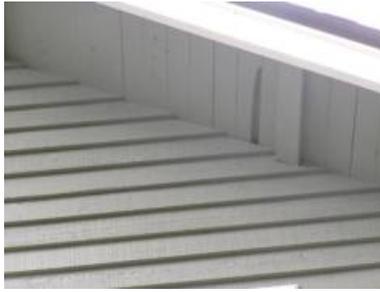
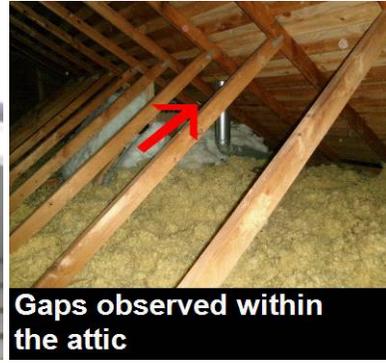
There are openings between the ends of the skip sheathing boards under the overhang through which rodents can enter into the attic. These openings should be covered with wood, wire mesh or filled with aerosol foam.

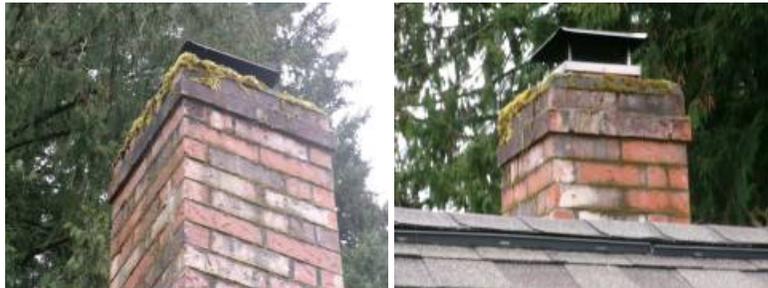
Moss/vegetation was observed in several areas around the upper portion of the chimney. This will lead to accelerated deterioration of the brick masonry mortar. We recommend removal of all organic growth. Damaged areas can be repaired by filling in cutout or defective mortar joints with fresh mortar. (Tuck pointing)

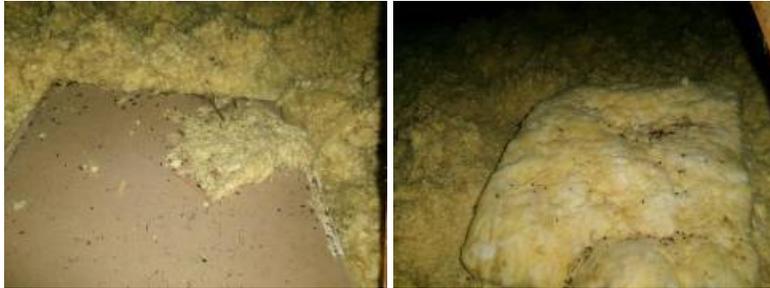
There is evidence of rodent activity in the attic. The first step in eliminating rodents from the attic is to seal all possible entry points using wire mesh, caulking, wood, stainless steel wool, or aerosol foam. Careful work sealing cracks, holes and gaps over 1/4" in size will discourage further activity. Once this work is completed, snap traps baited with peanut butter should be installed and monitored. The absence of rodents in the traps typically means that the rodents have been excluded from the area.

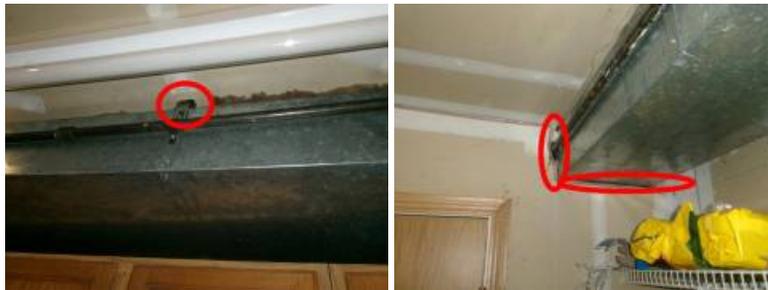
There are voids in the fire resistive barrier between the living space and garage that will allow flames to penetrate. The gypsum barrier slows the spread of a fire from the garage to the structure and/or living space. Patching the voids with a fire retardant caulk is recommended.

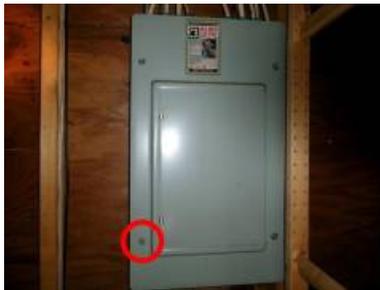
One of the screws that secure the panel cover to the panel box is missing. This is a potential hazard. Missing screws should be replaced with the original style blunt end screws.

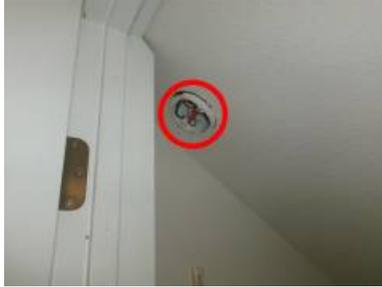
There is a junction box with a missing cover in the closet under the stairs. This is a fire/shock hazard. Covers should be installed on all junction boxes.

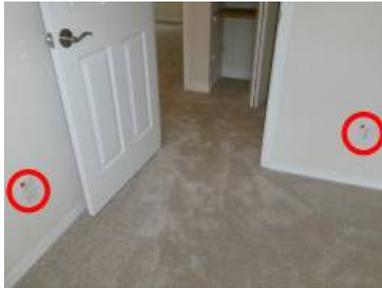
Testing revealed open grounds (ungrounded receptacles) in the primary bedroom. Open grounds are a potential hazard and could damage some electronic equipment. All receptacles with open grounds should be repaired in accordance with applicable electrical codes.

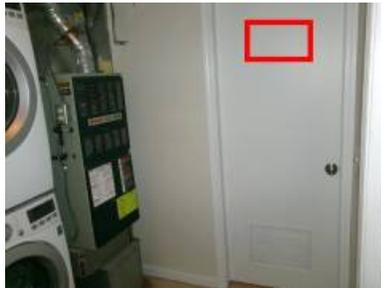
The combustion supply is inadequate. Most appliance manufacturers and municipalities require that there be at least two openings of 100 square inches. The upper opening should be within 12" of the ceiling. The lower opening should be within 12" of the floor. A louvered closet door is also adequate. The supply of combustion air can come from outside, or can come from inside the house, providing that the area it is being drawn from communicates freely with the rest of the house.

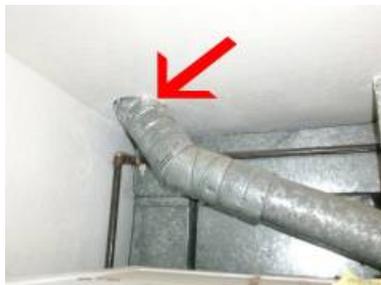
The furnace type B vent is in contact with combustible materials in the garage. This is a fire hazard. A minimum clearance of 1" is required between the type B vent and the combustible material. Repairs are recommended.

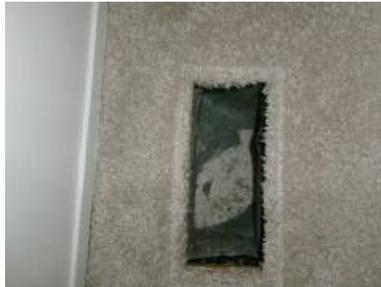
The visible portion of the duct in the primary bedroom contains construction debris. Ducts should be cleaned as necessary.

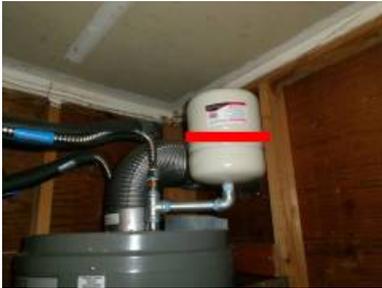
<i>LOCATION OF UNIT</i>	The water heater is located in the garage.
<i>GENERAL INFORMATION</i>	The water heater fuel is natural gas. The capacity of the water heater is 50 gallons. The input rating of the burner is approximately 36,000 BTU. The water heater is approximately 3 years old. Water heaters of this type typically last about 10-15 years.
<i>PRESSURE RELIEF VALVE</i>	The pressure relief valve is properly installed. The valve was not tested, as this could cause the valve to leak.
<i>SHUTOFF VALVE</i>	The shutoff valve for the water supply to the water heater is properly installed and is functioning as intended.
<i>WATER CONNECTIONS AT TANK</i>	The water connections at the tank are properly installed and are performing their intended function.
<i>EXPANSION TANK</i>	The expansion tank is not adequately secured to the wall. As code requirements start to call for engineered expansion tank supports we recommend the installation of seismic restraints to secure the expansion tank instead of allowing it to simply depend on piping connections that could result in damage to the water pipe and leakage during an earthquake.

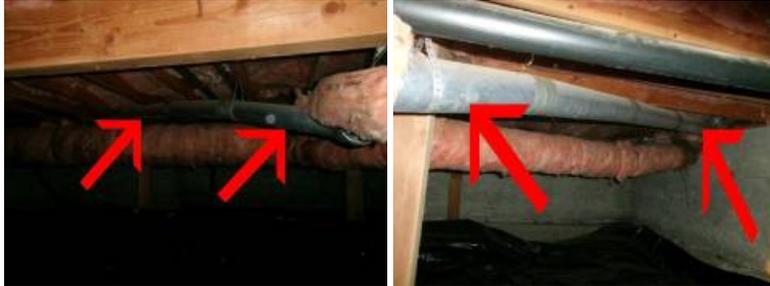
Present standards for dryer vents require a 4 inch, smooth wall duct, no longer than 35 feet, with a hooded damper at the exterior termination. A flexible duct (6 ft max) can only be used between the dryer and floor or wall inlet.

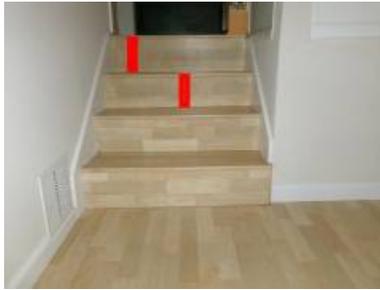
The lower stairs are non-conforming due to the variable and/or excessive rise. Stair design standards require that stair risers do not exceed 8" and that the variation in rise not exceed 3/8" in order to reduce falls from tripping. To increase the margin of safety, consideration should be given to reconfiguring the stairs so that rise and run do not vary by more than 3/8". If this proves to be too impractical or expensive, then we recommend exercising caution when using these stairs.

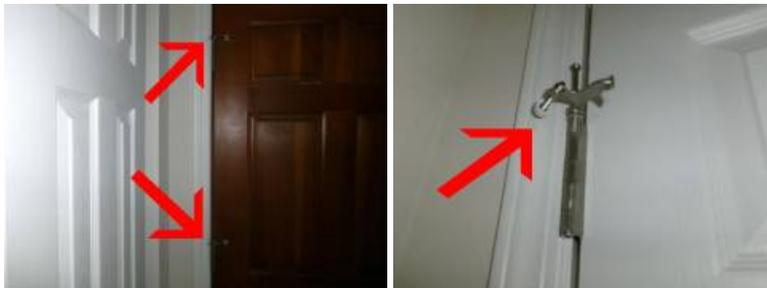
Several of the doors are equipped with hinge mounted door stops. This type of door stop can damage the door skin, tear out hinge screws, and damage the door trim and frame. The removal and replacement with wall or floor mounted door stops is recommended.

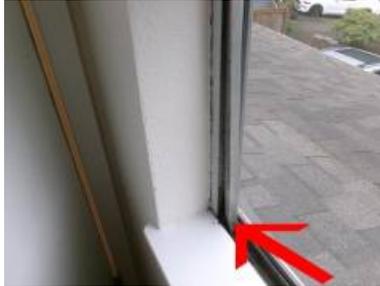
The window should not be used until repairs are completed. Several windows do not operate smoothly which makes them difficult to open and close. Windows should be adjusted or repaired as necessary to improve operation.

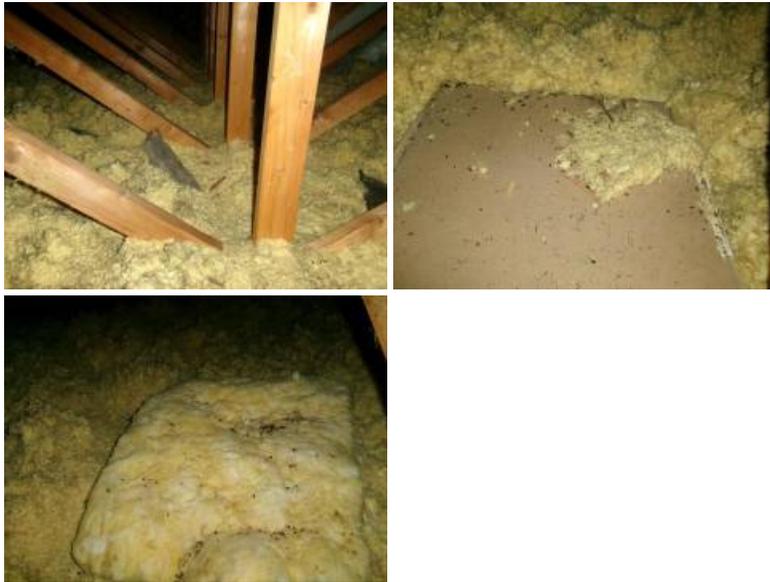
Rodent feces observed within the attic.

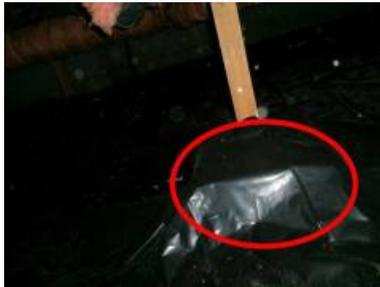
The support post concrete piers are covered with the plastic vapor retarder. This allows the transmission of water vapor from the soil up and into the floor framing. The plastic vapor retarder should be removed from the pier so that it covers at least 85% of the entire surface of the soil only.
