**NOTICE TO BUYER: SELLER-PROCURED INSPECTION REPORT**

**Paddleford (Seller)**  
**17249 NE 125<sup>th</sup> Street, Redmond, WA 98052**

The home pre-sale inspection was completed on March 20, 2024 by Terry Clark with Clark Inspections. The following items listed on the pre-sale inspection report summary dated March 21, 2024 have been corrected by the seller as part of preparation for sale in good faith.

At your request, a visual inspection of the above referenced property was conducted on 03/20/2024. We have inspected the major structural components, plumbing, heating and electrical systems for signs of significant non-performance, excessive or unusual wear and general state of repair.

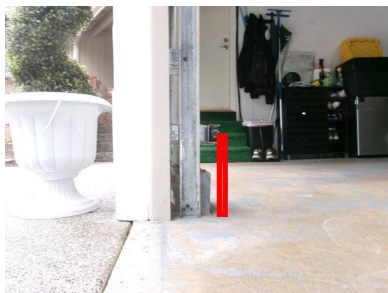
#### ATTACHED GARAGE: GARAGE DOOR OPENER

The Photo-eye beam was installed to high above the floor of the garage to adequately offer protection for small children and/or pets. We recommend that the photo-eye be lowered to within 4-6" of the floor.

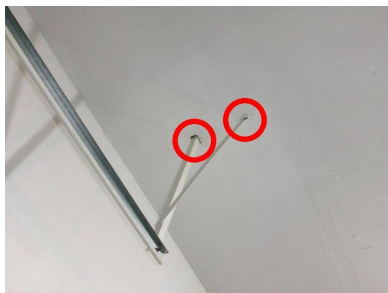
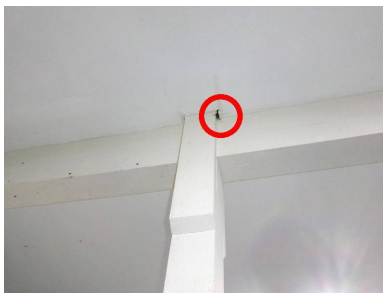
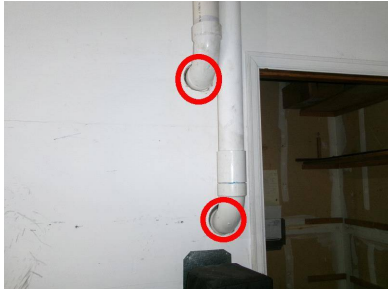
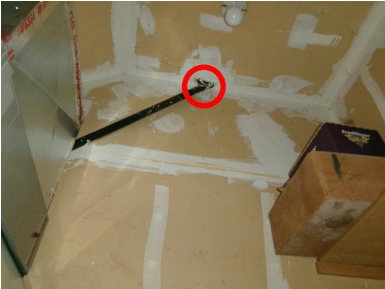
#### *FIRE SEPARATION*

There are voids in the fire resistive barrier between the living space and garage that will allow flames to penetrate. The gypsum barrier slows the spread of a fire from the garage to the structure and/or living space. Patching the voids with a fire retardant caulk is recommended.

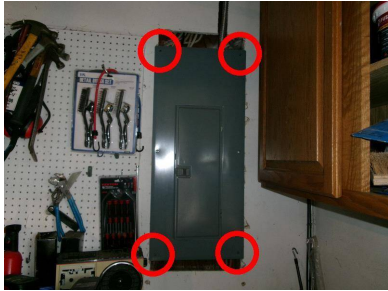
**SERVICE PANEL**

Screws that secure the panel cover to the panel box are missing. This is a potential hazard. Missing screws should be replaced with the original style blunt end screws.

- Replaced missing screws in the panel box cover in garage.
- Repaired open grounds in kitchen.
- Installed additional GFCI protection in all the garage, kitchen and laundry room receptacles.

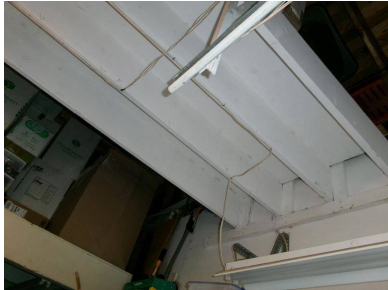
**WIRING**

There is Romex cable in the garage that is run over the surfaces of the wall and ceiling. This cable is vulnerable to damage. The cable should be relocated or protected in conduit.

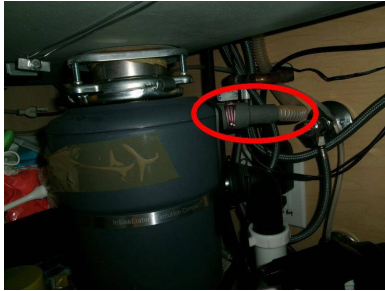
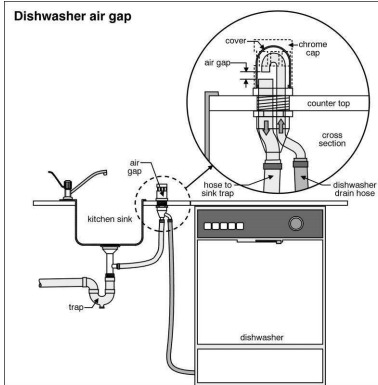
**AIR GAP**

The dishwasher drain lacks an air gap. The dishwasher will function without one, but there is a risk of contamination of the inside of the dishwasher by waste water. The installation of an air gap above the flood rim of the sink is recommended.

- The dishwasher currently utilizes a high loop which prevents wastewater flowing from sink to the dishwasher, as well it protects against mild cases of back siphoning. Seller can remove the instant hot water tap and replace it with an air gap.

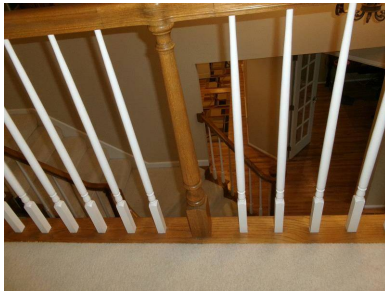
The spacing between the balusters is too wide. This is a hazard to small children. The balusters should be spaced close enough together so that a 4" sphere cannot pass through. Upgrading the guard railing is recommended if small children are present.

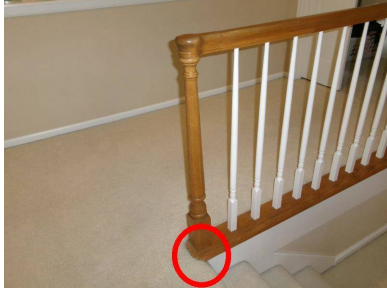
The guard railing lacks lateral stability. The installation of additional lateral supports is recommended.

- The guard railings were secured to fix the lateral instability.

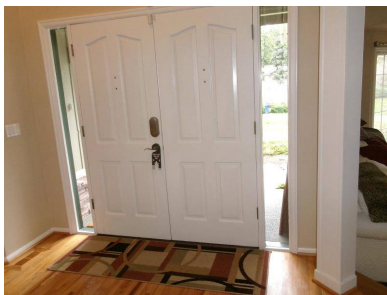
### **WINDOWS**

The glass adjacent the entry door is not tempered safety glass. Tempered glass can be identified by the etched emblem in one corner of each pane. A higher margin of safety could be achieved if the glass was approved safety glass. Consideration should be given to protecting or replacing the glass as a safety upgrade.

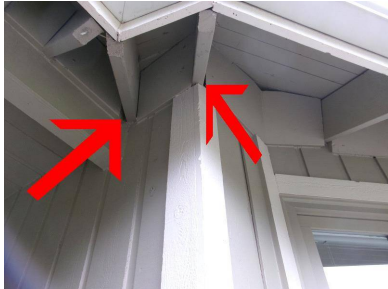
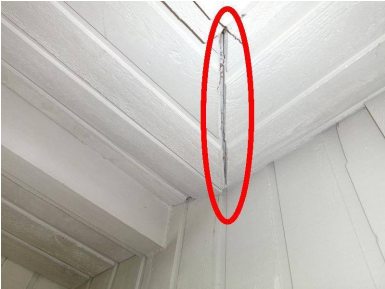
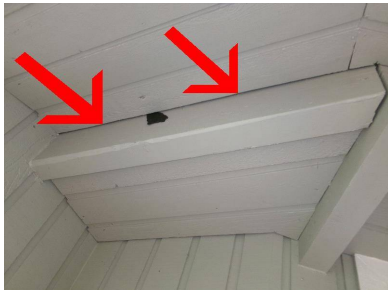
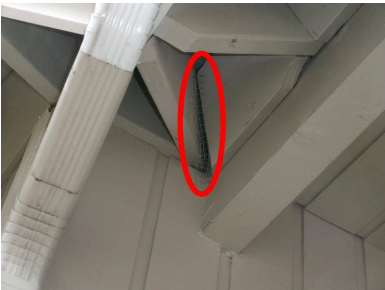
There are large gaps over 1/4" in size adjacent the soffit vent blocks. These gaps allow insects and rodents to enter the attic. Covering the gaps with screening, a strip of wood and/or caulking is recommended.

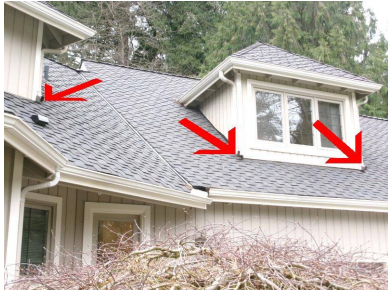
**GUTTERS AND DOWNSPOUTS**

Downspouts draining directly onto the asphalt shingle surface causes excessive wear of the roofing material. Downspout extensions to the lower gutters should be installed to prevent excessive wear and tear of the roofing.

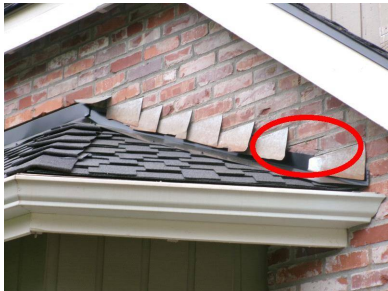
**FLASHINGS**

A section of counter flashing is missing at the roof to masonry wall intersection. This is allowing leakage to occur. The installation of counter flashings is recommended.

- Flashings. Installation of flashing where pieces were missing.

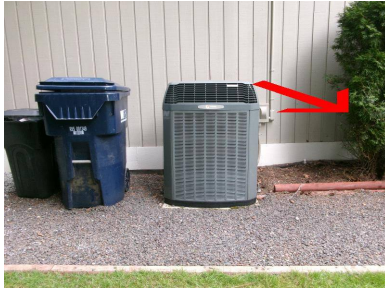
The pad supporting the outdoor condensing unit has settled, leaving it out of level. The connections can be stressed and accelerated wear of the bearings and other components may occur. The unit should be leveled.

- A/C unit was relevelled.

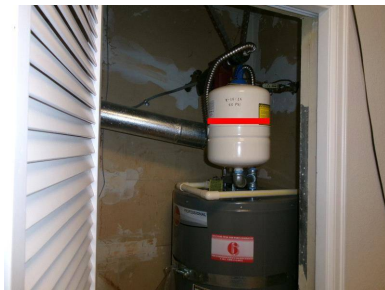
### *EXPANSION TANK*

The expansion tank is not adequately secured to the wall. As code requirements start to call for engineered expansion tank supports we recommend the installation of seismic restraints to secure the expansion tank instead of allowing it to simply depend on piping connections that could result in damage to the water pipe and leakage during an earthquake.

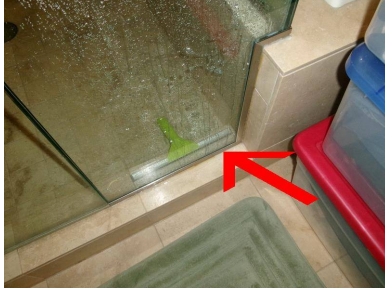
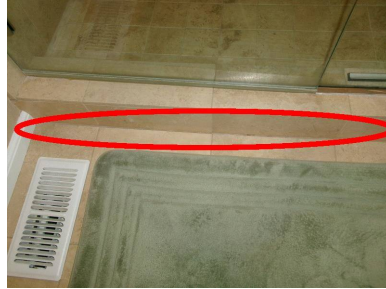
The glass enclosure has been leaking at the lower corner. No damage was visible, but resealing or repairing the enclosure is recommended as preventive maintenance.

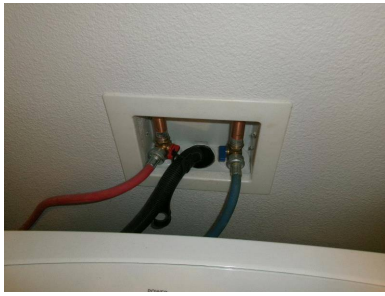
Upgrading the washer connections to high pressure (steel braided) lines is recommended.

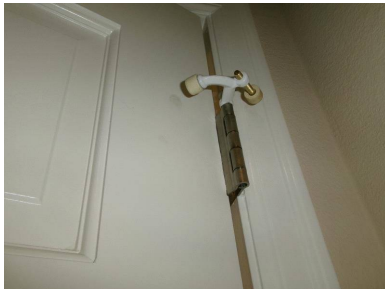
**DOORS**

Doors are equipped with hinge mounted door stops can damage the door skin, tear out hinge screws, and damage the door trim and frame. The removal and replacement with wall or floor mounted door stops is recommended.

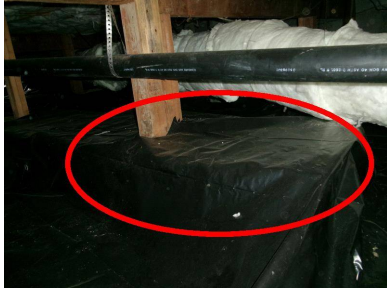
**VAPOR RETARDER**

Several of the support post concrete piers are covered with the plastic vapor retarder. This allows the transmission of water vapor from the soil up and into the floor framing. The plastic vapor retarder should be removed from the pier so that it covers at least 85% of the entire surface of the soil only.

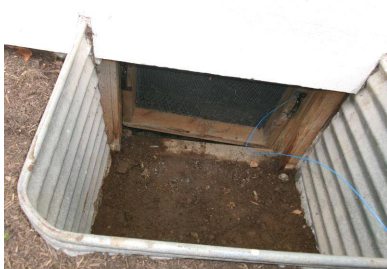
**PEST CONTROL**

Soil is in contact with the bottom of the wood crawl space access frame. Replacing the wood frame with ground contact lumber is optional. Ground-contact lumber is pressure treated with chemicals to withstand the effects of being close to the ground, in contact with the ground and/or exposed to continuous moisture.

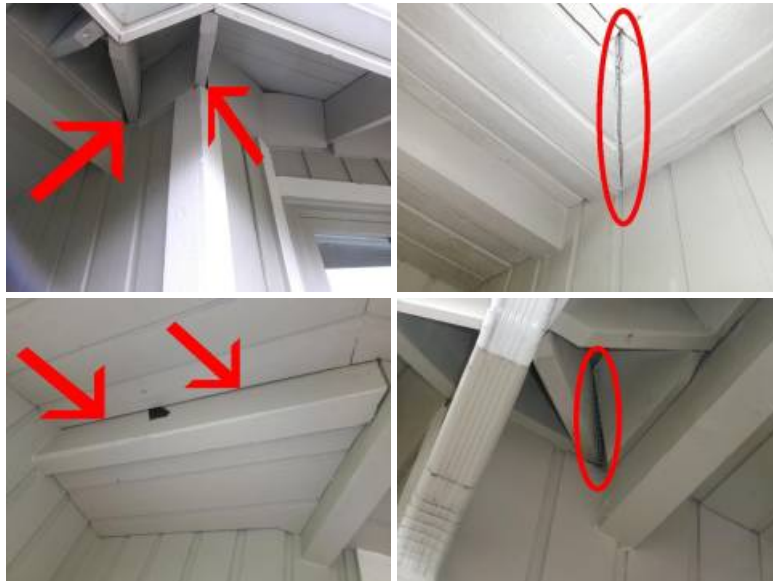
There are large gaps over 1/4" in size adjacent the soffit vent blocks. These gaps allow insects and rodents to enter the attic. Covering the gaps with screening, a strip of wood and/or caulking is recommended.

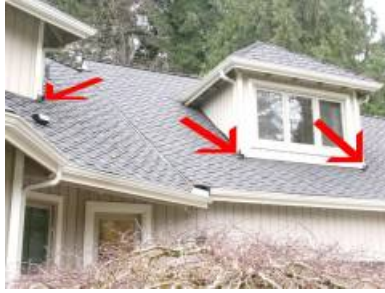
Downspouts draining directly onto the asphalt shingle surface causes excessive wear of

the roofing material. Downspout extensions to the lower gutters should be installed to prevent excessive wear and tear of the roofing.

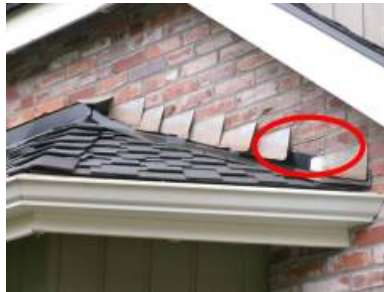
A section of the counter flashing is missing at the roof to masonry wall intersection. This is allowing leakage to occur. The installation of counter flashings is recommended.

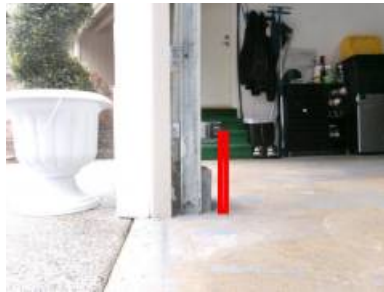
The Photo-eye beam was installed to high above the floor of the garage to adequately offer protection for small children and/or pets. We recommend that the photo-eye be lowered to within 4-6" of the floor.

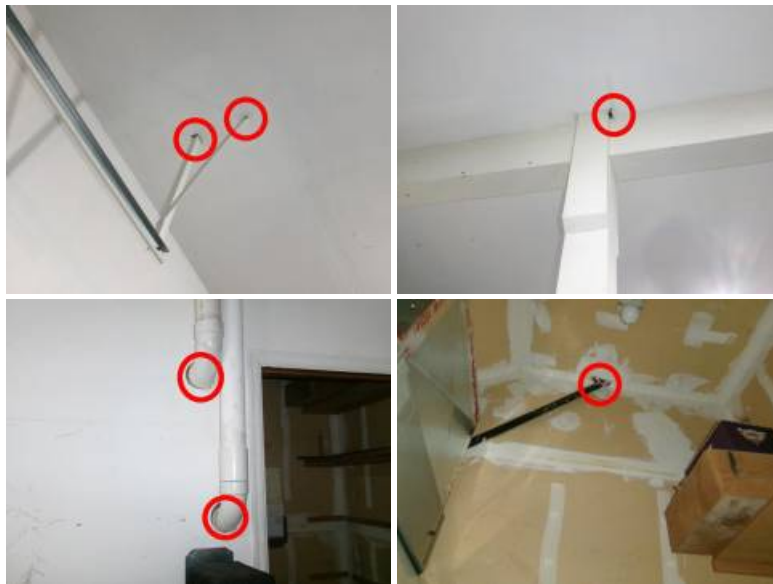
### FIRE SEPARATION

There are voids in the fire resistive barrier between the living space and garage that will allow flames to penetrate. The gypsum barrier slows the spread of a fire from the garage to the structure and/or living space. Patching the voids with a fire retardant caulk is recommended.

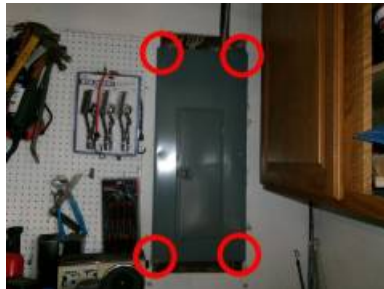
Screws that secure the panel cover to the panel box are missing. This is a potential hazard. Missing screws should be replaced with the original style blunt end screws.

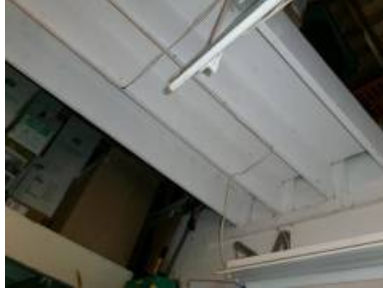
There is Romex cable in the garage that is run over the surfaces of the wall and ceiling. This cable is vulnerable to damage. The cable should be relocated or protected in conduit.

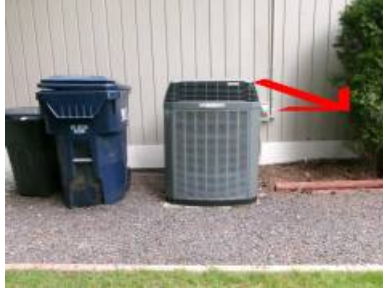
The pad supporting the outdoor condensing unit has settled, leaving it out of level. The connections can be stressed and accelerated wear of the bearings and other components may occur. The unit should be releveled.

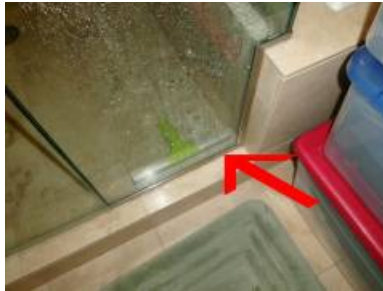
The glass enclosure has been leaking at the lower corner. No damage was visible, but resealing or repairing the enclosure is recommended as preventive maintenance.

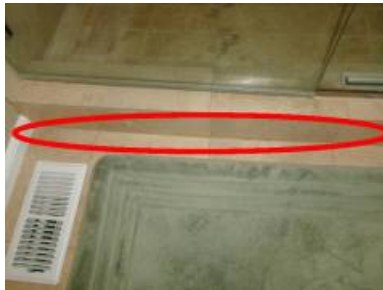
The caulking is cracked at the intersection between the tub/shower and floor. This can lead to water damage to the flooring and substrate. Caulking this area with a flexible caulk is recommended.

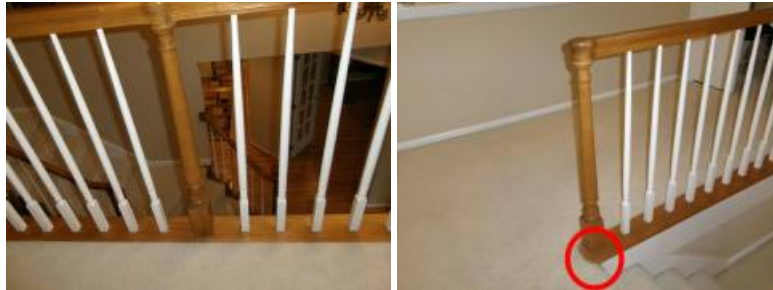
The guard railing lacks lateral stability. The installation of additional lateral supports is recommended.

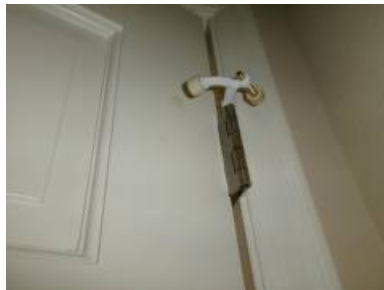
Doors are equipped with hinge mounted door stops can damage the door skin, tear out hinge screws, and damage the door trim and frame. The removal and replacement with wall or floor mounted door stops is recommended.

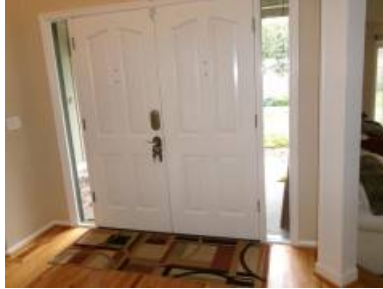
The glass adjacent the entry door is not tempered safety glass. Tempered glass can be identified by the etched emblem in one corner of each pane. A higher margin of safety could be achieved if the glass was approved safety glass. Consideration should be given to protecting or replacing the glass as a safety upgrade.

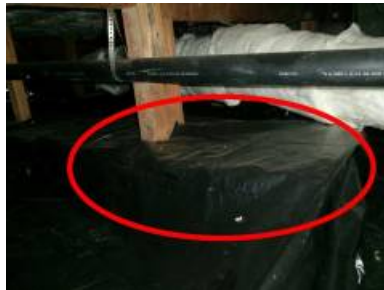
Several of the support post concrete piers are covered with the plastic vapor retarder. This allows the transmission of water vapor from the soil up and into the floor framing. The plastic vapor retarder should be removed from the pier so that it covers at least 85% of the entire surface of the soil only.

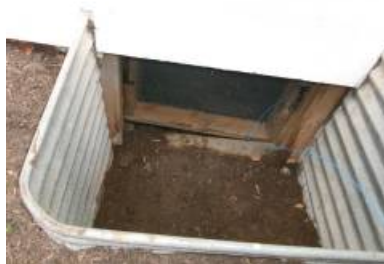
Good building practice requires that foundation walls or pier footings supporting wood frame construction, should extend at least 8" above the finish grade with at least a 6" clearance between the top of the soil and the bottom of the wood finish materials. Untreated wood should be raised 1-2" above surrounding flatwork and should have a moisture barrier such as 30 lb. asphalt impregnated felt installed between the concrete and wood. For additional information and treatment options, you should retain the services of a qualified pest control operator.
