NOTICE TO BUYER: SELLER-PROCURED INSPECTION REPORT

The following notice is given with respect to the Purchase and Sale Agreement dated _____ between _____ ("Buyer") and **Mats Helander** **Theza Helander** ("Seller") concerning **14349 172nd Ave NE Redmond WA 98052** ("the Property").

April 9, 2024

Re: 14349 172nd Ave. NE
Redmond, WA.

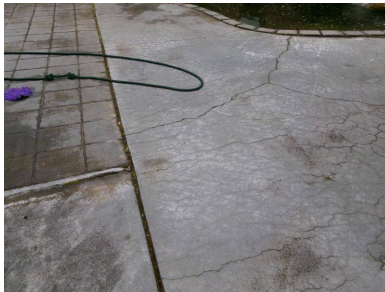
Cracks were observed in the concrete surface of the patio. Minor cracks can be sealed to minimize moisture entry and further settlement of the concrete.

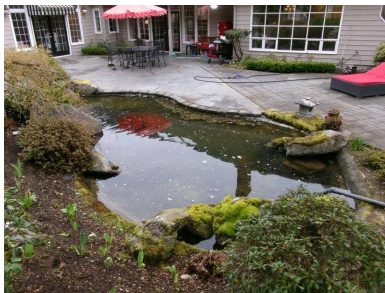
There is no child protection fencing along the walkway adjacent the water pond feature. This is a safety hazard. The installation of a guardrail that conforms to present industry standards is recommended.

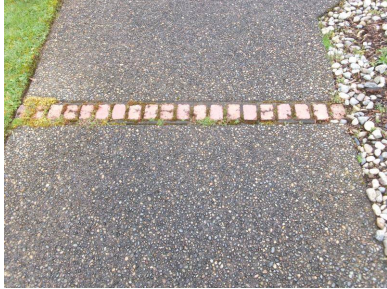
The gaps separating the concrete walkway sections are a trip hazard. Replacement with mortar is recommended.

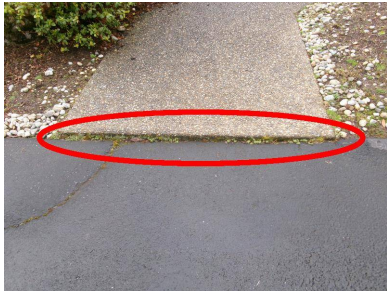
The raised edge of the concrete walkway can be a trip hazard for some people. Grinding down the raised edge of the concrete will mitigate the hazard. Repairs should be made as necessary.

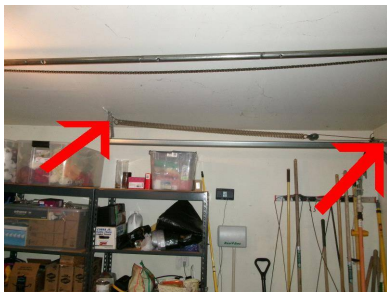
Safeties are cables run through the center of the garage door springs that prevent broken springs from becoming projectiles that can cause injury. There are no safeties installed. The installation of safeties is recommended.

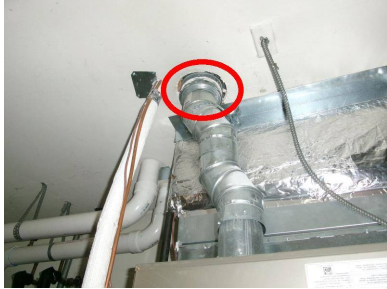
The installation of a furnace vent thimble is recommended to prevent flames from spreading to the structure.

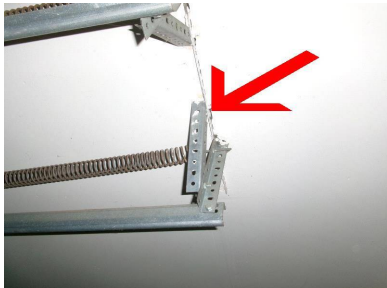
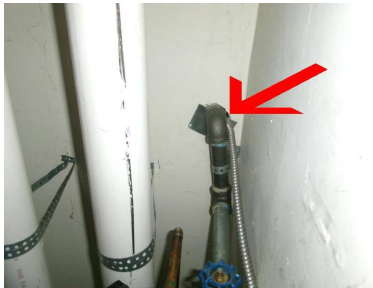
There are voids (adjacent the overhead door brackets) in the fire resistive barrier between the living space and garage that will allow flames to penetrate. The gypsum barrier slows the spread of a fire from the garage to the structure and/or living space. Patching the voids with a fire retardant caulk is recommended.

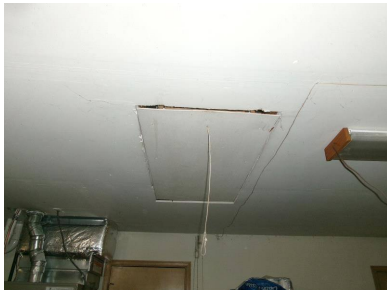
The pull down ladder is a breach in the fire resistive barrier in the garage. This is a safety concern. The gypsum barrier on the ceiling slows the spread of a fire from the garage to the attic. The installation of a layer of 5/8" gypsum type X board over the 1/4" plywood is recommended.

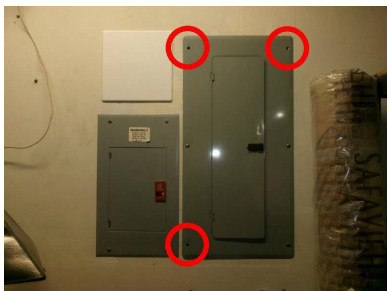
Screws that secure the panel cover to the panel box are missing. This is a potential hazard. Missing screws should be replaced with the original style blunt end screws.

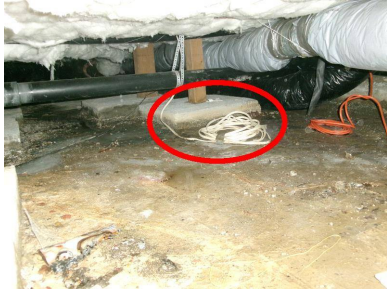
There is an abandoned electrical cable with exposed conductors in the crawlspace. This is a shock hazard. The cable should be terminated in a covered junction box or removed.

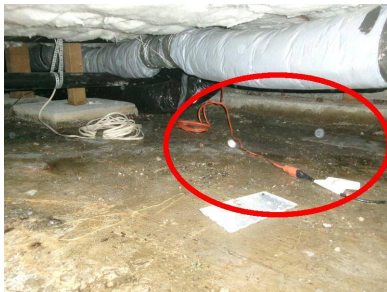
An extension cord is used as a power source for the sump pump. An extension cord is not suitable as a permanent wiring method. The installation of a receptacle within cords length of the unit is recommended.

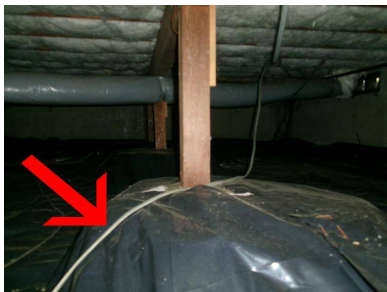
A loose electrical cable was observed in the crawlspace. Loose cables are vulnerable to damage. All loose cables should be secured at 4' intervals using approved cable staples.

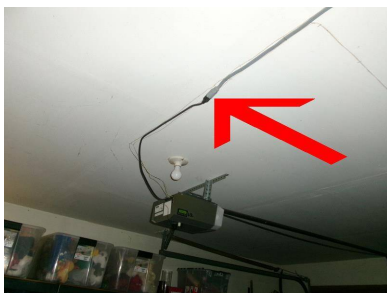
An extension cord is used as a temporary power source for the garage door opener. An extension cord is not suitable as a permanent wiring method. The installation of a receptacle within cords length of the motor is recommended.

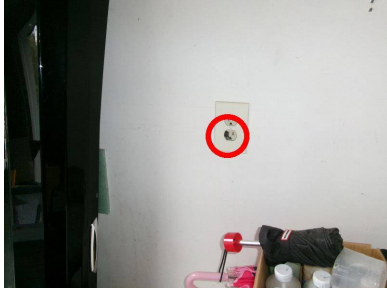
A receptacle in the garage is damaged leaving live components exposed to small children. This is a shock hazard. The damaged receptacle should be replaced.

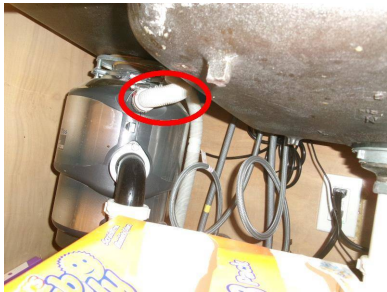
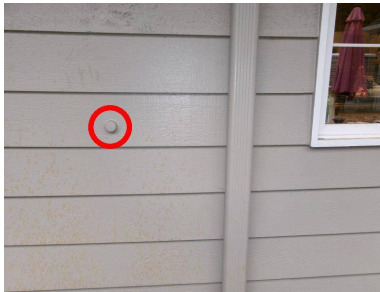
The cap protruding on the exterior wall opposite the dishwasher is not drilled. This air gap protects the dishwasher from contamination caused by a backflow of waste water when in use. Drilling a 1/4" hole in the end of the cap will restore its function when connected to the dishwasher waste line.

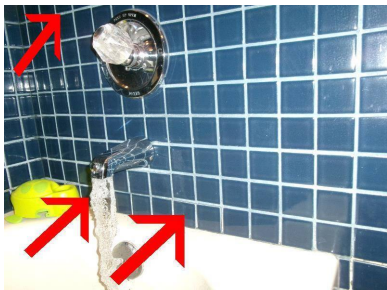
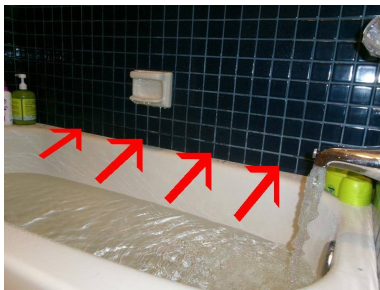
Several of the lower tub wall surround tiles are loose. Water may be penetrating through the tile into the wall. The loose tiles should be removed and the underlying material investigated and repaired, if necessary, before new tile is installed.

Grout is missing from between some of the wall tiles. This can allow water to enter through the tile and can damage the walls. Regrouting the wall tile is recommended.

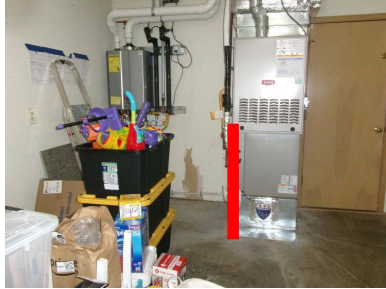
The gas pipes in front of the furnace are not protected by a bumper stop. A vertical steel pipe, bolted to the floor, is typically installed in front of the water heater to prevent a car bumper from damaging the gas lines.

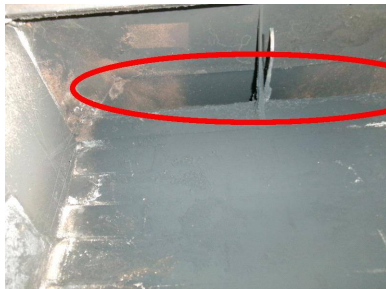
The office fireplace damper is stuck in the open position. This allows heat to escape up the chimney and could result in odors emanating from the fireplace. Repairing the damper is recommended.

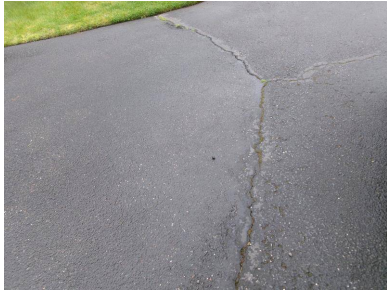
Large cracks were observed in the asphalt surface of the driveway. Minor cracks can be sealed to minimize moisture entry, vegetation establishment and further settlement of the asphalt. Minor cracks are common and do not affect the serviceability of the asphalt..

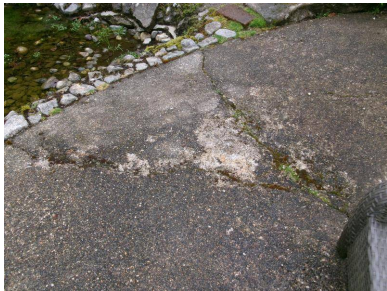
A portion of the patio has settled differentially. This condition can be repaired by pressure grouting the sunken portion of the patio or by removing and replacing it. The patio remains functional despite this condition.

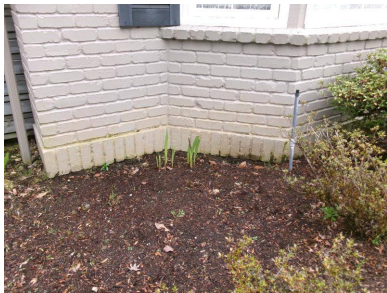
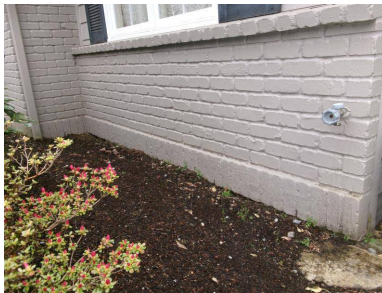
The brick is a veneer installed over the wood wall structure. It is not a structural component of the wall. Weep holes are missing at the bottom of the masonry wall. This allows moisture to become trapped behind the brick. Weep holes are recommended to mitigate moisture damage.

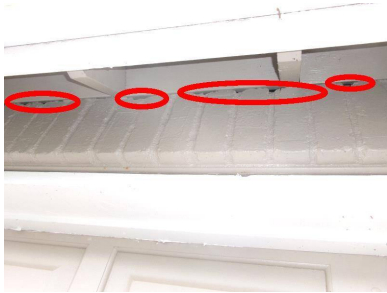
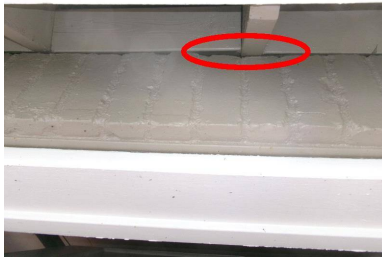
Gaps over 1/4" in size adjacent the brick cladding and soffit vent blocks will allow insects and rodents to enter the structure. Covering any gaps with screening, a strip of trim and/or caulking is recommended.

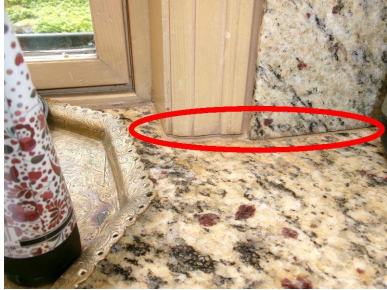
The backsplash caulking is cracked. Cracking of the caulk allows water to enter the gap and is difficult to clean. Caulking the cracks and/or gaps is recommended.

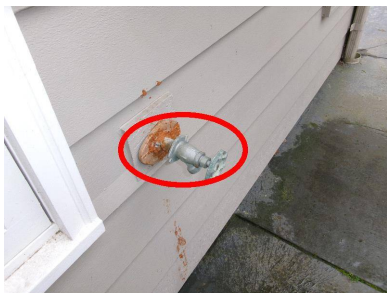
There are water pipes on the exterior of the house that will freeze in cold weather. These water pipes should be shut off and drained or protected via a thermostatically installed heat tape.

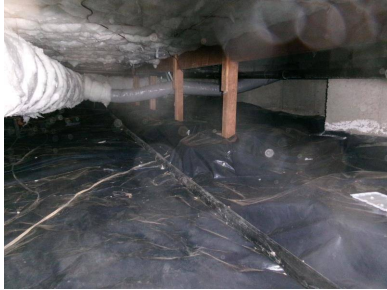
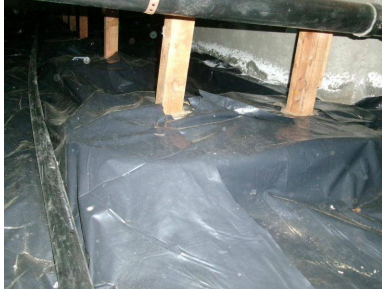
The support post concrete piers are covered with the plastic vapor retarder. This allows the transmission of water vapor from the soil up and into the floor framing. The plastic vapor retarder should be removed from the pier so that it covers at least 85% of the entire surface of the soil only.

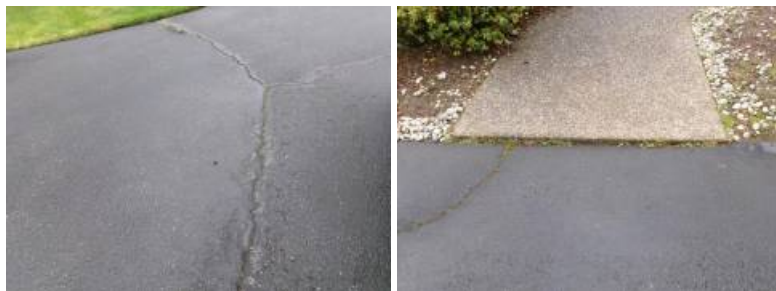
Large cracks were observed in the asphalt surface of the driveway. Minor cracks can be sealed to minimize moisture entry, vegetation establishment and further settlement of the asphalt. Minor cracks are common and do not affect the serviceability of the asphalt..

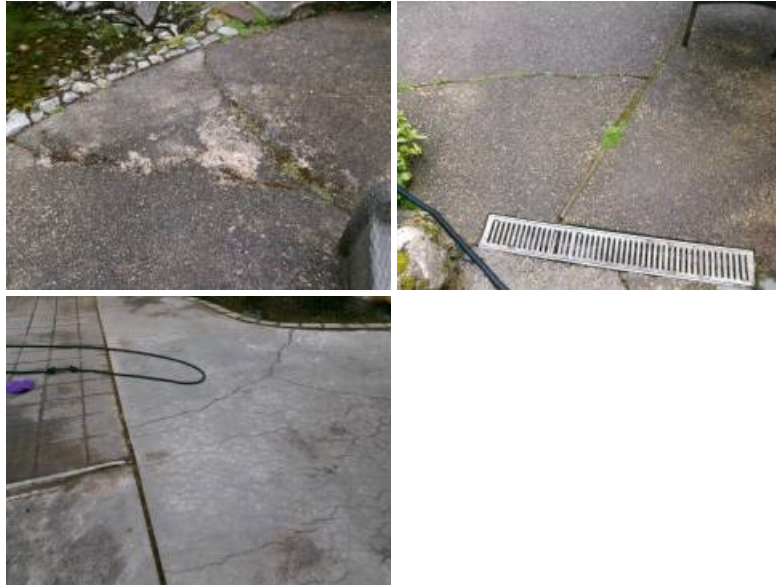
Cracks were observed in the concrete surface of the patio. Minor cracks can be sealed to minimize moisture entry and further settlement of the concrete.

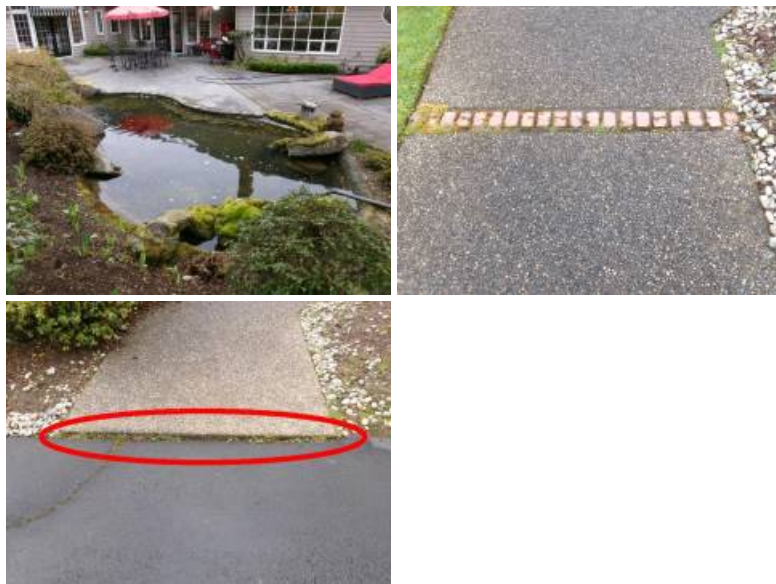
The raised edge of the concrete walkway can be a trip hazard for some people. Grinding down the raised edge of the concrete will mitigate the hazard. Repairs should be made as necessary.

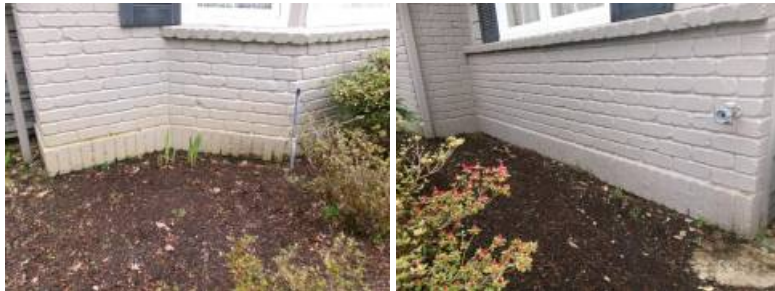
The brick is a veneer installed over the wood wall structure. It is not a structural component of the wall. Weep holes are missing at the bottom of the masonry wall. This allows moisture to become trapped behind the brick. Weep holes are recommended to mitigate moisture damage.

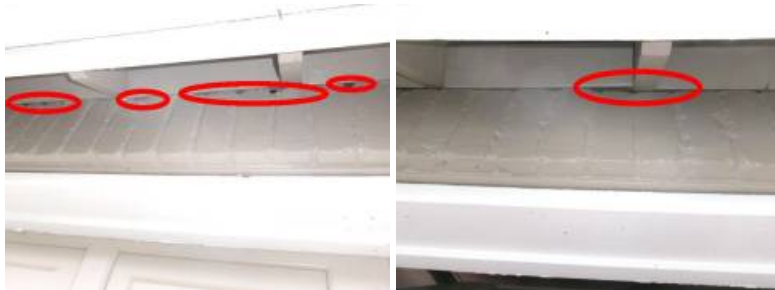
Gaps over 1/4" in size adjacent the brick cladding and soffit vent blocks will allow insects and rodents to enter the structure. Covering any gaps with screening, a strip of trim and/or caulking is recommended.

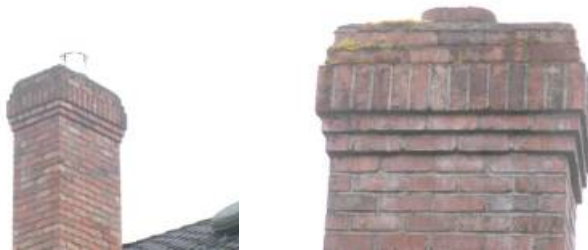
The top of the north masonry chimney does not have a spark arrestor/rain cap. The installation of a spark arrestor/rain cap is recommended as a safety upgrade and to prevent moisture damage to the inside of the chimney and fireplace. An additional benefit of a rain cap is that it will keep birds and rodents from entering the house when the damper is left open.

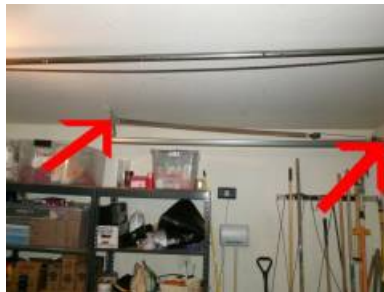
Safeties are cables run through the center of the garage door springs that prevent broken springs from becoming projectiles that can cause injury. There are no safeties installed. The installation of safeties is recommended.

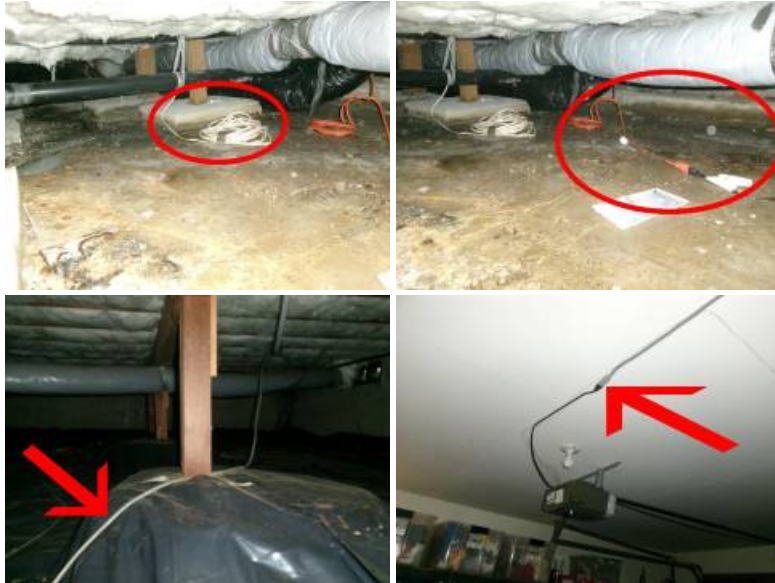
An extension cord is used as a temporary power source for the garage door opener. An extension cord is not suitable as a permanent wiring method. The installation of a receptacle within cords length of the motor is recommended.

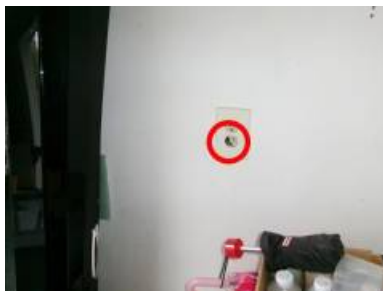
A receptacle in the garage is damaged leaving live components exposed to small children. This is a shock hazard. The damaged receptacle should be replaced.

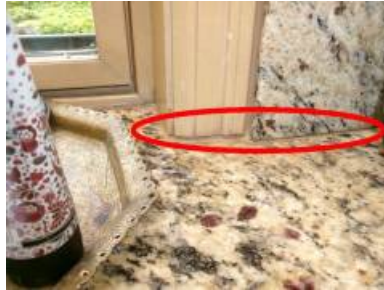
The backsplash caulking is cracked. Cracking of the caulk allows water to enter the gap and is difficult to clean. Caulking the cracks and/or gaps is recommended.

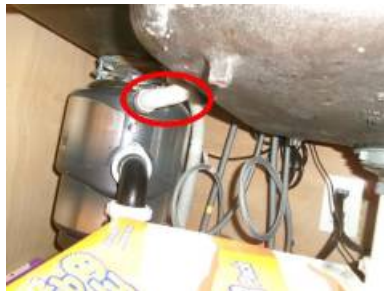
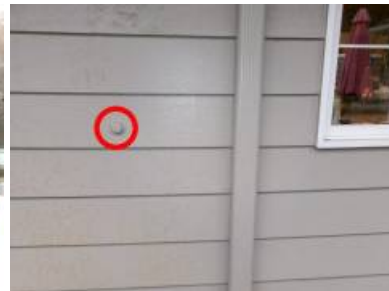
The cap protruding on the exterior wall opposite the dishwasher is not drilled. This air gap protects the dishwasher from contamination caused by a backflow of waste water when in use. Drilling a 1/4" hole in the end of the cap will restore its function when connected to the dishwasher waste line.

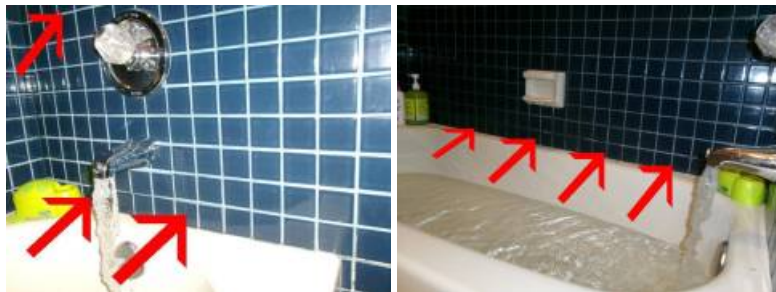
Grout is missing from between some of the wall tiles. This can allow water to enter through the tile and can damage the walls. Regrouting the wall tile is recommended.

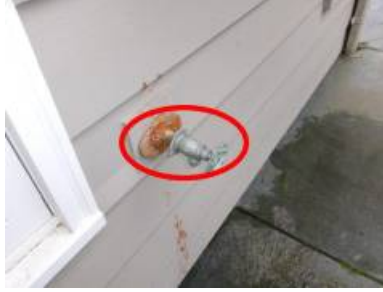
<i>VENT PIPES</i>		The visible portions of the vent pipes are properly installed and are performing their intended function.
<i>FAUCET FIXTURES</i>		All faucet fixtures were tested and were functioning as intended with exceptions noted below. The hallway bathroom left sink faucet is leaking at its base. Leaking faucets should be rebuilt or replaced.
<i>HOSE BIBBS AND SUPPLY PIPES</i>	<i>EXTERIOR</i>	The hose bibbs on this building are the frost free type. These hose bibbs typically will not freeze as long as the hoses are removed. Failure to remove hoses during freezing weather could result in a cracked pipe and leakage. The bibbs were tested and were functioning as intended. There are water pipes on the exterior of the house that will freeze in cold weather. These water pipes should be shut off and drained or protected via a thermostatically installed heat tape.

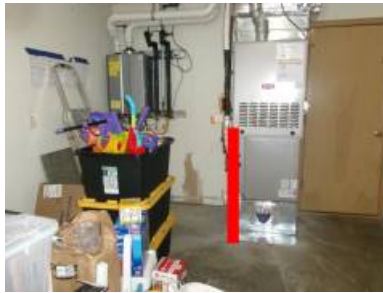
The gas pipes in front of the furnace are not protected by a bumper stop. A vertical steel pipe, bolted to the floor, is typically installed in front of the water heater to prevent a car bumper from damaging the gas lines.

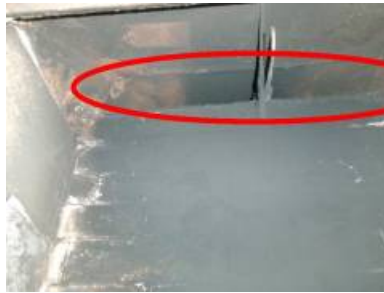
The office fireplace damper is stuck in the open position. This allows heat to escape up the chimney and could result in odors emanating from the fireplace. Repairing the damper is recommended.

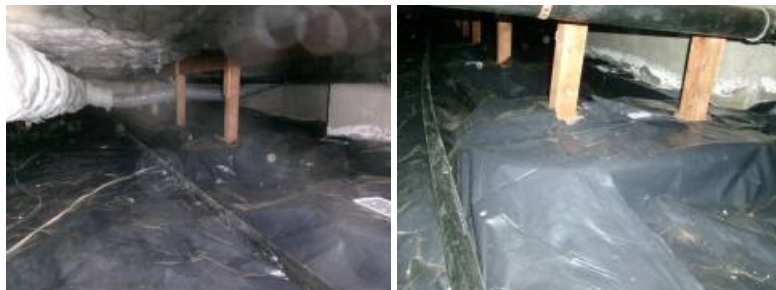
The support post concrete piers are covered with the plastic vapor retarder. This allows the transmission of water vapor from the soil up and into the floor framing. The plastic vapor retarder should be removed from the pier so that it covers at least 85% of the entire surface of the soil only.
