**James & Deborah Hunt
14320 173rd Place NE
Redmond, WA 98052**

Per the seller, the following items listed on the pre-sale inspection summary dated April 16, 2024, are being corrected by the seller as part of preparation for sale in good faith.

At your request, a visual inspection of the above referenced property was conducted on 04/15/2024. We have inspected the major structural components, plumbing, heating and electrical systems for signs of significant non-performance, excessive or unusual wear and general state of repair.

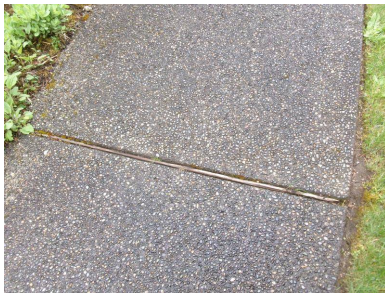
One or more of the wooden dividers separating the concrete walkway sections and porch were infested by wood destroying organisms and have deteriorated to a point where they are becoming a trip hazard. Replacement with mortar is recommended.

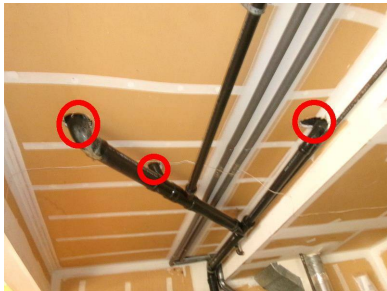
There are voids in the fire resistive barrier between the living space and garage that will allow flames to penetrate. The gypsum barrier slows the spread of a fire from the garage to the structure and/or living space. Patching the voids with a fire retardant caulk is recommended.

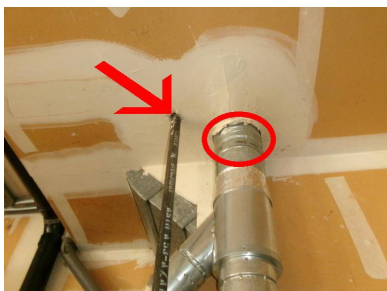
The installation of a furnace vent thimble is recommended to prevent flames from spreading to the structure.

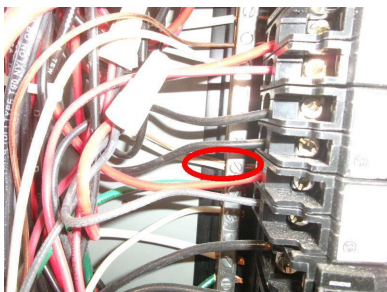
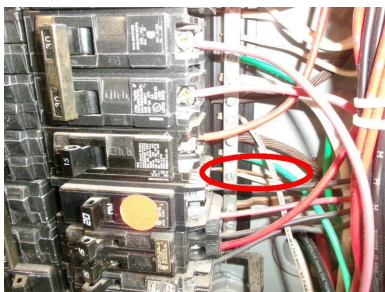
Neutral (white wire) and equipment grounding conductors (bare wire) terminate under the same lug. An individual terminal should be provided for the connection of each branch-circuit neutral conductor. When the neutral is disconnected, the objective is to still have the equipment ground connected. If both the neutral and grounded conductor is under the same terminal, this cannot be accomplished. The services of a qualified electrical contractor should be retained to repair the circuit(s).

Electrical panel has been serviced per recommendations in survey

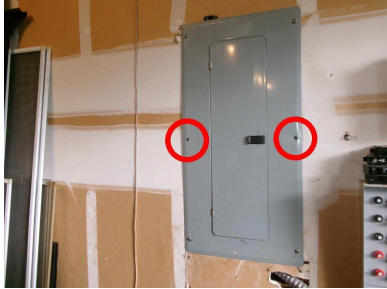
Screws that secure the panel cover to the panel box are missing. This is a potential hazard. Missing screws should be replaced with the original style blunt end screws.

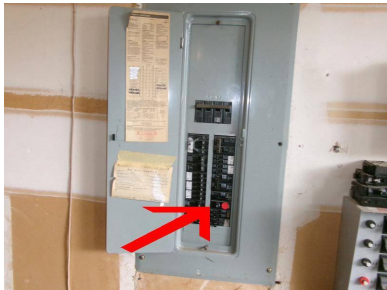
One of the circuit breakers in the panel was "tripped" off. The services of a qualified electrical contractor should be retained to repair the circuit.

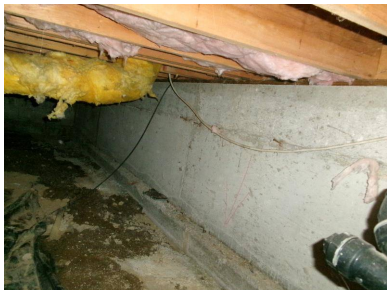
A loose electrical cable was observed in the crawlspace. Loose cables are vulnerable to damage. All loose cables should be secured at 4' intervals using approved cable staples.

Loose wiring in the crawl space has been secured in the crawlspace

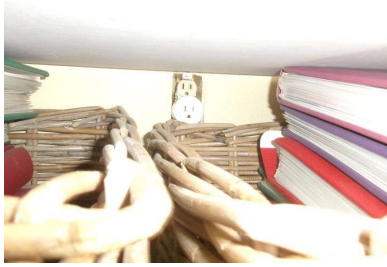
The cover plate is missing from a receptacle in the dining room. This is a shock and fire hazard. The installation of a cover plate is recommended.

Receptacles - Loose cover plates have been secured and missing cover plates have been provided and secured

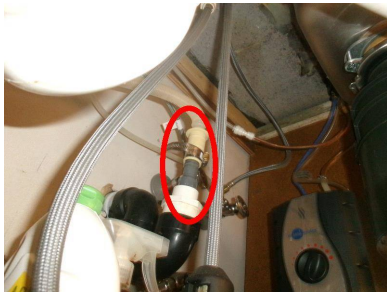
The dishwasher drain lacks an air gap. The dishwasher will function without one, but there is a risk of contamination of the inside of the dishwasher by waste water. The installation of an air gap above the flood rim of the sink is recommended.

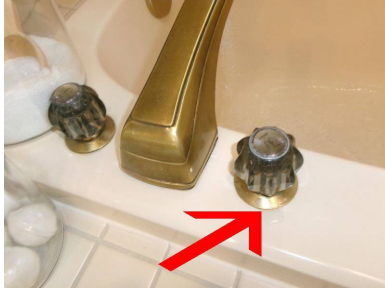
The tub fixture is leaking at the base. The fixture should be repaired.

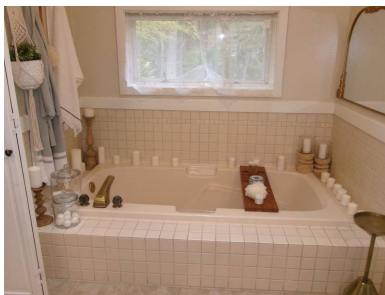
The bottom edge of the shower wall window is less than 60" above the standing surface and drain inlet and is not safety glass. The glass should be replaced with tempered safety glass in order to prevent possible injury in the event of breakage.

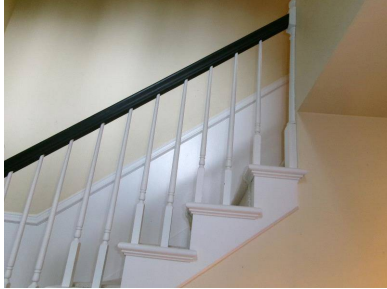
The stair railing baluster spacing is too wide. This is a hazard for small children. The baluster spacing should be reduced as a safety upgrade. Current standards require that a 4-3/8" sphere not pass through the railing.

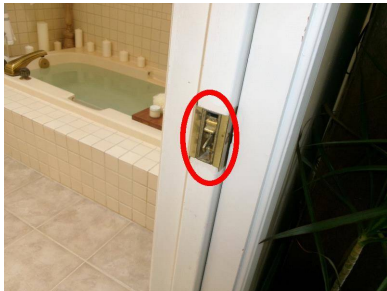
Several of the doors are equipped with hinge mounted door stops. This type of door stop can damage the door skin, tear out hinge screws, and damage the door trim and frame. The removal and replacement with wall or floor mounted door stops is recommended.

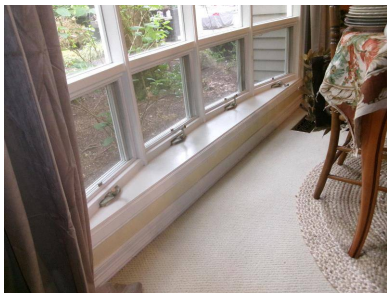
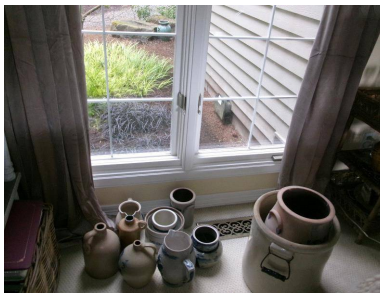
The lower window glass is not labeled as tempered safety glass. The existing glass is nonconforming by current building standards and would be hazardous if broken. The installation of safety glass is recommended as a safety upgrade for all windows less than 18" from the walking surface.

One of the bedroom windows does not operate smoothly which makes it difficult to close completely. We recommend repairs as necessary to restore the windows proper operation.

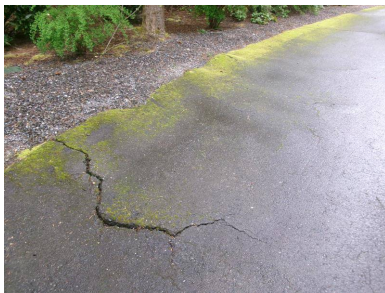
There is minor tree root damage visible in the asphalt driveway. The damage is not affecting the function of the driveway. Patching or resurfacing is optional. Seal coating the surface of the asphalt is recommended to maximize the service life of the paving. Asphalt sealers are available at most home improvement stores.

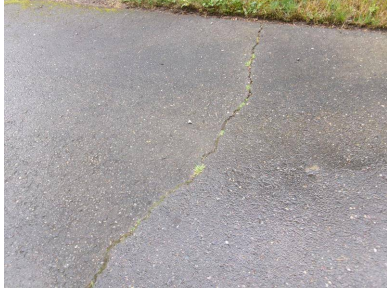
Large cracks were observed in the asphalt surface of the driveway. Cracks can be sealed to minimize moisture entry, vegetation establishment and further settlement of the asphalt. Minor cracks are common and do not affect the serviceability of the asphalt.

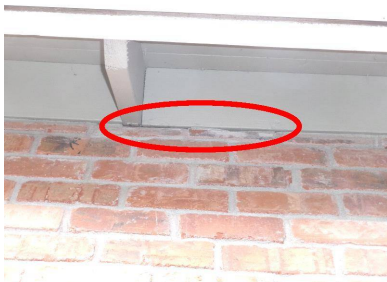
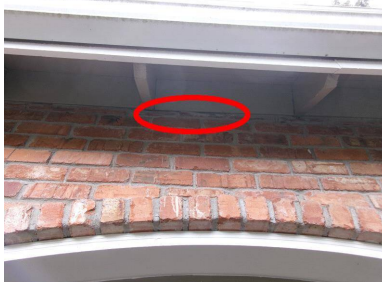
Gaps over 1/4" in size adjacent the brick cladding and soffit vent blocks will allow insects and rodents to enter the structure. Covering any gaps with screening, a strip of trim and/or caulking is recommended.

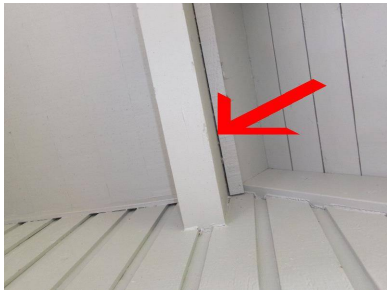
There are large gaps over 1/4" in size adjacent the beam. These gaps allow insects and rodents to enter the attic. Covering the gaps with screening, a strip of wood and/or caulking is recommended.

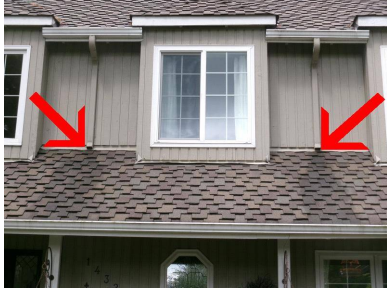
Downspouts draining directly onto the asphalt shingle surface causes excessive wear of the roofing material. Downspout extensions to the lower gutters should be installed to prevent excessive wear and tear of the roofing.

Gutters and downspouts have been serviced

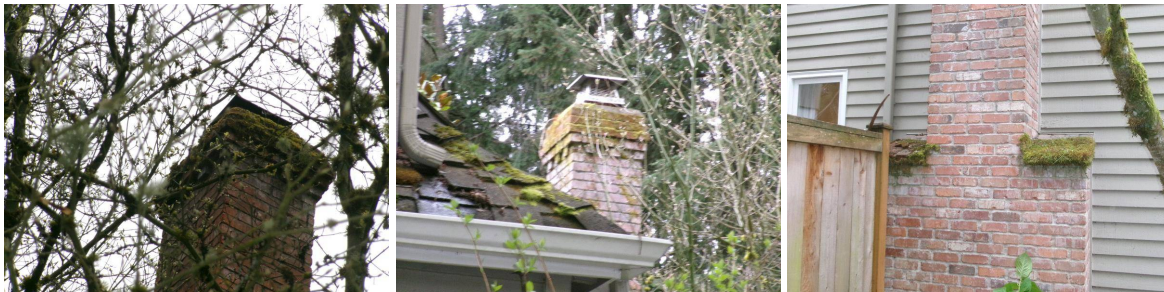
Moss/vegetation was observed in several areas around the chimneys. This will lead to accelerated deterioration of the brick masonry mortar. We recommend removal of all organic growth. Damaged areas can be repaired by filling in cutout or defective mortar joints with fresh mortar. (Tuck pointing)

Chimneys have had vegetation and moss removed

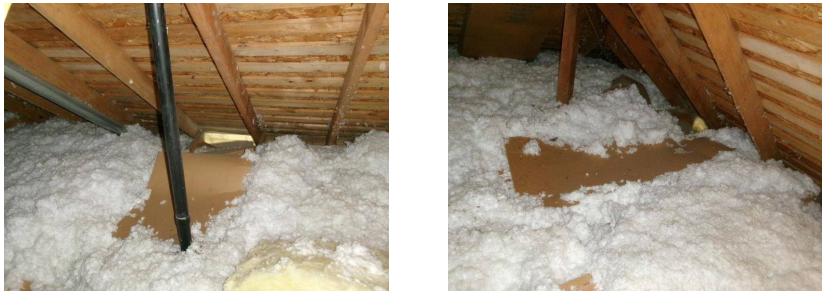
Wind baffles locations are compromised in some areas of the attic. The proper placement of wind baffles in front of all soffit vents is recommended.

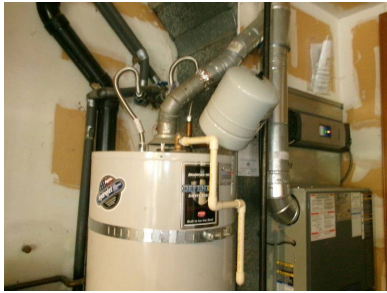
The expansion tank is not adequately secured to the wall. As code requirements start to call for engineered expansion tank supports we recommend the installation of seismic restraints to secure the expansion tank instead of allowing it to simply depend on piping connections that could result in damage to the water pipe and leakage during an earthquake.

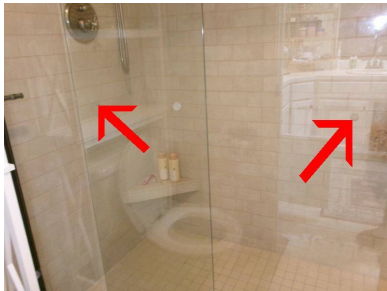
The glass door is in serviceable condition. However, the hardware is missing. Missing hardware/handles could result in damage to the doors. The installation of hardware is recommended.

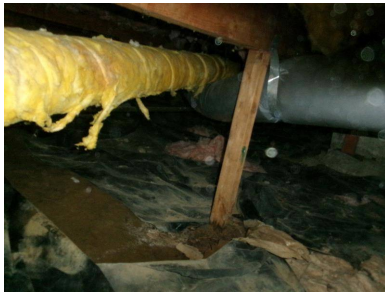
One 2x4 post has been propped up under the family room floor and is improperly supported by a block of wood. Water seeping into the crawlspace over the 1-1/2" piece of wood block has caused the bottom of the post to rot. Damaged posts should be replaced. Replacement should be done under current industry standards.

Two damaged posts in the crawlspace have been replaced per recommendation

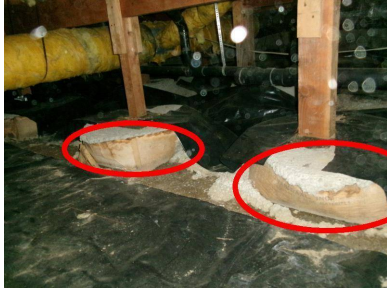
Cellulose forms were left in place on the pier footings. This cellulose is conducive to the infestation of various wood destroying organisms. The removal of the cellulose is recommended.

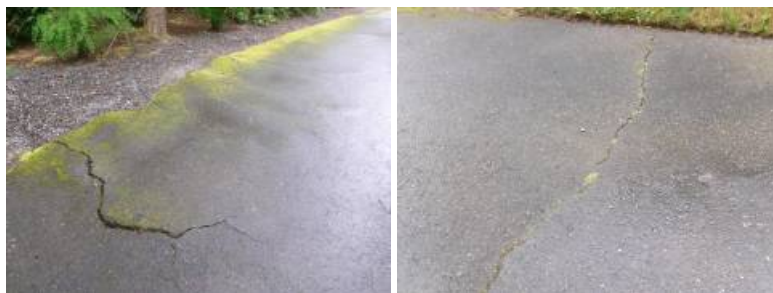
Large cracks were observed in the asphalt surface of the driveway. Cracks can be sealed to minimize moisture entry, vegetation establishment and further settlement of the asphalt. Minor cracks are common and do not affect the serviceability of the asphalt.

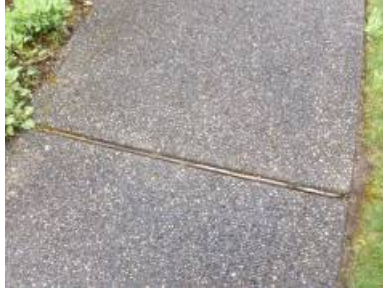
Many legal and public works departments have defined a trip hazard as an irregularity in a walking surface exceeding one inch (1") in height. All walking surfaces should maintain, free of a vertical surface change of 3/4" or more, in the interest of public and personal safety.

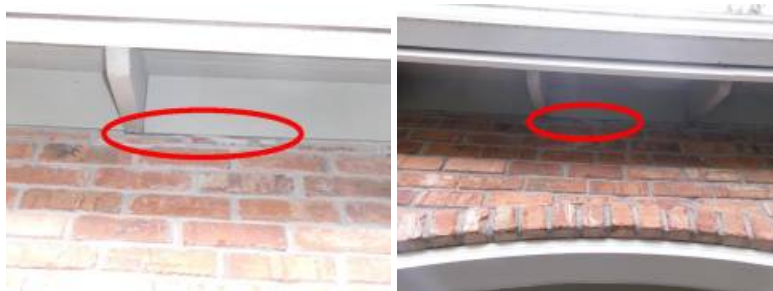
There are large gaps over 1/4" in size adjacent the beam. These gaps allow insects and rodents to enter the attic. Covering the gaps with screening, a strip of wood and/or caulking is recommended.

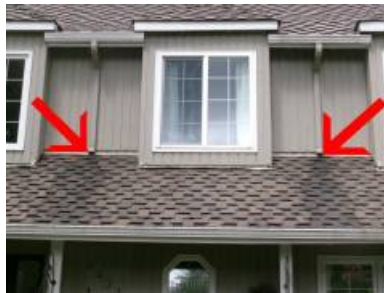
Downspouts draining directly onto the asphalt shingle surface causes excessive wear of the roofing material. Downspout extensions to the lower gutters should be installed to prevent excessive wear and tear of the roofing.

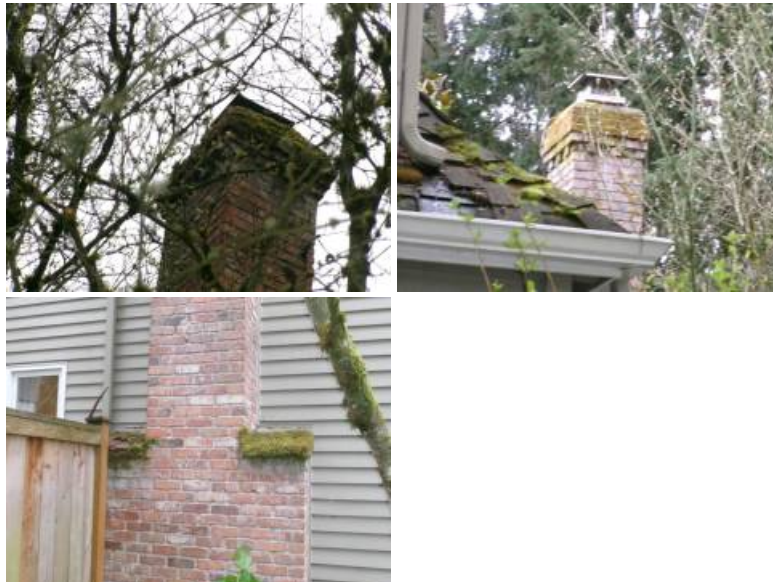
Moss/vegetation was observed in several areas around the chimneys. This will lead to accelerated deterioration of the brick masonry mortar. We recommend removal of all organic growth. Damaged areas can be repaired by filling in cutout or defective mortar joints with fresh mortar. (Tuck pointing)

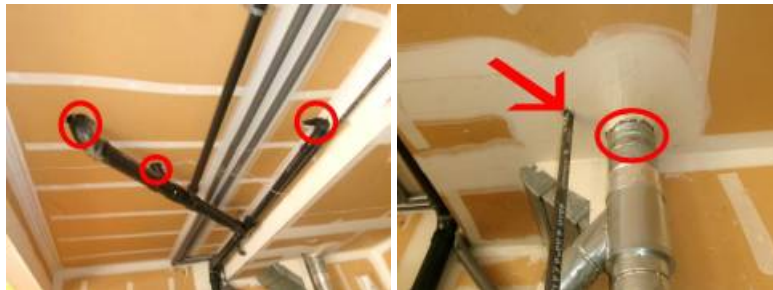
The installation of a furnace vent thimble is recommended to prevent flames from spreading to the structure.

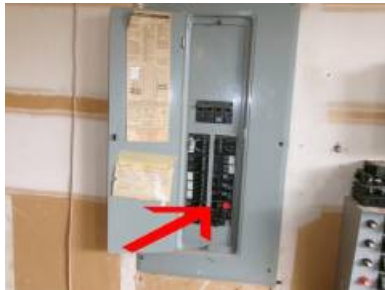
One of the circuit breakers in the panel was "tripped" off. The services of a qualified electrical contractor should be retained to repair the circuit.

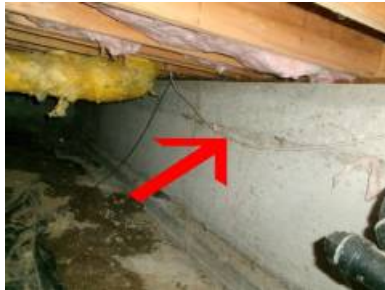
A loose electrical cable was observed in the crawlspace. Loose cables are vulnerable to damage. All loose cables should be secured at 4' intervals using approved cable staples.

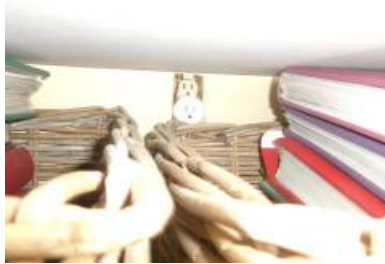
The cover plate is missing from a receptacle in the dining room. This is a shock and fire hazard. The installation of a cover plate is recommended.

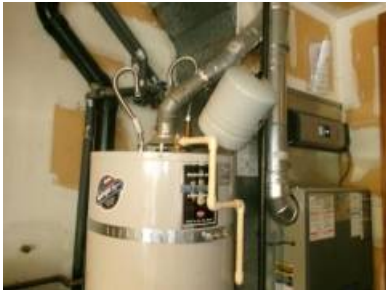
<i>LOCATION OF UNIT</i>	The water heater is located in the garage.
<i>GENERAL INFORMATION</i>	The water heater fuel is natural gas. The capacity of the water heater is 50 gallons. The input rating of the burner is approximately 40,000 BTU. The water heater is approximately 3 years old. Water heaters of this type typically last about 10-15 years.
<i>PRESSURE RELIEF VALVE</i>	The pressure relief valve is properly installed. The valve was not tested, as this could cause the valve to leak.
<i>SHUTOFF VALVE</i>	The shutoff valve for the water supply to the water heater is properly installed and is functioning as intended.
<i>WATER CONNECTIONS AT TANK</i>	The water connections at the tank are properly installed and are performing their intended function.
<i>EXPANSION TANK</i>	The expansion tank is not adequately secured to the wall. As code requirements start to call for engineered expansion tank supports we recommend the installation of seismic restraints to secure the expansion tank instead of allowing it to simply depend on piping connections that could result in damage to the water pipe and leakage during an earthquake.

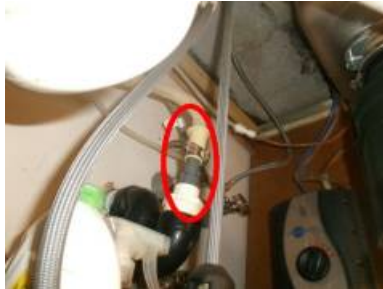
- AIR GAP* The dishwasher drain lacks an air gap. The dishwasher will function without one, but there is a risk of contamination of the inside of the dishwasher by waste water. The installation of an air gap above the flood rim of the sink is recommended.

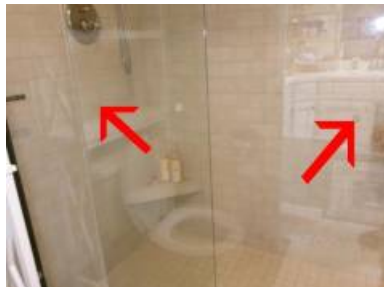
The glass door is in serviceable condition. However, the hardware is missing. Missing hardware/handles could result in damage to the doors. The installation of hardware is recommended.

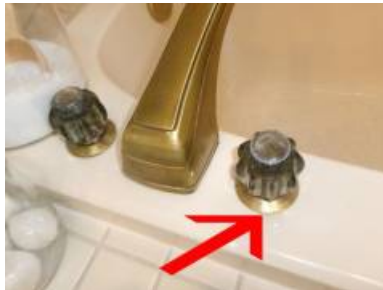
The tub fixture is leaking at the base. The fixture should be repaired.

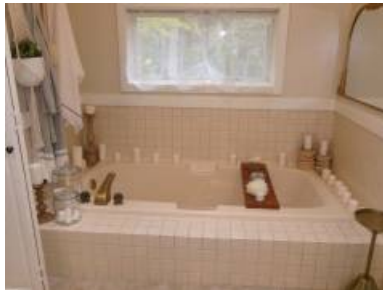
The bottom edge of the shower wall window is less than 60" above the standing surface and drain inlet and is not safety glass. The glass should be replaced with tempered safety glass in order to prevent possible injury in the event of breakage.

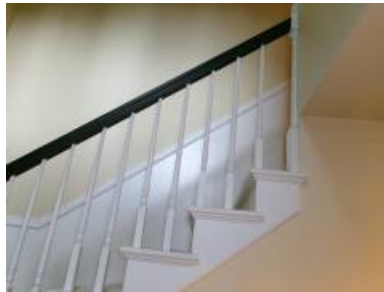
The stair railing baluster spacing is too wide. This is a hazard for small children. The baluster spacing should be reduced as a safety upgrade. Current standards require that a 4-3/8" sphere not pass through the railing.

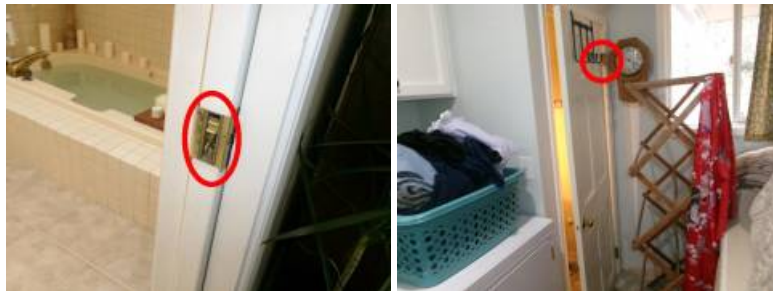
The laundry room closet door is missing a hinge. Door hinges should be installed where necessary.

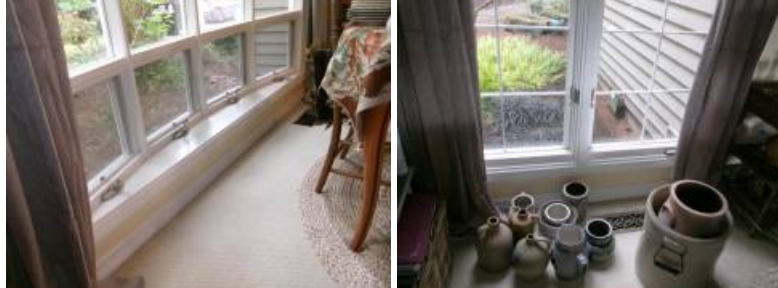
One of the bedroom windows does not operate smoothly which makes it difficult to close completely. We recommend repairs as necessary to restore the windows proper operation.
