NOTICE TO BUYER: SELLER-PROCURED INSPECTION REPORT

May 21, 2024

**Re: 3432 175th Ave. NE
Redmond, Wa.**

At your request, a visual inspection of the above referenced property was conducted on 05/20/2024. We have inspected the major structural components, plumbing, heating and electrical systems for signs of significant non-performance, excessive or unusual wear and general state of repair.

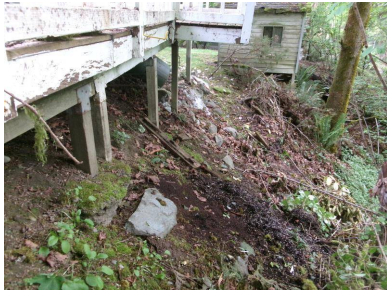
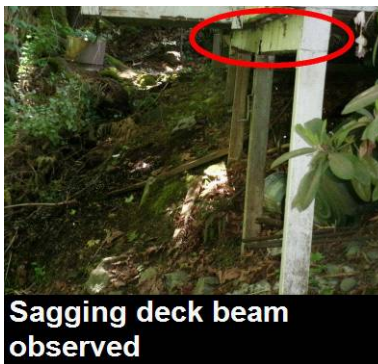
The deck support posts are located at the top of a steep slope. There is evidence visible there has been problems with soil instability. Hidden conditions may also exist that could contribute to instability during the right combination of circumstances (e.g., flooding, improper drainage, earthquake, development or condition of neighboring properties, broken water mains, etc.). You should consider these risks when acquiring this property.

If you have concerns about slides, erosion or soil stability, you should retain the services of a qualified geotechnical engineer to evaluate the building site.

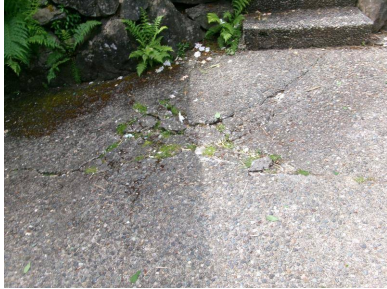
DRIVEWAY

The driveway has cracked and settled differentially. This was probably caused by inadequate preparation of the soil prior to the placement of the concrete. This condition can be repaired by pressure grouting the sunken portion of the driveway or by removing and replacing it. The driveway remains functional despite this condition.

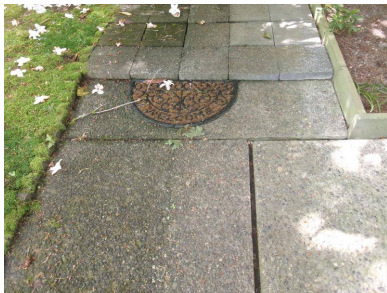
PATIO

The gaps separating the concrete patio sections are a trip hazard. Replacement with mortar is recommended.

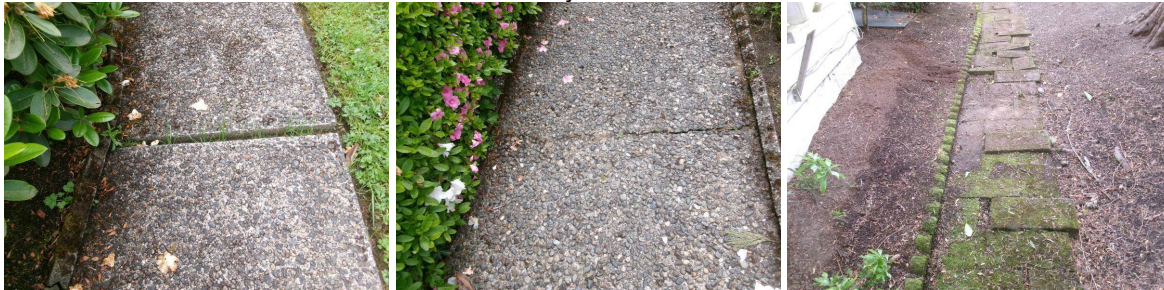
WALKWAY

The gaps separating the concrete walkway sections are a trip hazard. Replacement with mortar is recommended.

Cracks can be sealed to minimize moisture entry and further settlement.

The walking surface was not even and trip hazards were present. We recommend all walking surfaces be maintained free of trip hazards.

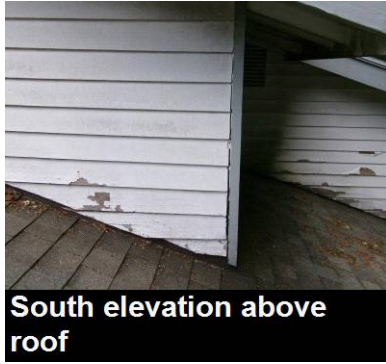
The paint is cracked, peeling, faded and in generally poor condition. Paint protects the wood from cupping, checking, warping and rot. Repainting the house exterior is recommended.

The caulking is cracked and deteriorated. Caulking prevents water intrusion into the wall. Removing and replacing deteriorated caulk is recommended.

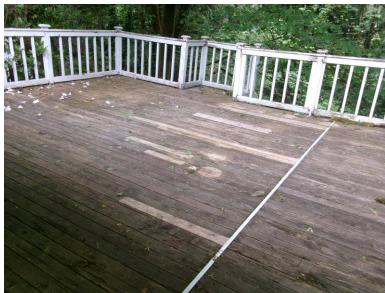
DECK

A significant portion of the deck is rotted. Rot weakens the wood and can result in catastrophic failure of the structure. Rebuilding the deck structure is recommended.

The deck railing is rotted. The spacing between the balusters is too wide. This is a hazard. The balusters should be spaced close enough together so that a 4" sphere cannot pass through. Replacing and upgrading the deck railing is recommended.

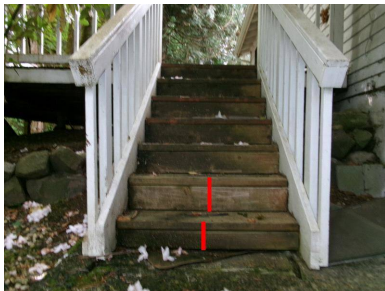
STAIRS

The deck stairs are non-conforming due to the variable and/or excessive rise. Deck stair/step design standards require that step risers do not exceed 8" and that the variation in rise not exceed 3/8" in order to reduce falls from tripping. We recommend reconfiguring the steps so that rise and run do not vary by more than 3/8".

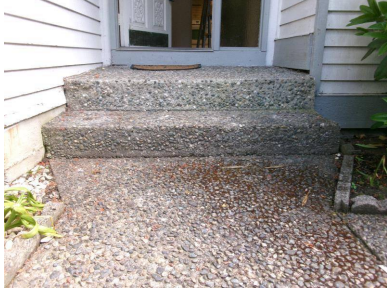
PORCH STEPS

The steps are non-conforming due to the variable and/or excessive rise. Stair design standards require that step risers do not exceed 8" and that the variation in rise not exceed 3/8" in order to reduce falls from tripping. To increase the margin of safety, consideration should be given to reconfiguring the steps so that rise and run do not vary by more than 3/8". If this proves to be too impractical or expensive, then we recommend exercising caution when using.

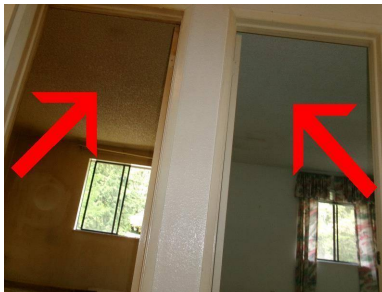
ATTIC

There is no access to the attic. The installation of an attic access under the highest point of the roof is recommended for inspection and servicing of components in the attic. Defects or deficiencies may exist in inaccessible areas.

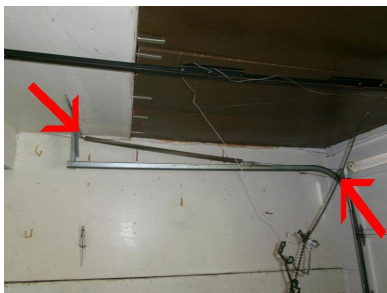
GARAGE

The north garage door is difficult to operate. The garage door hardware is in need of adjustment and repair.

Safeties are cables run through the center of the garage door springs that prevent broken springs from becoming projectiles that can cause injury. There are no safeties installed. The installation of safeties is recommended.

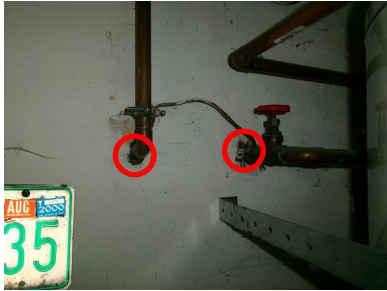
GARAGE DOOR OPENER

The garage door opener was not tested or inspected. The services of a contractor specializing in automatic openers should be retained to perform the necessary repairs.

There was no photo-eye sensor installed for the garage door to offer protection for small children and/or pets. We recommend that a photo-eye sensor be installed for the garage door at a height of within 4-6" of the floor.

There are voids in the fire resistive barrier between the living space and garage that will allow flames to penetrate. The gypsum barrier slows the spread of a fire from the garage to the structure and/or living space. Patching the voids with a fire retardant caulk is recommended.

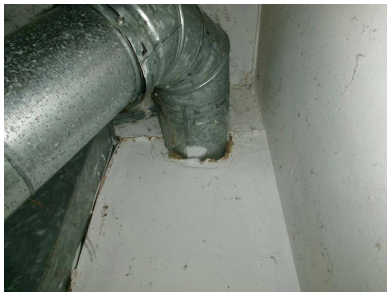
The installation of a furnace vent thimble is recommended to prevent flames from spreading to the structure.

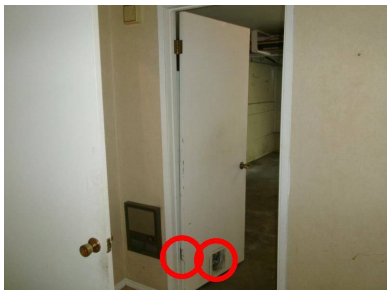
PASSAGE DOOR

The door between the garage and living space is a solid core door. The door hinge is not installed and the door is inoperative. We recommend repairs as necessary.

The Interior entry door lacks a self closing hinge and there is a pet door at the bottom which nullifies the fire rating of the door. Patching the hole in the door and the installation of a self closing hinge is recommended as a safety upgrade.

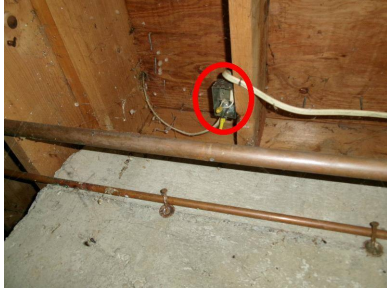
ELECTRICAL SYSTEM

There are junction boxes with missing covers in the crawlspace. This is a fire/shock hazard. Covers should be installed on all junction boxes.

An extension cord is used as a temporary power source for the garage door opener. An extension cord is not suitable as a permanent wiring method. The installation of a receptacle within cords length of the motor is recommended.

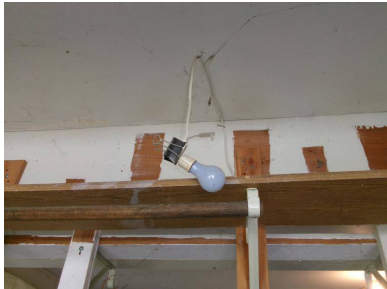
RECEPTACLES

Testing revealed open grounds (ungrounded receptacles) in the primary bedroom/bathroom wall. Open grounds are a potential hazard and could damage some electronic equipment. All receptacles with open grounds should be repaired in accordance with applicable electrical codes.

The installation of additional GFCI protection in the garage and kitchen receptacles is recommended.

The laundry closet luminaires is not working. Testing the luminaries with a voltage tester revealed that there is current to them. Light bulbs should be replaced in non-functional luminaries and then they should be tested for proper operation.

The luminaires in the garage is detached and is hanging from its wires. This is a hazard. The luminaires should be reattached and secured to the ceiling.

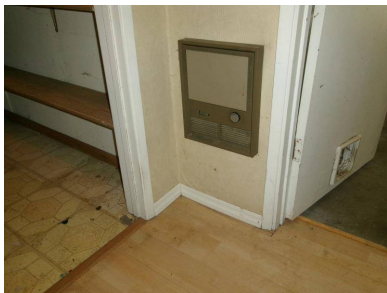
ELECTRIC HEATING

An electric fan assisted wall heater is used for heating in the family room. The heater was tested and was not working. Repairs or replacement is recommended.

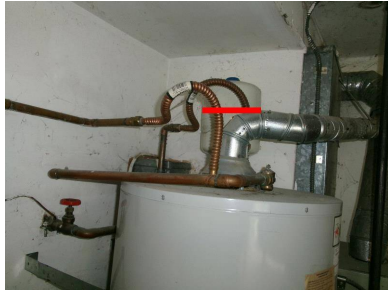
HEATING SYSTEM

The air filter behind the return air grille in the hallway is redundant. Removal of one, of the two filters is recommended.

There is no heat source in the family room. The installation of a heat source is recommended.

The furnace is 39 years old and is nearing the end of its service life. The need for furnace replacement should be anticipated.

The expansion tank is not adequately secured to the wall. As code requirements start to call for engineered expansion tank supports we recommend the installation of seismic restraints to secure the expansion tank instead of allowing it to simply depend on piping connections that could result in damage to the water pipe and leakage during an earthquake.

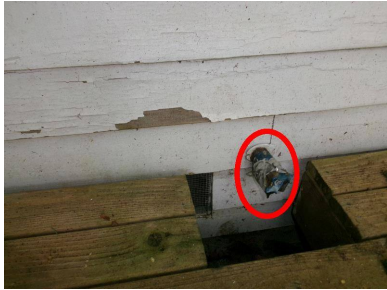
The hose bibb on the rear of the building is damaged. This is indicative of a frozen valve. Replacement of the hose bibb is recommended.

The hose bibb on the rear of the house is also loose. This could result in damage to the water pipe and leakage. The bibb should be securely fastened to the wall.

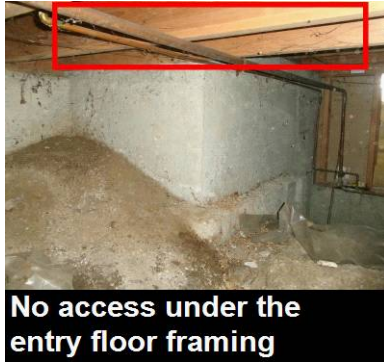
Carpet is damaged and dirty. Carpet replacement is recommended.

The entry floor tile is cracked and the subflooring adjacent the entry stoop was damaged. We recommend repairs as needed. The flooring under the entry was not accessible from the crawl space.

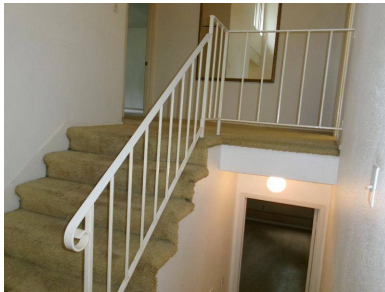
STAIRS

The stair railing baluster spacing is too wide. This is a hazard for small children. The baluster spacing should be reduced as a safety upgrade. Current standards require that a 4-3/8" sphere not pass through the railing.

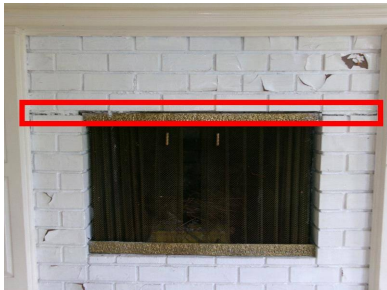
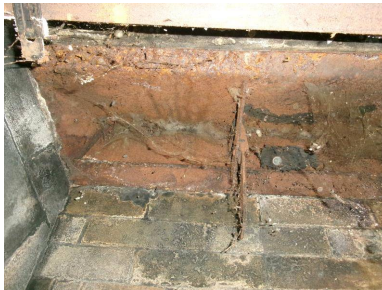
Deteriorated mortar joints of the brick veneer was observed outside the firebox adjacent the firebox lintel. Steel lintels with chronic exposure to moisture will rust, expand and damage the brick veneer. Consideration should be given to retooling (Tuck pointing) the defective mortar joints. An evaluation of the smoke chamber was not made. If you have concerns regarding the condition of the chimney's interior, the services of a certified chimney sweep is likely to determine the condition of the smoke chamber and flue.

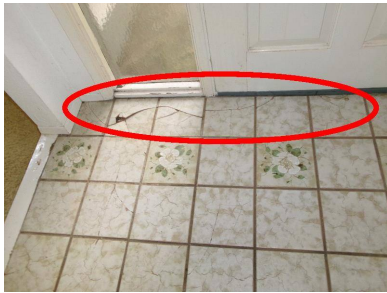
The floor is not insulated. This allows significant heat loss to occur through the floor. The installation of floor insulation is recommended.

The entry floor tile has cracked and the subflooring adjacent the entry stoop was damaged. We recommend repairs as needed. The flooring under the entry was not accessible from the crawl space.

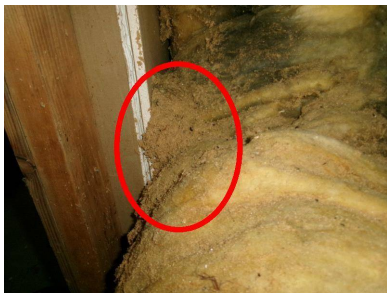
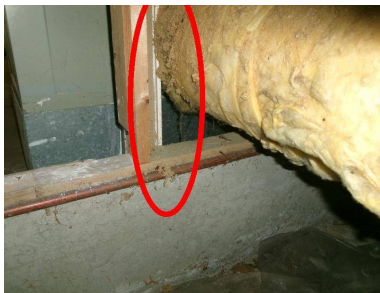
Dead carpenter ants and frass were observed in the crawlspace adjacent the furnace. This suggests that there was a past infestation that has been treated, or that there is a current infestation. You should query the seller as to the history of previous carpenter ant activity.

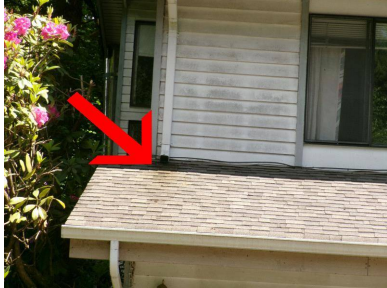
There is a build-up of organic debris inside the gutters. Proper maintenance of gutters and downspouts is essential and should be performed routinely in order to prevent clogging. Maintenance consists primarily of keeping leaves and other organic debris out of the system. Failure to clean the gutters will result in water splash on the building when they overflow. Gutters can be damaged under the weight of the water and organic matter inside the gutter. Gutters should be cleaned as necessary to maintain a free flow of water into the downspouts.

Downspouts draining directly onto the asphalt shingle surface causes excessive wear of the roofing material. Downspout extensions to the lower gutters should be installed to prevent excessive wear and tear of the roofing.

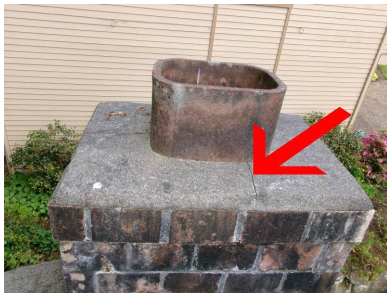
The chimney crown is cracked and deteriorated. The mortar chimney crown prevents water from entering and damaging the masonry. Repairing or replacing the chimney crown will extend the service life of the chimney.

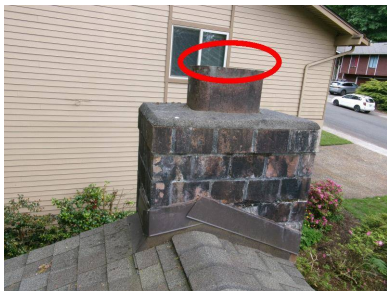
The top of the masonry chimney does not have a spark arrestor/rain cap. The installation of a spark arrestor/rain cap is recommended as a safety upgrade and to prevent moisture damage to the inside of the chimney and fireplace. An additional benefit of a rain cap is that it will keep birds and rodents from entering the house when the damper is left open.

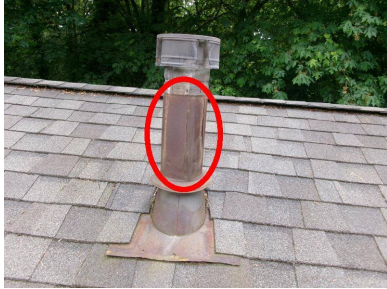
GAS APPLIANCE VENTS

The outer portion of the gas appliance vent above the roof is deteriorated. This section of vent should be replaced.

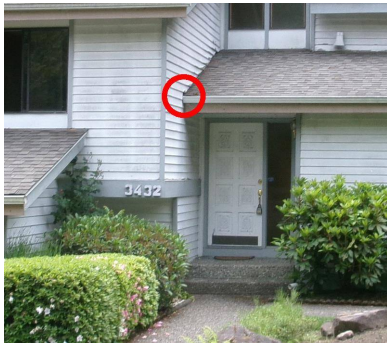
FLASHINGS

There is no kick out flashing at the roof edge to wall intersection above the gutter adjacent the entry. This will allow water to enter the wall behind the siding. The installation of a kick-out flashing is recommended.

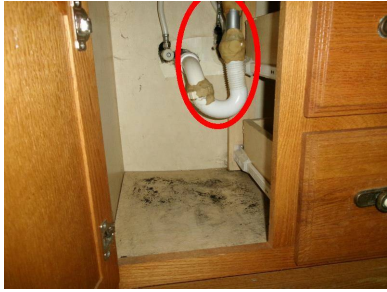
Grout is cracked between some of the wall tiles. This can allow water to enter through the tile and can damage the walls. Regrouting the wall tile is recommended.

The caulking is deteriorated at the intersection between the tub/shower and floor. This can lead to water damage to the flooring and substrate. Recaulking this area is recommended.

The vinyl strip flooring is worn and is nearing the end of its service life. Flooring replacement should be considered.

Improper, non-conforming material has been used for the drain pipe fitting. This material will not function reliably. Replacement with industry standard fittings is recommended.

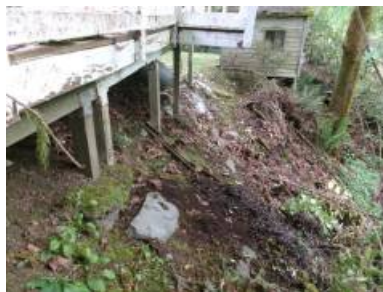
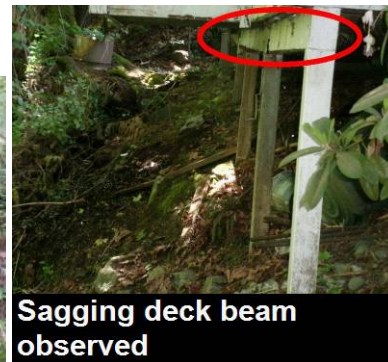
The deck support posts are located at the top of a steep slope. There is evidence visible there has been problems with soil instability. Hidden conditions may also exist that could contribute to instability during the right combination of circumstances (e.g., flooding, improper drainage, earthquake, development or condition of neighboring properties, broken water mains, etc.). You should consider these risks when acquiring this property. If you have concerns about slides, erosion or soil stability, you should retain the services of a qualified geotechnical engineer to evaluate the building site.

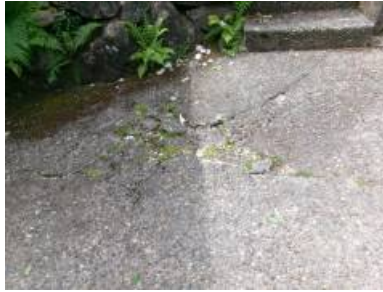
and replacing it. The driveway remains functional despite this condition.

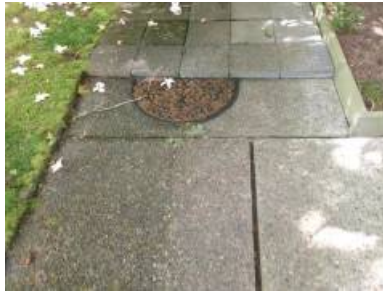
PATIO

The gaps separating the concrete patio sections are a trip hazard. Replacement with mortar is recommended.

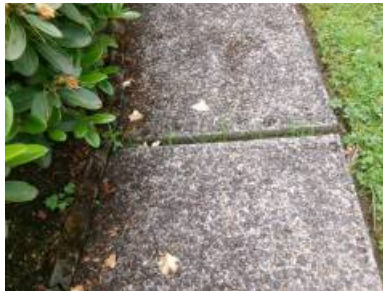
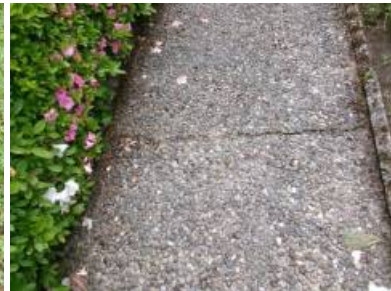
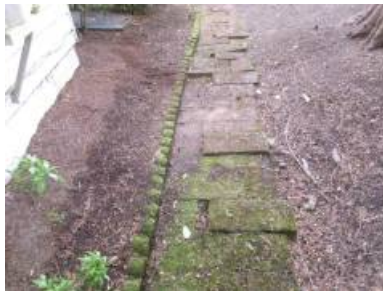
The walking surface was not even and trip hazards were present. We recommend all walking surfaces be maintained free of trip hazards.

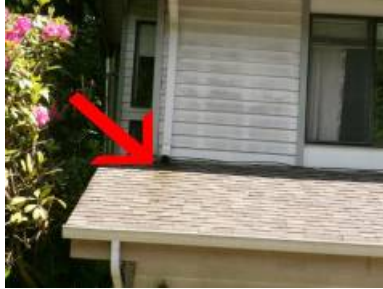
Downspouts draining directly onto the asphalt shingle surface causes excessive wear of the roofing material. Downspout extensions to the lower gutters should be installed to prevent excessive wear and tear of the roofing.

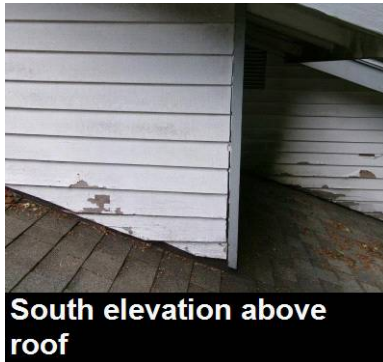
The caulking is cracked and deteriorated. Caulking prevents water intrusion into the wall. Removing and replacing deteriorated caulk is recommended.

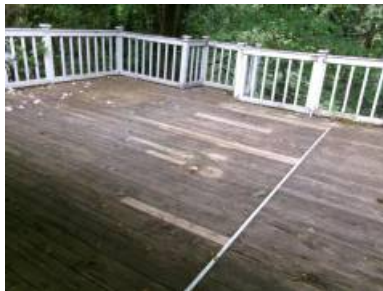
The deck railing is rotted. The spacing between the balusters is too wide. This is a hazard. The balusters should be spaced close enough together so that a 4" sphere cannot pass through. Replacing and upgrading the deck railing is recommended.

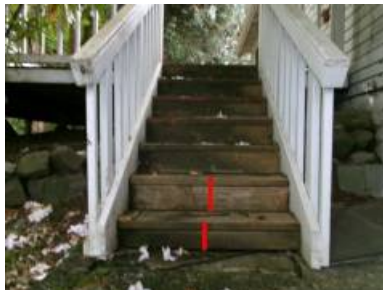
**STAIRS**

The deck stairs are non-conforming due to the variable and/or excessive rise. Deck stair/step design standards require that step risers do not exceed 8" and that the variation in rise not exceed 3/8" in order to reduce falls from tripping. We recommend reconfiguring the steps so that rise and run do not vary by more than 3/8".

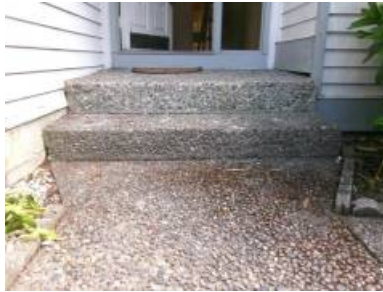
PORCH STEPS

The steps are non-conforming due to the variable and/or excessive rise. Stair design standards require that step risers do not exceed 8" and that the variation in rise not exceed 3/8" in order to reduce falls from tripping. To increase the margin of safety, consideration should be given to reconfiguring the steps so that rise and run do not vary by more than 3/8". If this proves to be too impractical or expensive, then we recommend exercising caution when using.

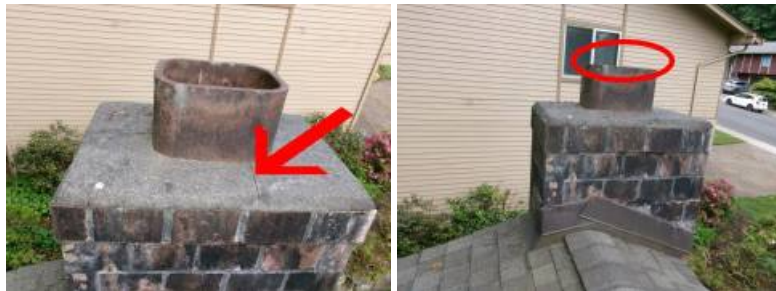
The top of the masonry chimney does not have a spark arrestor/rain cap. The installation of a spark arrestor/rain cap is recommended as a safety upgrade and to prevent moisture damage to the inside of the chimney and fireplace. An additional benefit of a rain cap is that it will keep birds and rodents from entering the house when the damper is left open.

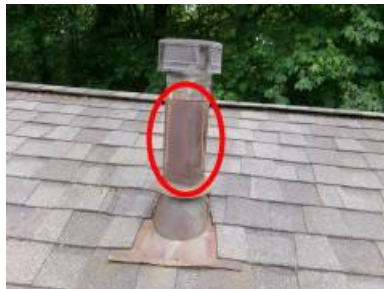
GAS APPLIANCE VENTS

The outer portion of the gas appliance vent above the roof is deteriorated. This section of vent should be replaced.

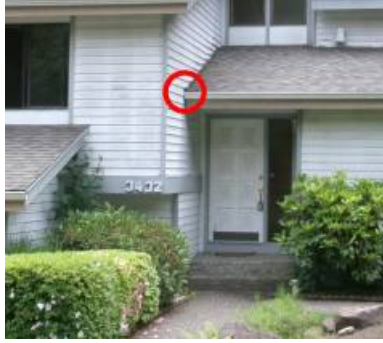
There is no kick out flashing at the roof edge to wall intersection above the gutter adjacent the entry. This will allow water to enter the wall behind the siding. The installation of a kick-out flashing is recommended.

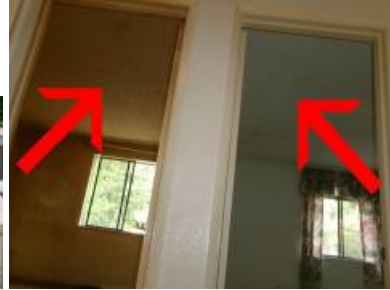
There is no access to the attic. The installation of an attic access under the highest point of the roof is recommended for inspection and servicing of components in the attic. Defects or deficiencies may exist in inaccessible areas.

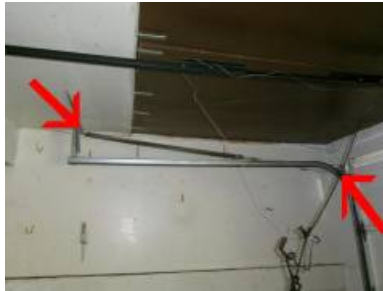
Safeties are cables run through the center of the garage door springs that prevent broken springs from becoming projectiles that can cause injury. There are no safeties installed. The installation of safeties is recommended.

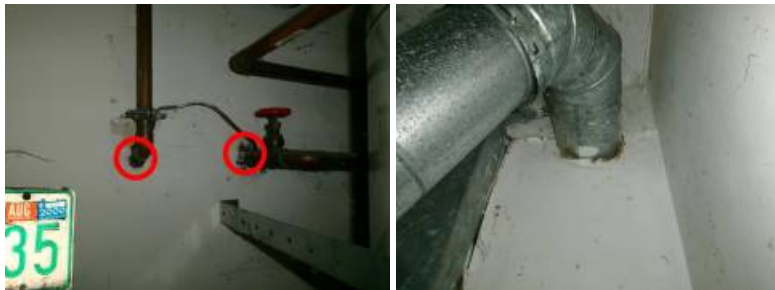
The installation of a furnace vent thimble is recommended to prevent flames from spreading to the structure.

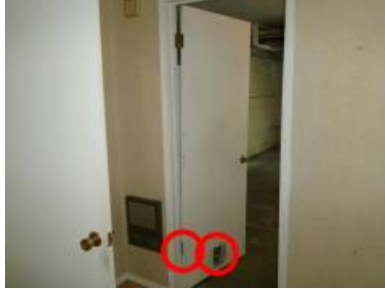
The interior entry door lacks a self-closing hinge and there is a pet door at the bottom which nullifies the fire rating of the door. Patching the hole in the door and the installation of a self-closing hinge is recommended as a safety upgrade.
