NOTICE TO BUYER: SELLER-PROCURED INSPECTION REPORT

Sushwanth Nimmagadda, Hema Gudavalli
 13619 174th Ave NE,
 Redmond, WA 98052

May 10, 2024

Re: 13619 174th Avenue NE
Redmond, WA.

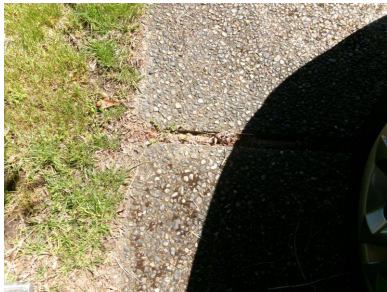
The wooden divider separating the concrete driveway sections has deteriorated to a point where it is a trip hazard. Replacement with mortar is recommended.

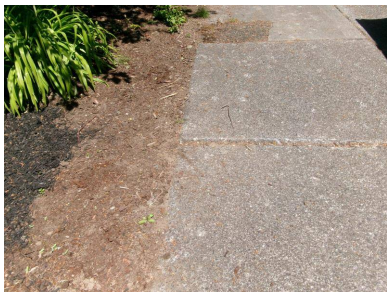
WALKWAY

The walkway has settled differentially. The walkway remains functional despite this condition. However, the raised edges of the concrete can be a trip hazard for some people. Grinding down the raised edges of the concrete will mitigate the hazard. Repairs should be made as necessary.

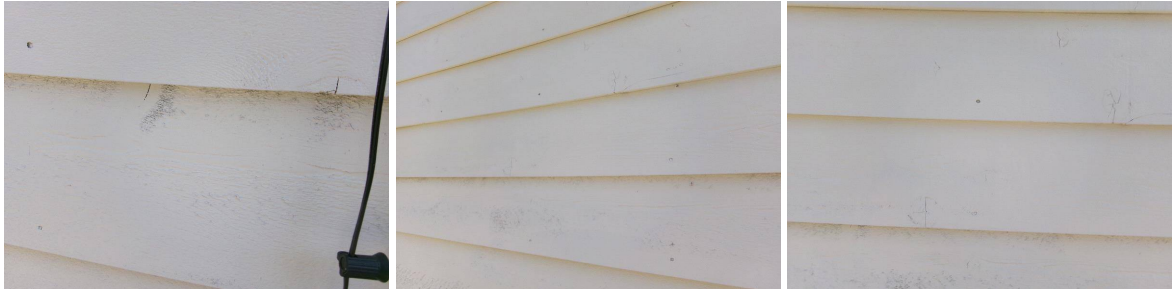
PAINT

The thin coat of paint applied will weather quickly from exposure and repainting the house will be required in the near future.

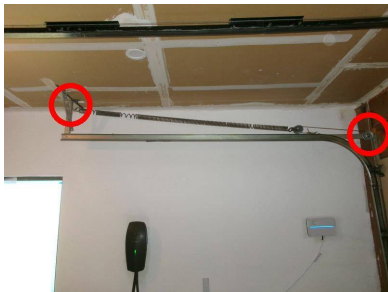
OVERHEAD GARAGE DOORS

Safeties are cables run through the center of the garage door springs that prevent broken springs from becoming projectiles that can cause injury. There are no safeties installed. The installation of safeties is recommended.

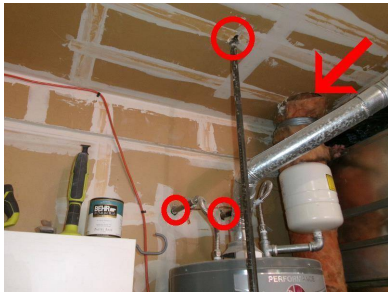
FIRE SEPARATION

There are voids in the fire resistive barrier between the living space and garage that will allow flames to penetrate. The gypsum barrier slows the spread of a fire from the garage to the structure and/or living space. Patching the voids with a fire retardant caulk is recommended.

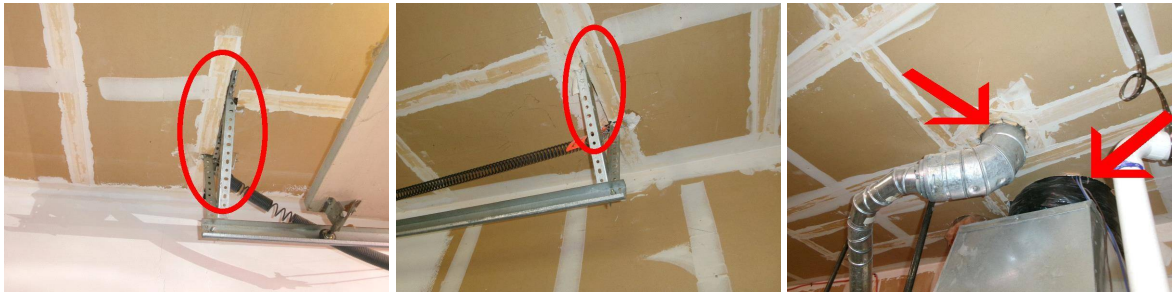
There are voids (adjacent the overhead door brackets) in the fire resistive barrier between the living space and garage that will allow flames to penetrate. The gypsum barrier slows the spread of a fire from the garage to the structure and/or living space. Patching the voids with a fire retardant caulk is recommended.

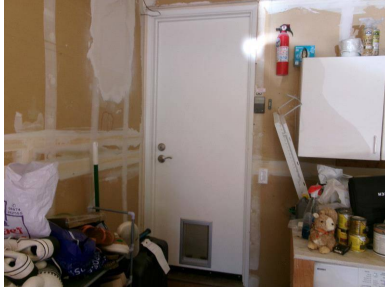
PASSAGE DOOR

The door between the garage and living space is a solid core door with a self closing hinge. The door is properly installed and is in good condition. However, there is a pet door at the bottom which nullifies the fire rating of the door. Patching the hole in the door is recommended as a safety upgrade.

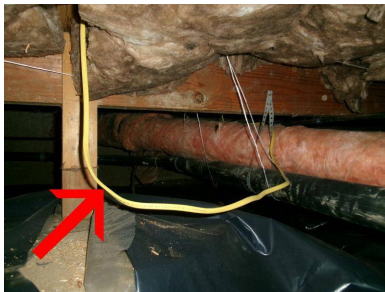
Loose electrical cables were observed in the crawlspace. Loose cables are vulnerable to damage. All loose cables should be secured at 4' intervals using approved cable staples.

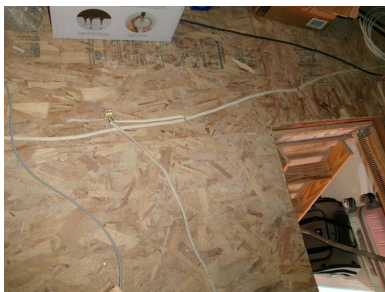
There is Romex cable in the garage attic that is run over the walking surface. These cables are vulnerable to damage. The cables should be relocated or protected in conduit.

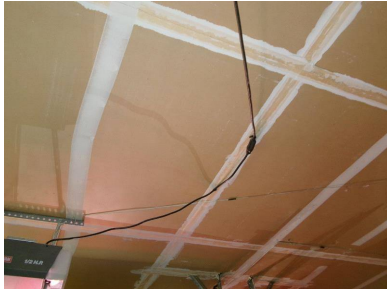
An extension cord is used as a temporary power source for the garage door openers. An extension cord is not suitable as a permanent wiring method. The installation of a receptacle within cords length of the motors is recommended.

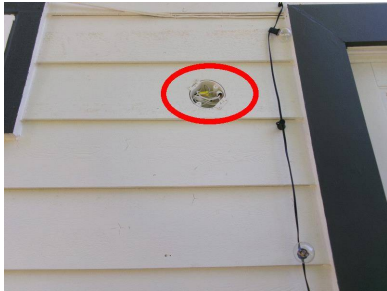
LUMINARIES

The exterior luminaire above the deck is missing. A luminaire should be installed to provide proper lighting in this area.

The cover plate is missing from the luminaries box above the deck. This is a shock and fire hazard. The installation of a cover plate is recommended.

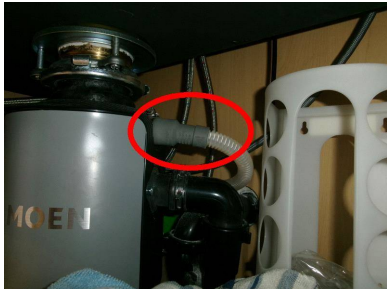
AIR GAP

The dishwasher drain lacks an air gap. The dishwasher will function without one, but there is a risk of contamination of the inside of the dishwasher by waste water. The installation of an air gap above the flood rim of the sink is recommended.

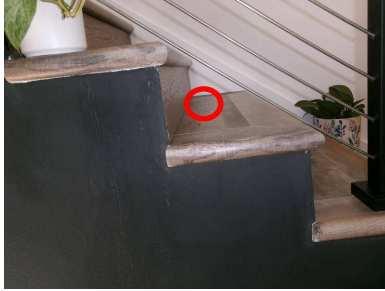
The stair railing spacing at the stair treads is too wide. This is a hazard for small children. The railing spacing

should be reduced as a safety upgrade. Current standards require that a 6" sphere not pass through or under the railing.

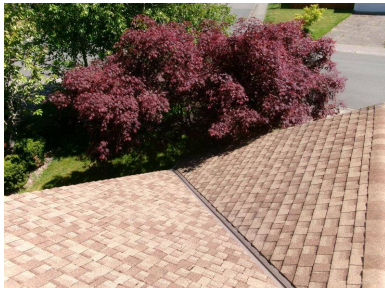
Trees are touching the building on the northeast corner. Low hanging tree branches can damage the roof, gutters, siding, doors and/or windows. Tree branches should be trimmed back where necessary.

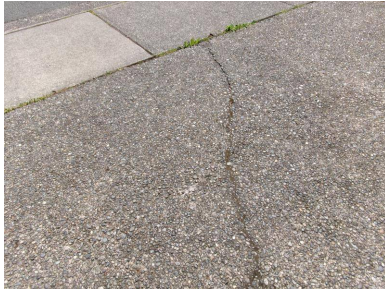
DRIVEWAY

Cracks were observed in the concrete surface of the driveway. Minor cracks can be sealed to minimize moisture entry and further settlement of the concrete. Minor cracks are common and do not affect the serviceability of the concrete.

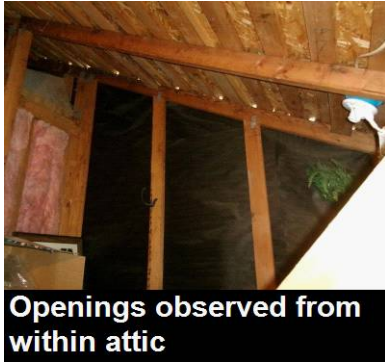
Gaps over 1/4" in size will allow insects and rodents to enter the attic. Covering any gaps with screening, a strip of wood and/or caulking is recommended.

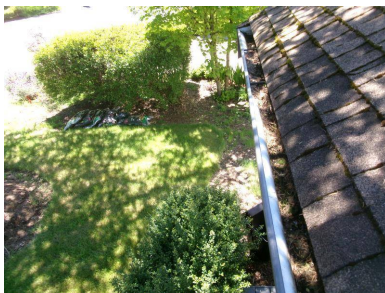
Roof runoff is collected and channeled into the downspouts by aluminum gutters fastened to the rafter tails. The gutters and downspouts are properly installed and are performing their intended function. Gutters should be cleaned regularly to prevent clogging and overflow.

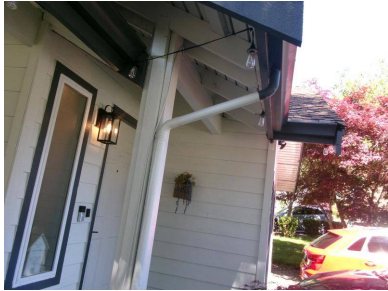
The 2" round downspouts are too small and are more vulnerable to clogging than the larger rectangular ones. Consideration should be given to upgrading the downspouts.

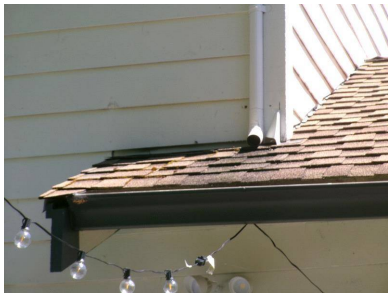
Downspouts draining directly onto the asphalt shingle surface causes excessive wear of the roofing material. Downspout extensions to the lower gutters should be installed to prevent excessive wear and tear of the roofing.

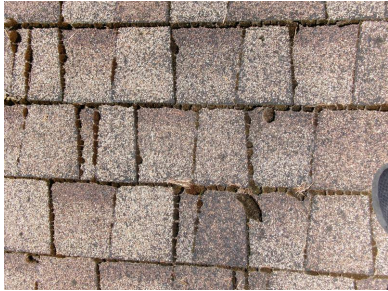
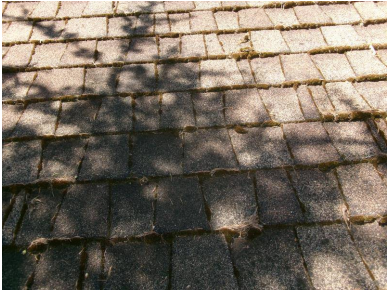
MAINTENANCE AND REPAIRS

The roof is in need of routine maintenance. The surface should be treated for moss, lichen, and algae growth. Then the vegetation debris can be removed by brushing and washing off with a high volume low pressure hose to remove moss and organic debris. Performing this maintenance will improve the appearance and increase the life expectancy of the roof.

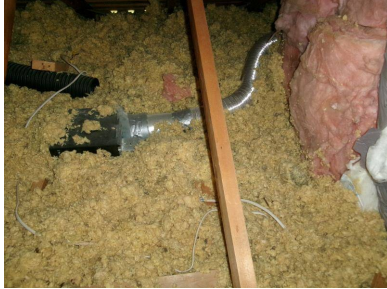
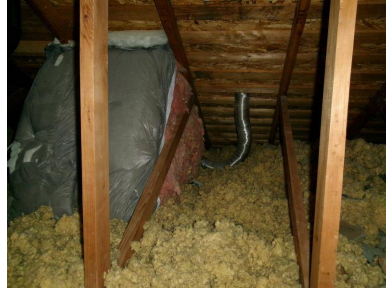
Flexible plastic duct is used to direct air from the vent fan to the exterior. This type of material is unreliable. Replacing the plastic duct with 4" smooth-wall sheet metal duct is recommended.

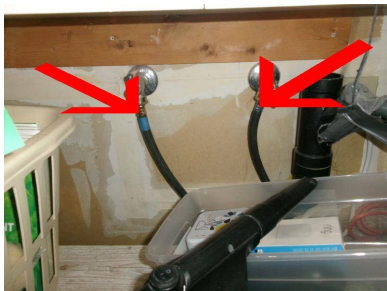
Upgrading the washer connections to high pressure (steel braided) lines is recommended.

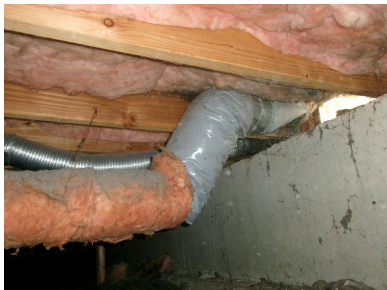
The flex ducts sag, are kinked and lack adequate strapping. These conditions will adversely affect the performance and efficiency of the heating system. New straps should be installed in accordance with industry standards.

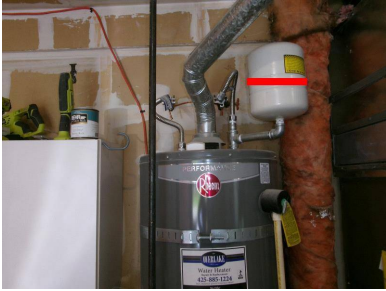
The expansion tank is not adequately secured to the wall. As code requirements start to call for engineered expansion tank supports we recommend the installation of seismic restraints to secure the expansion tank instead of allowing it to simply depend on piping connections that could result in damage to the water pipe and leakage during an earthquake.

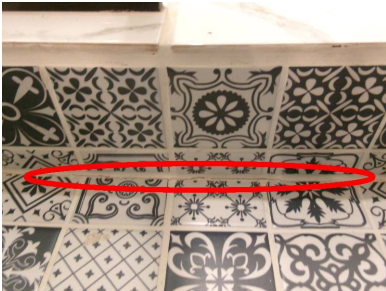
The grout is cracked at the intersection between the tub/shower and floor. This can lead to water damage to the flooring and substrate. Caulking this area with a flexible grout is recommended.

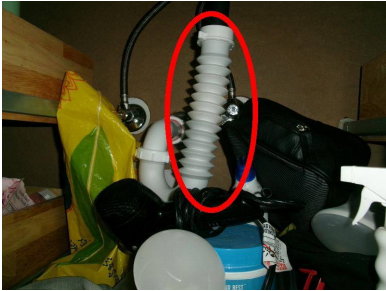
Improper, non-conforming material has been used for the drain pipe fitting. This material will not function reliably. Replacement with industry standard fittings is recommended.

Action Items			
Location	Item	Fixed	Disputing
Garage	Overhead Garage doors	Replaced old garage doors and motors with insulated doors and belt-drive wifi motors	
	Fire Separation	Added fire resistant caulk to the gaps in the garage ceiling	
Electrical System	Wiring	Added new circuit to plug in the Garage door openers. Removed the extension chords.	
	Luminaries	Added new flood light for the backyard	
Bathroom	Faucet fixtures		The handle should be moved left for hot water and right for cold water. It is working as expected.
Maintenance Items			
Building Site	Vegetation	Tree touching the North East corner has been trimmed.	
Roof	Maintenance and Repairs	Roof and gutters has been cleaned and treated for moss. Driveway has been pressure washed.	
Heating System	Forced air ducts	New straps have been installed for supporting the ducts.	
Bathrooms	Flooring Material	Flexible grout has been applied.	
	Drains, Traps	Flexible drain pipe has been replaced with industry standard PVC fittings

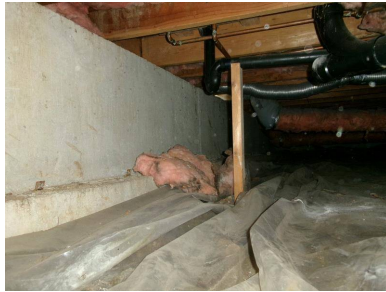
There is an insufficient number of support straps holding up the waste pipe in the crawlspace. This can cause traps to form and will lead to drain blockage. The installation of additional support straps is recommended.

Drain and waste pipes	Additional straps have been added for the drain pipes in crawl space	
Insulation	Floor Insulation	Fallen insulation batts were reinstalled and secured	
	Duct insulation	Fallen duct insulation has been reinstalled

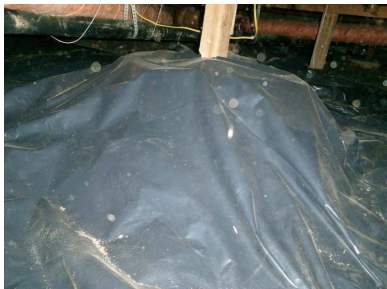
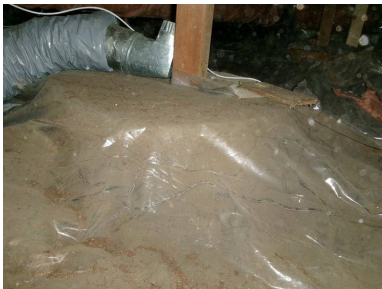
The support post concrete piers are covered with the plastic vapor retarder. This allows the transmission of water vapor from the soil up and into the floor framing. The plastic vapor retarder should be removed from the pier so that it covers at least 85% of the entire surface of the soil only.

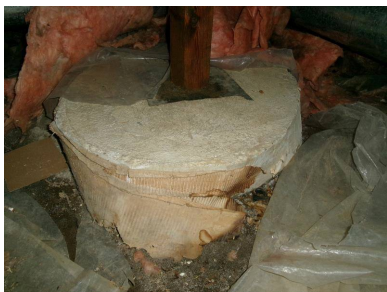
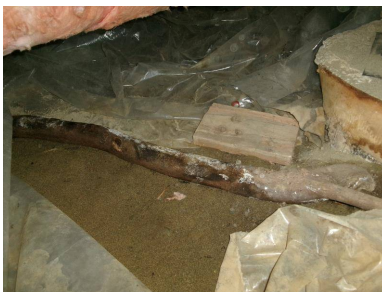
PEST CONTROL

Cellulose forms were left in place on the pier footings. This cellulose is conducive to the infestation of various wood destroying organisms. The removal of the cellulose is recommended.

Scrap-wood and other cellulose debris was observed on the crawl floor. This wood debris creates conducive conditions for wood boring insects. The removal of all cellulose debris is recommended.

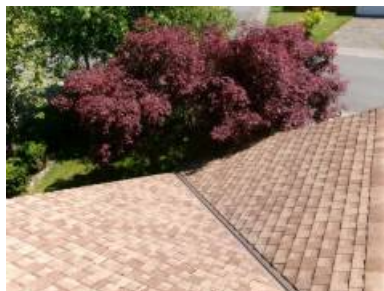
Trees are touching the building on the northeast corner. Low hanging tree branches can damage the roof, gutters, siding, doors and/or windows. Tree branches should be trimmed back where necessary.

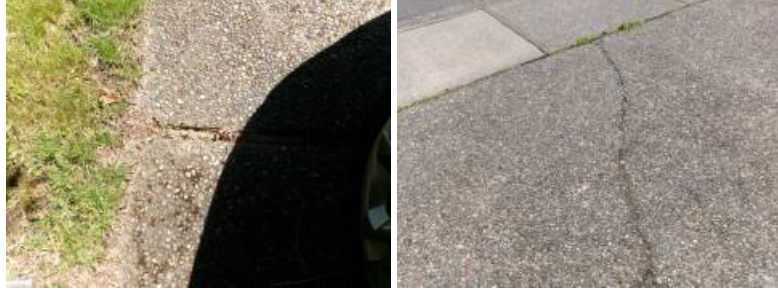
DRIVEWAY The wooden divider separating the concrete driveway sections has deteriorated to a point where it is a trip hazard. Replacement with mortar is recommended.

Cracks were observed in the concrete surface of the driveway. Minor cracks can be sealed to minimize moisture entry and further settlement of the concrete. Minor cracks are common and do not affect the serviceability of the concrete.

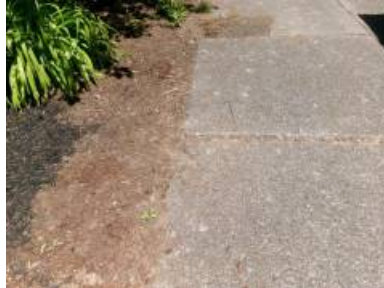
Many legal and public works departments have defined a trip hazard as an irregularity in a walking surface exceeding one inch (1") in height. All walking surfaces should maintain, free of a vertical surface change of 3/4" or more, in the interest of public and personal safety.

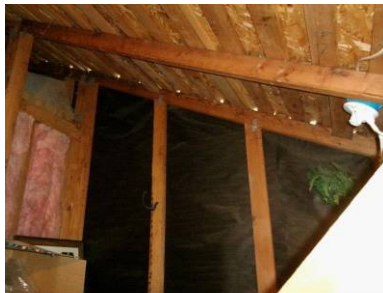
Gaps over 1/4" in size will allow insects and rodents to enter the attic. Covering any gaps with screening, a strip of wood and/or caulking is recommended.

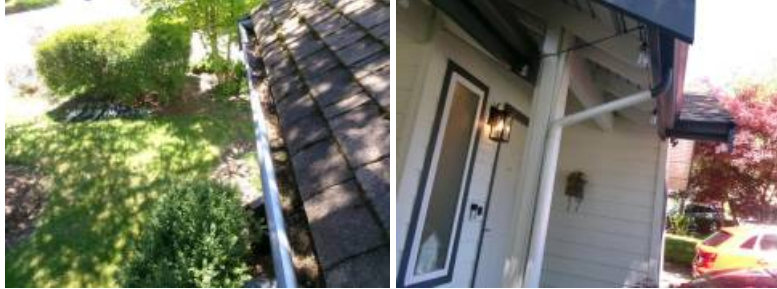
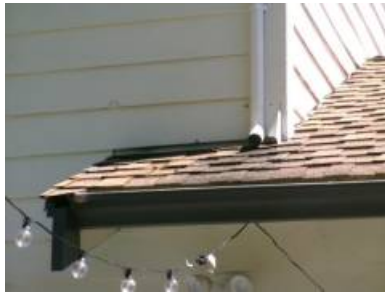
Downspouts draining directly onto the asphalt shingle surface causes excessive wear of the roofing material. Downspout extensions to the lower gutters should be installed to prevent excessive wear and tear of the roofing.

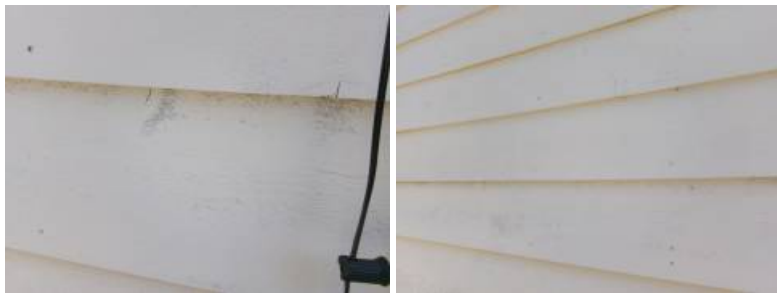
PAINT

The thin coat of paint applied will weather quickly from exposure and repainting the house will be required in the near future.

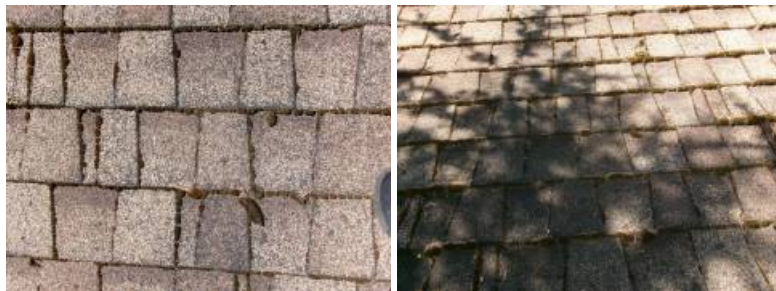
Moss growth once established acts like a sponge, soaking up and storing rainwater. Some of that water then wicks up under the shingles through capillary action and soaks into and through the roof underlayment, which is typically 15- or 30-pound felt. Eventually, it saturates the roof sheathing below.

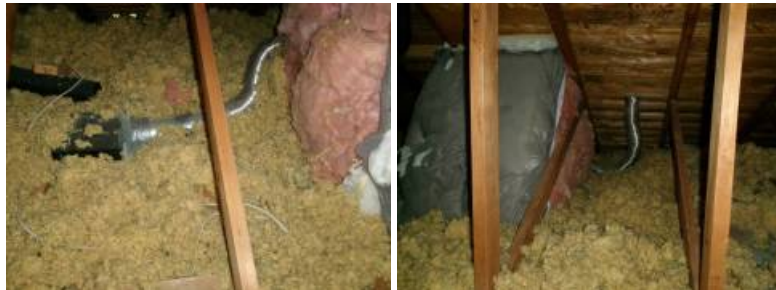
Flexible plastic duct is used to direct air from the vent fan to the exterior. This type of material is unreliable. Replacing the plastic duct with 4" smooth-wall sheet metal duct is recommended.

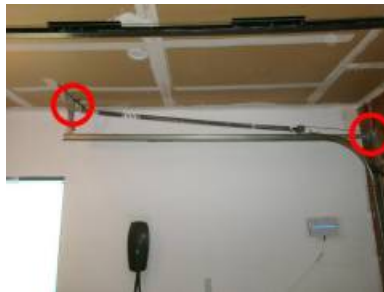
Safeties are cables run through the center of the garage door springs that prevent broken springs from becoming projectiles that can cause injury. There are no safeties installed. The installation of safeties is recommended.

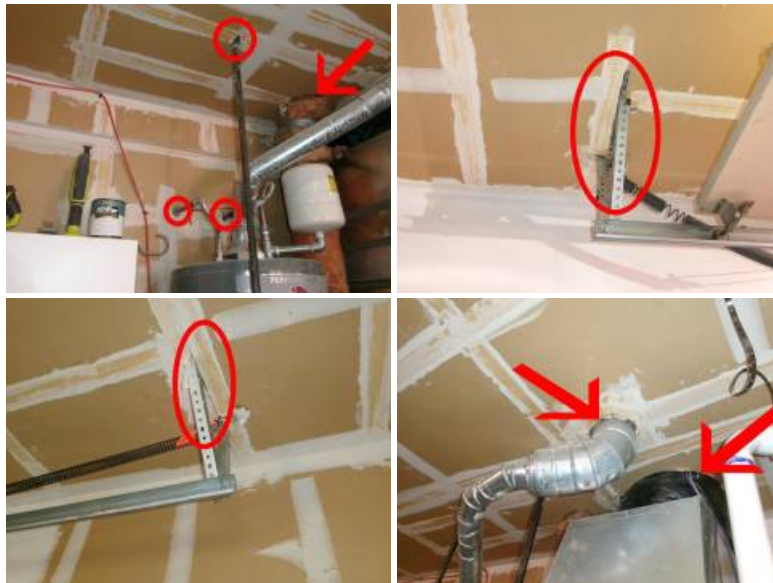
There are voids (adjacent the overhead door brackets) in the fire resistive barrier between the living space and garage that will allow flames to penetrate. The gypsum barrier slows the spread of a fire from the garage to the structure and/or living space. Patching the voids with a fire retardant caulk is recommended.

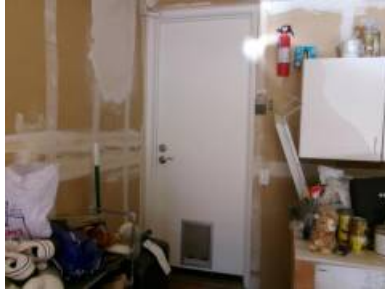
door at the bottom which nullifies the fire rating of the door. Patching the hole in the door is recommended as a safety upgrade.

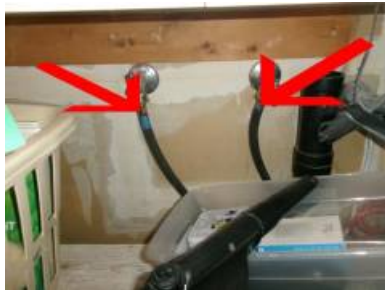
Upgrading the washer connections to high pressure (steel braided) lines is recommended.

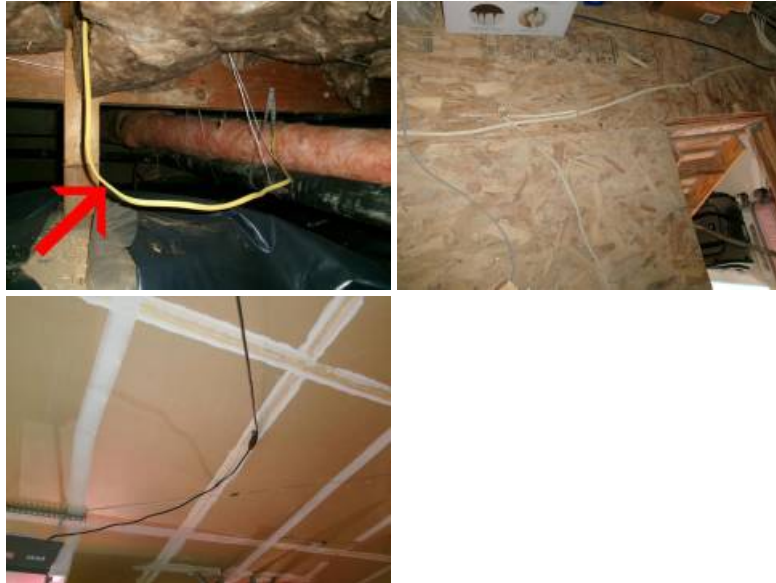
<i>WIRING</i>		The visible portions of the wiring are properly installed except where noted below. Loose electrical cables were observed in the crawlspace. Loose cables are vulnerable to damage. All loose cables should be secured at 4' intervals using approved cable staples. There is Romex cable in the garage attic that is run over the walking surface. These cables are vulnerable to damage. The cables should be relocated or protected in conduit. An extension cord is used as a temporary power source for the garage door openers. An extension cord is not suitable as a permanent wiring method. The installation of a receptacle within cords length of the motors is recommended.

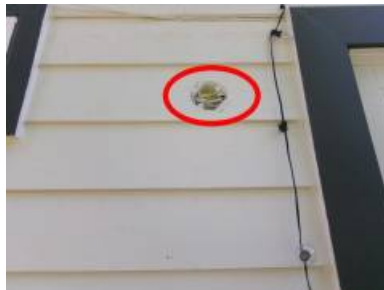
The cover plate is missing from the luminaries box above the deck. This is a shock and fire hazard. The installation of a cover plate is recommended.

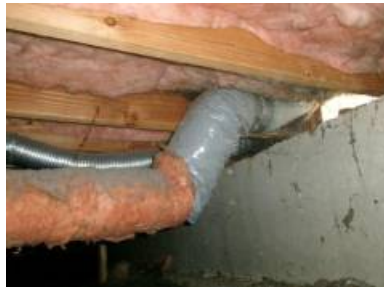
The flex ducts sag, are kinked and lack adequate strapping. These conditions will adversely affect the performance and efficiency of the heating system. New straps should be installed in accordance with industry standards.

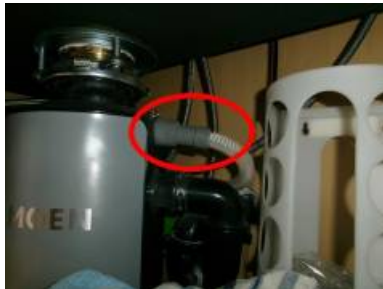
<i>COUNTERTOPS</i>	The countertops are covered with slab quartz. The counter tops are properly installed and are in good condition.
<i>CABINETS</i>	The finish on the kitchen cabinets is slightly worn. The cabinets are otherwise in good condition.
<i>FLOORING MATERIAL</i>	The floor is covered with plastic laminated strip flooring. The floor is properly installed and is in good condition.
<i>VENTILATION</i>	Ventilation in the kitchen is provided by a range hood over the stove. The vent is ducted to the exterior. The vent fan is properly installed and is performing its intended function.
<i>SINK FAUCET</i>	The sink faucet is properly installed and is in good condition.
<i>SINK</i>	The kitchen sink is properly installed and is in good condition.
<i>DRAINS, TRAPS AND TRAP ARMS</i>	The sink drain is properly installed and is performing its intended function.
<i>AIR GAP</i>	The dishwasher drain lacks an air gap. The dishwasher will function without one, but there is a risk of contamination of the inside of the dishwasher by waste water. The installation of an air gap above the flood rim of the sink is recommended.

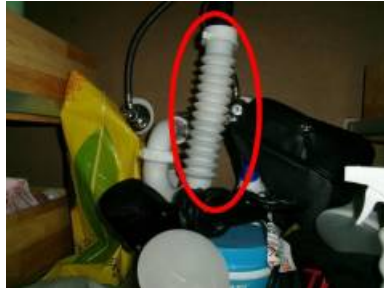
Improper, non-conforming material has been used for the drain pipe fitting. This material will not function reliably. Replacement with industry standard fittings is recommended.

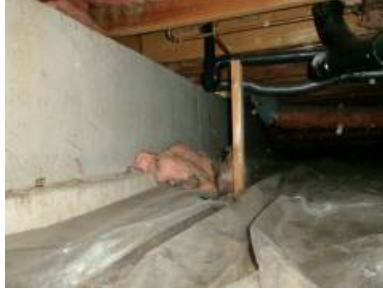
There is an insufficient number of support straps holding up the waste pipe in the crawlspace. This can cause traps to form and will lead to drain blockage. The installation of additional support straps is recommended.

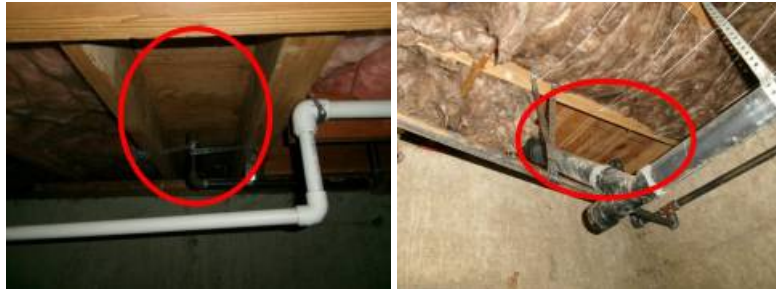
Some of the insulation batts were not properly secured and have falling down. The fallen batts should be reinstalled and secured.
