NOTICE TO BUYER: SELLER-PROCURED INSPECTION REPORT

The following notice is given with respect to the Purchase and Sale Agreement dated _____
 between _____ (“Buyer”)
 and **Kevin J Hafer Revocable Living** _____ (“Seller”)
 concerning 8317 NE 120th Pl Kirkland WA 98034 (“the Property”).

DATE OF INSPECTION: 5/1/2024.
 INSPECTOR'S NAME: Terry Clark.
 CLIENT NAME: Mr. Kevin Hafer.
 ADDRESS OF PROPERTY INSPECTED: 8317 NE 120th Pl.
 Kirkland, WA.

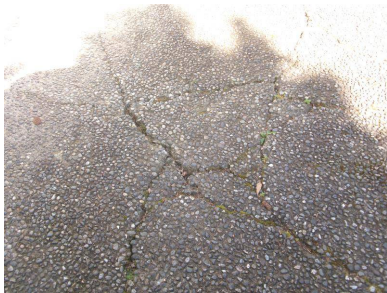
The driveway has cracked and settled differentially. This was probably caused by inadequate preparation of the soil prior to the placement of the concrete. This condition can be repaired by pressure grouting the sunken portion of the driveway or by removing and replacing it. The driveway remains functional despite this condition.

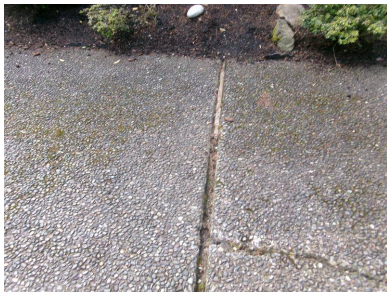
One or more of the wooden dividers separating the concrete driveway sections were infested by wood destroying organisms and have deteriorated to a point where they are becoming a trip hazard. Replacement with mortar is recommended.

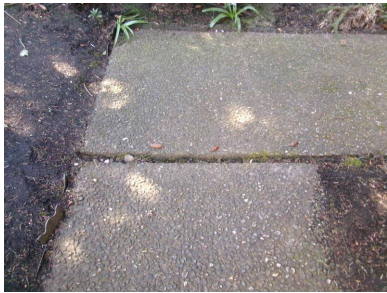
One or more of the wooden dividers separating the concrete walkway sections were infested by wood destroying organisms and have deteriorated to a point where they are becoming a trip hazard. Replacement with mortar is recommended.

The raised edge of the concrete can be a trip hazard for some people. Grinding down the raised edge of the concrete will mitigate the hazard. Repairs should be made as necessary.

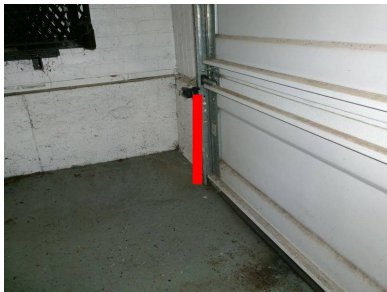
The Photo-eye beam was installed to high above the floor of the garage to adequately offer protection for small children and/or pets. We recommend that the photo-eye be lowered to within 4-6" of the floor.

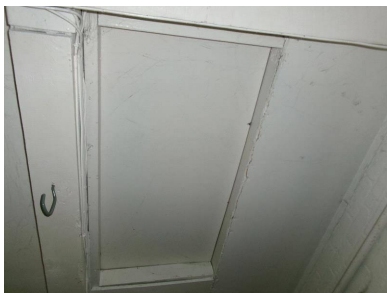
The cover for the attic access is missing. This is a safety concern. The gypsum barrier on the ceiling slows the spread of a fire from the garage to the attic. The installation of an access cover is recommended.

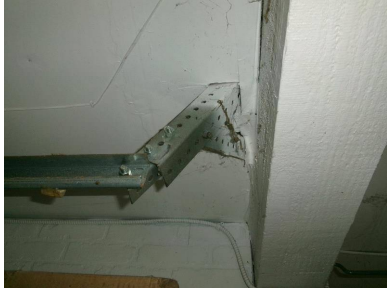
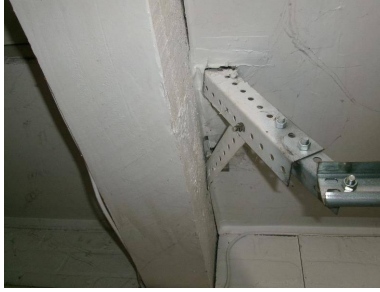
There are voids (adjacent the overhead door brackets) in the fire resistive barrier between the living space and garage that will allow flames to penetrate. The gypsum barrier slows the spread of a fire from the garage to the

structure and/or living space. Patching the voids with a fire retardant caulk is recommended.

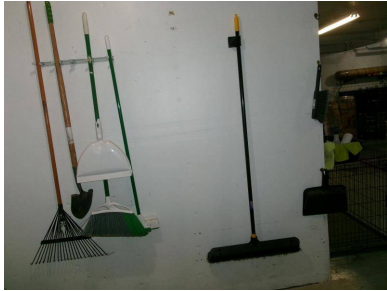
The exposed wood is a breach in the fire resistive barrier in the garage. This is a safety concern. The gypsum barrier slows the spread of a fire from the garage to the structure. The installation of a layer of 5/8" gypsum type X board over the exposed wood is recommended.

Several of the holes are not covered. Consideration should be given to "fire taping" the entire drywall as a safety upgrade.

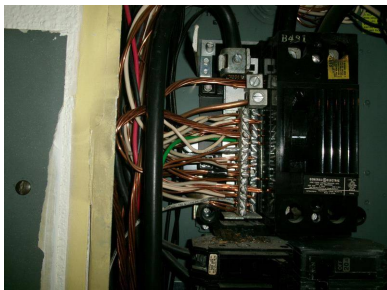
Neutral (white wire) and equipment grounding conductors (bare wire) terminate under the same lug. An individual terminal should be provided for the connection of each branch-circuit neutral conductor. When the neutral is disconnected, the objective is to still have the equipment ground connected. If both the neutral and grounded conductor is under the same terminal, this cannot be accomplished. The services of a qualified electrical contractor should be retained to repair the circuit(s).

| Task # | Description | Quantity | Price | Total |
|---|---|---|---|---|
| T&M - Labor | 6/12/24 Inspected electrical panels to find what home inspector had issue with. Previous electrician daisy chained (2) single pole arc fault breakers to share a neutral. Replaced with (2) pole arc fault. Replaced (2) 20A single pole sharing neutral with 2-pole to have handle tie. X2 | 1.00 | \$469.00 | \$469.00 |

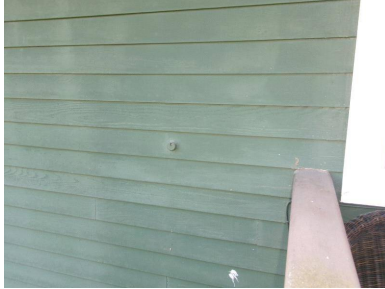
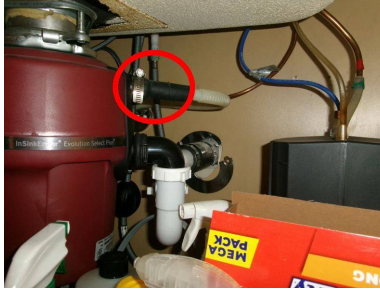
The dishwasher drain lacks an air gap. The dishwasher will function without one, but there is a risk of contamination of the inside of the dishwasher by waste water. The installation of an air gap above the flood rim of the sink is recommended or connecting to the existing Johnson Tee that is installed in the exterior kitchen wall. This (air gap) or Johnson Tee protects the dishwasher from contamination caused by a backflow of waste water.

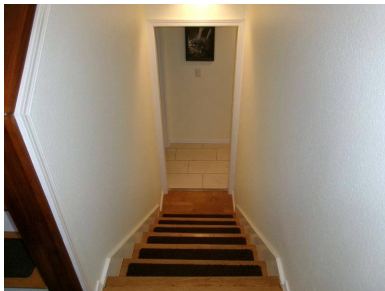
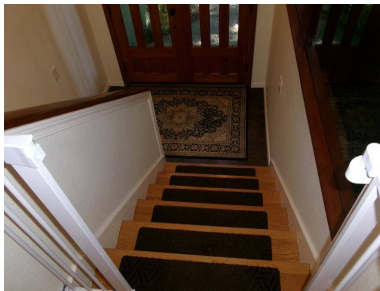
There is no graspable handrail along the upper portion of the stairs. This is a safety hazard. The installation of a graspable handrail should be considered as a safety upgrade.

There is no handrail in the lower stairwell. This is a safety hazard. The installation of a graspable handrail that conforms to present industry standards is recommended.

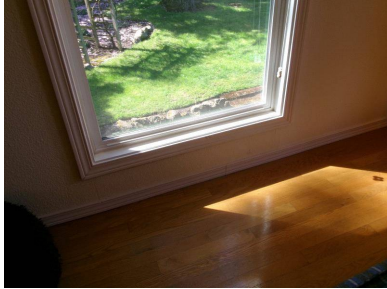
The lower window glass is not labeled as tempered safety glass. The existing glass is nonconforming by current building standards and would be hazardous if broken. The installation of safety glass is recommended as a safety upgrade for all windows less than 18" from the walking surface.

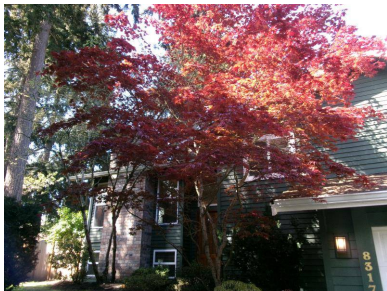
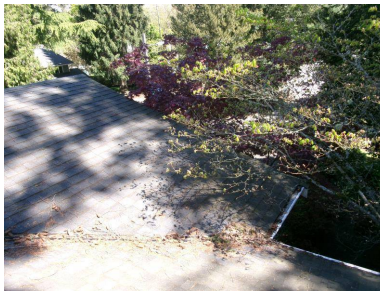
Trees are touching the building on the southeast side. Low hanging tree branches can damage the roof, gutters, siding, doors and/or windows. Tree branches should be trimmed back where necessary.

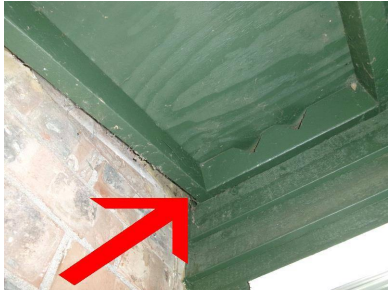
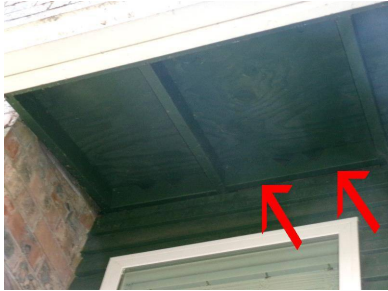
There are openings at the intersection adjacent the chimney and roof through which birds and rodents can enter into the attic. These openings should be covered with wood, wire mesh or filled with aerosol foam.

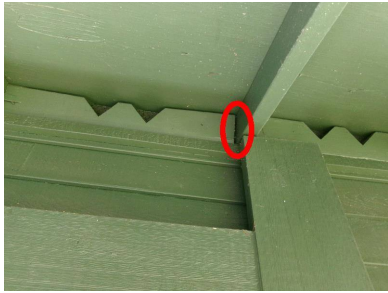
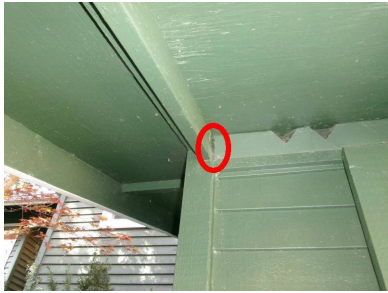
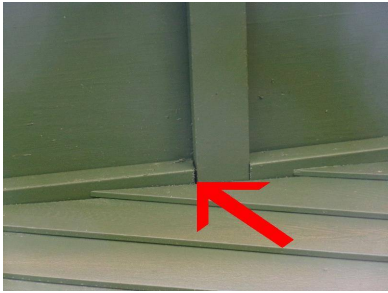
There are large gaps over 1/4" in size adjacent the soffit vent blocks. These gaps allow insects and rodents to enter the attic. Covering the gaps with screening, a strip of wood and/or caulking is recommended.

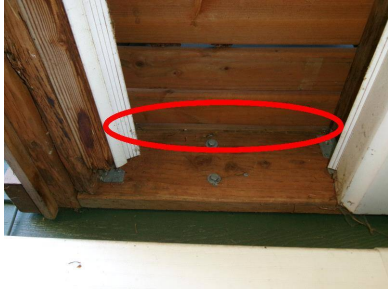
There is no flashing at the intersection between the deck and house. This will allow water to enter behind the siding. The installation of flashing in this area is recommended.

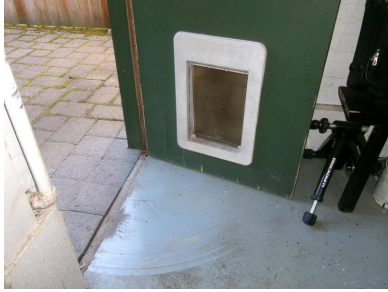
The exterior garage door rubs on the floor making it difficult to open and close. The door should be repaired as necessary to improve operation.

Wood doors are undesirable for use at any location that has chronic exposure to rainfall or water splash. Consideration should be given to upgrading the exposed wood door to aluminum or vinyl clad door.

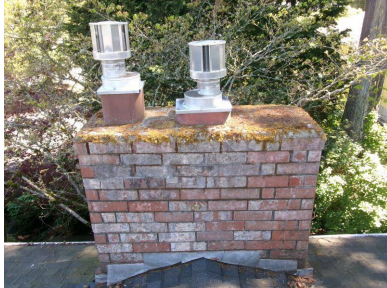
Moss/vegetation was observed in several areas around the upper portion of the chimney. This will lead to accelerated deterioration of the brick masonry mortar. We recommend removal of all organic growth. Damaged areas can be repaired by filling in cutout or defective mortar joints with fresh mortar. (Tuck pointing)

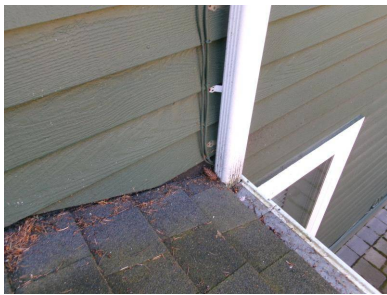
There is no kick out flashing at the roof edge to wall intersection above the gutter. This will allow water to enter the wall behind the siding. The installation of a kick-out flashing is recommended.

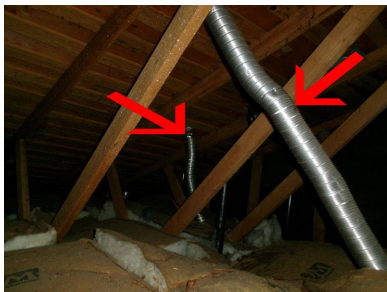
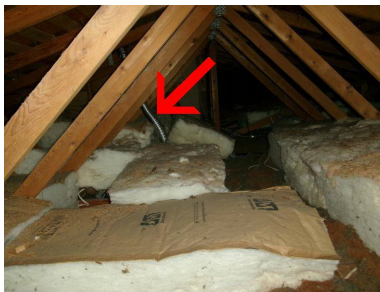
Flexible plastic duct is used to direct air from the vent fans to the exterior. This type of material is unreliable. Replacing the plastic duct with 4" smooth-wall sheet metal duct is recommended.

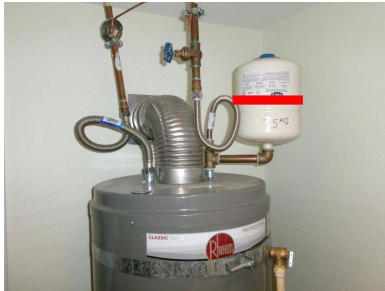
The expansion tank is not adequately secured to the wall. As code requirements start to call for engineered expansion tank supports we recommend the installation of seismic restraints to secure the expansion tank instead of allowing it to simply depend on piping connections that could result in damage to the water pipe and leakage during an earthquake.

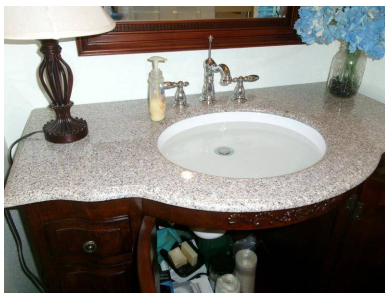
The backsplash is missing. The installation of a backsplash is recommended.

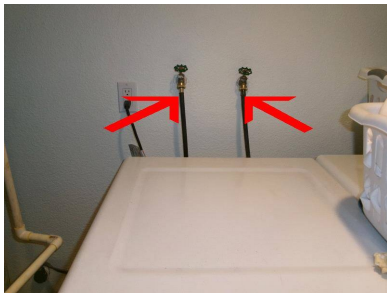
Upgrading the washer connections to high pressure (steel braided) lines is recommended.

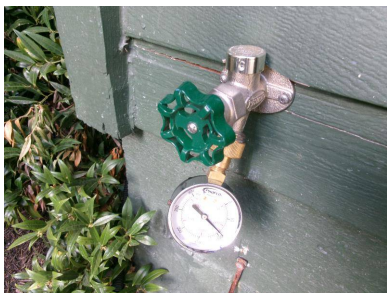
The water pressure at 90 PSI is excessive. The normal range is 30-80 PSI. High water pressure can result in leaking valves, detached supply tubes, water hammer and is hard on solenoid valves. Consideration should be given to the installation of a pressure reduction valve.

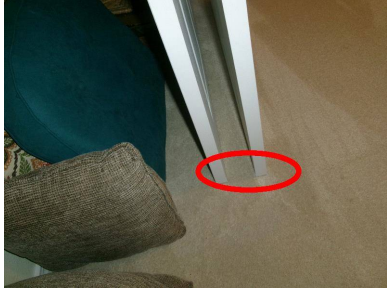
The floor guides are missing from the bypass closet doors in the bedroom. Missing floor guides could result in

damage to the doors. The installation of floor guides is recommended.

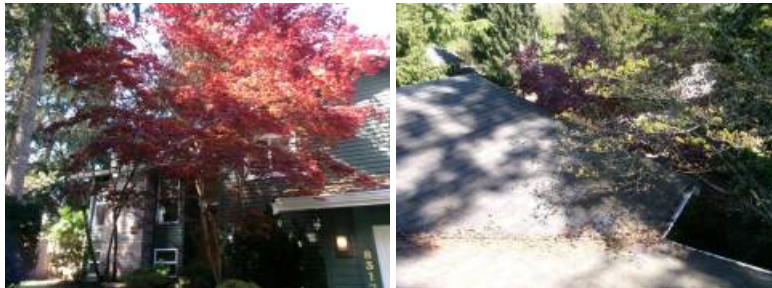
Trees are touching the building on the southeast side. Low hanging tree branches can damage the roof, gutters, siding, doors and/or windows. Tree branches should be trimmed back where necessary.

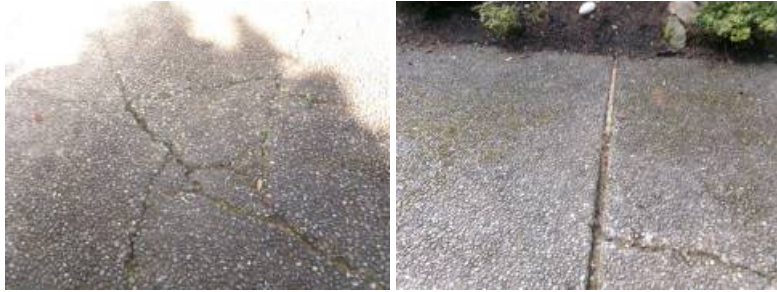
becoming a trip hazard. Replacement with mortar is recommended.

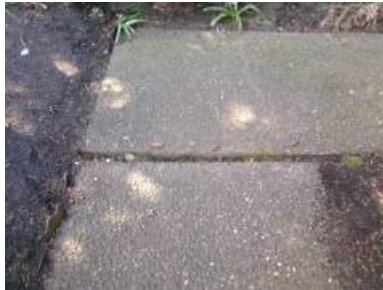
Many legal and public works departments have defined a trip hazard as an irregularity in a walking surface exceeding one inch (1") in height. All walking surfaces should maintain, free of a vertical surface change of 3/4" or more, in the interest of public and personal safety.

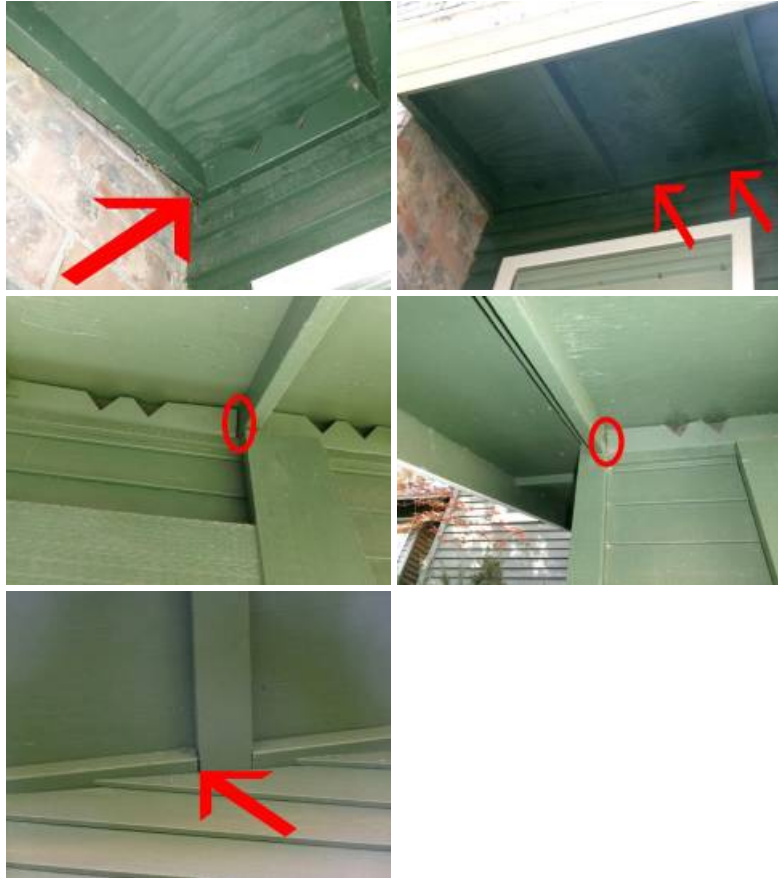
There are large gaps over 1/4" in size adjacent the soffit vent blocks. These gaps allow insects and rodents to enter the attic. Covering the gaps with screening, a strip of wood and/or caulking is recommended.

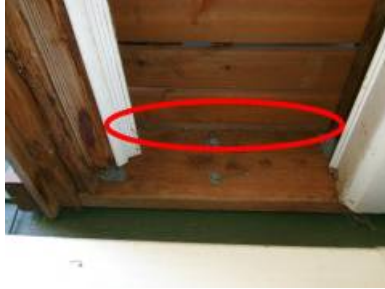
There is no flashing at the intersection between the deck and house. This will allow water to enter behind the siding. The installation of flashing in this area is recommended.

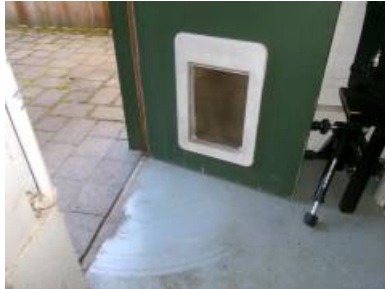
Wood doors are undesirable for use at any location that has chronic exposure to rainfall or water splash. Consideration should be given to upgrading the exposed wood door to aluminum or vinyl clad door.

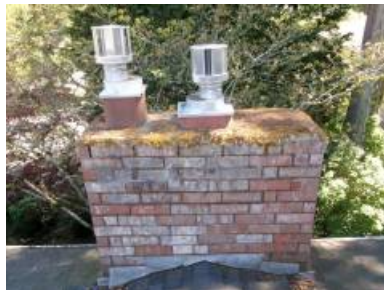
Moss/vegetation was observed in several areas around the upper portion of the chimney. This will lead to accelerated deterioration of the brick masonry mortar. We recommend removal of all organic growth. Damaged areas can be repaired by filling in cutout or defective mortar joints with fresh mortar. (Tuck pointing)

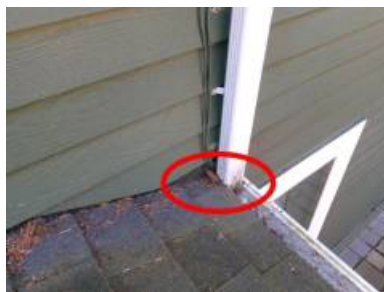
There is no kick out flashing at the roof edge to wall intersection above the gutter. This will allow water to enter the wall behind the siding. The installation of a kick-out flashing is recommended.

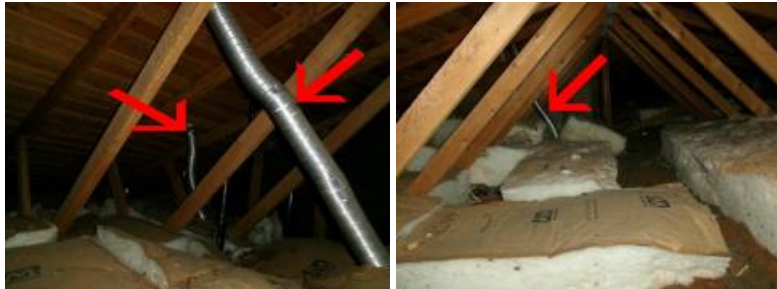
VENTILATION Flexible plastic duct is used to direct air from the vent fans to the exterior. This type of material is unreliable. Replacing the plastic duct with 4" smooth-wall sheet metal duct is recommended.

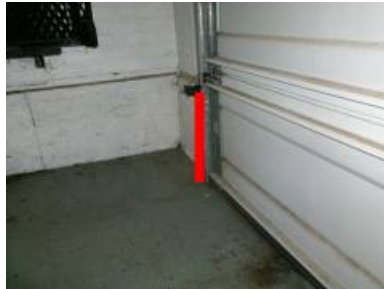
The Photo-eye beam was installed to high above the floor of the garage to adequately offer protection for small children and/or pets. We recommend that the photo-eye be lowered to within 4-6" of the floor.

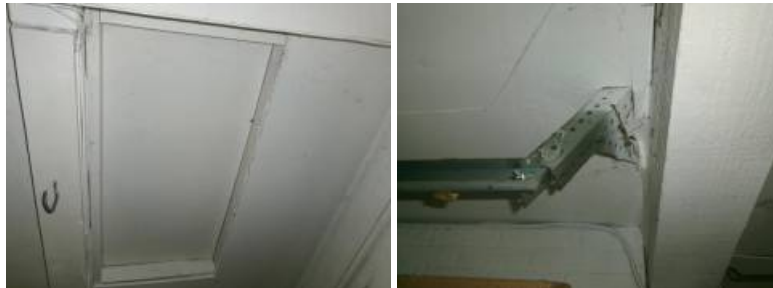
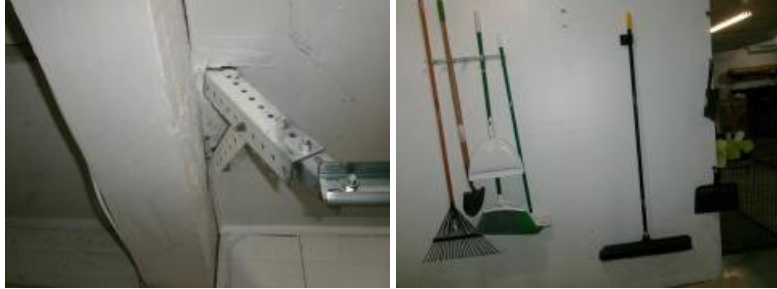
Several of the holes are not covered. Consideration should be given to "fire taping" the entire drywall as a safety upgrade.

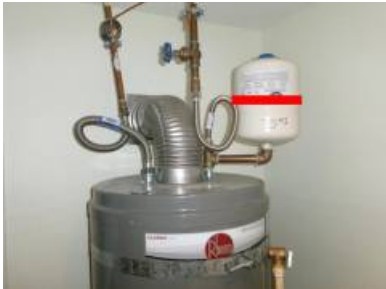
| <i>EXPANSION TANK</i> | The expansion tank is not adequately secured to the wall. As code requirements start to call for engineered expansion tank supports we recommend the installation of seismic restraints to secure the expansion tank instead of allowing it to simply depend on piping connections that could result in damage to the water pipe and leakage during an earthquake. |

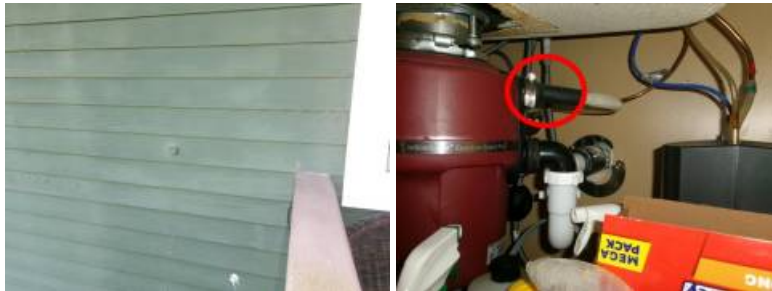
| <i>AIR GAP</i> | The dishwasher drain lacks an air gap. The dishwasher will function without one, but there is a risk of contamination of the inside of the dishwasher by waste water. The installation of an air gap above the flood rim of the sink is recommended or connecting to the existing Johnson Tee that is installed in the exterior kitchen wall. This (air gap) or Johnson Tee protects the dishwasher from contamination caused by a backflow of waste water. |

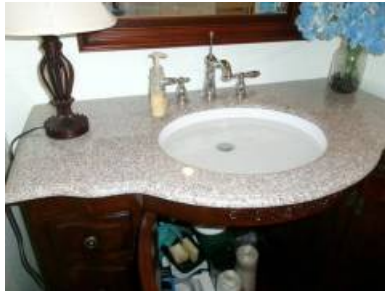
The backsplash is missing. The installation of a backsplash is recommended.

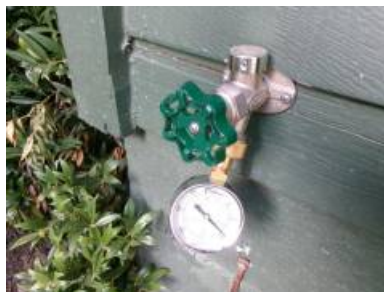
- WATER PRESSURE* The water pressure at 90 PSI is excessive. The normal range is 30-80 PSI. High water pressure can result in leaking valves, detached supply tubes, water hammer and is hard on solenoid valves. Consideration should be given to the installation of a pressure reduction valve.

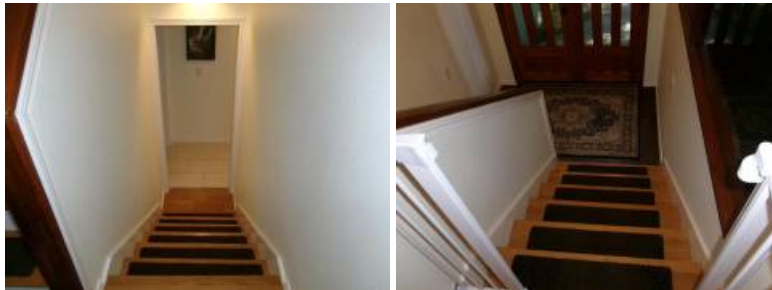
There is no handrail in the lower stairwell. This is a safety hazard. The installation of a graspable handrail that conforms to present industry standards is recommended.

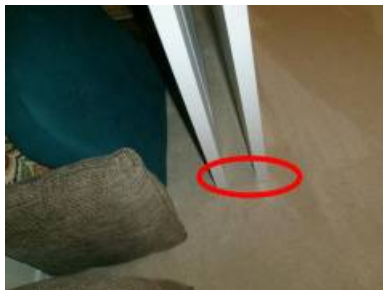
The floor guides are missing from the bypass closet doors in the bedroom. Missing floor guides could result in damage to the doors. The installation of floor guides is recommended.

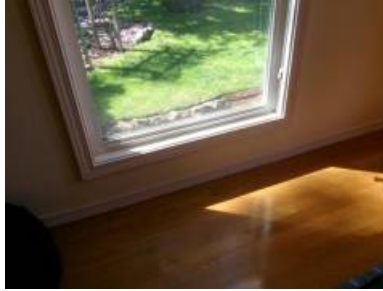
nonconforming by current building standards and would be hazardous if broken. The installation of safety glass is recommended as a safety upgrade for all windows less than 18" from the walking surface.
