June 27, 2024

**Re: 23233 SE 242nd St.**  
**Maple Valley, Wa.**

At your request, a visual inspection of the above referenced property was conducted on 06/26/2024. We have inspected the major structural components, plumbing, heating and electrical systems for signs of significant non-performance, excessive or unusual wear and general state of repair.

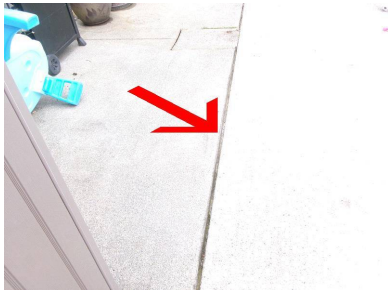
The gaps separating the concrete patio sections are a trip hazard. Filling with mortar is recommended.

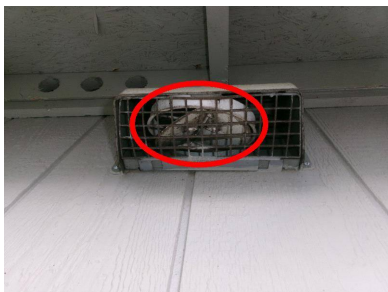
The range hood exhaust fan damper is disconnected at the termination. Repairs or replacement of the back-draft damper is recommended to prevent entry by rodents, birds insects, etc.

Exterior / Vent dampers - Fixed hood vent on the home's exterior.

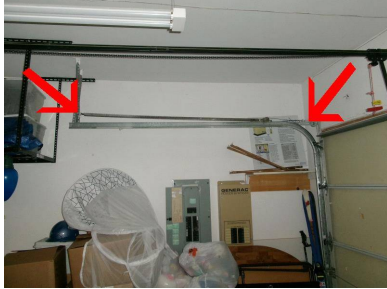
Safeties are cables run through the center of the garage door springs that prevent broken springs from becoming projectiles that can cause injury. There are no safeties installed. The installation of safeties is recommended.

Garage Doors - Safety cables installed in garage door springs.

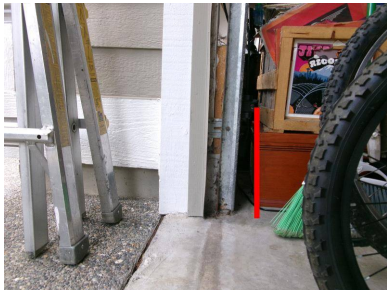
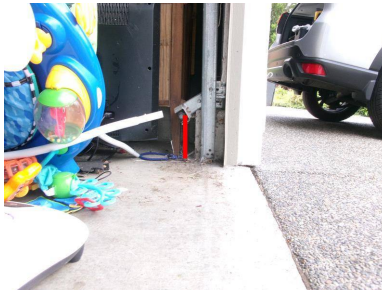
The Photo-eye beam was installed to high above the floor of the garage to adequately offer protection for small children and/or pets. We recommend that the photo-eye be lowered to within 4-6" of the floor.

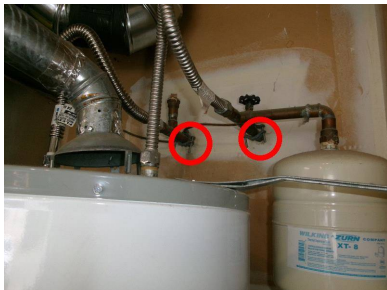
There are voids in the fire resistive barrier between the living space and garage that will allow flames to penetrate. The gypsum barrier slows the spread of a fire from the garage to the structure and/or living space. Patching the voids with a fire retardant caulk is recommended.

Garage / Fire Separation - Fire retardant applied to all openings indicated in garage on ceiling and wall.

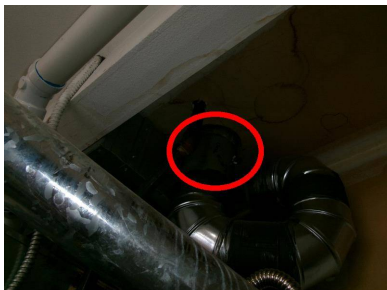
The installation of a furnace vent thimble is recommended to prevent flames from spreading to the structure.

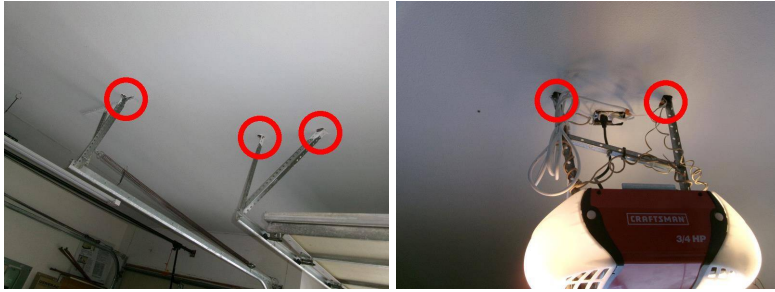
There are voids (adjacent the overhead door brackets) in the fire resistive barrier between the living space and garage that will allow flames to penetrate. The gypsum barrier slows the spread of a fire from the garage to the structure and/or living space. Patching the voids with a fire retardant caulk is recommended.

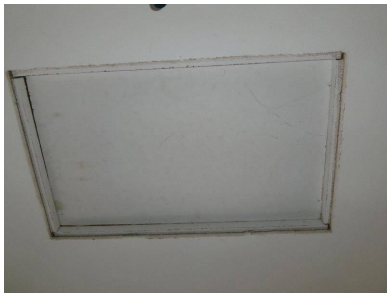
The cover for the attic access is a breach in the fire resistive barrier in the garage. This is a safety concern. The gypsum barrier on the ceiling slows the spread of a fire from the garage to the attic. The installation of a layer of 5/8" gypsum type X board over the 1/4" plywood is recommended.

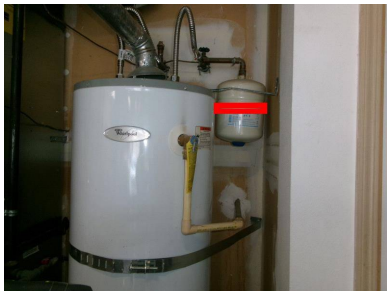
The expansion tank is not adequately secured to the wall. As code requirements start to call for engineered expansion tank supports we recommend the installation of seismic restraints to secure the expansion tank instead of allowing it to simply depend on piping connections that could result in damage to the water pipe and leakage during an earthquake.

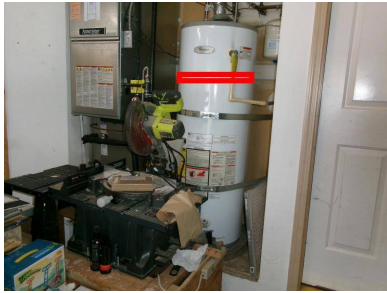
Straps are recommended to be installed within the upper 1/3 and lower 1/3 of the water heater body. The lower Strap must be at least 4" above the water heater controls.

Water Heater - Seismic restraints were adjusted to the correct spacing position.

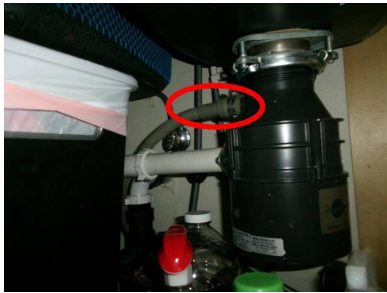
The dishwasher drain lacks an air gap. The dishwasher will function without one, but there is a risk of contamination of the inside of the dishwasher by waste water. The installation of an air gap above the flood rim of the sink is recommended.

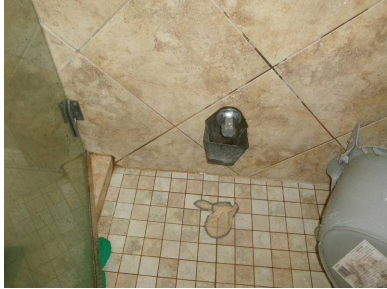
The shower steamer was not tested and its function was not verified.

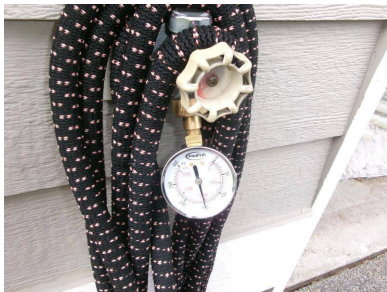
The water pressure at 150 PSI is excessive. The normal range is 30-80 PSI. High water pressure can result in leaking valves, detached supply tubes, water hammer and is hard on solenoid valves. The installation of a pressure reduction valve is recommended.

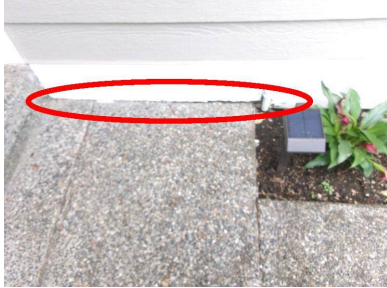
Untreated damaged wood in direct contact with concrete was observed adjacent to the entry stoop. Untreated wood should be raised 1-2" above the concrete. Treating the wood with a preservative sometimes will prevent wood destroy organism damage.

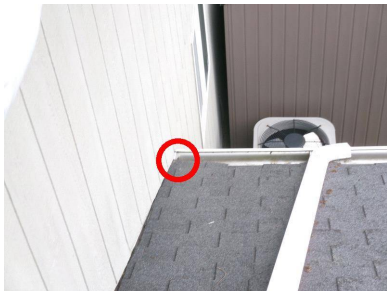
There is no kick out flashing at the roof edge to wall intersection above the gutter. This will allow water to enter the wall behind the siding. The installation of a kick-out flashing is recommended.

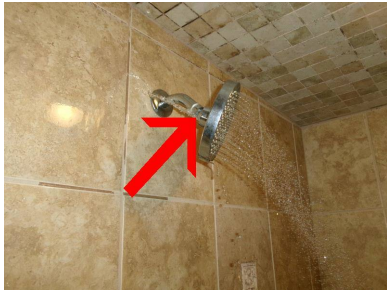
The shower head is leaking. Leaking fixtures should be rebuilt or replaced.

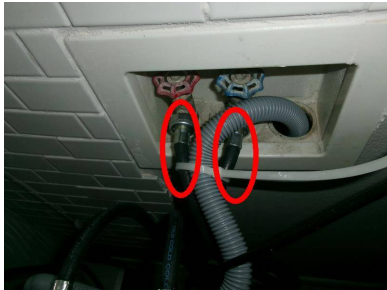
Upgrading the washer connections to high pressure (steel braided) lines is recommended.

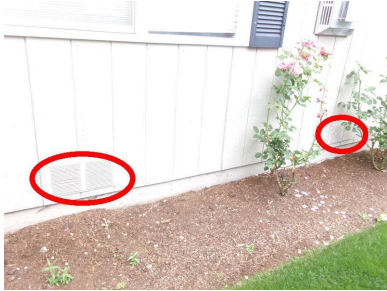
The vents are covered with louvered vent covers. This type of vent cover blocks the flow of air and the screen behind the cover becomes easily clogged with dust and dirt. Better ventilation can be achieved by installing 1/4" wire mesh over the vents.

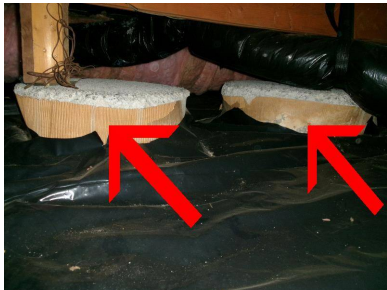
Cellulose forms were left in place on the pier footings. This cellulose is conducive to the infestation of various wood destroying organisms. The removal of the cellulose is recommended.

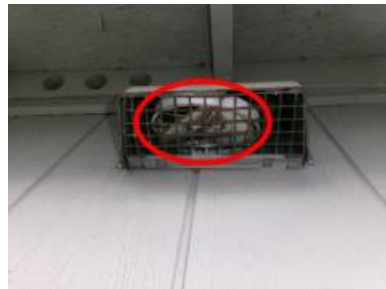
The rangehood exhaust fan damper is disconnected at the termination. Repairs or replacement of the back-draft damper is recommended to prevent entry by rodents, birds insects, etc.

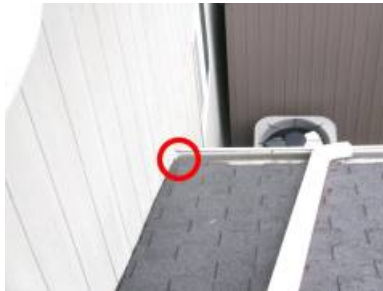
There is no kick out flashing at the roof edge to wall intersection above the gutter. This will allow water to enter the wall behind the siding. The installation of a kick-out flashing is recommended.

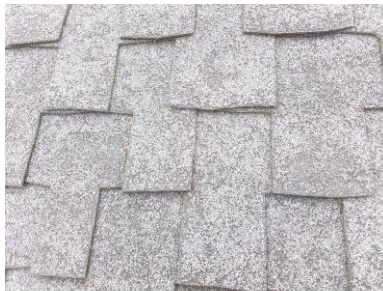
The roof is worn but remains in serviceable condition. With proper maintenance, this roof should remain serviceable for 8 to 10 more years.

**Heavy loss of granulation observed**

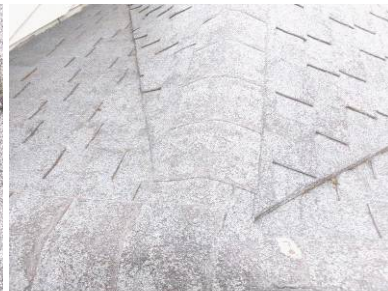
**Heavy loss at ridge observed**

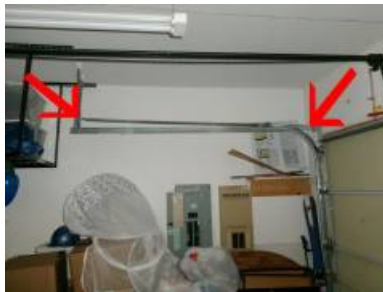
Safeties are cables run through the center of the garage door springs that prevent broken springs from becoming projectiles that can cause injury. There are no safeties installed. The installation of safeties is recommended.

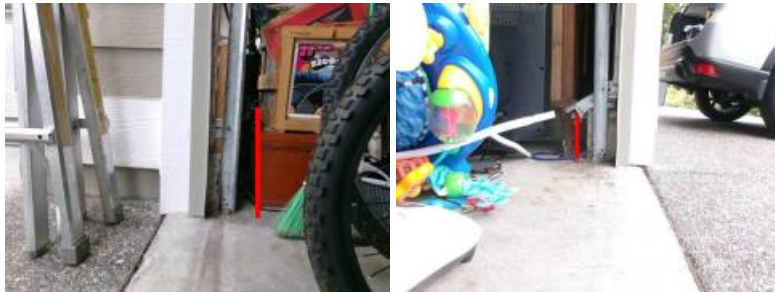
The Photo-eye beam was installed too high above the floor of the garage to adequately offer protection for small children and/or pets. We recommend that the photo-eye be lowered to within 4-6" of the floor.

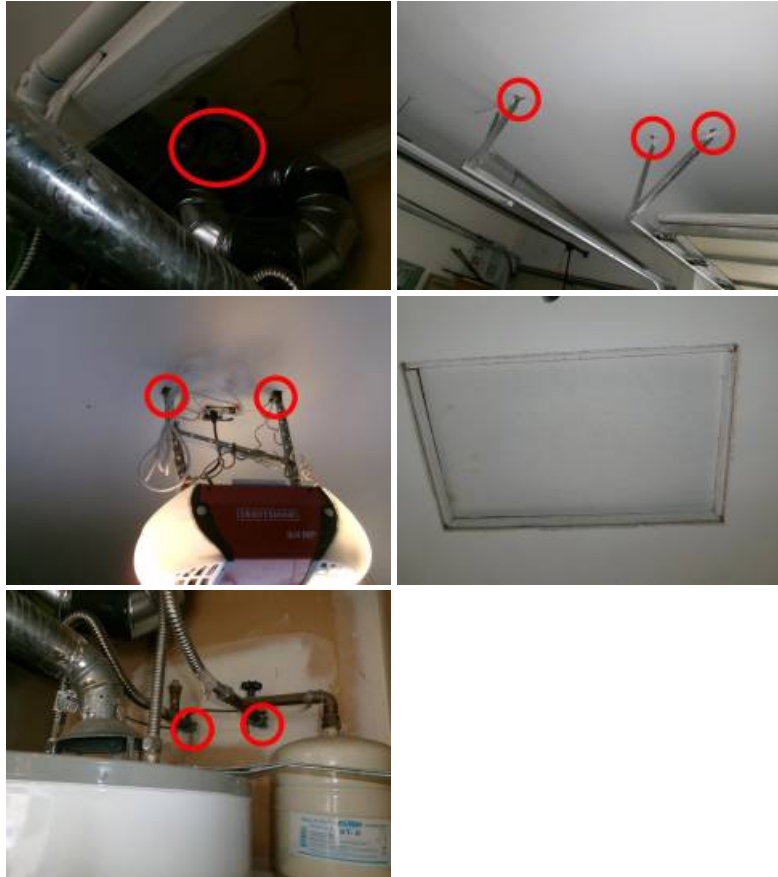
There are voids in the fire resistive barrier between the living space and garage that will allow flames to penetrate. The gypsum barrier slows the spread of a fire from the garage to the structure and/or living space. Patching the voids with a fire retardant caulk is recommended.

The cover for the attic access is a breach in the fire resistive barrier in the garage. This is a safety concern. The gypsum barrier on the ceiling slows the spread of a fire from the garage to the attic. The installation of a layer of 5/8" gypsum type X board over the 1/4" plywood is recommended.

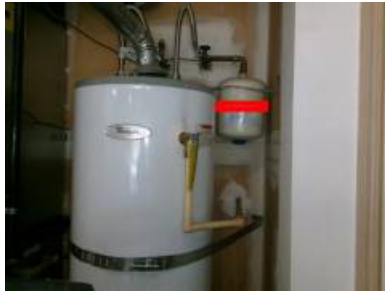
LOCATION OF UNIT	The water heater is located in the garage.
GENERAL INFORMATION	The water heater fuel is natural gas. The capacity of the water heater is 50 gallons. The input rating of the burner is approximately 40,000 BTU. The water heater is approximately 17 years old. Water heaters of this type typically last about 10-15 years.
PRESSURE RELIEF VALVE	The pressure relief valve is properly installed. The valve was not tested, as this could cause the valve to leak.
SHUTOFF VALVE	The shutoff valve for the water supply to the water heater is properly installed and is functioning as intended.
WATER CONNECTIONS AT TANK	The water connections at the tank are properly installed and are performing their intended function.
EXPANSION TANK	The expansion tank is not adequately secured to the wall. As code requirements start to call for engineered expansion tank supports we recommend the installation of seismic restraints to secure the expansion tank instead of allowing it to simply depend on piping connections that could result in damage to the water pipe and leakage during an earthquake.

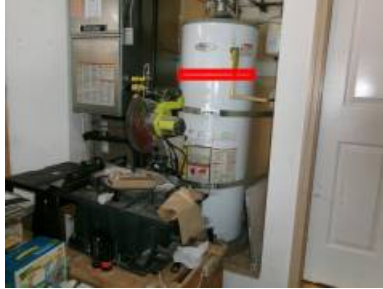
Straps are recommended to be installed within the upper 1/3 and lower 1/3 of the water heater body. The lower Strap must be at least 4" above the water heater controls.

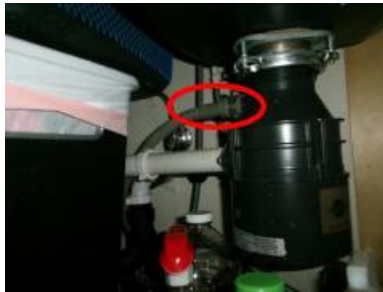
The dishwasher drain lacks an air gap. The dishwasher will function without one, but there is a risk of contamination of the inside of the dishwasher by waste water. The installation of an air gap above the flood rim of the sink is recommended.

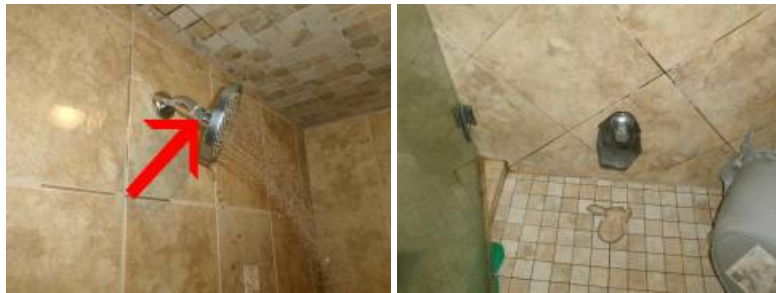
The shower steamer was not tested and its function was not verified.

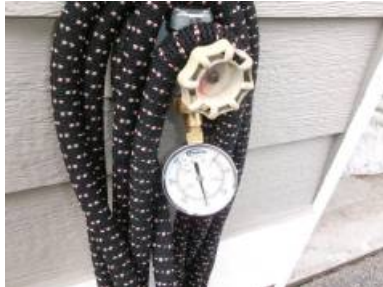
<i>INTERIOR WATER PIPES</i>	<i>SUPPLY</i>	The visible portions of the copper water supply pipes are properly installed and functional. Copper is considered one of the most desirable materials for interior supply pipes and is expected to last the lifetime of the building.
<i>WATER PRESSURE</i>		The water pressure at 150 PSI is excessive. The normal range is 30-80 PSI. High water pressure can result in leaking valves, detached supply tubes, water hammer and is hard on solenoid valves. The installation of a pressure reduction valve is recommended.

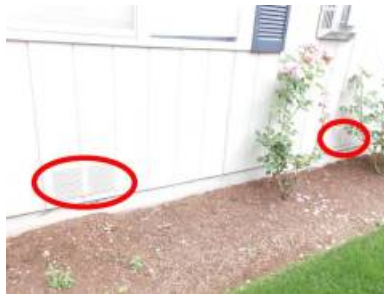
The vents are covered with louvered vent covers. This type of vent cover blocks the flow of air and the screen behind the cover becomes easily clogged with dust and dirt. Better ventilation can be achieved by installing 1/4" wire mesh over the vents.

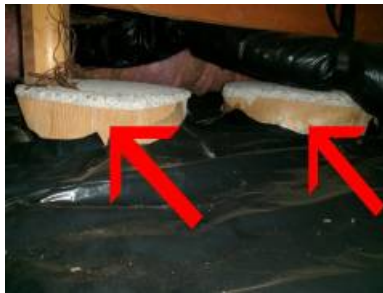
Good building practice requires that foundation walls or pier footings supporting wood frame construction, should extend at least 8" above the finish grade with at least a 6" clearance between the top of the soil and the bottom of the wood finish materials. Untreated wood should be raised 1-2" above surrounding flatwork and should have a moisture barrier such as 30 lb. asphalt impregnated felt installed between the concrete and wood. For additional information and treatment options, you should retain the services of a qualified pest control operator.
