**NOTICE TO BUYER: SELLER-PROCURED INSPECTION REPORT**

Per the seller, the following items listed on the pre-sale inspection summary dated June 21, 2024, are being corrected by the seller as part of preparation for sale in good faith.

June 21, 2024

At your request, a visual inspection of the above referenced property was conducted on 06/21/2024. We have inspected the major structural components, plumbing, heating and electrical systems for signs of significant non-performance, excessive or unusual wear and general state of repair.

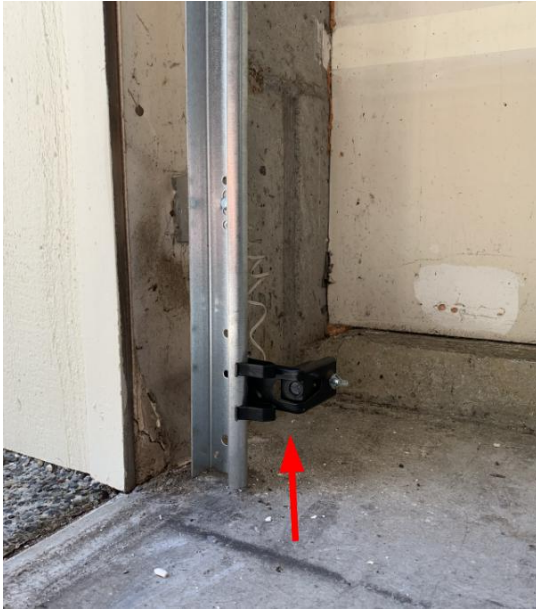
- **GARAGE DOOR OPENER:** Photo beam sensors are 7" above floor and are operating per spec. The sensors have lowered to within 4-6" of the floor

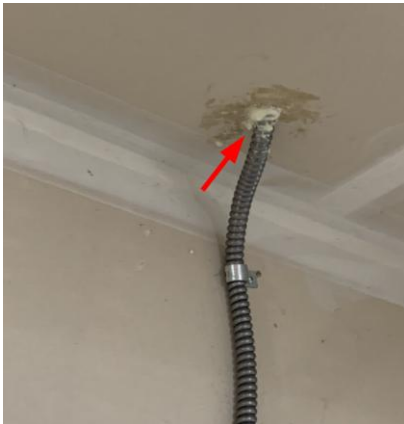
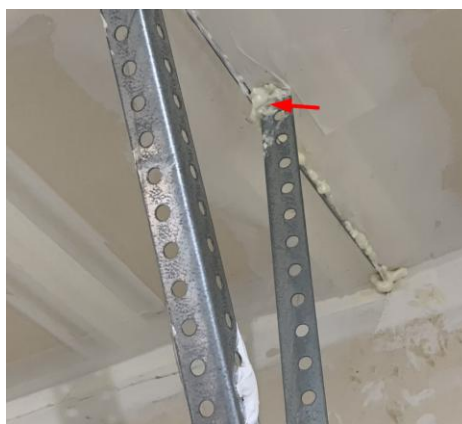
- **FIRE SEPARATION:** Garage fire resistive barrier patched with fire retardant caulk. The overhead door brackets and cable penetration gap have been patched.

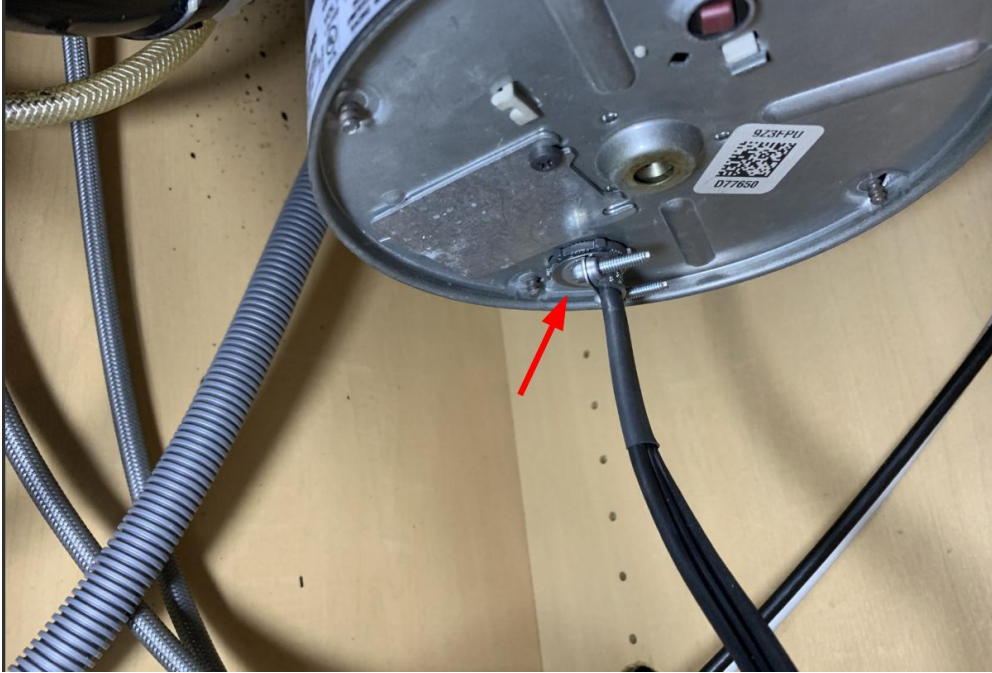
- **GARBAGE DISPOSAL:** Installed the power cable clamp on the garbage disposal.

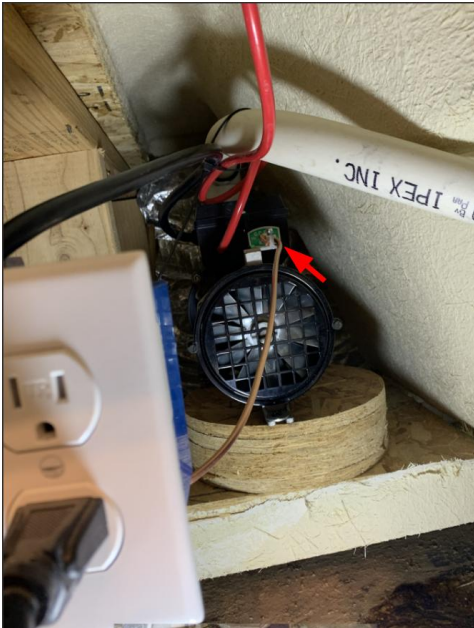
- **PRIMARY BATHROOM BATHTUB:** The pump motor has been bonded.

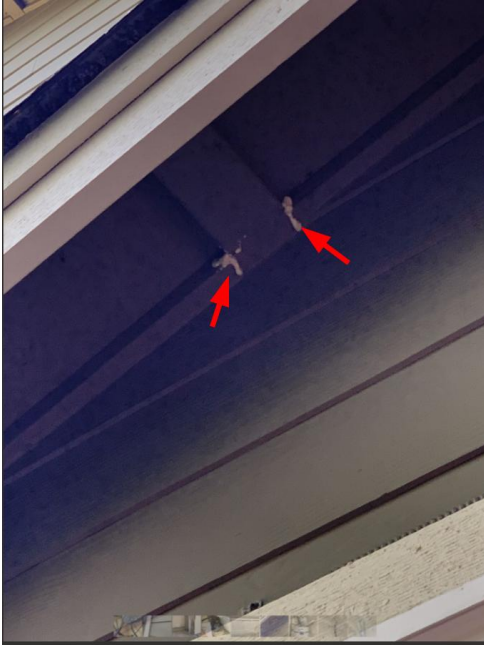
- **BUILDING EXTERIOR SOFFITS AND OVERHANG:** Openings adjacent the ends of the outlook boards outside the nook was closed by foam.

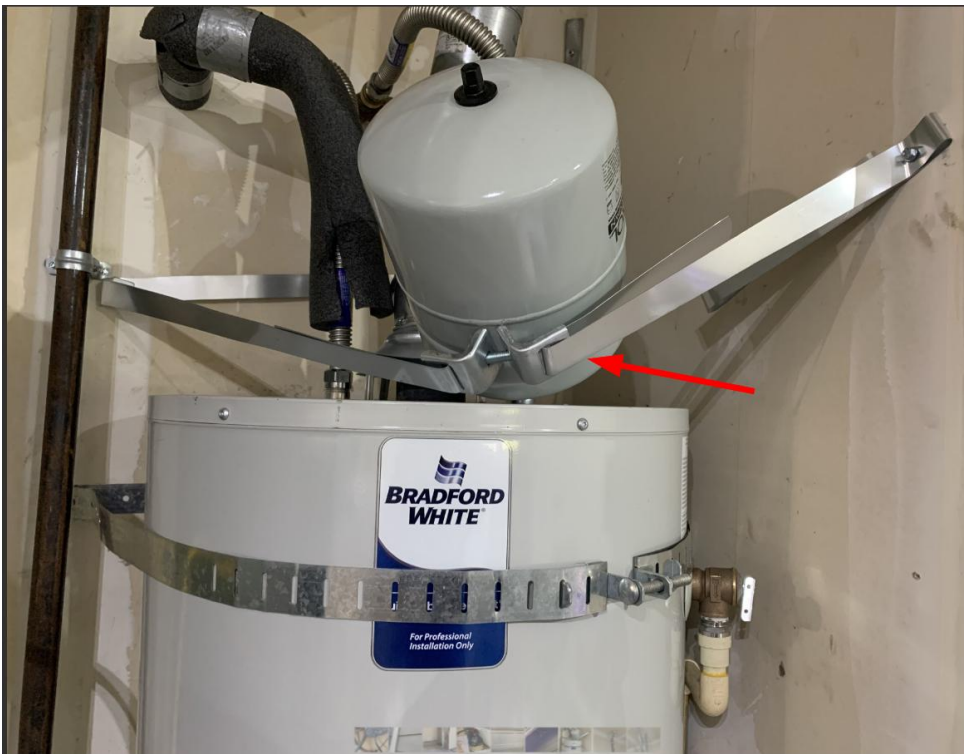
- **WATER HEATER EXPANSION TANK:** The expansion tank have been secured to the wall.

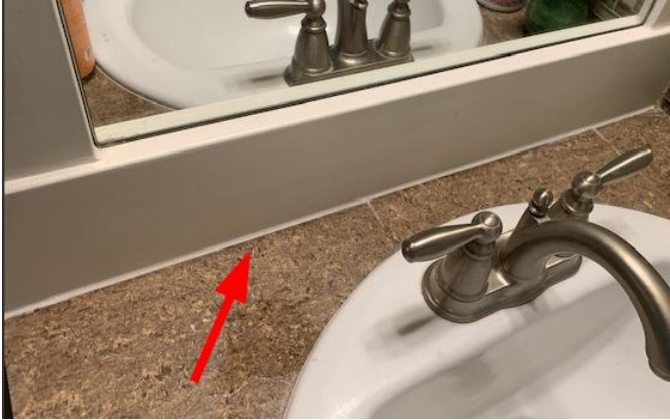
- **MAIN FLOOR BATHROOM:** Counter top, sink & toilet have been re-caulked.

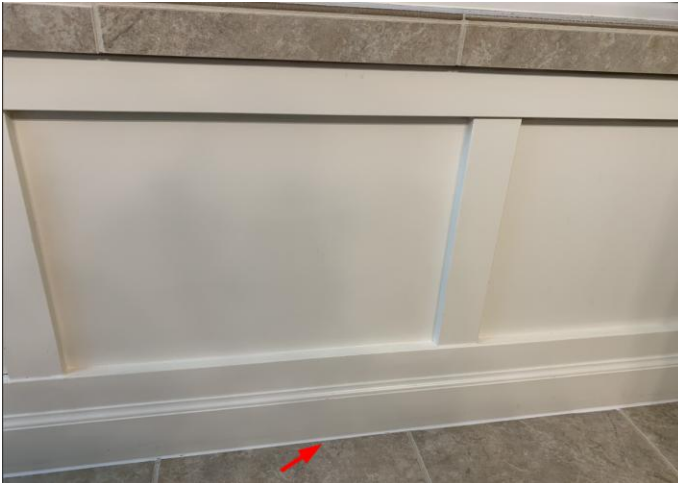
- **PRIMARY BATHROOM:** Tub, sinks, shower & toilet have been re-caulked.

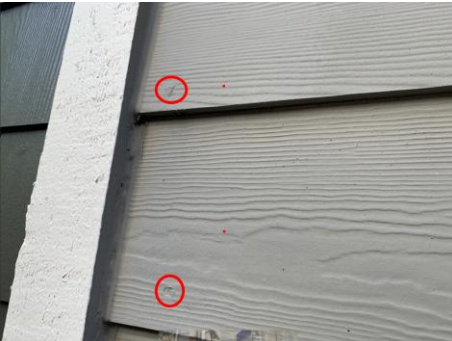
- **PAINT:** Siding nails have been caulked and painted.

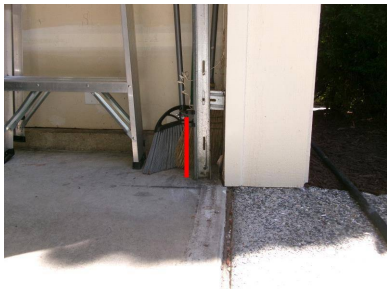
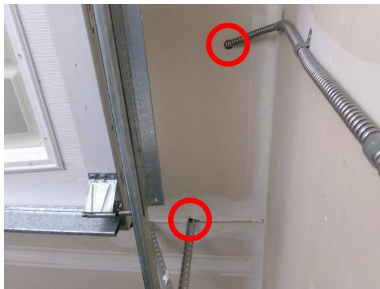
The Photo-eye beam was installed to high above the floor of the garage to adequately offer protection for small children and/or pets. We recommend that the photo-eye be lowered to within 4-6" of the floor.

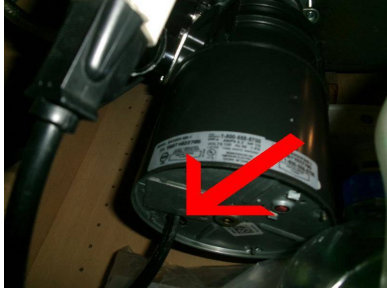
The cord is not clamped where it enters the disposal. This could damage the wires or cause a ground fault. The cord should be clamped in accordance with industry standards.

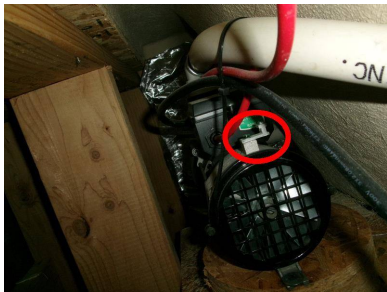
The pump motor is not bonded. This is a safety concern. The installation of a bonding wire between the motor chassis and water pipes is recommended.

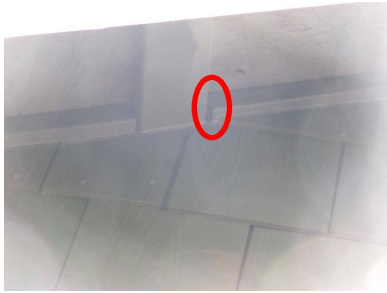
There are openings adjacent the ends of the outlook boards under the overhang through which insects and

rodents can enter into the attic. These openings should be covered with wood, wire mesh or filled with aerosol foam.

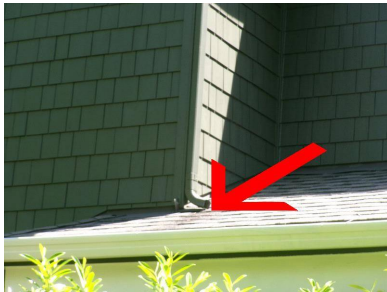
Downspouts draining directly onto the asphalt shingle surface causes excessive wear of the roofing material. Downspout extensions to the lower gutters should be installed to prevent excessive wear and tear of the roofing.

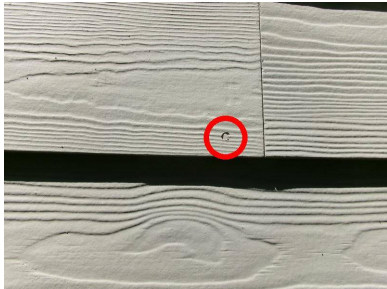
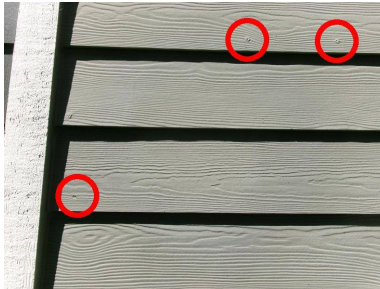
The bottom edge of the lower sections of siding on the exterior are unprotected. Paint protects the siding from moisture absorption and its propensity to hold paint. Painting of the exposed edges is recommended.

Siding nails that have damaged the surface overlay need to be caulked. Caulking prevents water intrusion of the siding. Consideration should be given to caulking the siding as necessary. Exterior caulking is recommended.

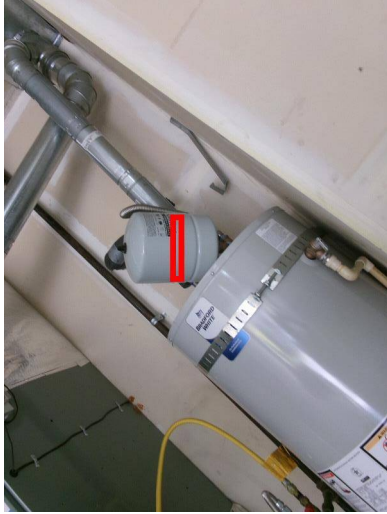
The expansion tank is not adequately secured to the wall. As code requirements start to call for engineered expansion tank supports we recommend the installation of seismic restraints to secure the expansion tank instead of allowing it to simply depend on piping connections that could result in damage to the water pipe and leakage during an earthquake.

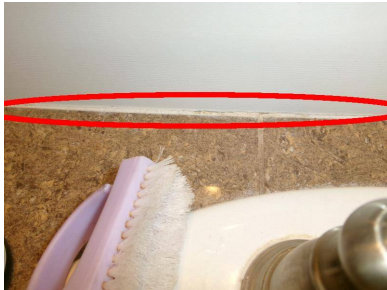
The backsplash caulking is cracked. Cracking of the caulk allows water to enter the gap and is difficult to clean. Caulking the cracks and/or gaps is recommended.

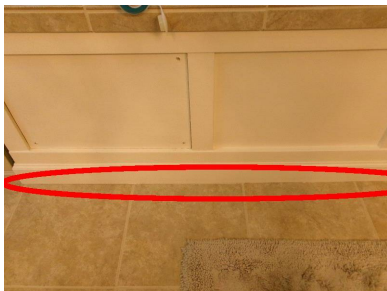
The caulking is cracked at the intersection between the tub and floor. This can lead to water damage to the flooring and substrate. Caulking this area with a flexible caulk is recommended.

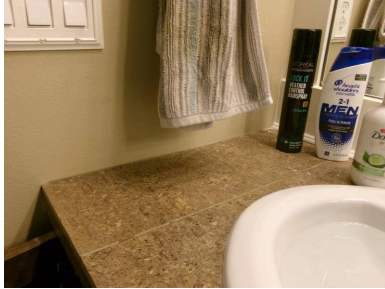
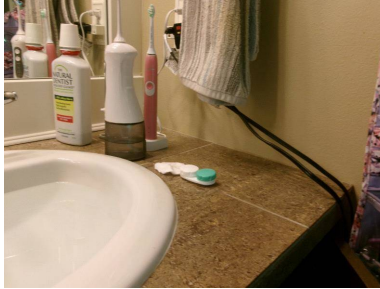
The side backsplash is missing. The installation of a backsplash is recommended.

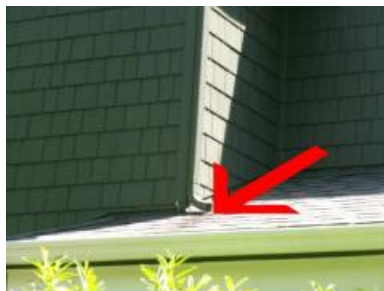
Downspouts draining directly onto the asphalt shingle surface causes excessive wear of the roofing material. Downspout extensions to the lower gutters should be installed to prevent excessive wear and tear of the roofing.

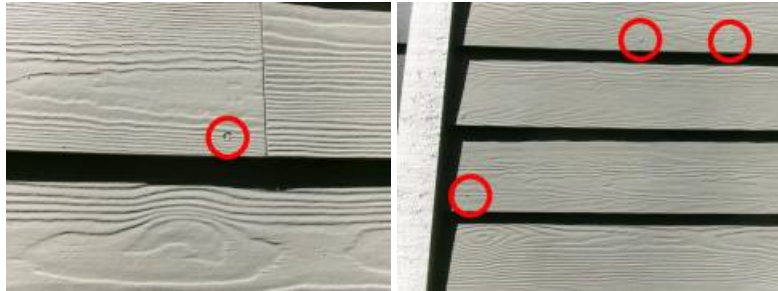
The bottom edge of the lower sections of siding on the exterior are unprotected. Paint protects the siding from moisture absorption and its propensity to hold paint. Painting of the exposed edges is recommended.

Siding nails that have damaged the surface overlay need to be caulked. Caulking prevents water intrusion of the siding. Consideration should be given to caulking the siding as necessary. Exterior caulking is recommended.

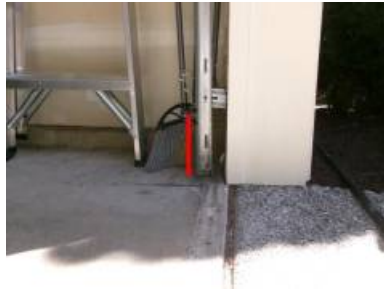
The Photo-eye beam was installed to high above the floor of the garage to adequately offer protection for small children and/or pets. We recommend that the photo-eye be lowered to within 4-6" of the floor.

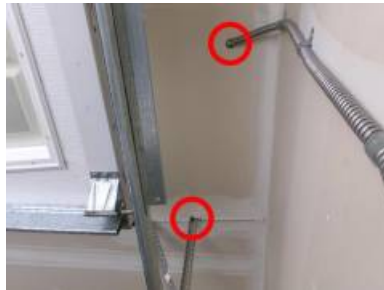
There are voids (adjacent the overhead door brackets) and cable penetration in the fire resistive barrier between the living space and garage that will allow flames to penetrate. The gypsum barrier slows the spread of a fire from the garage to the structure and/or living space. Patching the voids with a fire retardant caulk is recommended.

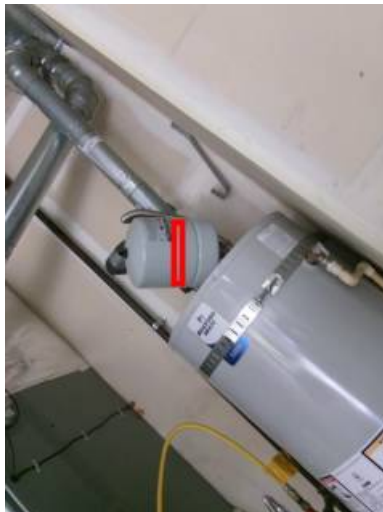
<i>LOCATION OF UNIT</i>	The water heater is located in the garage.
<i>GENERAL INFORMATION</i>	The water heater fuel is natural gas. The capacity of the water heater is 50 gallons. The input rating of the burner is approximately 40,000 BTU. The water heater was just recently installed. Water heaters of this type typically last about 10-15 years.
<i>PRESSURE RELIEF VALVE</i>	The pressure relief valve is properly installed. The valve was not tested, as this could cause the valve to leak.
<i>SHUTOFF VALVE</i>	The shutoff valve for the water supply to the water heater is properly installed and is functioning as intended.
<i>WATER CONNECTIONS AT TANK</i>	The water connections at the tank are properly installed and are performing their intended function.
<i>EXPANSION TANK</i>	The expansion tank is not adequately secured to the wall. As code requirements start to call for engineered expansion tank supports we recommend the installation of seismic restraints to secure the expansion tank instead of allowing it to simply depend on piping connections that could result in damage to the water pipe and leakage during an earthquake.

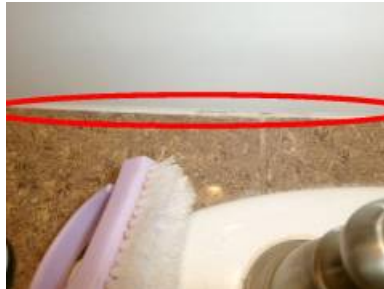
The backsplash caulking is cracked. Cracking of the caulk allows water to enter the gap and is difficult to clean. Caulking the cracks and/or gaps is recommended.

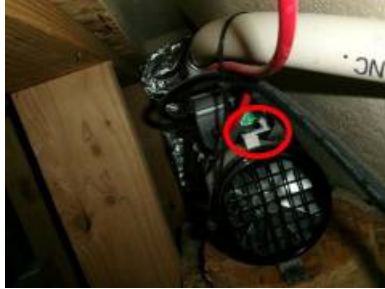
The pump motor is not bonded. This is a safety concern. The installation of a bonding wire between the motor chassis and water pipes is recommended.

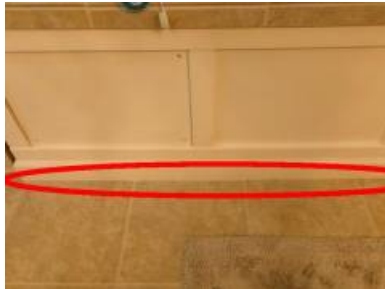
The caulking is cracked at the intersection between the tub and floor. This can lead to water damage to the flooring and substrate. Caulking this area with a flexible caulk is recommended.

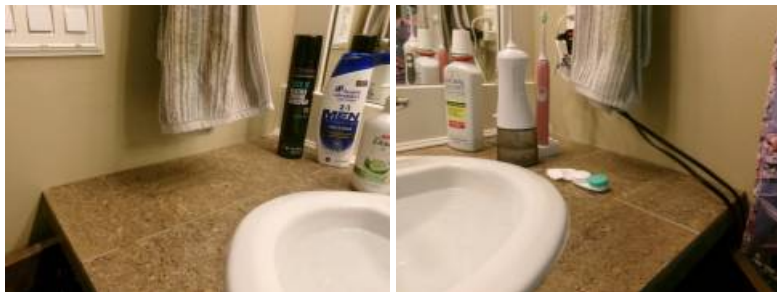
The side backsplash is missing. The installation of a backsplash is recommended.
