NOTICE TO BUYER: SELLER-PROCURED INSPECTION REPORT

Mr. Andrew Sexton & Ms. Jennifer Duren
13710 178th Ave. NE
Redmond, WA.

Re: 13710 178th Ave. NE
Redmond, WA.

At your request, a visual inspection of the above referenced property was conducted on 07/16/2024. We have inspected the major structural components, plumbing, heating and electrical systems for signs of significant non-performance, excessive or unusual wear and general state of repair.

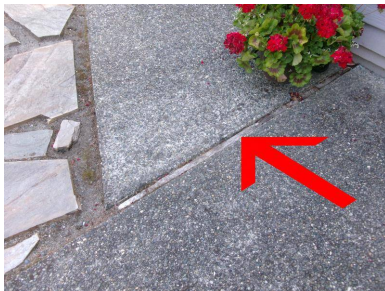
WALKWAY

One or more of the wooden dividers separating the concrete walkway sections were infested by wood destroying organisms and have deteriorated to a point where they are becoming a trip hazard. Replacement with mortar is recommended.

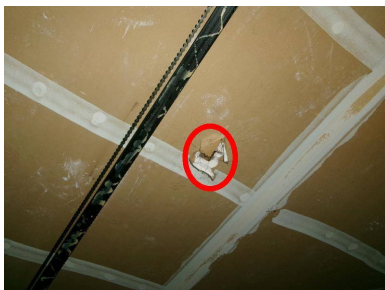
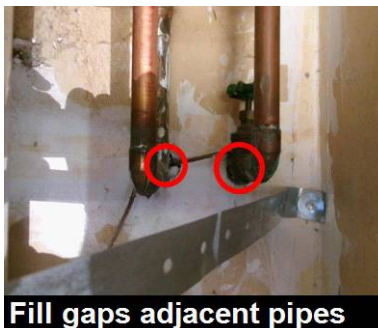
FIRE SEPARATION

There are voids in the fire resistive barrier between the living space and garage that will allow flames to penetrate. The gypsum barrier slows the spread of a fire from the garage to the structure and/or living space. Patching the voids with a fire retardant caulk is recommended.

Garage - Fire Separation: Patch voids in gypsum barrier with fire retardant caulk.

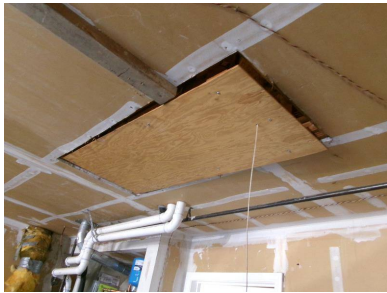
The pull down ladder is a breach in the fire resistive barrier in the garage. This is a safety concern. The gypsum barrier on the ceiling slows the spread of a fire from the garage to the attic. The installation of a layer of 5/8" gypsum type X board over the 1/4" plywood is recommended.

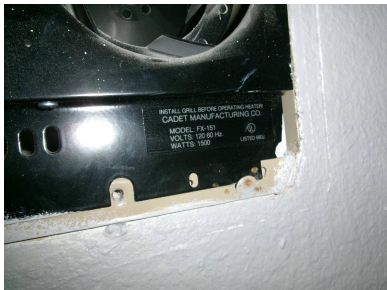
ELECTRIC FAN ASSISTED WALL HEATERS

The Cadet electric heater in this house, (model #FX151) has been recalled by the manufacturer and is considered unsafe. Replacement of the recalled heater is recommended.

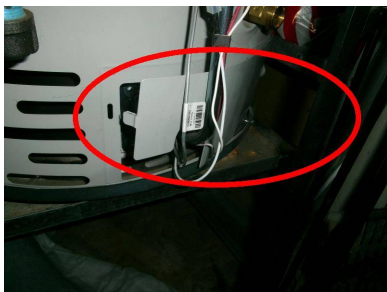
BURNER

The flame guard in front of the burner is loose. This is a fire hazard. Repairs or replacement of the flame guard is recommended.

Water Heater - Burner: Repair loose flame guard.

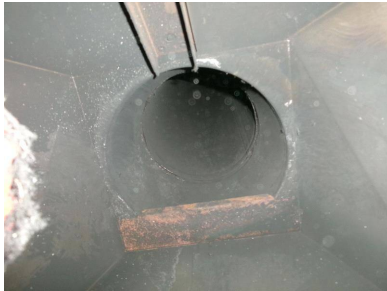
DAMPERS

The fireplace does not have a damper. This allows heat to escape up the chimney. The installation of a line damper is recommended.

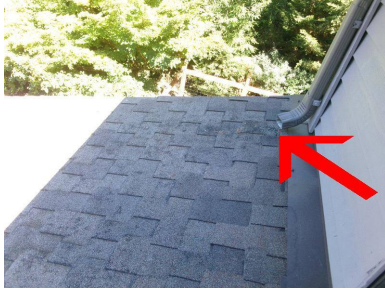
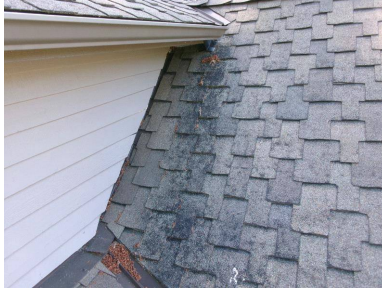
GUTTERS AND DOWNSPOUTS

Downspouts draining directly onto the asphalt shingle surface causes excessive wear of the roofing material. Downspout extensions should be installed to prevent excessive wear and tear of the roofing.

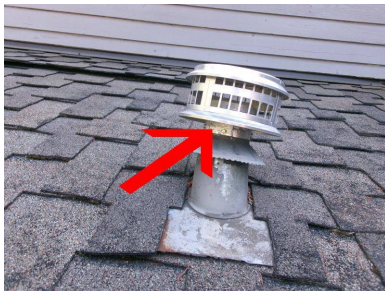
GAS APPLIANCE VENTS

One of the storm collars is not sealed. This is allowing leakage to occur. Sealing the storm collar is recommended.

Roof - Gas Appliance Vents: Seal storm collar.

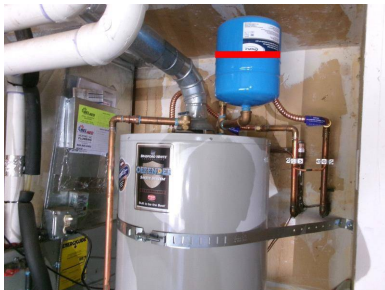
EXPANSION TANK

The expansion tank is not adequately secured to the wall. As code requirements start to call for engineered expansion tank supports we recommend the installation of seismic restraints to secure the expansion tank instead of allowing it to simply depend on piping connections that could result in damage to the water pipe and leakage during an earthquake.

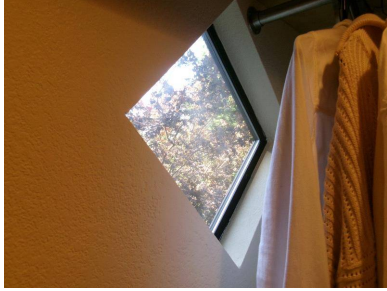
WINDOWS

There is condensation or mineral deposits between the panes of glass in one of the insulated glass window panes. This indicates a failed seal. The glass assembly should be replaced, which is the only method for correcting this deficiency.

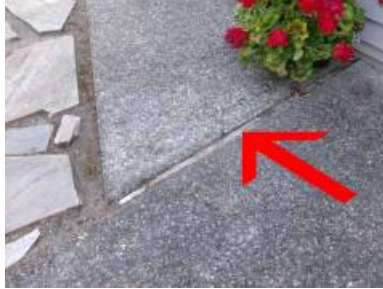
WALKWAY One or more of the wooden dividers separating the concrete walkway sections were infested by wood destroying organisms and have deteriorated to a point where they are becoming a trip hazard. Replacement with mortar is recommended.

Many legal and public works departments have defined a trip hazard as an irregularity in a walking surface exceeding one inch (1") in height. All walking surfaces should maintain, free of a vertical surface change of 3/4" or more, in the interest of public and personal safety.

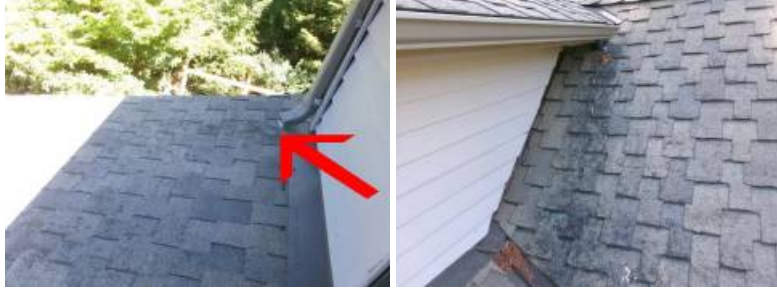
Downspouts draining directly onto the asphalt shingle surface causes excessive wear of the roofing material. Downspout extensions to the lower gutters should be installed to prevent excessive wear and tear of the roofing.

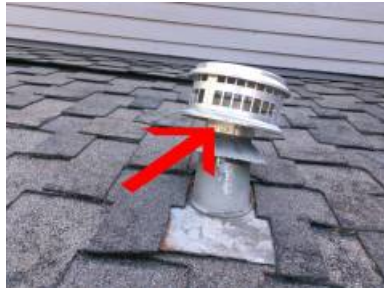
One of the storm collars is not sealed. This is allowing leakage to occur. Sealing the storm collar is recommended.

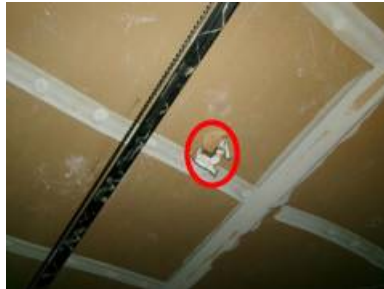
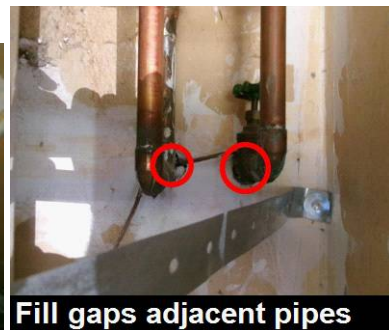
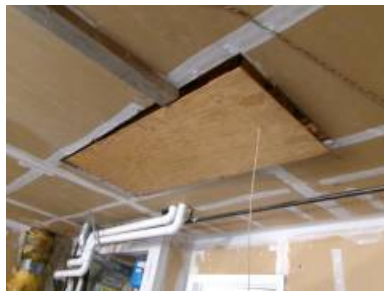
There are voids in the fire resistive barrier between the living space and garage that will allow flames to penetrate. The gypsum barrier slows the spread of a fire from the garage to the structure and/or living space. Patching the voids with a fire retardant caulk is recommended.

The pull down ladder is a breach in the fire resistive barrier in the garage. This is a safety concern. The gypsum barrier on the ceiling slows the spread of a fire from the garage to the attic. The installation of a layer of 5/8" gypsum type X board over the 1/4" plywood is recommended.

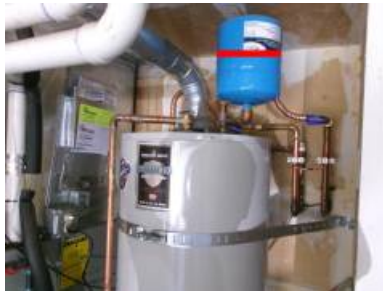
EXPANSION TANK

The expansion tank is not adequately secured to the wall. As code requirements start to call for engineered expansion tank supports we recommend the installation of seismic restraints to secure the expansion tank instead of allowing it to simply depend on piping connections that could result in damage to the water pipe and leakage during an earthquake.

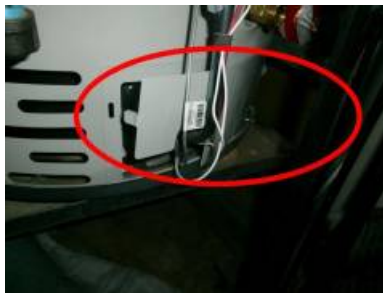
The flame guard in front of the burner is loose. This is a fire hazard. Repairs or replacement of the flame guard is recommended.

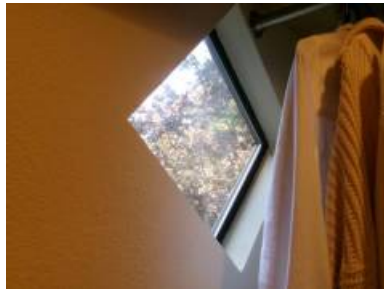
There is condensation or mineral deposits between the panes of glass in one of the insulated glass window panes. This indicates a failed seal. The glass assembly should be replaced, which is the only method for correcting this deficiency.

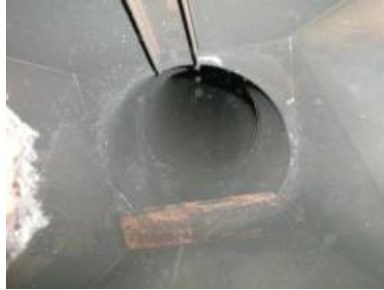
DAMPERS

The fireplace does not have a damper. This allows heat to escape up the chimney. The installation of a line damper is recommended.
