NOTICE TO BUYER: SELLER-PROCURED INSPECTION REPORT

The following notice is given with respect to the Purchase and Sale Agreement dated _____
between _____ ("Buyer")
and **BSFW Living Trust** _____ ("Seller")
concerning **11605 106th Ave NE Kirkland WA 98034** ("the Property").

**Felicia & Brian Swindell
11605 106th Ave NE
Kirkland, WA 98034**

At your request, a visual inspection of the above referenced property was conducted on 07/23/2024. We have inspected the major structural components, plumbing, heating and electrical systems for signs of significant non-performance, excessive or unusual wear and general state of repair.

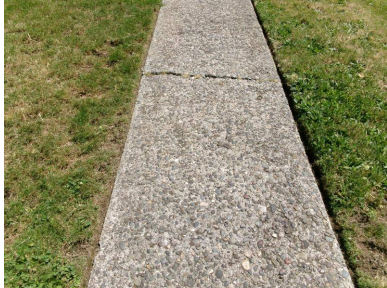
WALKWAY

The gaps separating the concrete walkway sections are a trip hazard. Replacement with mortar is recommended.

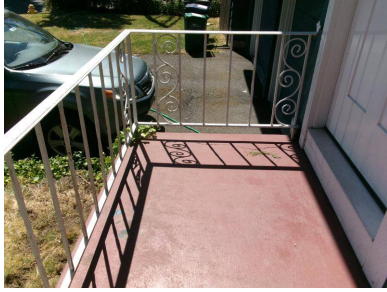
PORCH RAILING

The spacing between the balusters is too wide. This is a hazard to small children. The balusters should be spaced close enough together so that a 4" sphere cannot pass through. Upgrading the porch railing is recommended if small children are present.

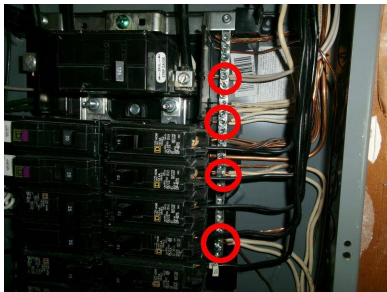
SERVICE PANEL

Several of the neutral wires are double tapped on the buss bar. Double tapping means that two conductors share a single terminal. Double tapped terminals can loosen and overheat and therefore are not permitted unless the terminal is specifically listed for multiple wires. This defect is easily repaired by connecting the two wires to a "pig tail", securing them with a wire cap, and then inserting the pig tail conductor under the terminal.

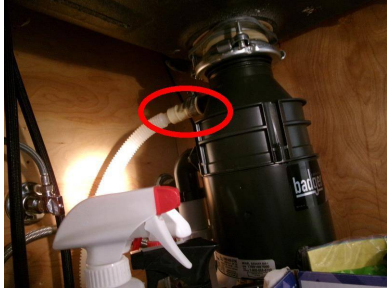
AIR GAP

The dishwasher drain lacks an air gap. The dishwasher will function without one, but there is a risk of contamination of the inside of the dishwasher by waste water. The installation of an air gap above the flood rim of the sink is recommended.

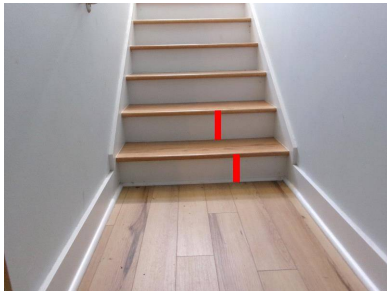
STAIRS

The stairs are non-conforming due to the variable rise. Stair design standards require that stair risers do not exceed 8" and that the variation in rise not exceed 3/8" in order to reduce falls from tripping. To increase the margin of safety, consideration should be given to reconfiguring the stairs so that rise and run do not vary by more than 3/8". If this proves to be too impractical or expensive, then we recommend exercising caution when using these stairs.

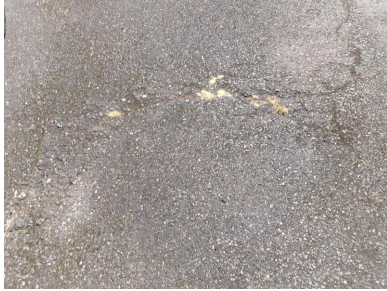
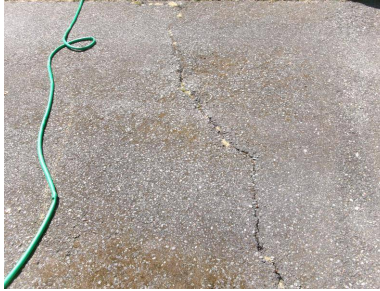
Large cracks were observed in the asphalt surface of the driveway. Minor cracks can be sealed to minimize

moisture entry, vegetation establishment and further settlement of the asphalt. Minor cracks are common and do not affect the serviceability of the asphalt..

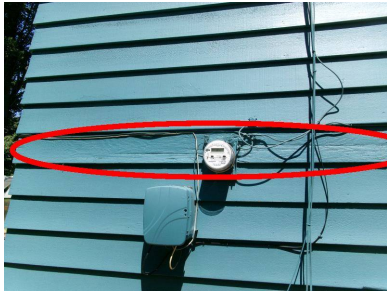
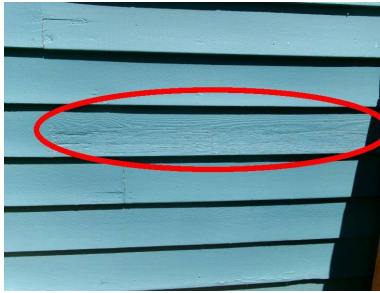
PRIMARY EXTERIOR WALL CLADDING

Several boards on the south side of the house are heavily checked and are rot damaged. This type of damage usually occurs with chronic contact with moisture or when the exterior finish is not maintained. Consideration should be given to replacing the damaged sections of siding.

Primary exterior wall cladding - Rot damaged boards replaced.

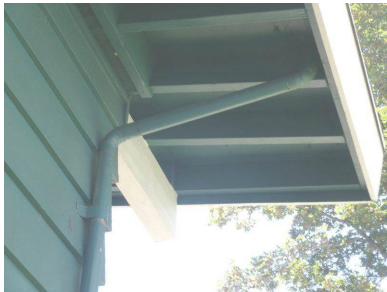
GUTTERS AND DOWNSPOUTS

The 2" round downspouts are too small and are more vulnerable to clogging than the larger rectangular ones. Consideration should be given to upgrading the downspouts.

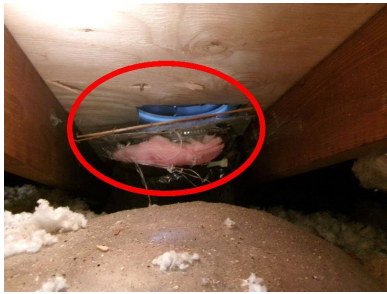
The kitchen range hood over the stove is discharging into the attic. The vent fan should carry the exhaust from the vent to the exterior.

Flexible ducting is used to direct air from the vent fan to the exterior. This type of material is unreliable. Replacing the flexible ducting with smooth-wall sheet metal ducting is recommended.

Kitchen range hood – vent fixed to exhaust to exterior.

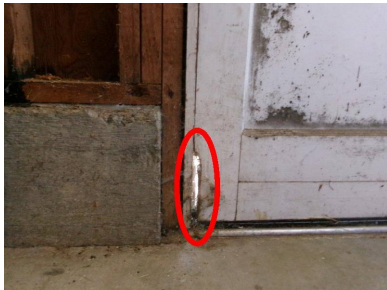
EXTERIOR DOOR(S)

The exterior door from the garage is damaged. The deterioration is cosmetic and door remains functional. However the door is no longer rodent proof. Repairs are recommended to exclude rodents from the garage.

Exterior door - Damaged exterior door in garage was repaired.

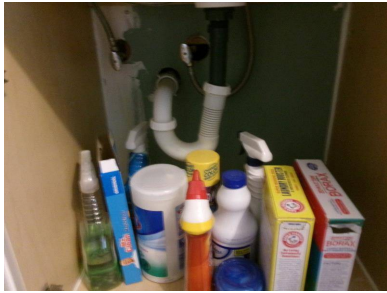
DRAINS, TRAPS AND TRAP ARMS

Improper, non-conforming material has been used for the drain pipe fitting. This material will not function reliably. Replacement with industry standard fittings is recommended.

Laundry room bathroom - Non-conforming drain pipe replaced with industry standard.

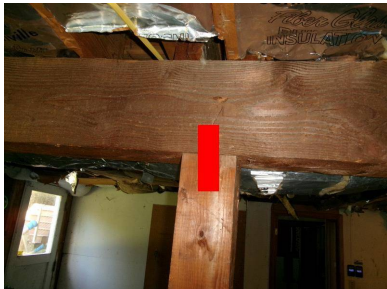
BEAMS AND POSTS

There are no visible positive connections tying the posts and concrete pier footing together. The installation of gusset plates is recommended to reduce the likelihood of damage during an earthquake.

Beams and posts - Gusset plates added to tops and bottoms of beams.

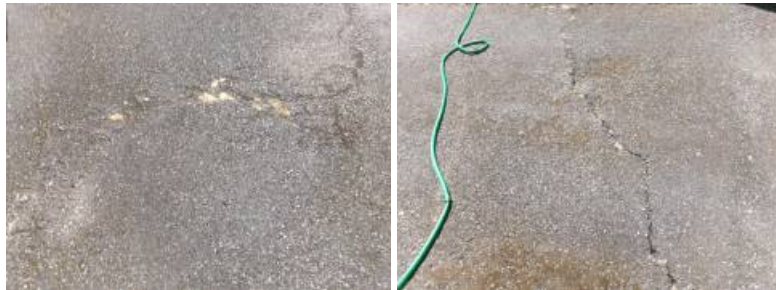
DRIVEWAY Large cracks were observed in the asphalt surface of the driveway. Minor cracks can be sealed to minimize moisture entry, vegetation establishment and further settlement of the asphalt. Minor cracks are common and do not affect the serviceability of the asphalt..

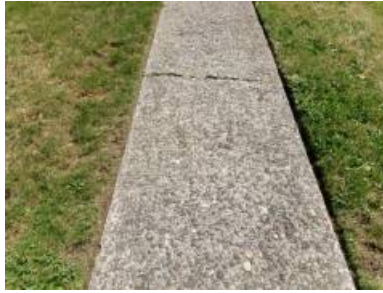
WALKWAY The gaps separating the concrete walkway sections are a trip hazard. Replacement with mortar is recommended.

Many legal and public works departments have defined a trip hazard as an irregularity in a walking surface exceeding one inch (1") in height. All walking surfaces should maintain, free of a vertical surface change of 3/4" or more, in the interest of public and personal safety.

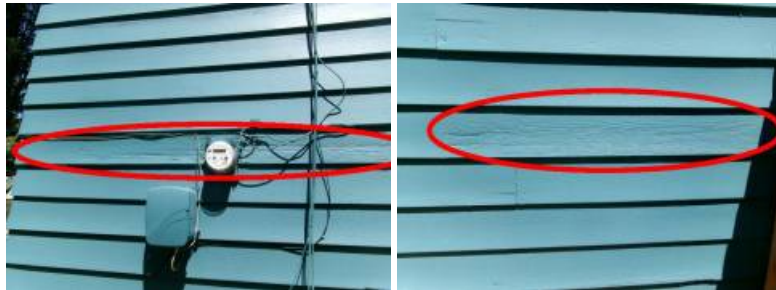
Several boards on the south side of the house are heavily checked and are rot damaged. This type of damage usually occurs with chronic contact with moisture or when the exterior finish is not maintained. Consideration should be given to replacing the damaged sections of siding.

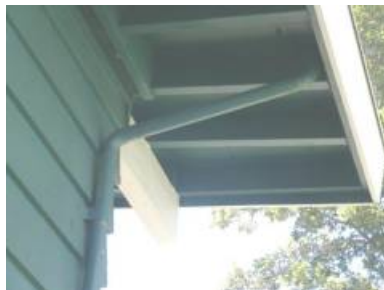
The 2" round downspouts are too small and are more vulnerable to clogging than the larger rectangular ones. Consideration should be given to upgrading the downspouts.

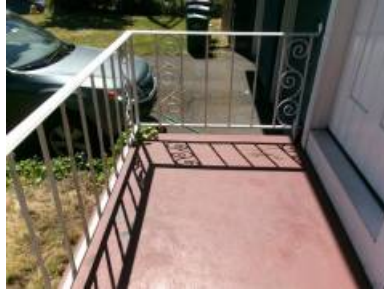
PORCH RAILING

The spacing between the balusters is too wide. This is a hazard to small children. The balusters should be spaced close enough together so that a 4" sphere cannot pass through. Upgrading the porch railing is recommended if small children are present.

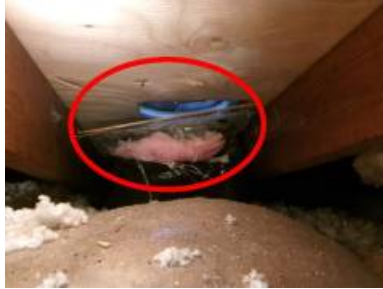
Flexible ducting is used to direct air from the vent fan to the exterior. This type of material is unreliable. Replacing the flexible ducting with smooth-wall sheet metal ducting is recommended.

For the best airflow, use smooth galvanized metal ducting rather than flexible or corrugated ducting. Rigid ducts can withstand extreme temperatures. They don't require as much maintenance and last a long time. Seal joints with UL listed duct-joint mastic tape.

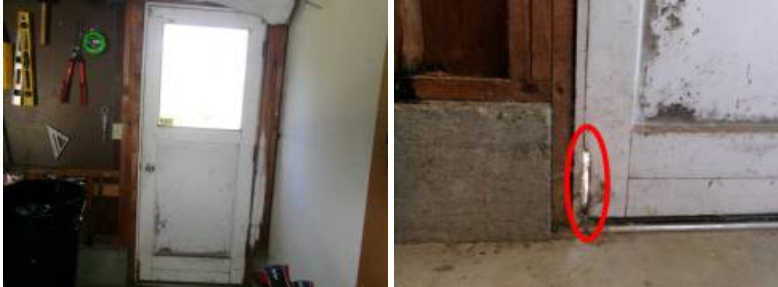
<i>PASSAGE DOOR</i>	The door between the garage and living space is not fire rated and will not slow the spread of a garage fire to the rest of the building. Consideration should be given to replacing the door with a fire rated door as a safety upgrade.
<i>EXTERIOR DOOR(S)</i>	<p>The glass in the garage door is not tempered safety glass. Tempered glass can be identified by the etched emblem in one corner of each pane. A higher margin of safety could be achieved if the glass was approved safety glass. Consideration should be given to replacing the glass as a safety upgrade.</p> <p>The exterior door from the garage is damaged. The deterioration is cosmetic and door remains functional. However the door is no longer rodent proof. Repairs are recommended to exclude rodents from the garage.</p>

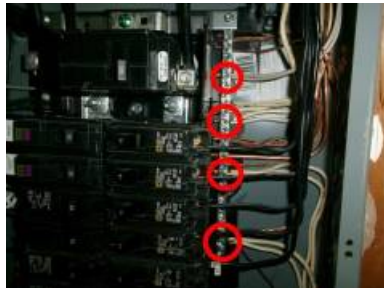
Several of the neutral wires are double tapped on the buss bar. Double tapping means that two conductors share a single terminal. Double tapped terminals can loosen and overheat and therefore are not permitted unless the terminal is specifically listed for multiple wires. This defect is easily repaired by connecting the two wires to a "pig tail", securing them with a wire cap, and then inserting the pig tail conductor under the terminal.

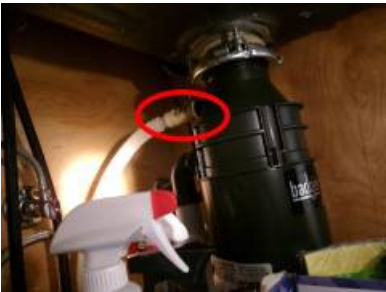
COUNTERTOPS	The countertops are covered with slab quartz. The counter tops are properly installed and are in good condition.
CABINETS	The finish on the kitchen cabinets is slightly worn. The cabinets are otherwise in good condition.
FLOORING MATERIAL	The floor is covered with hardwood. The floor is properly installed and is in good condition.
VENTILATION	Ventilation in the kitchen is provided by a range hood over the stove. The vent is ducted to the exterior. The vent fan is properly installed and is performing its intended function.
SINK FAUCET	The sink faucet is properly installed and is in good condition.
SINK	The kitchen sink is properly installed and is in good condition.
DRAINS, TRAPS AND TRAP ARMS	The sink drain is properly installed and is performing its intended function.
AIR GAP	The dishwasher drain lacks an air gap. The dishwasher will function without one, but there is a risk of contamination of the inside of the dishwasher by waste water. The installation of an air gap above the flood rim of the sink is recommended.

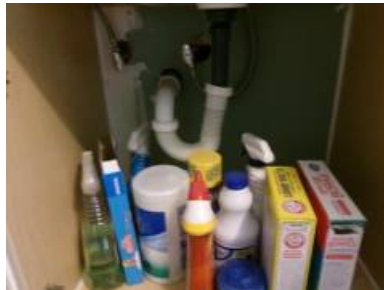
DRAINS, TRAPS AND TRAP ARMS Improper, non-conforming material has been used for the drain pipe fitting. This material will not function reliably. Replacement with industry standard fittings is recommended.

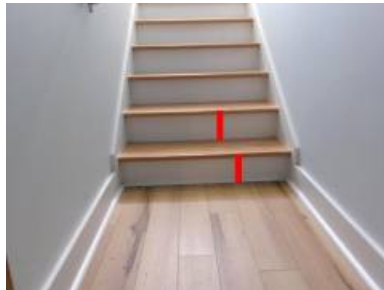
The stairs are non-conforming due to the variable rise. Stair design standards require that stair risers do not exceed 8" and that the variation in rise not exceed 3/8" in order to reduce falls from tripping. To increase the margin of safety, consideration should be given to reconfiguring the stairs so that rise and run do not vary by more than 3/8". If this proves to be too impractical or expensive, then we recommend exercising caution when using these stairs.

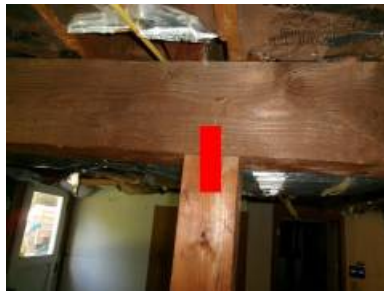
BEAMS AND POSTS

There are no visible positive connections tying the posts and concrete pier footing together. The installation of gusset plates is recommend to reduce the likelihood of damage during an earthquake.
