## NOTICE TO BUYER: SELLER-PROCURED INSPECTION REPORT

**Kevin J Hafer  
803 9<sup>th</sup> Ave S  
Edmonds WA 98020**

**Per the seller, the following items listed on the pre-sale inspection summary dated June 18<sup>th</sup>, 2024, are being corrected by the seller as part of preparation for sale in good faith.**

At your request, a visual inspection of the above referenced property was conducted on 06/18/2024. We have inspected the major structural components, plumbing, heating and electrical systems for signs of significant non-performance, excessive or unusual wear and general state of repair.

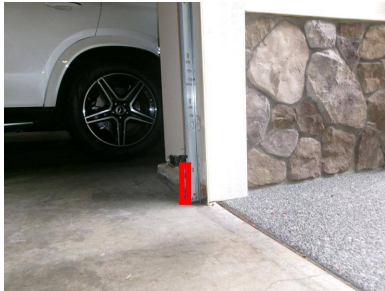
### GARAGE DOOR OPENER

The Photo-eye beam was installed to high above the floor of the garage to adequately offer protection for small children and/or pets. We recommend that the photo-eye be lowered to within 4-6" of the floor.

Garage Door opener – Photo eyes were adjusted to the required height.

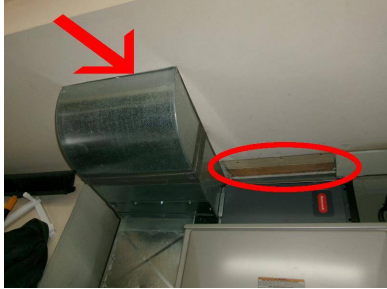
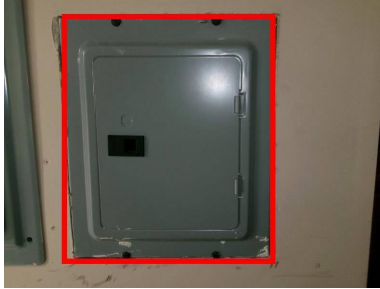
### FIRE SEPARATION

The fire resistive barrier between the garage and the living space is properly installed and in good condition, however, the gaps adjacent the furnace are not taped. Voids in the fire resistive barrier between the living space and garage will allow flames to penetrate. The gypsum barrier slows the spread of a fire from the garage to the structure and/or living space. Patching the small void(s) with a fire retardant caulk is recommended. A fire resistive barrier should be installed over larger voids.

Garage Fire separation - All identified areas were sealed.

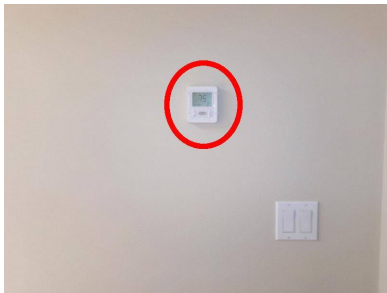
#### *THERMOSTAT*

The thermostat at the top of the stairs function was not determined.

Heating system thermostat – I dispute, as that controls the upstairs Zone

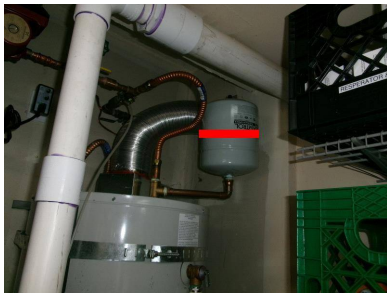
### *EXPANSION TANK*

The expansion tank is not adequately secured to the wall. As code requirements start to call for engineered expansion tank supports we recommend the installation of seismic restraints to secure the expansion tank instead of allowing it to simply depend on piping connections that could result in damage to the water pipe and leakage during an earthquake.

Water Heater expansion tank – I dispute this. It met the code when it was installed.

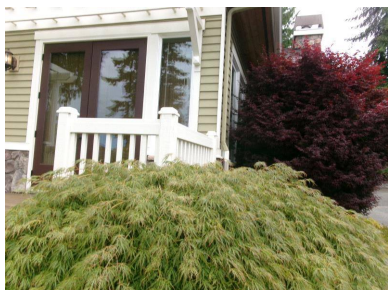
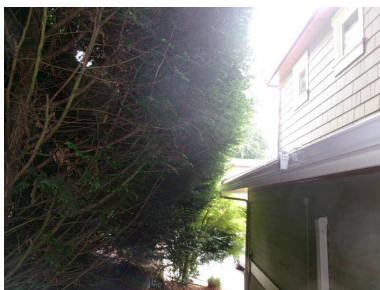
### *VEGETATION*

Trees are nearly touching the building on both the east and south sides. Low hanging tree branches can damage the roof, siding, doors and windows. Tree branches should be trimmed back where necessary.

Building Site Vegetation – all areas were addressed.

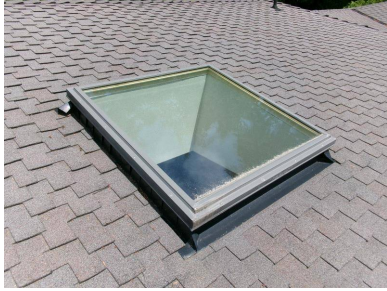
### *SKYLIGHTS*

The skylight is not secured to the roof. Skylights can get blown off roofs during high winds if they are not secured. Fastening the skylight to the curb with four plated or stainless screws is recommended.

Skylights – The skylight was bolted down

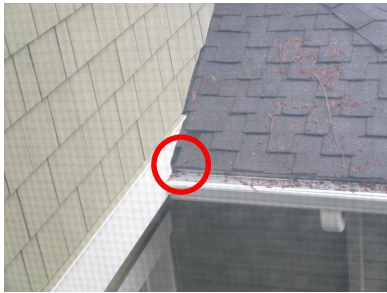
### *FLASHINGS*

There is no kick out flashing at the roof edge to wall intersection above the gutter. This will allow water to enter the wall behind the siding. The installation of a kick-out flashing is recommended.

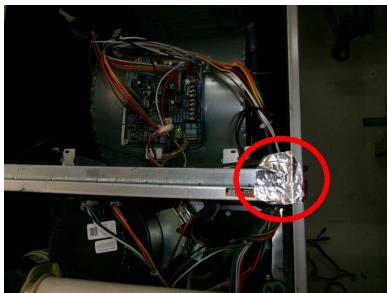
#### *BLOWER*

The blower door cut-out switch has been disabled. This is a potential hazard. The cut-out switch should be not be restricted.

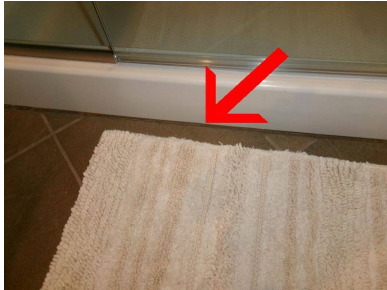
#### FLOORING MATERIAL

The caulking is cracked at the intersection between the tub/shower and floor. This can lead to water damage to the flooring and substrate. Caulking this area with a flexible caulk is recommended.

Main Floor Bathroom Cracked Caulking – caulked the entire area with new caulking

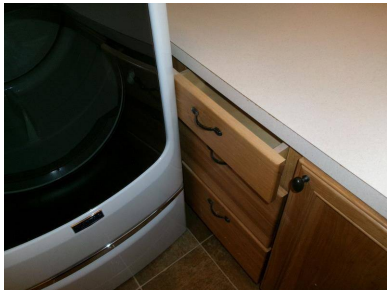
#### CABINETS

The cabinets are properly installed and are in good condition, however, some of the drawers full opening are restricted by the dryers placement.

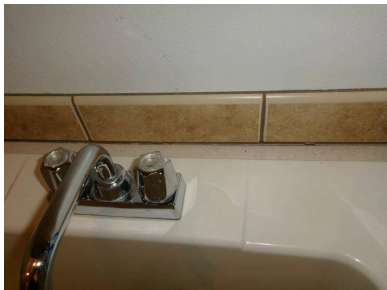
#### COUNTERTOP

The backsplash caulking is cracked. Cracking of the caulk allows water to enter the gap and is difficult to clean. Caulking the cracks and/or gaps is recommended.

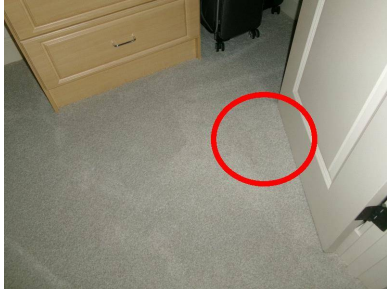
### *CLOSET DOORS*

One of the primary bedroom closet doors rubs on the carpet. Doors should be adjusted as necessary.

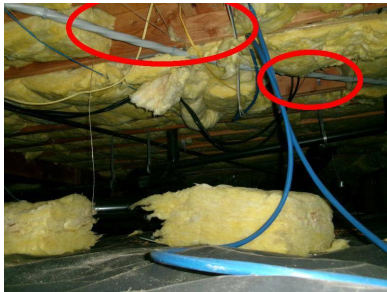
### *FLOOR INSULATION*

Some of the insulation batts were not properly secured and have falling down. The fallen batts should be reinstalled and secured.

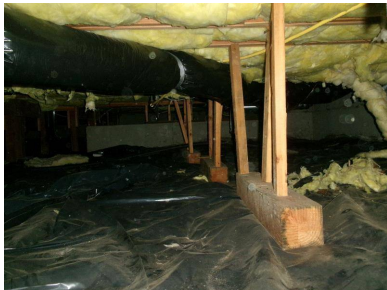
### *BEAMS AND POSTS*

Per the original homeowner, the builder installed those supports to address some floor flex on the main floor. I have lived in this home for 11 years. Over those years, I have had no settling or cracking. We have had several moderate earthquakes and large windstorms during that period.

The visible portions of the posts and beams are properly installed and are performing their intended function. However several 2X4 posts have been propped up under portions of the south floor structure and are improperly supported. Replacement if needed should be done under current industry standards.

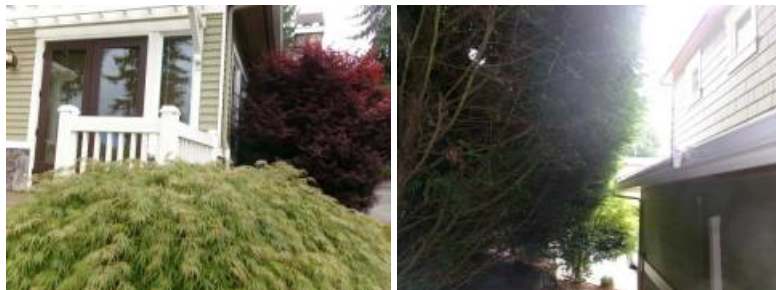
Trees are nearly touching the building on both the east and south sides. Low hanging tree branches can damage the roof, siding, doors and windows. Tree branches should be trimmed back where necessary.

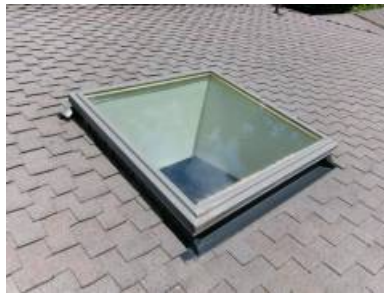
The skylight is not secured to the roof. Skylights can get blown off roofs during high winds if they are not secured. Fastening the skylight to the curb with four plated or stainless screws is recommended.

There was no evidence of leakage underneath the skylight.

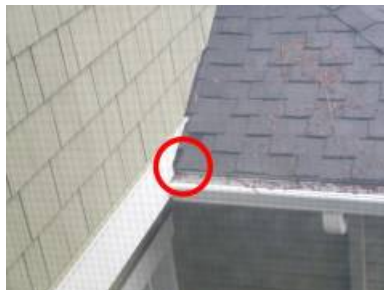
There is no kick out flashing at the roof edge to wall intersection above the gutter. This will allow water to enter the wall behind the siding. The installation of a kick-out flashing is recommended.

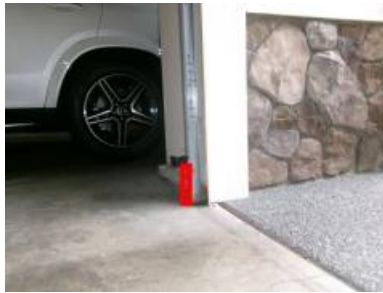
#### *GARAGE DOOR OPENER*

The Photo-eye beam was installed to high above the floor of the garage to adequately offer protection for small children and/or pets. We recommend that the photo-eye be lowered to within 4-6" of the floor.

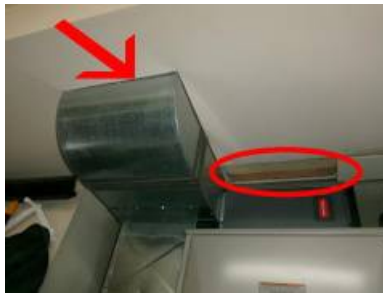
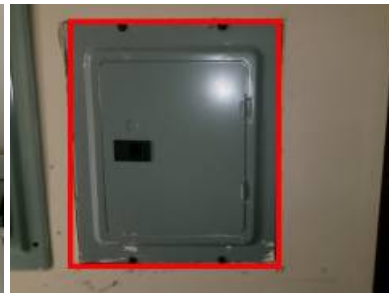
#### *FIRE SEPARATION*

The fire resistive barrier between the garage and the living space is properly installed and in good condition, however, the gaps adjacent the furnace are not taped. Voids in the fire resistive barrier between the living space and garage will allow flames to penetrate. The gypsum barrier slows the spread of a fire from the garage to the structure and/or living space. Patching the small void(s) with a fire retardant caulk is recommended. A fire resistive barrier should be installed over larger voids.

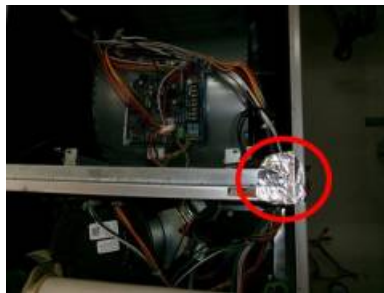
The blower door cut-out switch has been disabled. This is a potential hazard. The cut-out switch should be not be restricted.

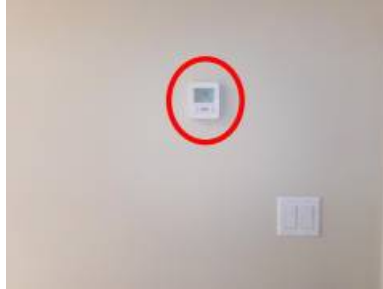
The thermostat at the top of the stairs function was not determined.

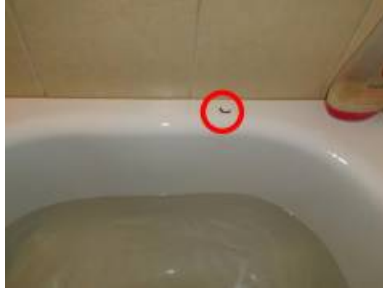
<i>LOCATION</i>	Upper Floor Hallway.
<i>BATHTUB</i>	The bathtub is properly installed and is in serviceable condition.
	The surface of the bathtub is chipped. This defect is primarily cosmetic and therefore repairs are optional. Chips can be touched up with appliance repair touch-up paint available at most home improvement centers.

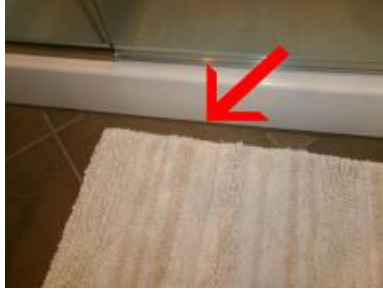
The caulking is cracked at the intersection between the tub/shower and floor. This can lead to water damage to the flooring and substrate. Caulking this area with a flexible caulk is recommended.

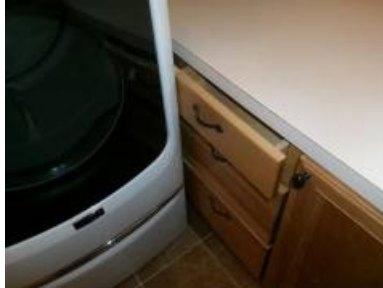
#### *CABINETS*

The cabinets are properly installed and are in good condition, however, some of the drawers full opening are restricted by the dryers placement.

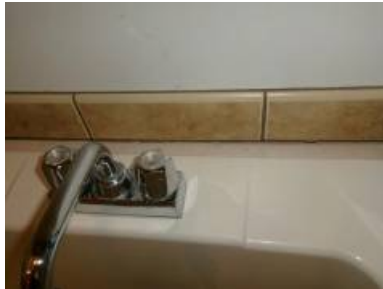
#### *COUNTERTOP*

The backsplash caulking is cracked. Cracking of the caulk allows water to enter the gap and is difficult to clean. Caulking the cracks and/or gaps is recommended.

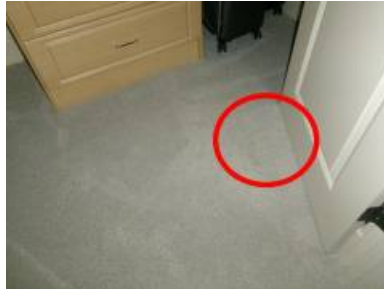
One of the primary bedroom closet doors rubs on the carpet. Doors should be adjusted as necessary.

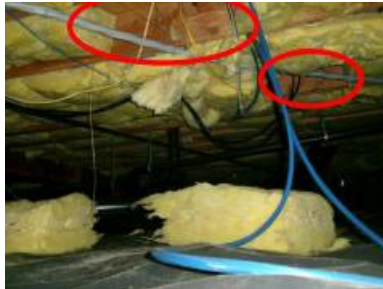
Some of the insulation batts were not properly secured and have falling down. The fallen batts should be reinstalled and secured.

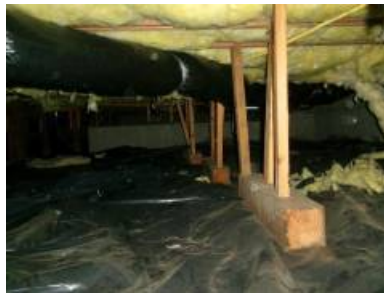
#### BEAMS AND POSTS

The visible portions of the posts and beams are properly installed and are performing their intended function. However several 2X4 posts have been propped up under portions of the south floor structure and are improperly supported. Replacement if needed should be done under current industry standards.
