**NOTICE TO BUYER: SELLER-PROCURED INSPECTION REPORT**

**Terrill Family Living Trust  
14120 176<sup>th</sup> Ave. NE  
Redmond, WA 98052**

At your request, a visual inspection of the above referenced property was conducted on 09/17/2024. We have inspected the major structural components, plumbing, heating and electrical systems for signs of significant non-performance, excessive or unusual wear and general state of repair.

DATE OF INSPECTION: 9/17/2024.  
INSPECTOR'S NAME: Terry Clark.  
CLIENT NAME: Mr. Peter Terrill & Ms. Elizabeth Camper.  
CLIENT E-MAIL ADDRESS mohrscircle73@gmail.com; [elizabethcamperx@gmail.com](mailto:elizabethcamperx@gmail.com).  
ADDRESS OF PROPERTY 14120 176th Ave. NE  
INSPECTED Redmond, WA.

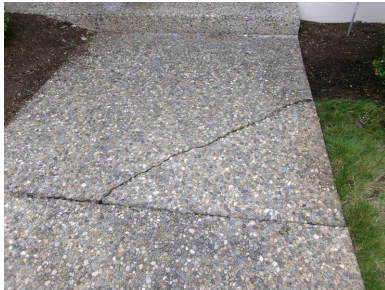
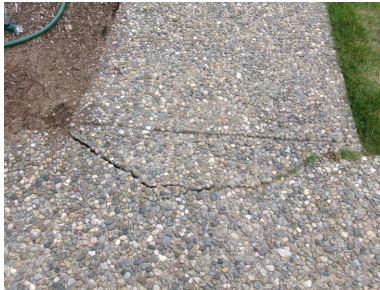
#### WALKWAY

The walkway has cracked and settled differentially. This was probably caused by inadequate preparation of the soil prior to the placement of the concrete. This condition can be repaired by pressure grouting the sunken portion of the walkway or by removing and replacing it. Grinding down the raised edges of the concrete will also mitigate the hazard. The walkway remains functional despite this condition. However, the raised edges of the concrete can be a trip hazard for some people. Repairs should be made as necessary.

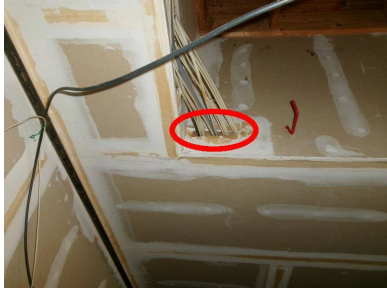
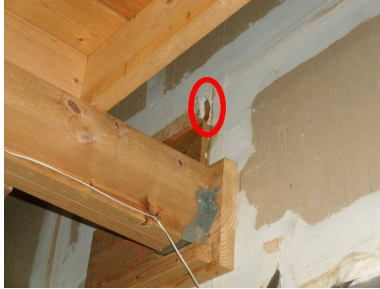
#### FIRE SEPARATION

There are voids in the fire resistive barrier between the living space and garage that will allow flames to penetrate. The gypsum barrier slows the spread of a fire from the garage to the structure and/or living space. Patching the voids with a fire retardant caulk is recommended.

- Voids in the fire-resistant barrier - Filled

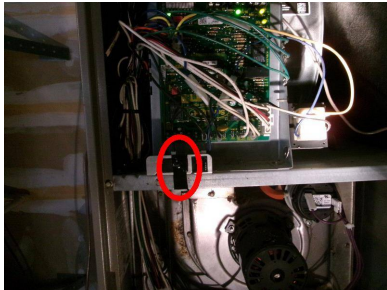
The blower door cut-out switch has been disabled. This is a potential hazard. The cut-out switch should be not be restricted.

- Blower door cut-out switch – Enabled/Repaired

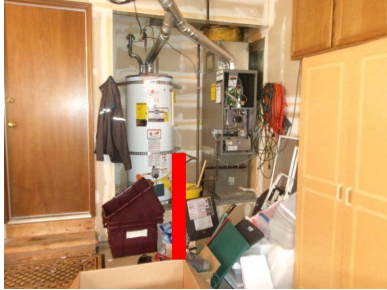
The gas pipes in front of the furnace and water heater are not protected by a bumper stop. A vertical steel pipe, bolted to the floor, is typically installed in front of the water heater to prevent a car bumper from damaging the gas lines.

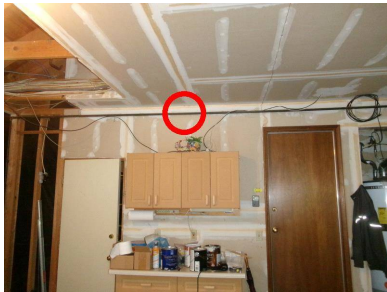
The gas pipe in the garage was not adequately secured. This can damage the pipe. The gas pipe should be secured in accordance with industry standards.

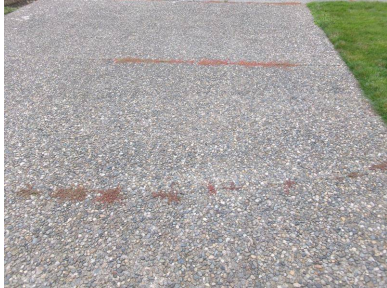
Cracks were observed in the concrete surface of the driveway. Minor cracks can be sealed to minimize moisture entry and further settlement of the concrete. Minor cracks are common and do not affect the serviceability of the concrete.

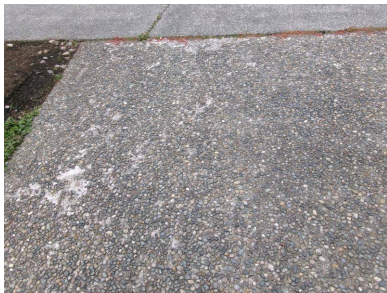
Severe aggregate loss and degradation of the surface of the driveway was observed. This may have been caused by an admixture or overworking of the material at the time of installation. Concrete surfaces can be sealed to minimize moisture penetration and further deterioration of the concrete.

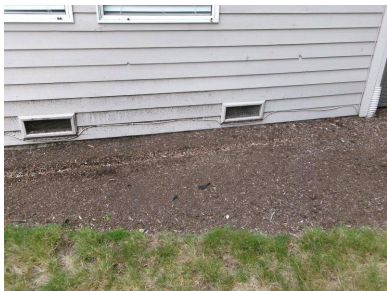
Soil is close to or in contact with siding in some areas around the building exterior. Good building practice requires that foundation walls or pier footings supporting wood frame construction, extend at least 8" above the finish grade with at least a 6" clearance between the top of the soil and the bottom of the wood finish materials. Soil in direct contact with wood creates a hospitable environment for wood destroying organisms. Establishing these minimum clearances is recommended.

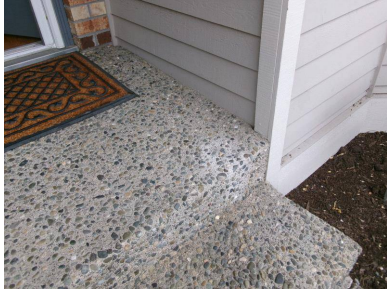
Untreated wood in direct contact with concrete was observed along the stoop. Untreated wood should be raised

1-2" above the concrete. Treating the wood with a preservative sometimes will prevent wood destroy organism damage.

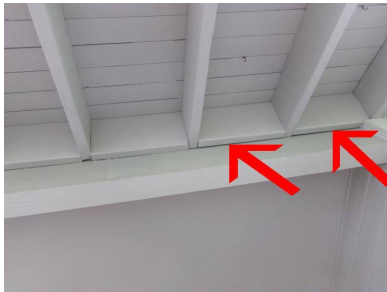
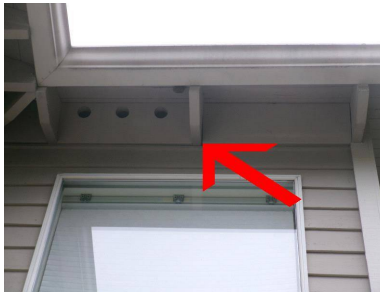
#### **SOFFITS AND OVERHANGS**

There are large gaps over 1/4" in size adjacent the soffit vent blocks. These gaps allow insects and rodents to enter the attic. Covering the gaps with screening, a strip of wood and/or caulking is recommended.

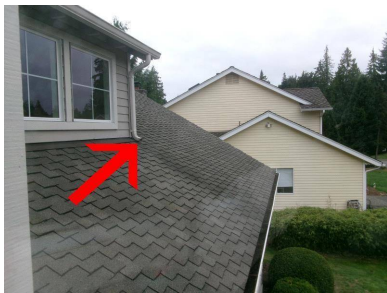
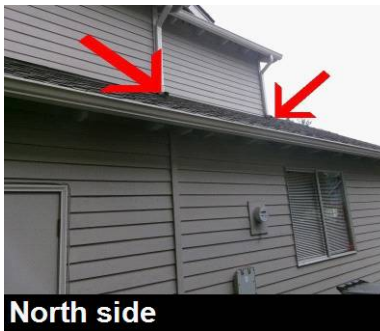
#### **GUTTERS AND DOWNSPOUTS**

Downspouts draining directly onto the asphalt shingle surface causes excessive wear of the roofing material. Downspout extensions to the lower gutters should be installed to prevent excessive wear and tear of the roofing.

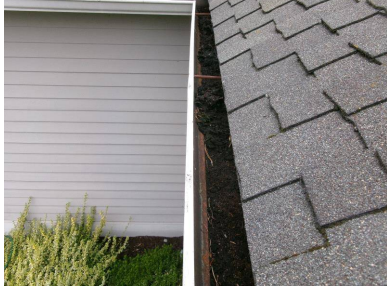
There is a build-up of organic debris inside the gutters. Gutters should be cleaned as necessary to maintain a free flow of water into the downspouts.

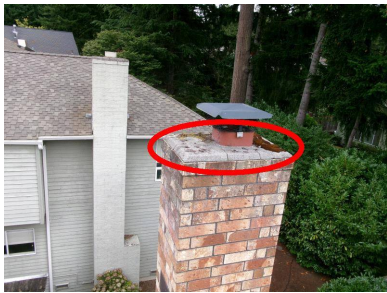
### *CHIMNEYS*

The chimney crown is cracked and deteriorated. The mortar chimney crown prevents water from entering and damaging the masonry. Repairing or replacing the chimney crown will extend the service life of the chimney.

- Chimney crown – Repaired

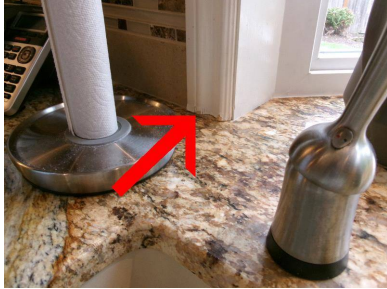
The backsplash is not caulked. This allows water and food to enter the gap between the back splash and counter and is difficult to clean. Caulking should be installed at this location.

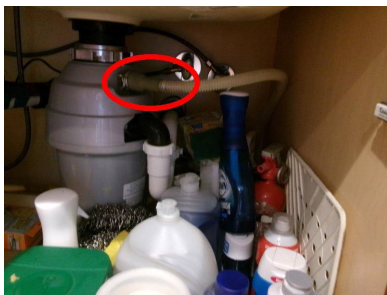
#### **AIR GAP**

The dishwasher drain lacks an air gap. The dishwasher will function without one, but there is a risk of contamination of the inside of the dishwasher by waste water. The installation of an air gap above the flood rim of the sink is recommended.

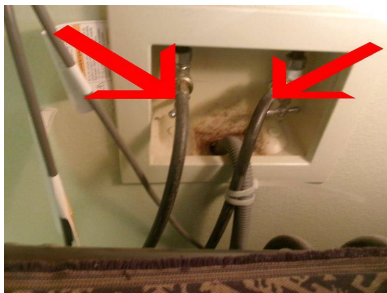
High pressure (steel braided) washer line connections is recommended.

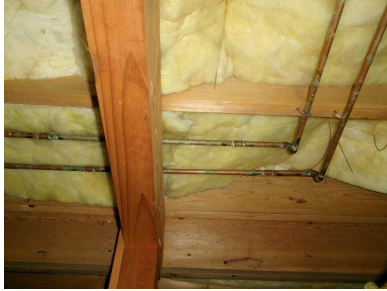
There are water pipes in the crawlspace that are not adequately insulated and could freeze. The installation of foam pipe insulation on all exposed water pipes is recommended.

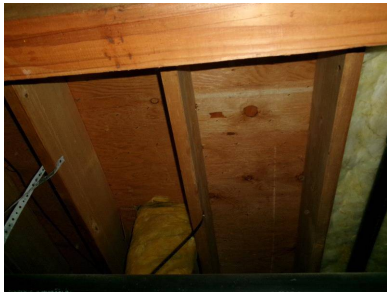
Several of the insulation batts are missing. The missing batts should be replaced .

- Insulation batts in crawlspace under main floor – Installed new batts
- Insulation on ducts – Installed/Replaced new insulation wraps

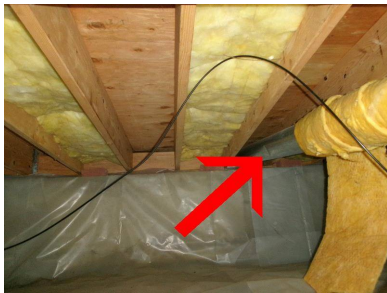
### *DUCT INSULATION*

Some of the duct insulation is missing or has fallen off the ducts. This increases the amount of heat loss. The installation of new duct insulation is recommended in areas where insulation is missing.

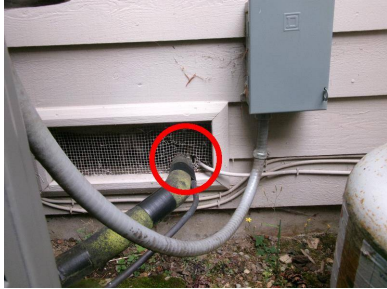
One of the crawlspace vent screens is damaged on the north side of the house. This will allow rodent entry into the crawlspace. The damaged screen should be repaired.

- Crawlspace vent screen – Repaired
- Pest control – No evidence of any recent pest activity. All entry points sealed and traps placed to monitor/handle any new pest activity

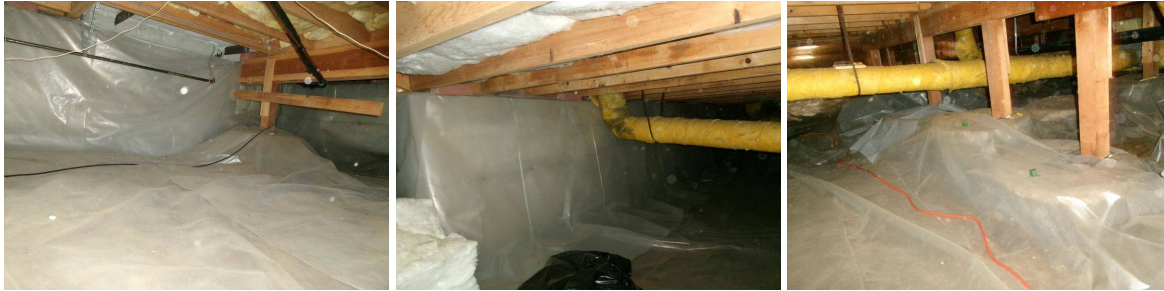
#### **VAPOR RETARDER**

The foundation walls are covered with the plastic vapor retarder. This allows the transmission of water vapor from the soil up and into the exterior wall framing. The plastic vapor retarder should be removed from the foundation.

The support post concrete piers are covered with the plastic vapor retarder. This allows the transmission of water vapor from the soil up and into the floor framing. The plastic vapor retarder should be removed from the piers.

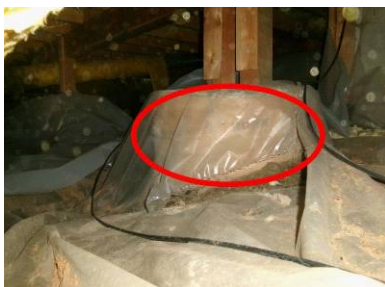
Cellulose forms were left in place on the pier footings. This cellulose is conducive to the infestation of various wood destroying organisms. The removal of the cellulose is recommended.

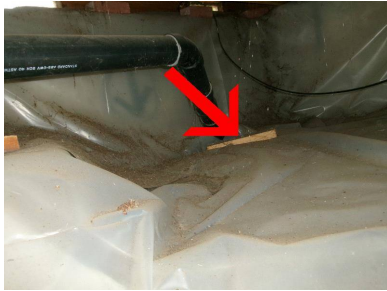
Scrap-wood and other cellulose debris was observed on the crawl floor. This wood debris creates conducive conditions for wood boring insects. The removal of all cellulose debris is recommended.

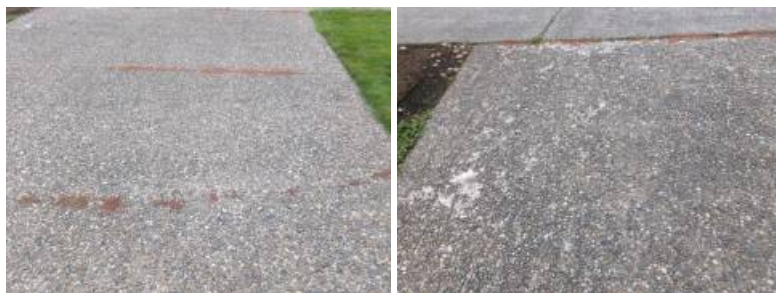
Severe aggregate loss and degradation of the surface of the driveway was observed. This may have been caused by an admixture or overworking of the material at the time of installation. Concrete surfaces can be sealed to minimize moisture penetration and further deterioration of the concrete.

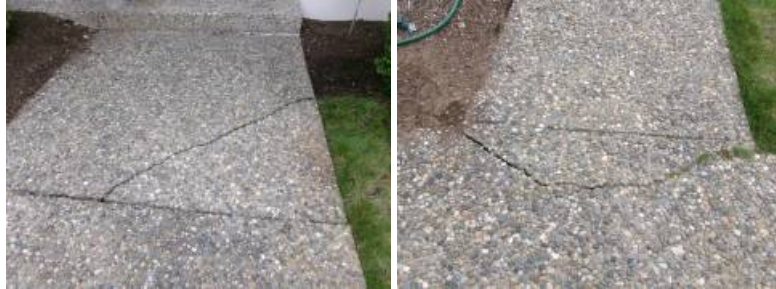
**WALKWAY** The walkway has cracked and settled differentially. This was probably caused by inadequate preparation of the soil prior to the placement of the concrete. This condition

can be repaired by pressure grouting the sunken portion of the walkway or by removing and replacing it. Grinding down the raised edges of the concrete will also mitigate the hazard. The walkway remains functional despite this condition. However, the raised edges of the concrete can be a trip hazard for some people. Repairs should be made as necessary.

Many legal and public works departments have defined a trip hazard as an irregularity in a walking surface exceeding one inch (1") in height. All walking surfaces should maintain, free of a vertical surface change of 3/4" or more, in the interest of public and personal safety.

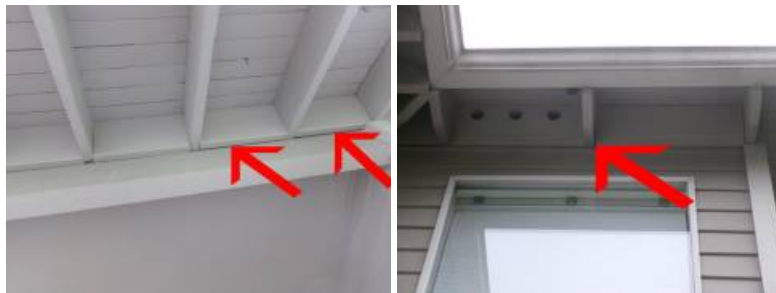
There are large gaps over 1/4" in size adjacent the soffit vent blocks. These gaps allow insects and rodents to enter the attic. Covering the gaps with screening, a strip of wood and/or caulking is recommended.

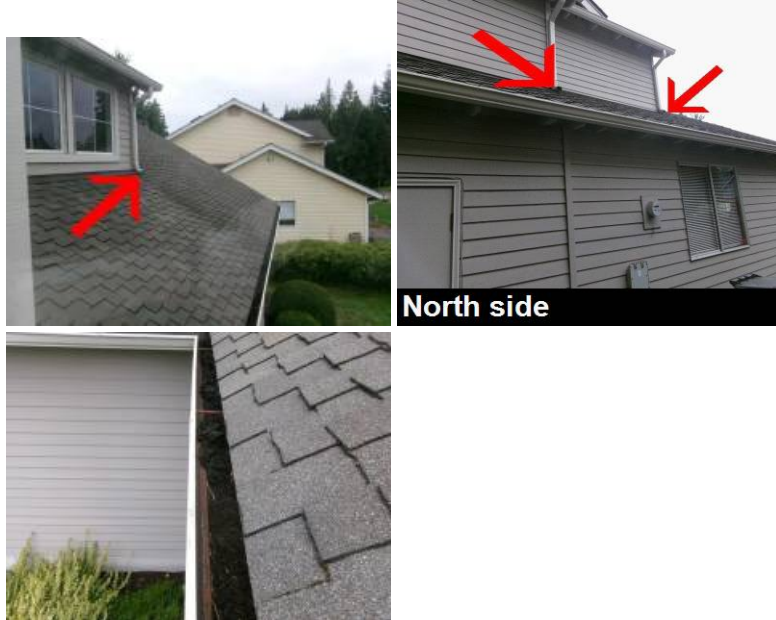
There is a build-up of organic debris inside the gutters. Proper maintenance of gutters and downspouts is essential and should be performed routinely in order to prevent clogging. Maintenance consists primarily of keeping leaves and other organic debris out of the system. Failure to clean the gutters will result in water splash on the building when they overflow. Gutters can be damaged under the weight of the water and organic matter inside the gutter. Gutters should be cleaned as necessary to maintain a free flow of water into the downspouts.

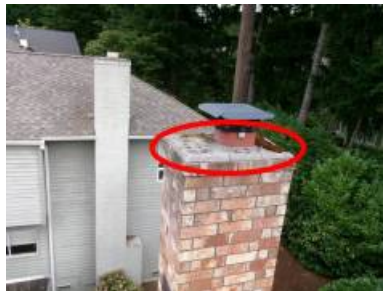
The chimney crown is cracked and deteriorated. The mortar chimney crown prevents water from entering and damaging the masonry. Repairing or replacing the chimney crown will extend the service life of the chimney.

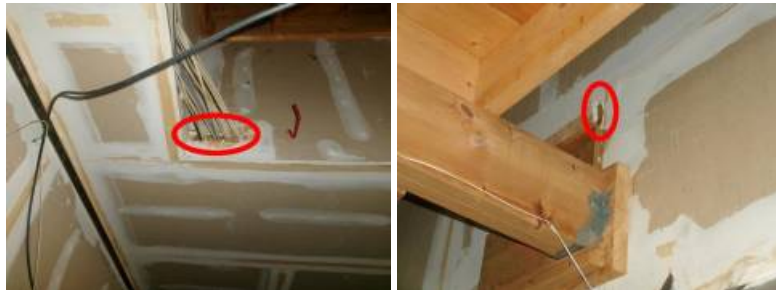
There are voids in the fire resistive barrier between the living space and garage that will allow flames to penetrate. The gypsum barrier slows the spread of a fire from the garage to the structure and/or living space. Patching the voids with a fire retardant caulk is recommended.

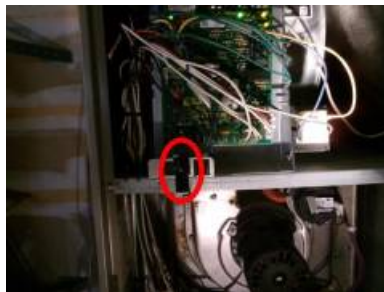
The blower door cut-out switch has been disabled. This is a potential hazard. The cut-out switch should be not be restricted.

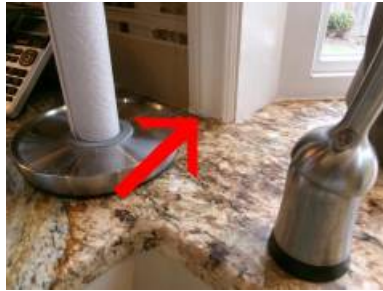
The backsplash is not caulked. This allows water and food to enter the gap between the back splash and counter and is difficult to clean. Caulking should be installed at this location.

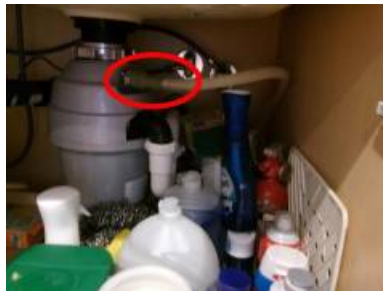
The dishwasher drain lacks an air gap. The dishwasher will function without one, but there is a risk of contamination of the inside of the dishwasher by waste water. The installation of an air gap above the flood rim of the sink is recommended.

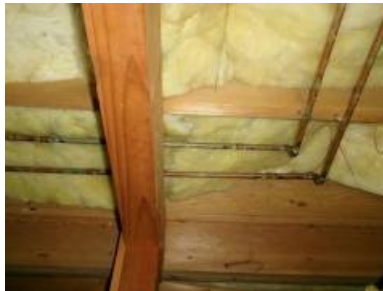
There are water pipes in the crawlspace that are not adequately insulated and could freeze. The installation of foam pipe insulation on all exposed water pipes is recommended.

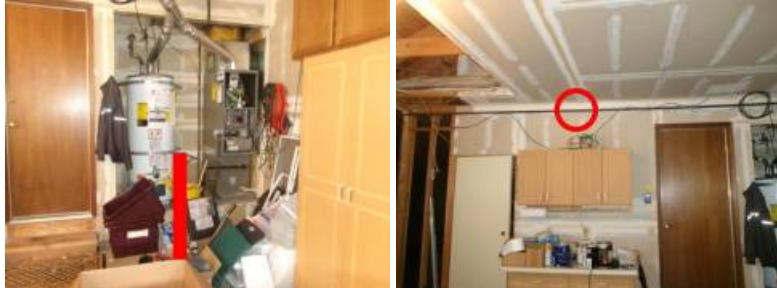
The gas pipe in the garage was not adequately secured. This can damage the pipe. The gas pipe should be secured in accordance with industry standards.

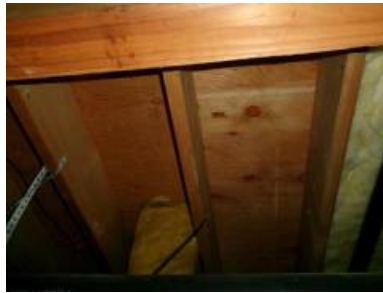
The floors are insulated with 3-1/2" R-11 fiberglass batt insulation. Several of the insulation batts are missing. The missing batts should be replaced .

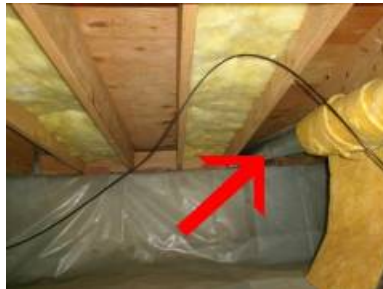
#### *DUCT INSULATION*

Some of the duct insulation is missing or has fallen off the ducts. This increases the amount of heat loss. The installation of new duct insulation is recommended in areas where insulation is missing.

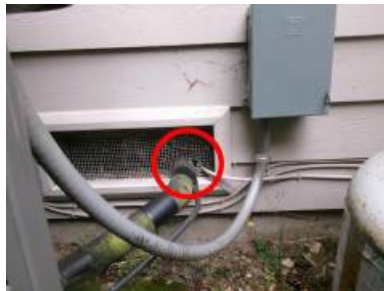
One of the crawlspace vent screens is damaged on the north side of the house. This will allow rodent entry into the crawlspace. The damaged screen should be repaired.

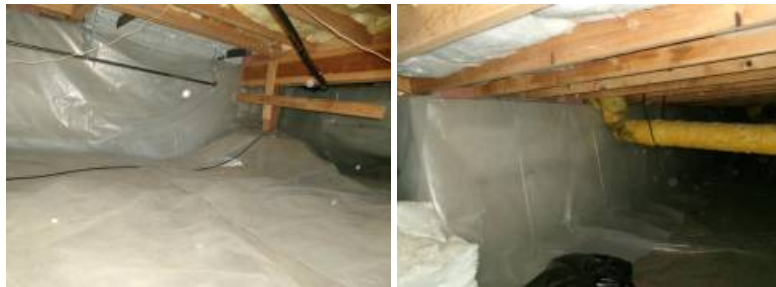
The support post concrete piers are covered with the plastic vapor retarder. This allows the transmission of water vapor from the soil up and into the floor framing. The plastic vapor retarder should be removed from the piers.

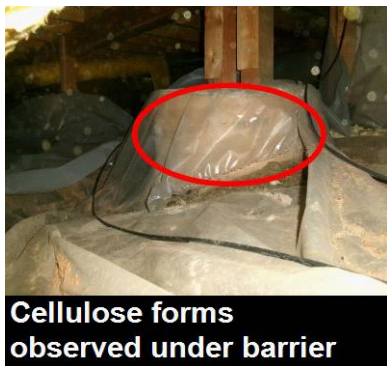
Good building practice requires that foundation walls or pier footings supporting wood frame construction, should extend at least 8" above the finish grade with at least a 6" clearance between the top of the soil and the bottom of the wood finish materials. Untreated wood should be raised 1-2" above surrounding flatwork and should have a moisture barrier such as 30 lb. asphalt impregnated felt installed between the concrete and wood. For additional information and treatment options, you should retain the services of a qualified pest control operator.

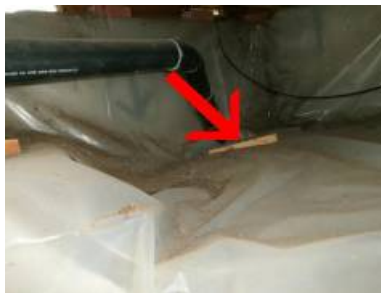
**Cellulose forms  
observed under barrier**
