NOTICE TO BUYER: SELLER-PROCURED INSPECTION REPORT

The following notice is given with respect to the Purchase and Sale Agreement dated _____ between _____ (“Buyer”) and **Annick Vogt** **Dominic Vogt** (“Seller”) concerning **17416 Ne 97th Way Redmond WA 98052** (“the Property”).

**Annick and Dominic Vogt
17416 NE 97th Way
Redmond, WA 98052**

At your request, a visual inspection of the above referenced property was conducted on 01/16/2025. We have inspected the major structural components, plumbing, heating and electrical systems for signs of significant non-performance, excessive or unusual wear and general state of repair.

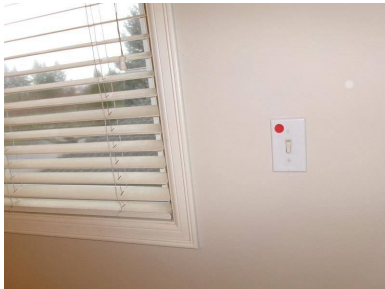
SWITCHES

One or more "mystery switches" (switches whose function could not be determined) were observed in the primary and in the west bedrooms. We suggest inquiry of the owner as to the purpose of these switches.

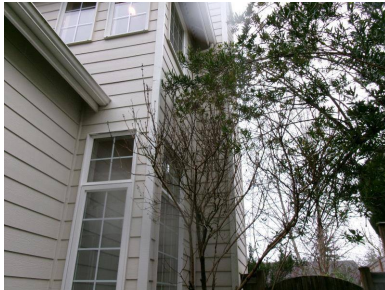
VEGETATION

Trees are touching the building on the east side. Low hanging tree branches can damage the roof, gutters, siding, doors and/or windows. Tree branches should be trimmed back where necessary.

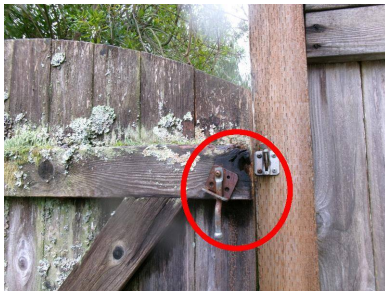
FENCES AND GATES

The gates need repairs, hardware should be adjusted or replaced as necessary to restore full function.

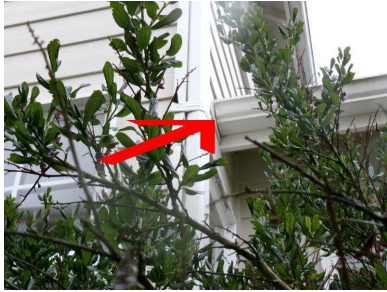
PRIMARY EXTERIOR WALL CLADDING

The Hardie Plank siding is vulnerable to damage where it is in contact with the gutter(s). The gutter(s) should be

modified to establish a 1" clearance from the end of the gutter to the siding.

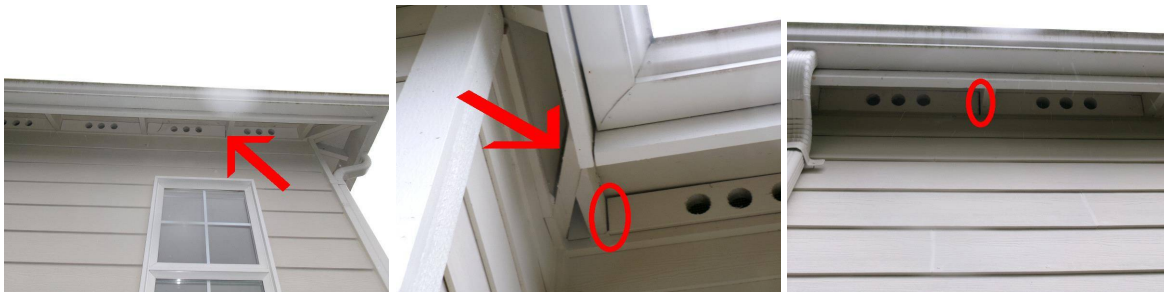
SOFFITS AND OVERHANGS

There are large gaps over 1/4" in size adjacent the soffit vent blocks. These gaps allow insects and rodents to enter the attic. Covering the gaps with screening, a strip of wood and/or caulking is recommended.

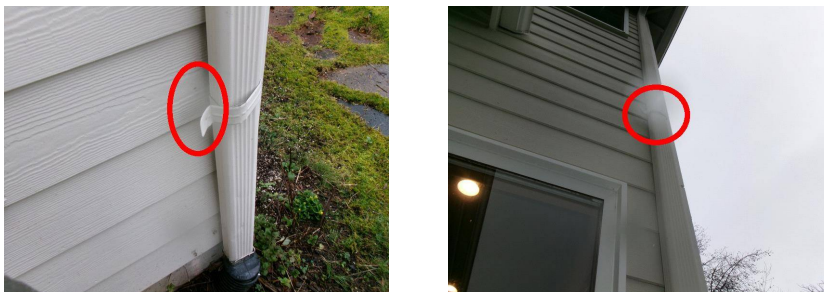
GUTTERS AND DOWNSPOUTS

The downspout is detached from the house at the rear. The downspout should be reattached and secured.

Luminaries – all nonfunctional lightbulbs will be replaced with functional lightbulbs
Gutters and downspouts – downspout will be reattached and secured

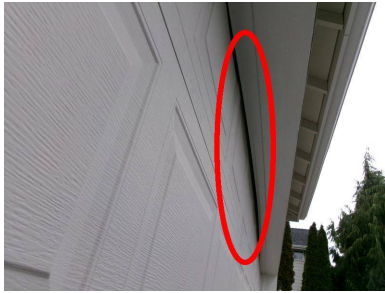
OVERHEAD GARAGE DOORS

The large gap at the top of the southwest garage door does not prevent rodent entry. The top fixtures on the overhead door are in need of adjustment. This is a cosmetic condition that does not affect the function of the door.

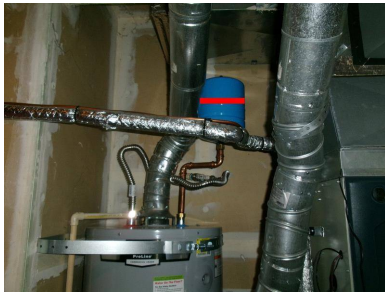
EXPANSION TANK

The expansion tank is not adequately secured to the wall. As code requirements start to call for engineered expansion tank supports we recommend the installation of seismic restraints to secure the expansion tank instead of allowing it to simply depend on piping connections that could result in damage to the water pipe and leakage during an earthquake.

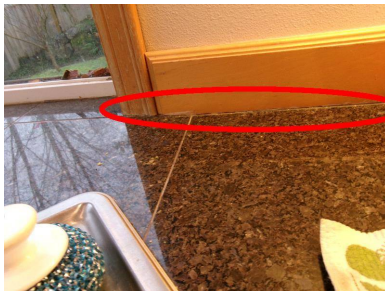
COUNTERTOPS

The backsplash is not caulked. This allows water and food to enter the gap between the back splash and counter and is difficult to clean. Caulking should be installed at this location.

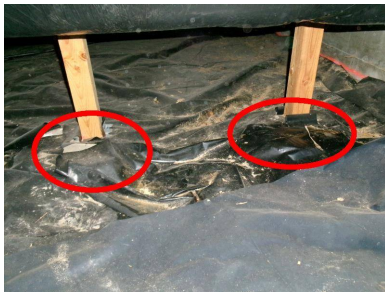
VAPOR RETARDER

The support post concrete piers are covered with the plastic vapor retarder. This allows the transmission of water vapor from the soil up and into the floor framing. The plastic vapor retarder should be removed from the pier so that it covers at least 85% of the entire surface of the soil only.

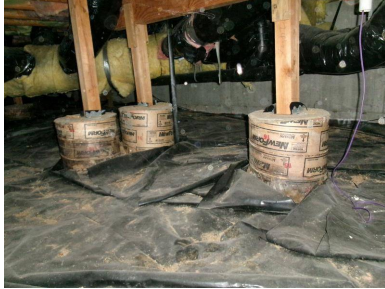
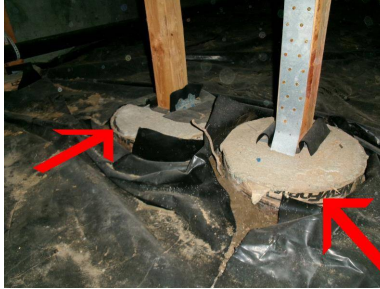
PEST CONTROL

Cellulose forms were left in place on the pier footings. This cellulose is conducive to the infestation of various wood destroying organisms. The removal of the cellulose is recommended.

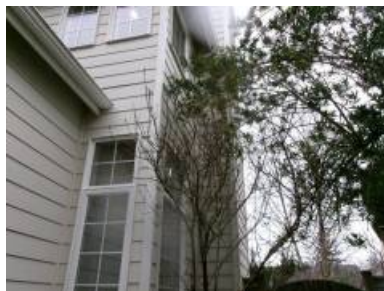
Trees are touching the building on the east side. Low hanging tree branches can damage the roof, gutters, siding, doors and/or windows. Tree branches should be trimmed back where necessary.

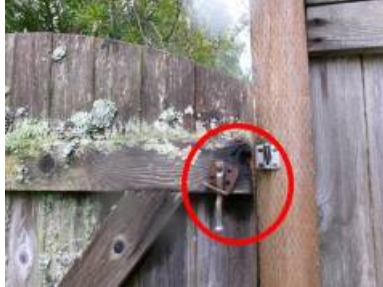
The gates need repairs, hardware should be adjusted or replaced as necessary to restore full function.

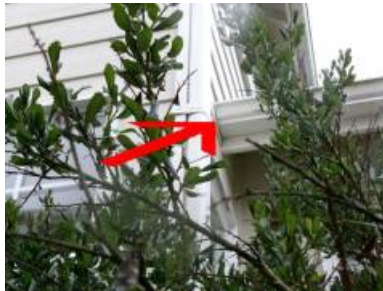
The Hardie Plank siding is vulnerable to damage where it is in contact with the gutter(s). The gutter(s) should be modified to establish a 1" clearance from the end of the gutter to the siding.

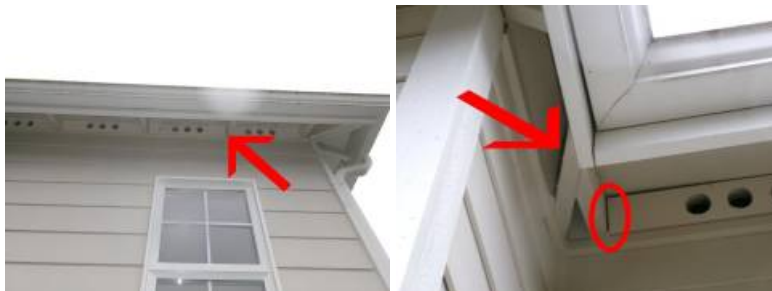
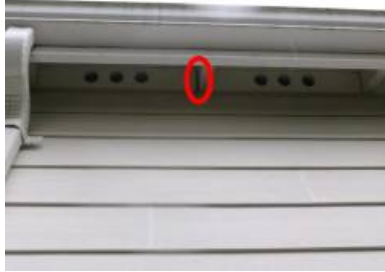
There are large gaps over 1/4" in size adjacent the soffit vent blocks. These gaps allow insects and rodents to enter the attic. Covering the gaps with screening, a strip of wood and/or caulking is recommended.

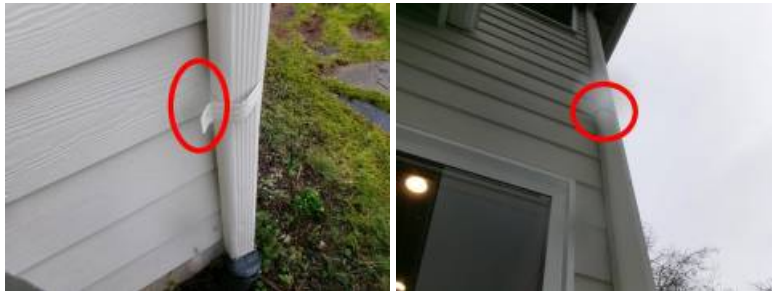
GUTTERS AND DOWNSPOUTS

The downspout is detached from the house at the rear. The downspout should be reattached and secured.

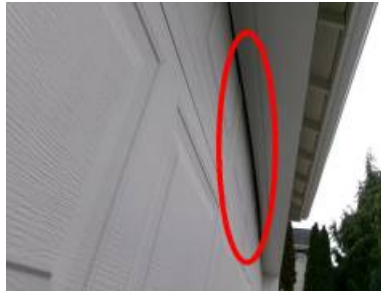
The large gap at the top of the southwest garage door does not prevent rodent entry. The top fixtures on the overhead door are in need of adjustment. This is a cosmetic condition that does not affect the function of the door.

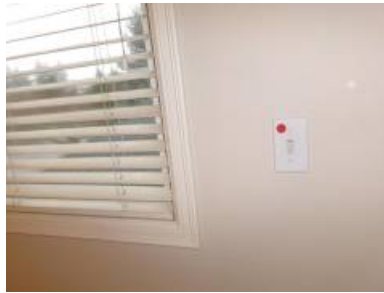
One or more "mystery switches" (switches whose function could not be determined) were observed in the primary and in the west bedrooms. We suggest inquiry of the owner as to the purpose of these switches.

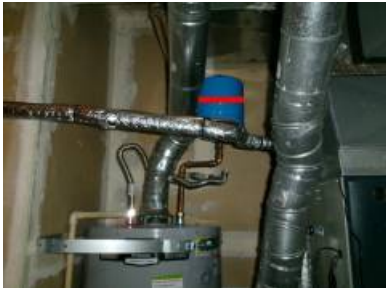
<i>LOCATION OF UNIT</i>	The water heater is located in the garage.
<i>GENERAL INFORMATION</i>	The water heater fuel is natural gas. The capacity of the water heater is 50 gallons. The input rating of the burner is approximately 40,000 BTU. The water heater was just recently installed. Water heaters of this type typically last about 8-12 years.
<i>PRESSURE RELIEF VALVE</i>	The pressure relief valve is properly installed. The valve was not tested, as this could cause the valve to leak.
<i>SHUTOFF VALVE</i>	The shutoff valve for the water supply to the water heater is properly installed and is functioning as intended.
<i>WATER CONNECTIONS AT TANK</i>	The water connections at the tank are properly installed and are performing their intended function.
<i>EXPANSION TANK</i>	The expansion tank is not adequately secured to the wall. As code requirements start to call for engineered expansion tank supports we recommend the installation of seismic restraints to secure the expansion tank instead of allowing it to simply depend on piping connections that could result in damage to the water pipe and leakage during an earthquake.

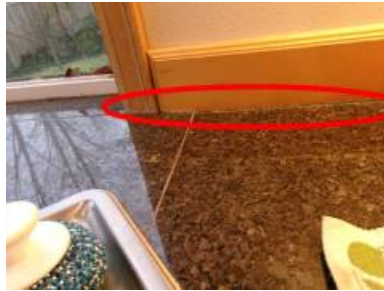
The backsplash is not caulked. This allows water and food to enter the gap between the back splash and counter and is difficult to clean. Caulking should be installed at this location.

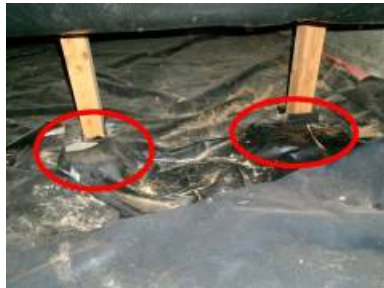
The support post concrete piers are covered with the plastic vapor retarder. This allows the transmission of water vapor from the soil up and into the floor framing. The plastic vapor retarder should be removed from the pier so that it covers at least 85% of the entire surface of the soil only.

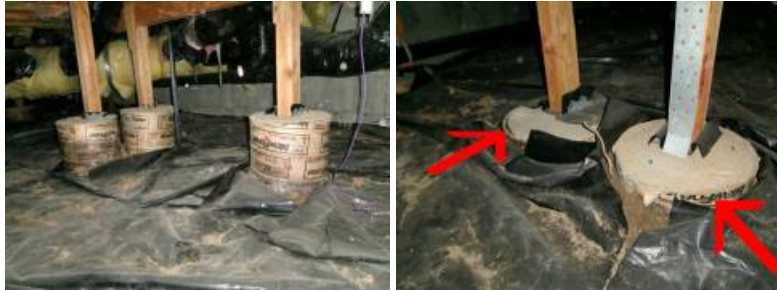
Good building practice requires that foundation walls or pier footings supporting wood frame construction, should extend at least 8" above the finish grade with at least a 6" clearance between the top of the soil and the bottom of the wood finish materials. Untreated wood should be raised 1-2" above surrounding flatwork and should have a moisture barrier such as 30 lb. asphalt impregnated felt installed between the concrete and wood. For additional information and treatment options, you should retain the services of a qualified pest control operator.
