NOTICE TO BUYER: SELLER-PROCURED INSPECTION REPORT

**Stephen and Sheila Couey
3935 226th PL SE #208
Issaquah WA 98029**

At your request, a visual inspection of the above referenced property was conducted on 02/12/2025. We have inspected the major structural components, plumbing, heating and electrical systems for signs of significant non-performance, excessive or unusual wear and general state of repair.

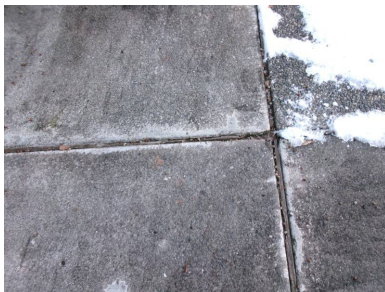
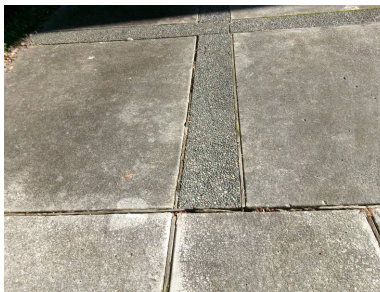
PATIO

One or more of the wooden dividers separating the concrete patio sections were infested by wood destroying organisms and have deteriorated to a point where they are becoming a trip hazard. Replacement with mortar is recommended.

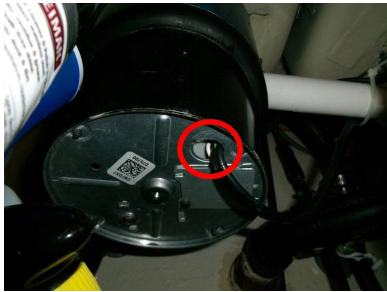
WIRING

The cord is not clamped where it enters the disposal. This could damage the wires or cause a ground fault. The cord should be clamped in accordance with industry standards.

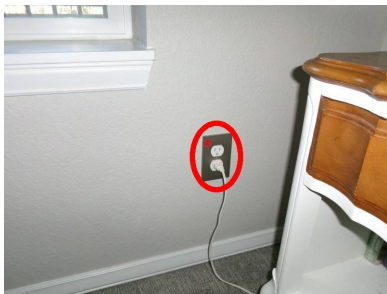
RECEPTACLES

The polarity is reversed in receptacles in the primary bedroom. Reversed polarity means that the hot and neutral wires are reversed at the back of the receptacle. This defect is a shock hazard and can damage some electronic equipment. All receptacles exhibiting reversed polarity should be rewired.

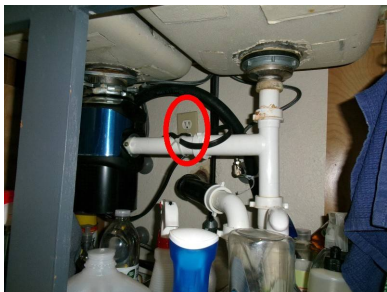
The receptacle on the wall under the kitchen sink is loose. This is a potential shock and a fire hazard. All loose receptacles should be repaired as necessary.

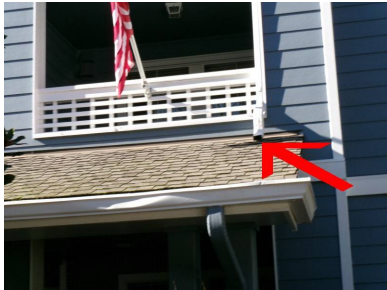
GUTTERS AND DOWNSPOUTS

Downspouts draining directly onto the asphalt shingle surface causes excessive wear of the roofing material. Downspout extensions to the lower gutters should be installed to prevent excessive wear and tear of the roofing.

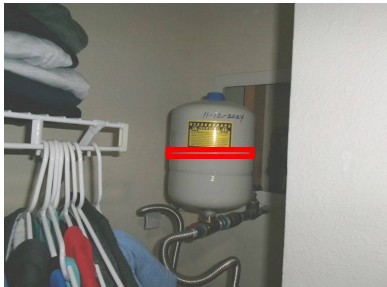
EXPANSION TANK

The expansion tank is not adequately secured to the wall. As code requirements start to call for engineered expansion tank supports we recommend the installation of seismic restraints to secure the expansion tank instead of allowing it to simply depend on piping connections that could result in damage to the water pipe and leakage during an earthquake.

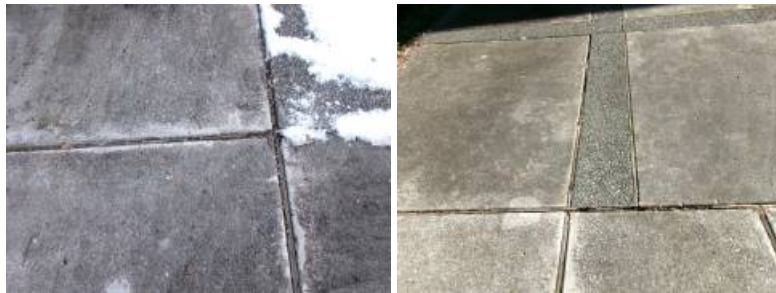
PATIO One or more of the wooden dividers separating the concrete patio sections were infested by wood destroying organisms and have deteriorated to a point where they are becoming a trip hazard. Replacement with mortar is recommended.

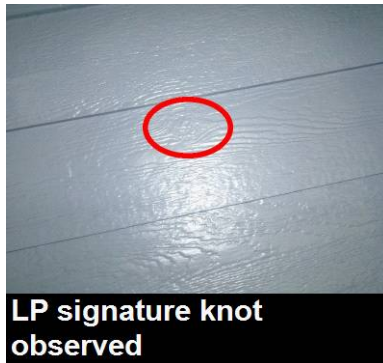
SECONDARY EXTERIOR WALL CLADDING Louisiana Pacific (LP) inner seal lap siding is also used as an exterior wall cladding. This material is undesirable due to its propensity to swell, rot and delaminate. The manufacturer was involved in a multi-million-dollar class action lawsuit that was ultimately settled. The life expectancy of this siding in most cases is less than ten years. Maintaining the finish on the siding and protecting it from exposure to rain will maximize its service life. Louisiana Pacific continues to manufacture the siding and now calls it "Smart Siding". They have revised the manufacturing process and now claim that the problems described above have been eliminated.

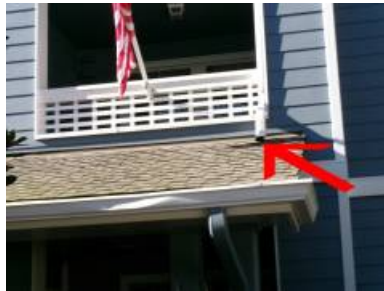
Downspouts draining directly onto the asphalt shingle surface causes excessive wear of the roofing material. Downspout extensions to the lower gutters should be installed to prevent excessive wear and tear of the roofing.

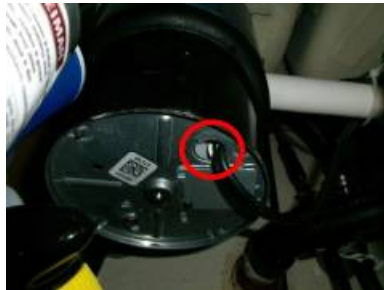
<i>WIRING</i>		The visible portions of the wiring are properly installed except where noted below.

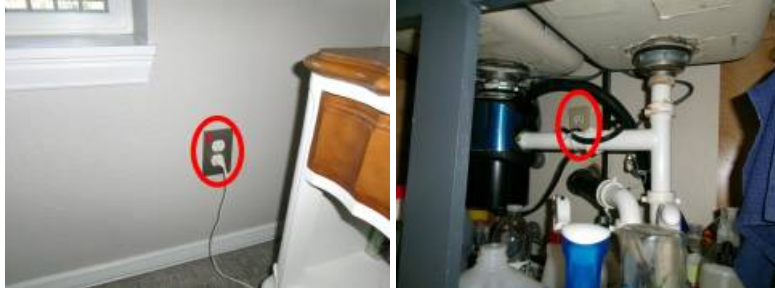
The polarity is reversed in receptacles in the primary bedroom. Reversed polarity means that the hot and neutral wires are reversed at the back of the receptacle. This defect is a shock hazard and can damage some electronic equipment. All receptacles exhibiting reversed polarity should be rewired.

The receptacle on the wall under the kitchen sink is loose. This is a potential shock and a fire hazard. All loose receptacles should be repaired as necessary.

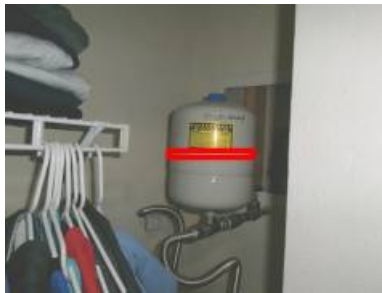
LOCATION OF UNIT	The water heater is located in the primary bedroom closet.
GENERAL INFORMATION	The water heater is electric. The capacity of the water heater is 40 gallons. The water heater is approximately 6 years old. Water heaters of this type typically last about 10-15 years.
PRESSURE RELIEF VALVE	The pressure relief valve is properly installed. The valve was not tested, as this could cause the valve to leak.
SHUTOFF VALVE	The shutoff valve for the water supply to the water heater is properly installed and is functioning as intended.
WATER CONNECTIONS TANK	AT The water connections at the tank are properly installed and are performing their intended function.
EXPANSION TANK	The expansion tank is not adequately secured to the wall. As code requirements start to call for engineered expansion tank supports we recommend the installation of seismic restraints to secure the expansion tank instead of allowing it to simply depend on piping connections that could result in damage to the water pipe and leakage during an earthquake.
