NOTICE TO BUYER: SELLER-PROCURED INSPECTION REPORT

**Linda Thompson
13821 176th PL NE
Redmond, WA 98052**

**Ms. Linda Thompson
13821 176th Pl. NE
Redmond, WA.**

**Re: 13821 176th Pl. NE
Redmond, WA.**

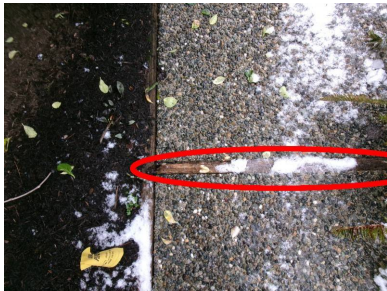
WALKWAY

The wooden dividers separating the concrete walkway sections have deteriorated to a point where the gaps are a trip hazard. Replacement with mortar is recommended.

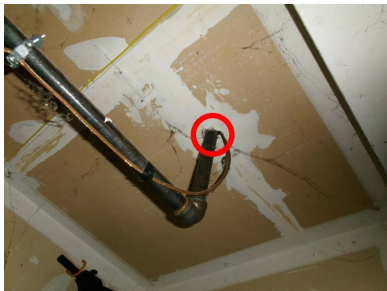
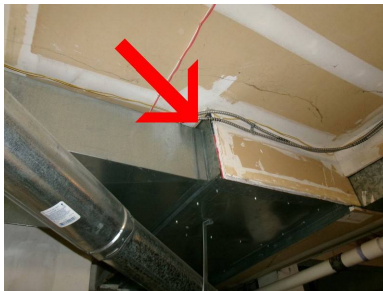
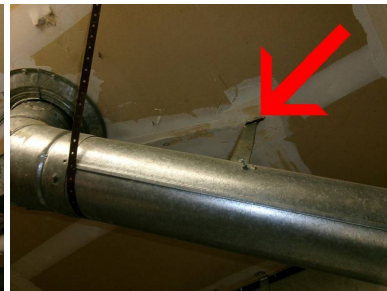
FIRE SEPARATION

There are voids in the fire resistive barrier between the living space and garage that will allow flames to penetrate. The gypsum barrier slows the spread of a fire from the garage to the structure and/or living space. Patching the voids with a fire retardant caulk is recommended.

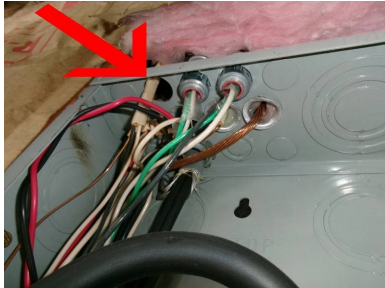
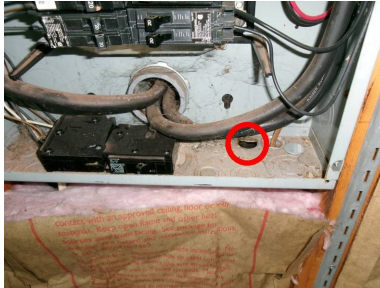
There is an electrical cable emanating from the service panel that is not clamped. The sharp edge of the panel box could cut through the wire insulation and cause a short circuit or fire. Clamping the cable to the panel box using an approved cable clamp is recommended.

There are openings in the panel box where knock-outs have been removed. Missing knock-outs should be replaced with snap in metal plugs.

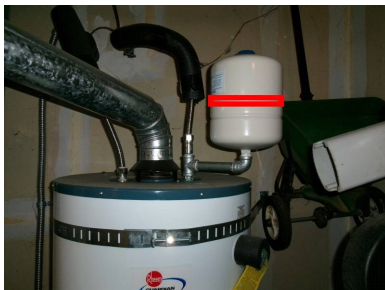
EXPANSION TANK

The expansion tank is not adequately secured to the wall. As code requirements start to call for engineered expansion tank supports we recommend the installation of seismic restraints to secure the expansion tank instead of allowing it to simply depend on piping connections that could result in damage to the water pipe and leakage during an earthquake.

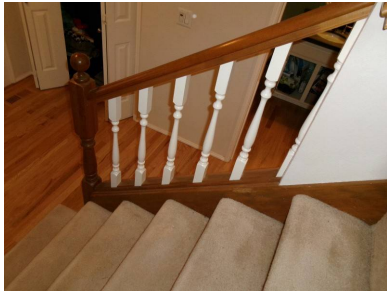
STAIRS

The stair railing baluster spacing is too wide. This is a hazard for small children. The baluster spacing should be reduced as a safety upgrade. Current standards require that a 4-3/8" sphere not pass through the railing.

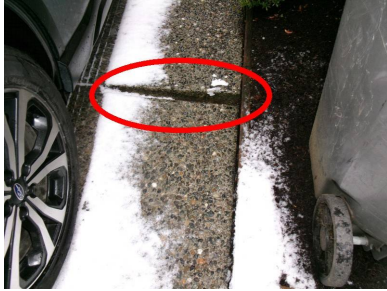
DRIVEWAY

The driveway has cracked and settled differentially. This was probably caused by inadequate preparation of the soil prior to the placement of the concrete. This condition can be repaired by pressure grouting the sunken portion of the driveway or by removing and replacing it. The driveway remains functional despite this condition.

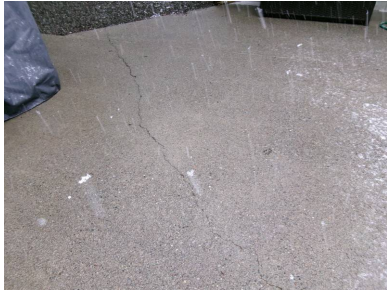
PATIO

Cracks were observed in the concrete surface of the patio. Minor cracks can be sealed to minimize moisture entry and further settlement of the concrete.

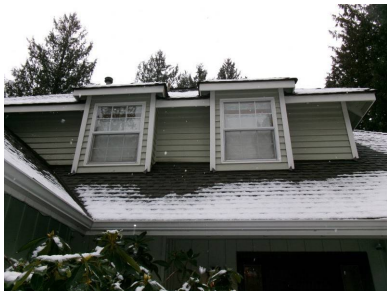
GUTTERS AND DOWNSPOUTS

The gutters are missing from the upper level at the front of the building. Missing gutters should be replaced to prevent water splash on the siding.

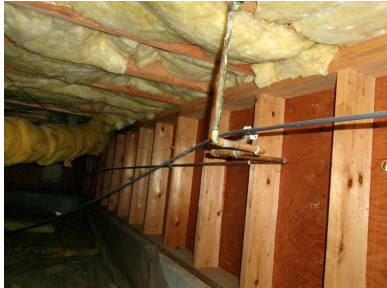
INTERIOR WATER SUPPLY PIPES

There are water pipes in the crawlspace that are not adequately insulated and could freeze. The installation of foam pipe insulation on all exposed water pipes is recommended.

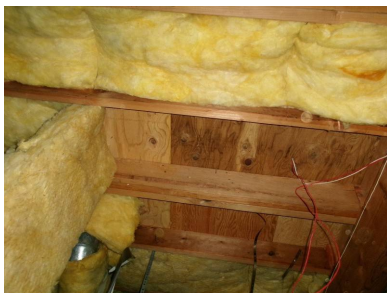
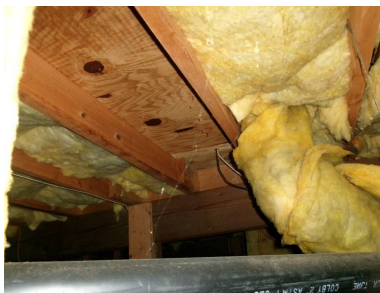
FLOOR INSULATION

Some of the insulation batts are missing and several were not properly secured and have falling down. The fallen batts should be reinstalled and secured. The missing batts should be replaced.

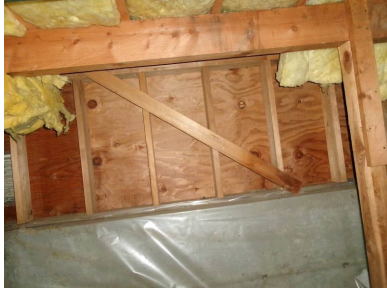
SHEAR PANELS

Shear panels are plywood or OSB panels that are mechanically fastened to both vertical and horizontal framing members in critical structural areas of the building. They prevent lateral movement of the structure during an earthquake. Shear panels are often visible in the crawlspace on cripple walls between the first floor and foundation. They may also be installed on interior walls that are covered with drywall. An examination of the crawlspace revealed the absence of shear panels on the cripple walls. The installation of shear panels on the cripple walls is recommended as an upgrade.

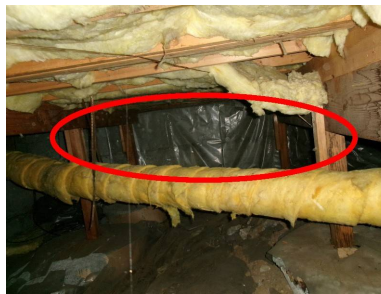
VAPOR RETARDER

Some of the soil under the house is not covered with a polyethylene plastic vapor retarder. This component is typically referred to as a "vapor barrier". While not a true vapor barrier, it does reduce the transmission of water vapor from the soil to the air. The vapor retarder should be maintained so that it covers at least 85% of the entire surface of the soil.

Some of the foundation walls are covered with the plastic vapor retarder. This allows the transmission of water vapor from the soil up and into the exterior wall framing. The plastic vapor retarder should be removed from the foundation so that it covers at least 85% of the entire surface of the soil only.

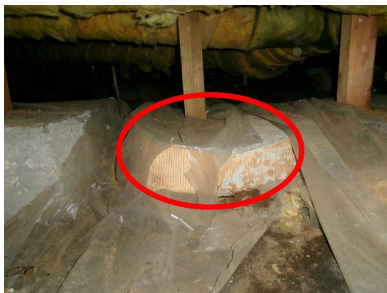
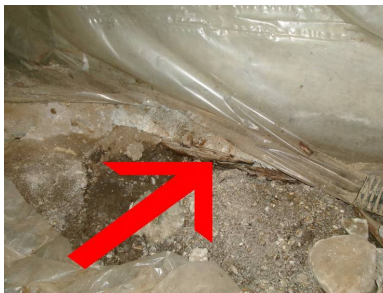
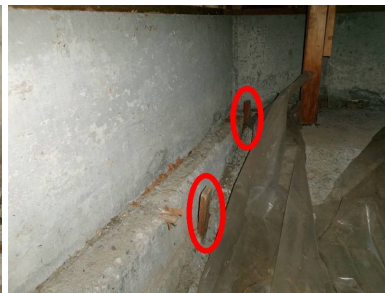
PEST CONTROL

There is evidence of rodent activity in the crawlspace. The first step in eliminating rodents from the crawlspace is to seal all possible entry points using wire mesh, caulking, wood, stainless steel wool, aerosol foam or mortar. Careful work sealing cracks, holes, gaps, and covering ground water drain inlets will discourage rodent activity. Once this work is completed, snap traps baited with peanut butter should be installed and monitored. The absence of rodents in the traps typically means that the rodents have been excluded from the area.

Cellulose forms were left in place on the pier footings. This cellulose is conducive to the infestation of various wood destroying organisms. The removal of the cellulose is recommended.

Form wood was left in place on the footings. This wood is conducive to the infestation of various wood destroying organisms. The removal of the form wood is recommended.

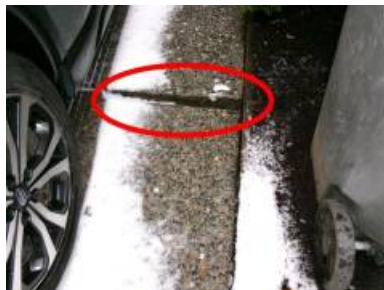
DRIVEWAY The driveway has cracked and settled differentially. This was probably caused by inadequate preparation of the soil prior to the placement of the concrete. This condition can be repaired by pressure grouting the sunken portion of the driveway or by removing and replacing it. The driveway remains functional despite this condition.

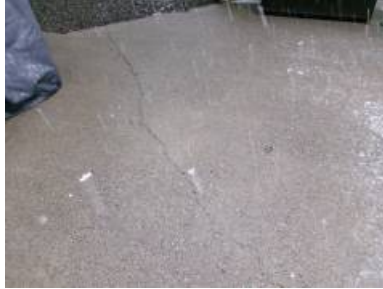
PATIO Cracks were observed in the concrete surface of the patio. Minor cracks can be sealed to minimize moisture entry and further settlement of the concrete.

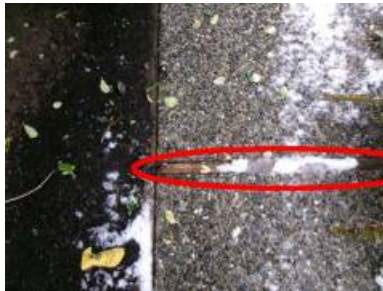
WALKWAY

The wooden dividers separating the concrete walkway sections have deteriorated to a point where the gaps are a trip hazard. Replacement with mortar is recommended.

Many legal and public works departments have defined a trip hazard as an irregularity in a walking surface exceeding one inch (1") in height. All walking surfaces should maintain, free of a vertical surface change of 3/4" or more, in the interest of public and personal safety.

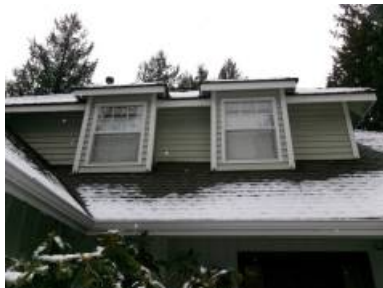
The gutters are missing from the upper level at the front of the building. Missing gutters should be replaced to prevent water splash on the siding.

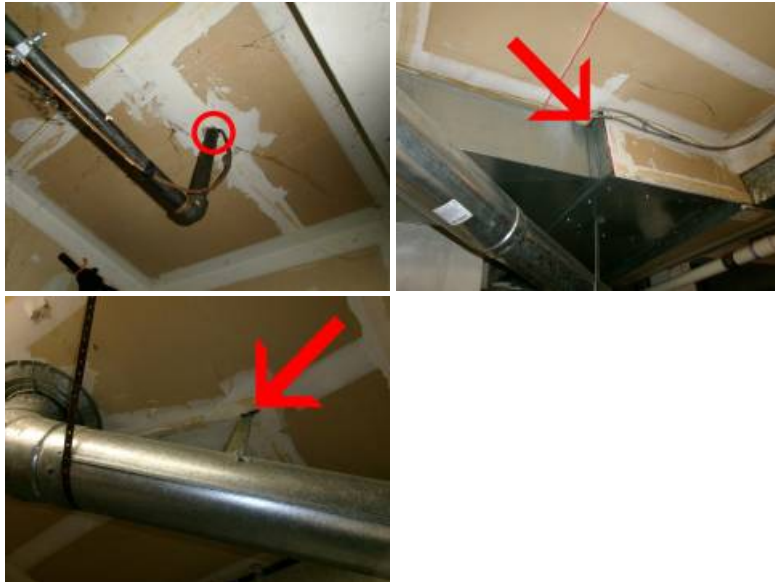
FIRE SEPARATION

There are voids in the fire resistive barrier between the living space and garage that will allow flames to penetrate. The gypsum barrier slows the spread of a fire from the garage to the structure and/or living space. Patching the voids with a fire retardant caulk is recommended.

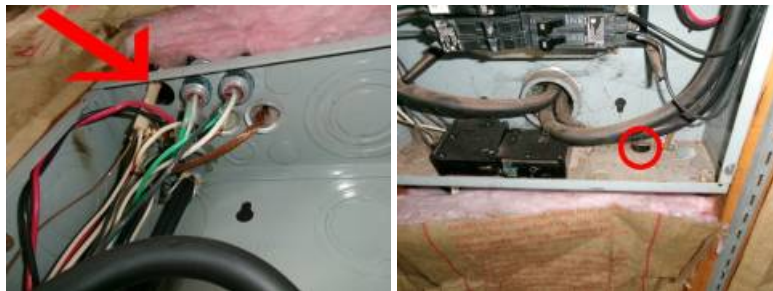
There is an electrical cable emanating from the service panel that is not clamped. The sharp edge of the panel box could cut through the wire insulation and cause a short circuit or fire. Clamping the cable to the panel box using an approved cable clamp is recommended.

There are openings in the panel box where knock-outs have been removed. Missing knock-outs should be replaced with snap in metal plugs.

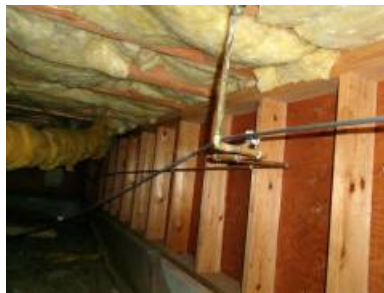
There are water pipes in the crawlspace that are not adequately insulated and could freeze. The installation of foam pipe insulation on all exposed water pipes is recommended.

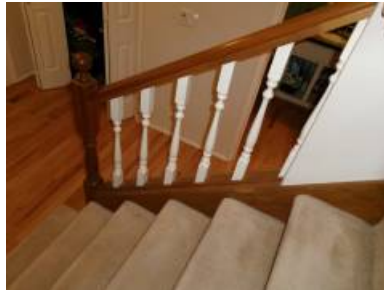
The stair railing baluster spacing is too wide. This is a hazard for small children. The baluster spacing should be reduced as a safety upgrade. Current standards require that a 4-3/8" sphere not pass through the railing.

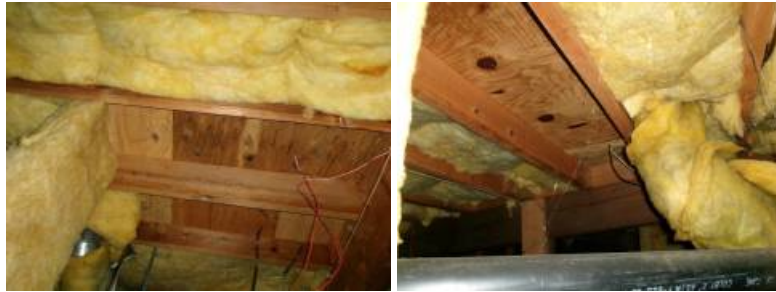
Some of the insulation batts are missing and several were not properly secured and have falling down. The fallen batts should be reinstalled and secured. The missing batts should be replaced.

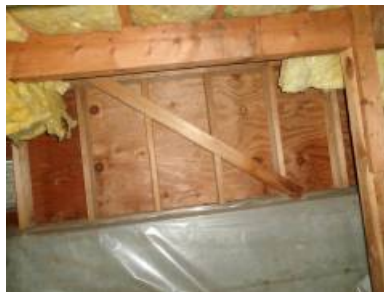
SHEAR PANELS

Shear panels are plywood or OSB panels that are mechanically fastened to both vertical and horizontal framing members in critical structural areas of the building. They prevent lateral movement of the structure during an earthquake. Shear panels are often visible in the crawlspace on cripple walls between the first floor and foundation. They may also be installed on interior walls that are covered with drywall. An examination of the crawlspace revealed the absence of shear panels on the cripple walls. The installation of shear panels on the cripple walls is recommended as an upgrade.

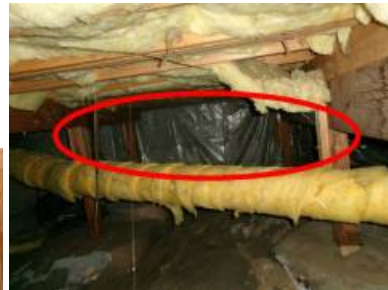
Some of the soil under the house is not covered with a polyethylene plastic vapor retarder. This component is typically referred to as a "vapor barrier". While not a true vapor barrier, it does reduce the transmission of water vapor from the soil to the air. The vapor retarder should be maintained so that it covers at least 85% of the entire surface of the soil.

Some of the foundation walls are covered with the plastic vapor retarder. This allows the transmission of water vapor from the soil up and into the exterior wall framing. The plastic vapor retarder should be removed from the foundation so that it covers at least 85% of the entire surface of the soil only.

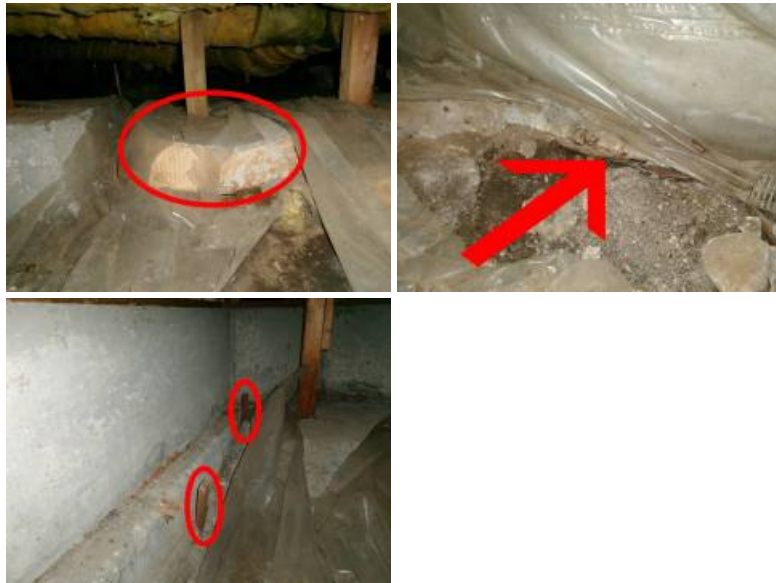
There should be no soil to wood contact in any part of the building exterior or crawlspace, unless that wood is pressure treated. For the greatest safety to permanent structures there should be no soil to wood contact of any kind. Untreated wood in direct contact with exterior flatwork should also be avoided.

Good building practice requires that foundation walls or pier footings supporting wood frame construction, should extend at least 8" above the finish grade with at least a 6" clearance between the top of the soil and the bottom of the wood finish materials. Untreated wood should be raised 1-2" above surrounding flatwork and should have a moisture barrier such as 30 lb. asphalt impregnated felt installed between the concrete and wood. For additional information and treatment options, you should retain the services of a qualified pest control operator.
