NOTICE TO BUYER: SELLER-PROCURED INSPECTION REPORT

**Ronald Roberts
Sheila Lempka
17503 NE 137th Street
Redmond, WA 98052**

At your request, a visual inspection of the above referenced property was conducted on 01/30/2025. We have inspected the major structural components, plumbing, heating and electrical systems for signs of significant non-performance, excessive or unusual wear and general state of repair.

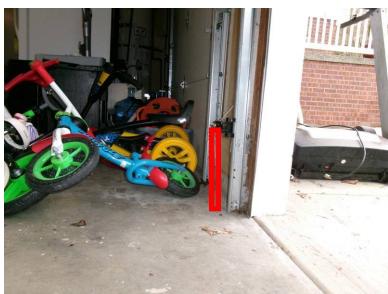
The Photo-eye beam was installed to high above the floor of the garage to adequately offer protection for small children and/or pets. We recommend that the photo-eye be lowered to within 4-6" of the floor.

- Garage Door Photo Eye: Adjusted to as close to 6" as possible. Concrete curb is in the way of going lower.
- Fire Separation: Fire retardant foam used to fill penetrations through the ceiling sheetrock at the garage door supports.

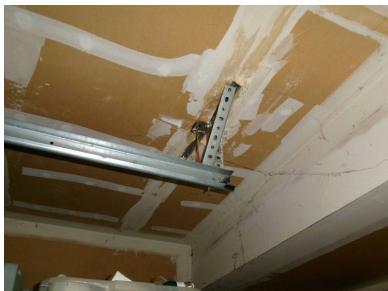
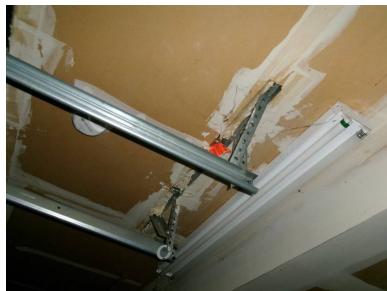
FIRE SEPARATION

There are voids (adjacent the overhead door brackets) in the fire resistive barrier between the living space and garage that will allow flames to penetrate. The gypsum barrier slows the spread of a fire from the garage to the structure and/or living space. Patching the voids with a fire retardant caulk is recommended.

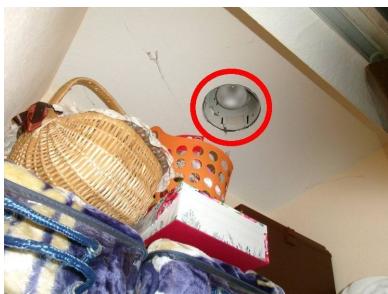
LUMINARIES

The luminaries in the closet is a fire hazard. They should be replaced with luminaries identified for use within the closet storage space. Such as surface or recessed incandescent or LED luminaries with an enclosed light source. Surface or recessed fluorescent luminaries are also permitted.

- Luminary in Den Closet: LED light with enclosure has been installed in can light.
- Water heater Expansion Tank: Expansion tank strapped to water heater so they both move the same during an earthquake.

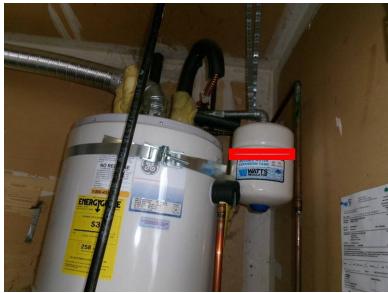
**WATER HEATER****EXPANSION TANK**

The expansion tank is not adequately secured to the wall. As code requirements start to call for engineered expansion tank supports we recommend the installation of seismic restraints to secure the expansion tank instead of allowing it to simply depend on piping connections that could result in damage to the water pipe and leakage during an earthquake.

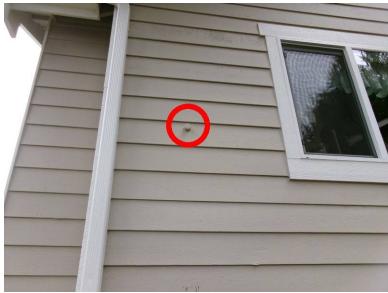
KITCHEN**AIR GAP**

An air gap called a Johnson Tee is installed in the kitchen wall. This air gap protects the dishwasher from contamination caused by a backflow of waste water. The cap protruding on the exterior wall opposite the dishwasher is not drilled. This renders the air gap non-functional. Drilling a 1/4" hole in the end of the cap will restore its function. The remaining visible portions of the Johnson Tee were properly installed and functioning as intended.

- Air gap for dishwasher: A ¼" diameter hole was drilled in the Johnson tee.
- Range tip out protection: No changes made
- Laundry room shower: shower enclosure re-caulked

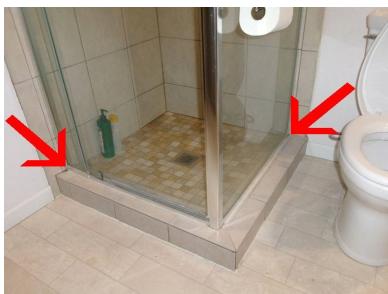
GLASS ENCLOSURE

The glass enclosure has been leaking at the lower corners. No damage was visible, but resealing or repairing the enclosure is recommended as preventive maintenance.

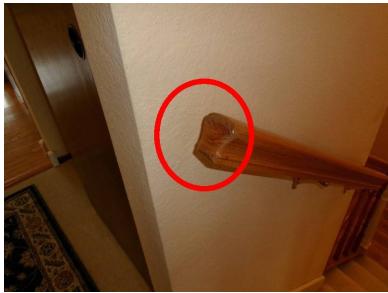
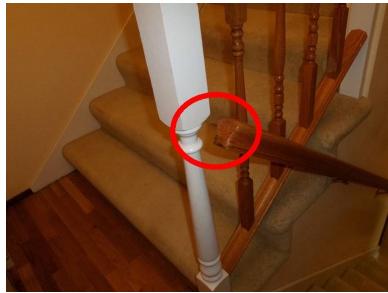
STAIRS

The railing ends in the stairwell does not return to the wall. This is a safety hazard. The installation of a continuous handrail should be considered as a safety upgrade.

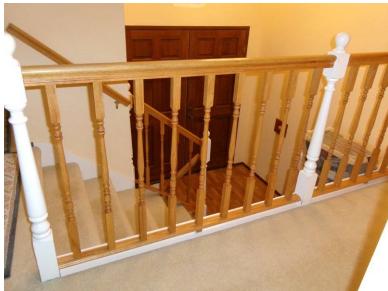
GUARD RAILINGS

The spacing between the balusters is too wide. This is a hazard to small children. The balusters should be spaced close enough together so that a 4" sphere cannot pass through. Upgrading the guard railing is recommended if small children are present.

- Guard rail spindle spacing. No changes made.
- Cracks in patio. No changes made. Patio and driveway pressure washed to remove moss.
- Soffits and Overhangs: Gaps adjacent to soffit vent blocks and skip sheathing boards were sealed by Critter Control. A copy of the repair description and attic sanitizing is available.

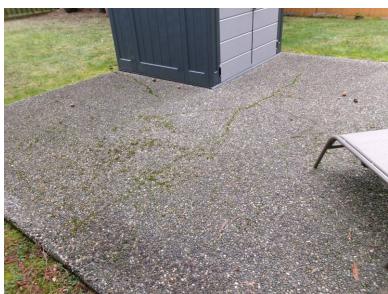
PATIO

Cracks were observed in the concrete surface of the patio. Minor cracks can be sealed to minimize moisture entry and further settlement of the concrete.

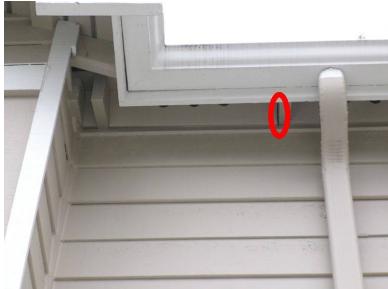
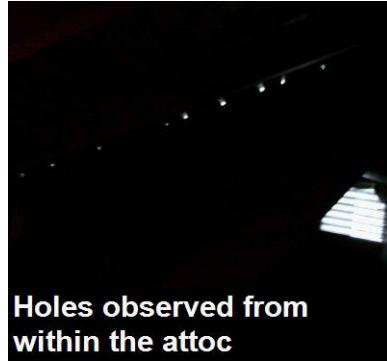
SOFFITS AND OVERHANGS

There are large gaps over 1/4" in size adjacent the soffit vent blocks. These gaps allow insects and rodents to enter the attic. Covering the gaps with screening, a strip of wood and/or caulking is recommended.

There are openings between the ends of the skip sheathing boards under the overhang through which birds and rodents can enter into the attic. These openings should be covered with wood, wire mesh or filled with aerosol foam.

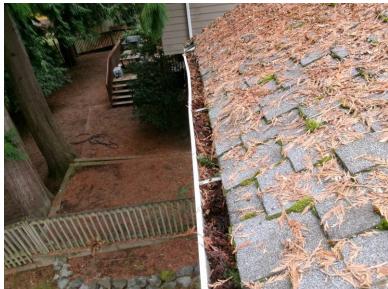
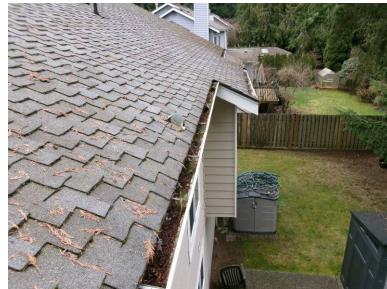
GUTTERS AND DOWNSPOUTS

There is a build-up of organic debris inside the gutters. Proper maintenance of gutters and downspouts is essential and should be performed routinely in order to prevent clogging. Maintenance consists primarily of keeping leaves and other organic debris out of the system. Failure to clean the gutters will result in water splash on the building when they overflow. Gutters can be damaged under the weight of the water and organic matter inside the gutter. Gutters should be cleaned as necessary to maintain a free flow of water into the downspouts.

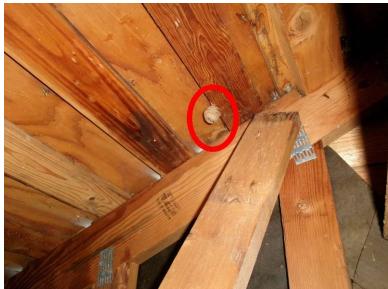
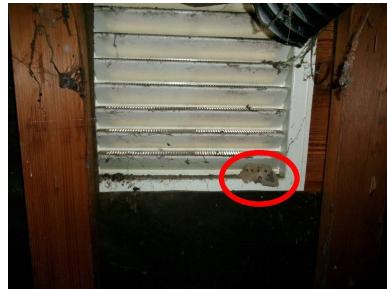
PEST CONTROL

There are yellow jacket (mud and paper wasp) nests in the attic. Yellow jackets are very aggressive in late summer and their sting is painful. Yellow jacket activity can be avoided by sealing all openings into the attic, particularly above the gable end walls and below vent blocks.

- Attic: yellow jacket nest: removed by Critter Control during gap sealing and sanitizing.
- Primary Bedroom Sink: Drain repaired
- Primary Bedroom Shower: Shower head reinstalled

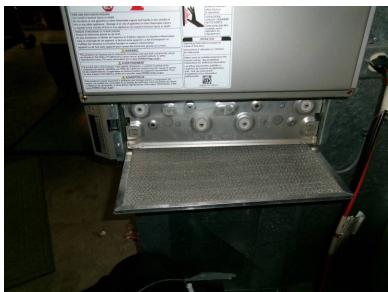
FORCED AIR HEATING SYSTEM AIR FILTER

Testing revealed that the electronic air filter is functional. However, the filters are dirty. Removal and cleaning the prefilters and filter cartridges is recommended.

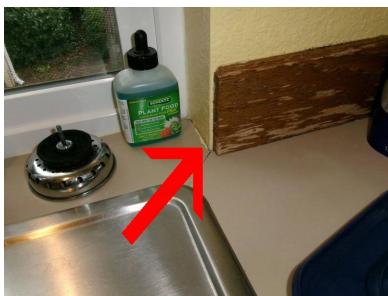
COUNTERTOPS

The backsplash is not caulked. This allows water and food to enter the gap between the back splash and counter and is difficult to clean. Caulking should be installed at this location.

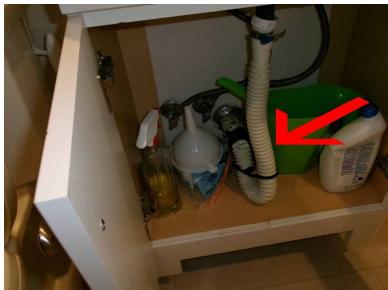
DRAINS, TRAPS AND TRAP ARMS

Improper, non-conforming material has been used for the drain pipe fitting. This material will not function reliably. Replacement with industry standard fittings is recommended.

- Upper hallway sink: Drain repaired
- Laundry Room Sink: Drainpipe fitting has been replaced.

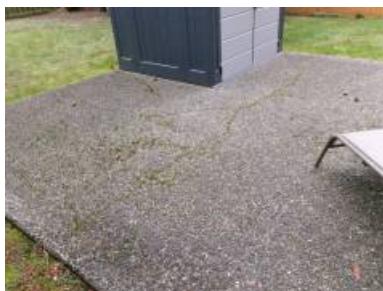
PATIO

Cracks were observed in the concrete surface of the patio. Minor cracks can be sealed to minimize moisture entry and further settlement of the concrete.

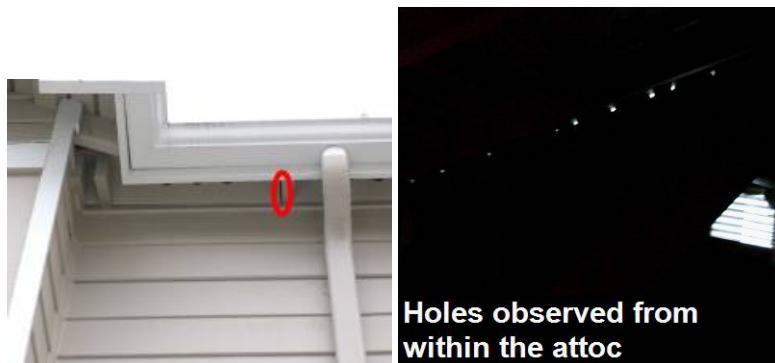
There are large gaps over 1/4" in size adjacent the soffit vent blocks. These gaps allow insects and rodents to enter the attic. Covering the gaps with screening, a strip of wood and/or caulking is recommended.

There are openings between the ends of the skip sheathing boards under the overhang through which birds and rodents can enter into the attic. These openings should be covered with wood, wire mesh or filled with aerosol foam.

Holes observed from within the attoc

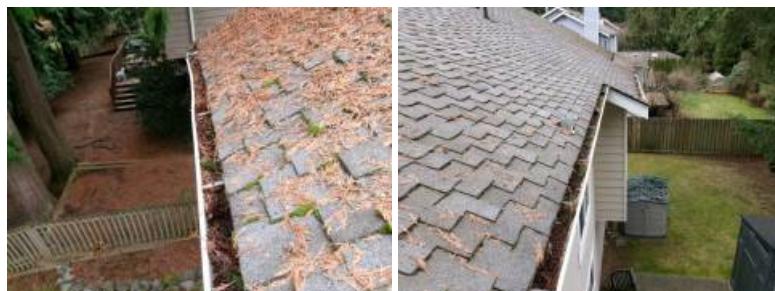
GUTTERS AND DOWNSPOUTS

There is a build-up of organic debris inside the gutters. Proper maintenance of gutters and downspouts is essential and should be performed routinely in order to prevent clogging. Maintenance consists primarily of keeping leaves and other organic debris out of the system. Failure to clean the gutters will result in water splash on the building when they overflow. Gutters can be damaged under the weight of the water and organic matter inside the gutter. Gutters should be cleaned as necessary to maintain a free flow of water into the downspouts.

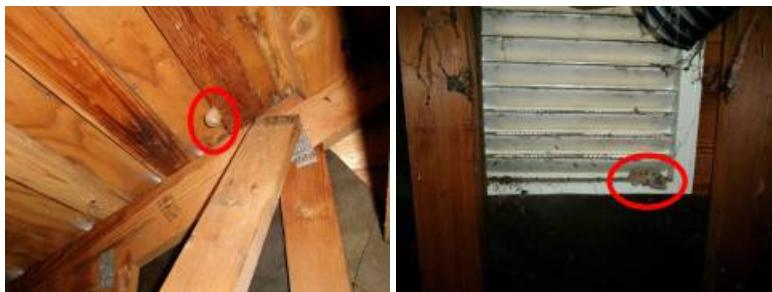
There are yellow jacket (mud and paper wasp) nests in the attic. Yellow jackets are very aggressive in late summer and their sting is painful. Yellow jacket activity can be avoided by sealing all openings into the attic, particularly above the gable end walls and below vent blocks.

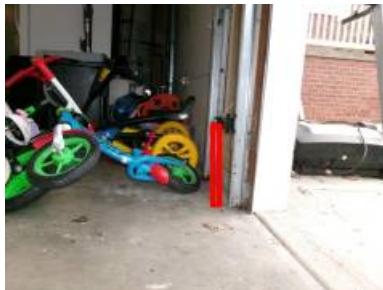
The Photo-eye beam was installed to high above the floor of the garage to adequately offer protection for small children and/or pets. We recommend that the photo-eye be lowered to within 4-6" of the floor.

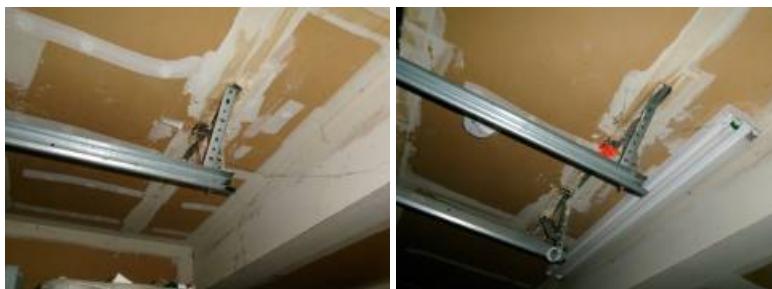
FIRE SEPARATION

There are voids (adjacent the overhead door brackets) in the fire resistive barrier between the living space and garage that will allow flames to penetrate. The gypsum barrier slows the spread of a fire from the garage to the structure and/or living space. Patching the voids with a fire retardant caulk is recommended.

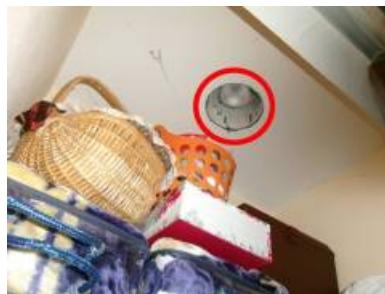
The luminaries in the closet is a fire hazard. They should be replaced with luminaries identified for use within the closet storage space. Such as surface or recessed incandescent or LED luminaries with an enclosed light source. Surface or recessed fluorescent luminaries are also permitted.

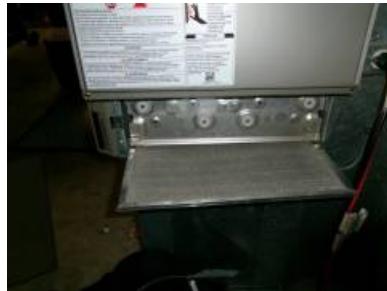
Testing revealed that the electronic air filter is functional. However, the filters are dirty. Removal and cleaning the prefilters and filter cartridges is recommended.

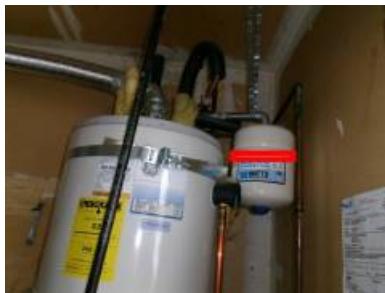
The expansion tank is not adequately secured to the wall. As code requirements start to call for engineered expansion tank supports we recommend the installation of seismic restraints to secure the expansion tank instead of allowing it to simply depend on piping connections that could result in damage to the water pipe and leakage during an earthquake.

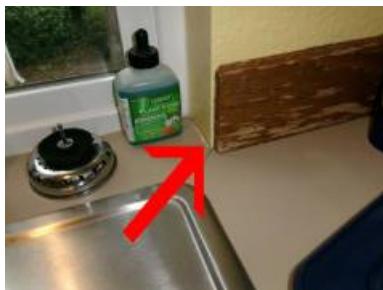
The backsplash is not caulked. This allows water and food to enter the gap between the back splash and counter and is difficult to clean. Caulking should be installed at this location.

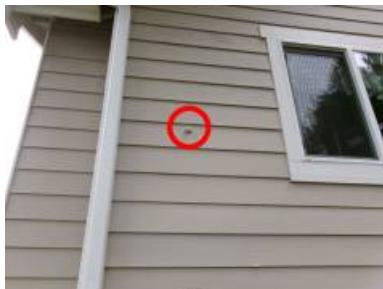
An air gap called a Johnson Tee is installed in the kitchen wall. This air gap protects the dishwasher from contamination caused by a backflow of waste water. The cap protruding on the exterior wall opposite the dishwasher is not drilled. This renders the air gap non-functional. Drilling a 1/4" hole in the end of the cap will restore its function. The remaining visible portions of the Johnson Tee were properly installed and functioning as intended.

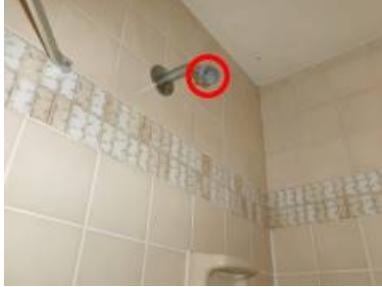
The drain stop is not operational. It should be repaired or replaced.
<i>DRAINS, TRAPS AND TRAP ARMS</i>	The sink drain is properly installed and is performing its intended function.
<i>FAUCET FIXTURES</i>	The sink faucet fixture was tested and was functioning as intended.
	The shower head is missing. We recommend the installation of a shower head for water flow adjustment.
	The shower faucet fixture's function was not verified.

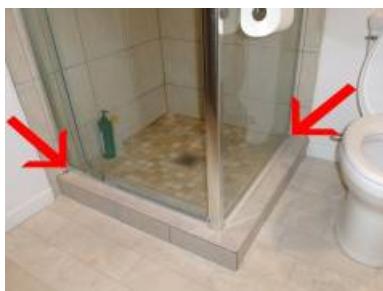
LOCATION	Laundry Room.
SHOWER	The shower walls are properly installed and are in good condition. Most ceramic tile is applied directly over gypsum board rather than on a concrete board such as "Durock" or "Wonder Board". Where the tile is applied directly over the gypsum board, it is critical that the tile grout be maintained to prevent water intrusion behind the tile. Missing or cracked grout should be repaired. Inside corners, and penetrations in the tile should be kept sealed with a high quality caulk.
GLASS ENCLOSURE	The glass enclosure has been leaking at the lower corners. No damage was visible, but resealing or repairing the enclosure is recommended as preventive maintenance.

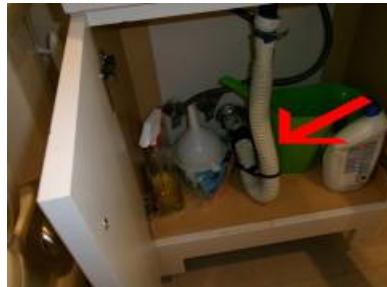
DRAINS, TRAPS AND TRAP ARMS Improper, non-conforming material has been used for the drain pipe fitting. This material will not function reliably. Replacement with industry standard fittings is recommended.

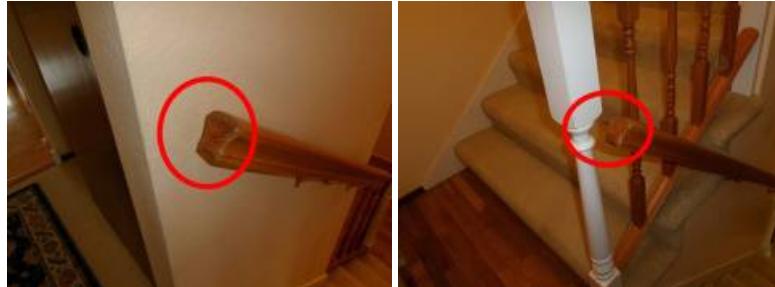
The railing ends in the stairwell does not return to the wall. This is a safety hazard. The installation of a continuous handrail should be considered as a safety upgrade.

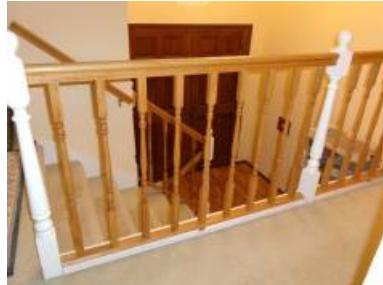
GUARD RAILINGS

The spacing between the balusters is too wide. This is a hazard to small children. The balusters should be spaced close enough together so that a 4" sphere cannot pass through. Upgrading the guard railing is recommended if small children are present.
