NOTICE TO BUYER: SELLER-PROCURED INSPECTION REPORT

Jonathan and Melanie Liperi
7432 245th Way NE
Redmond, WA 98053

February 11, 2025

DATE OF INSPECTION: 2/10/2025.
 INSPECTOR'S NAME: Terry Clark.
 CLIENT NAME: Mr. Jon & Melanie Liperi.
 MAILING ADDRESS: 7432 245th Way NE
 Redmond WA.
 CLIENT E-MAIL ADDRESS jliperi@outlook.com; mliperi@outlook.com.
 ADDRESS OF PROPERTY 7432 245th Way NE
 INSPECTED Redmond, WA.

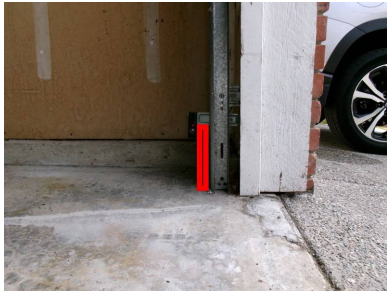
The Photo-eye beam was installed too high above the floor of the garage to adequately offer protection for small children and/or pets. We recommend that the photo-eye be lowered to within 4-6" of the floor.

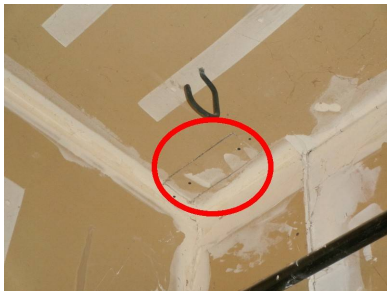
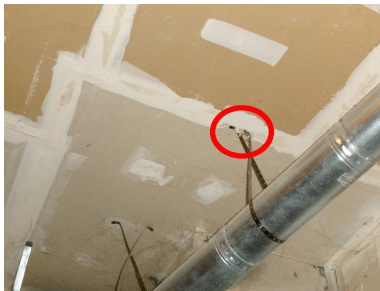
There are voids adjacent the vent support strap brackets in the fire resistive barrier between the living space and garage that will allow flames to penetrate. The gypsum barrier slows the spread of a fire from the garage to the structure and/or living space. Patching the voids with a fire retardant caulk is recommended.

- Garage: fire separation – fixed; patched hole in wall by water heater and applied fire foam/caulk where needed
- Garage: receptacles – fixed; replaced receptacles in garage with gcfi where applicable

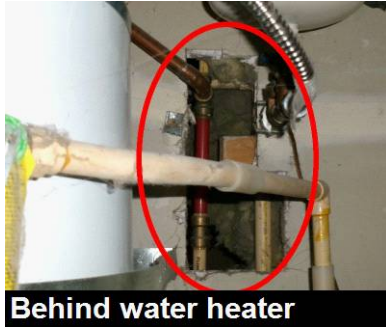
The exposed wood is a breach in the fire resistive barrier in the garage. Patching the void with 5/8" gypsum type X board over the exposed wood is recommended.

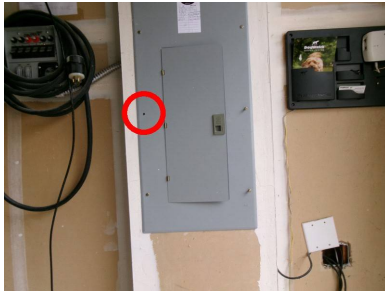
Screws that secure the panel cover to the panel box are missing. This is a potential hazard. Missing screws should be replaced with the original style blunt end screws.

- Garage: service panel – fixed; replaced screws on electrical panel
- Garage: air filter – fixed; replaced filter
- Garage: hot water heater expansion tank – fixed; Installed strap for expansion tank

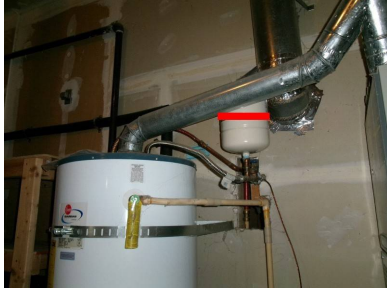
The expansion tank is not adequately secured to the wall. As code requirements start to call for engineered expansion tank supports we recommend the installation of seismic restraints to secure the expansion tank instead of allowing it to simply depend on piping connections that could result in damage to the water pipe and leakage during an earthquake.

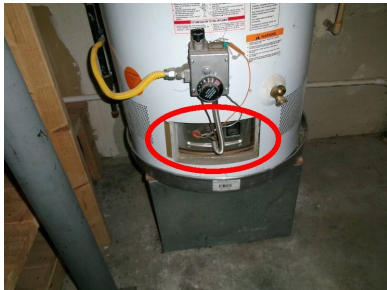
The flame guard is missing from in front of the burner. This is a fire hazard. The installation of a flame guard is recommended.

- Garage: hot water heater burner – fixed; replaced flame guard
- Kitchen: garbage disposal – fixed; repaired garbage disposal
- Bathrooms: angle stops, leak – fixed; Repaired leak from faucet handle

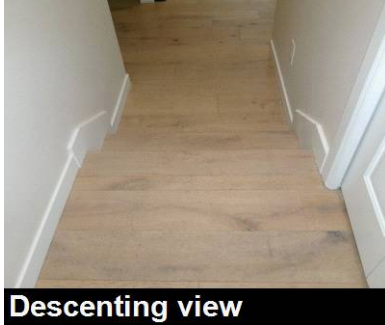
Descending view

There is no contrast to the steps in the hallway. To increase the margin of safety, consideration should be given to highlighting the stairs with a contrasting marking stripe on each tread at the nosing or leading edge such that the location of each tread is readily apparent when viewed in descent.

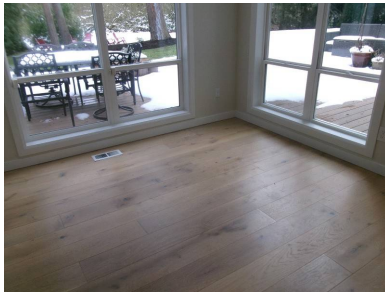
The lower window glass is not labeled as tempered safety glass. The existing glass is nonconforming by current building standards and would be hazardous if broken. The installation of safety glass is recommended as a safety upgrade for all windows less than 18" from the walking surface.

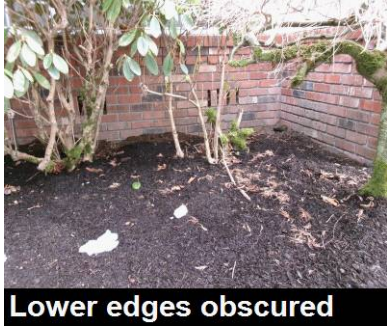
The brick is a veneer installed over the wood wall structure. It is not a structural component of the wall. Weep holes are missing at the bottom of the masonry wall. This allows moisture to become trapped behind the brick. Weep holes are recommended to mitigate moisture damage.

Lower edges obscured

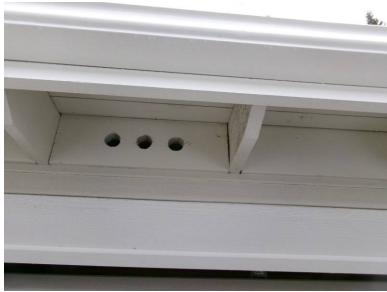
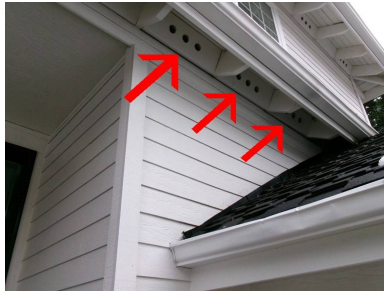
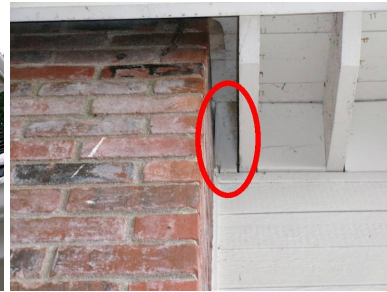
There are large gaps over 1/4" in size adjacent the soffit vent blocks. These gaps allow insects and rodents to enter the attic. Covering the gaps with screening, a strip of wood and/or caulking is recommended.

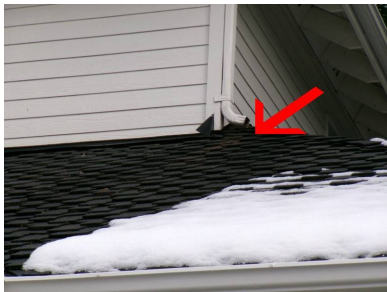
Downspouts draining directly onto the asphalt shingle surface causes excessive wear of the roofing material. Downspout extensions to the lower gutters should be installed to prevent excessive wear and tear of the roofing.

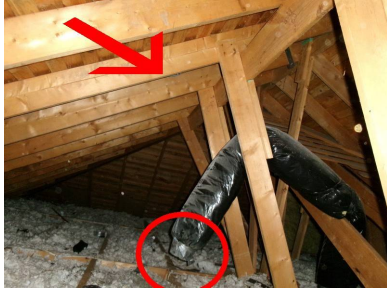
The duct for the hallway fan has become detached in the attic. The duct should be reconnected and secured.

- Septic system – no issues identified; system inspected and pumped 2/27/2025
- Roof: chimneys – fixed; removed all moss from chimney areas
- Attic: ventilation systems – fixed; Secured vent duct to roof jack

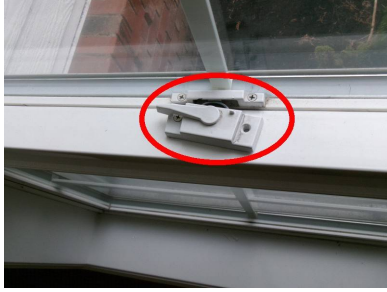
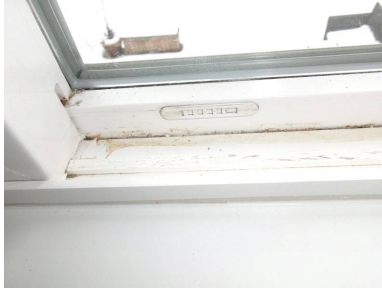
The latch/locking mechanism for one of the east facing bedroom windows does not secure the window closed.

We recommend repairs as necessary to restore the windows proper operation.

- Interior: windows latching mechanism – fixed; repaired window locking mechanism
- Insulation: floor insulation – fixed; secured floor insulation in garage attic

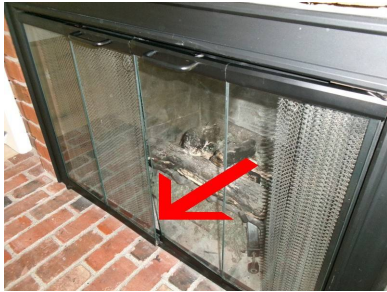
The glass doors are ill-fitting and are difficult to open and close. The glass doors should be repaired or replaced as necessary.

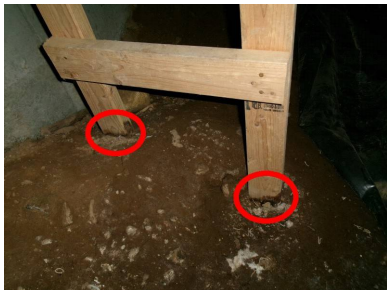
Soil is in contact with the bottom of the wood access ladder in the crawl space. Replacing the wooden legs with ground contact lumber is recommended.

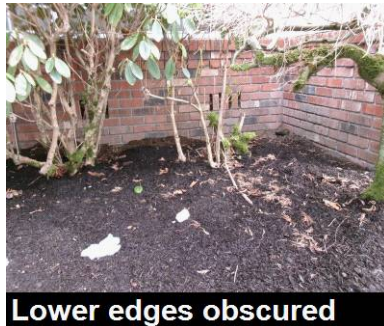
The brick is a veneer installed over the wood wall structure. It is not a structural component of the wall. Weep holes are missing at the bottom of the masonry wall. This allows moisture to become trapped behind the brick. Weep holes are recommended to mitigate moisture damage.

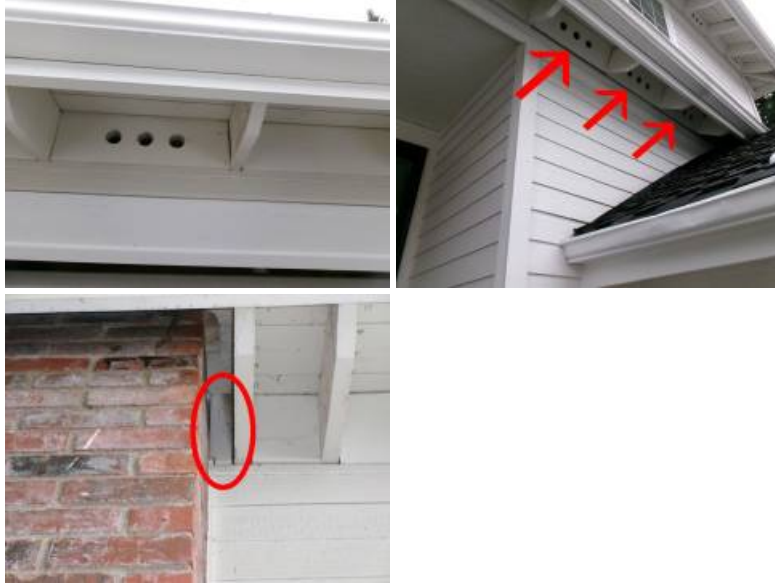
There are large gaps over 1/4" in size adjacent the soffit vent blocks. These gaps allow insects and rodents to enter the attic. Covering the gaps with screening, a strip of wood and/or caulking is recommended.

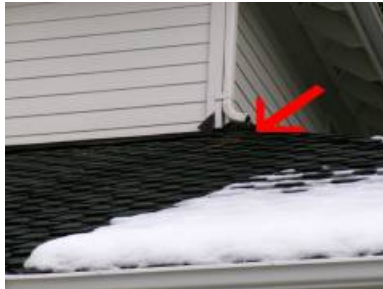
Downspouts draining directly onto the asphalt shingle surface causes excessive wear of the roofing material. Downspout extensions to the lower gutters should be installed to prevent excessive wear and tear of the roofing.

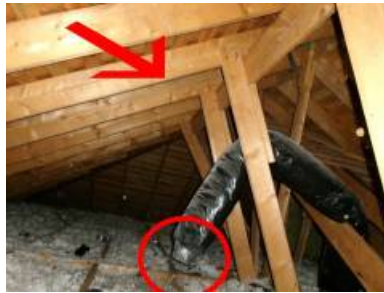
The duct for the hallway fan has become detached in the attic. The duct should be reconnected and secured.

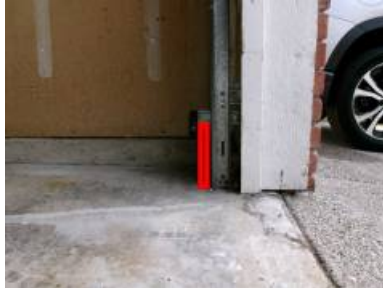
The Photo-eye beam was installed too high above the floor of the garage to adequately offer protection for small children and/or pets. We recommend that the photo-eye be lowered to within 4-6" of the floor.

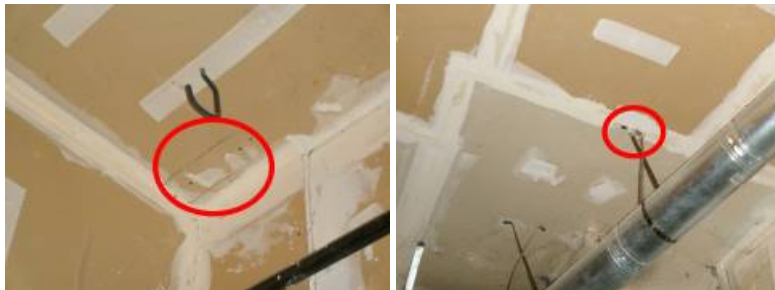
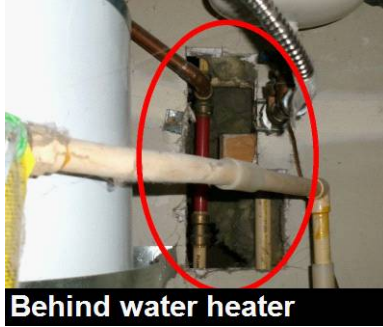
The exposed wood is a breach in the fire resistive barrier in the garage. Patching the void with 5/8" gypsum type X board over the exposed wood is recommended.

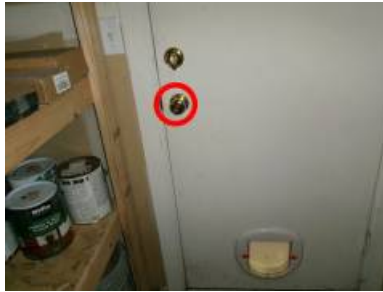
The turnkey for the doorknob lock is stuck. Door hardware should be repaired or replaced as necessary to restore full function.

- Garage: exterior doors – fixed; Replaced doorknobs/deadbolts to both garage doors
- Kitchen: countertops – fixed; Removed and applied grey siliconized grout on counter

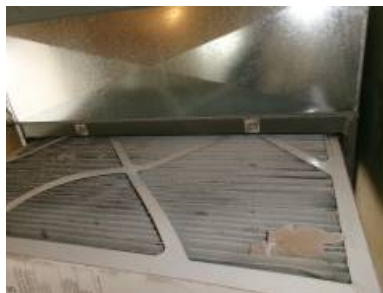
The air filter is clogged with dust. This reduces air flow and furnace efficiency. Removal and replacement of the air filter is recommended. Pleated style air filters are recommended as they offer better filtration of dust than the coarser hogs hair or fiberglass filters.

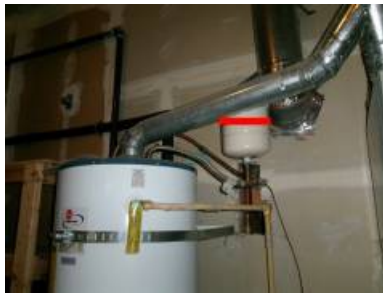
The expansion tank is not adequately secured to the wall. As code requirements start to call for engineered expansion tank supports we recommend the installation of seismic restraints to secure the expansion tank instead of allowing it to simply depend on piping connections that could result in damage to the water pipe and leakage during an earthquake.

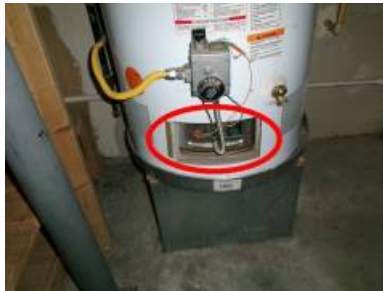
The flame guard is missing from in front of the burner. This is a fire hazard. The installation of a flame guard is recommended.

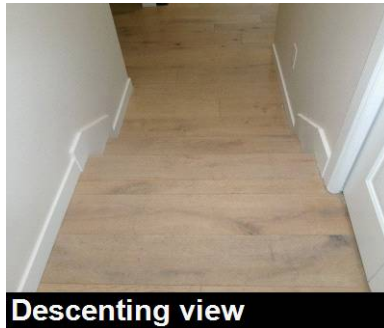
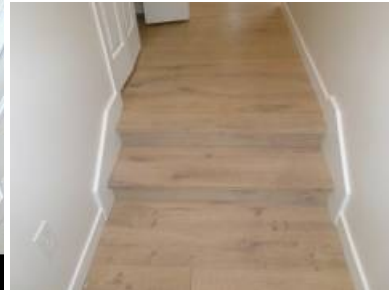
Descending view

There is no contrast to the steps in the hallway. To increase the margin of safety, consideration should be given to highlighting the stairs with a contrasting marking stripe on each tread at the nosing or leading edge such that the location of each tread is readily apparent when viewed in descent.

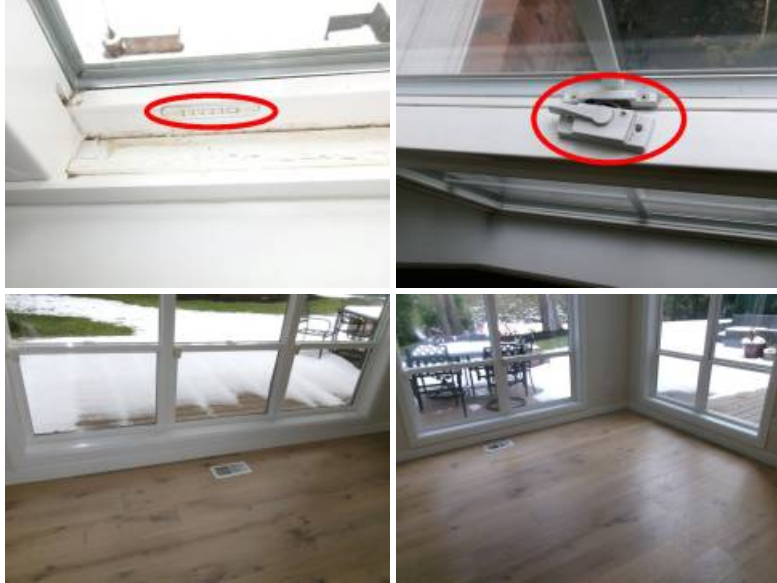
The lower window glass is not labeled as tempered safety glass. The existing glass is nonconforming by current building standards and would be hazardous if broken. The installation of safety glass is recommended as a safety upgrade for all windows less than 18" from the walking surface.

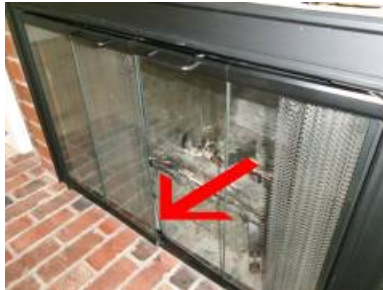
The glass doors are ill-fitting and are difficult to open and close. The glass doors should be repaired or replaced as necessary.

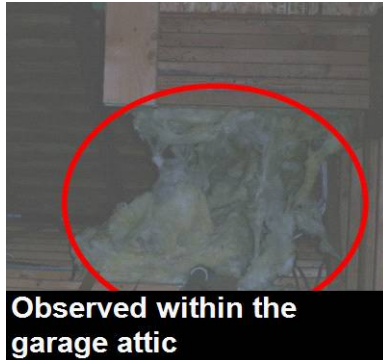
Some of the insulation batts above the garage have falling down. Insulation should be reinstalled and secured. The damaged insulation should be replaced.

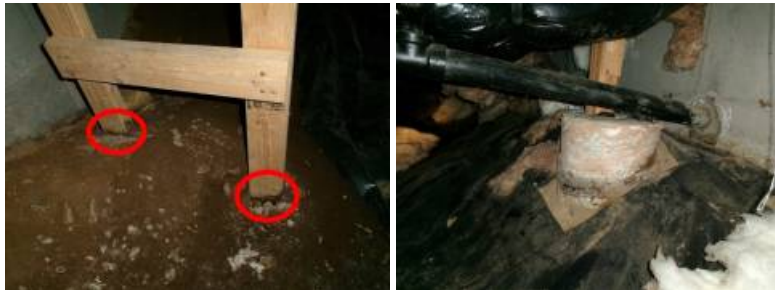
Cellulose forms were left in place on the pier footings. This cellulose is conducive to the infestation of various wood destroying organisms. The removal of the cellulose is recommended.
