NOTICE TO BUYER: SELLER-PROCURED INSPECTION REPORT

**Re: 13706 176th Ave. NE
Redmond, WA.**

At your request, a visual inspection of the above referenced property was conducted on 03/08/2025. We have inspected the major structural components, plumbing, heating and electrical systems for signs of significant non-performance, excessive or unusual wear and general state of repair.

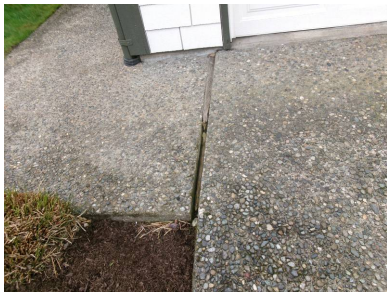
The wooden dividers separating the concrete walkway sections have deteriorated to a point where the gaps are a trip hazard. Replacement with mortar is recommended.

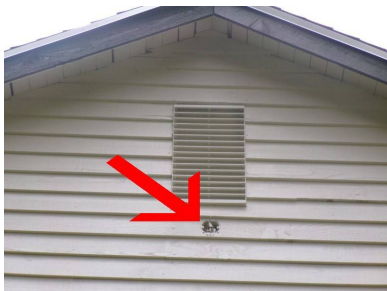
The cover plate is missing from the exterior junction box at the east side of the house. This is a shock and fire hazard. The installation of a weather tight cover plate is recommended.

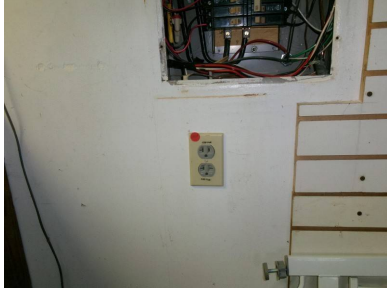
There is a dead receptacle in the garage. Repairs should be made as necessary.

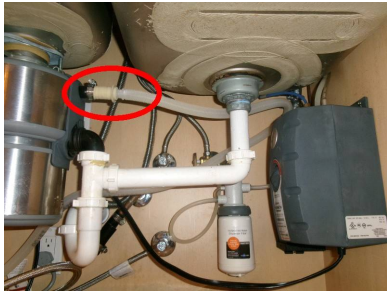
AIR GAP

The dishwasher drain lacks an air gap. The dishwasher will function without one, but there is a risk of contamination of the inside of the dishwasher by waste water. The installation of an air gap above the flood rim of the sink is recommended or connecting to the existing Johnson Tee that is installed in the exterior kitchen wall. This (air gap) or Johnson Tee protects the dishwasher from contamination caused by a backflow of waste water.

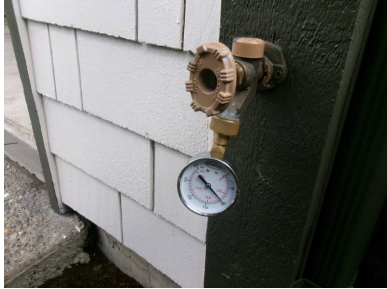
WATER PRESSURE

The water pressure at 100 PSI is excessive. The normal range is 30-80 PSI. High water pressure can result in leaking valves, detached supply tubes, water hammer and is hard on solenoid valves. The installation of a pressure reduction valve is recommended.

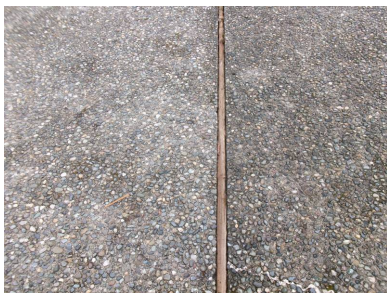
One or more of the wooden dividers separating the concrete driveway sections were infested by wood destroying organisms and have deteriorated to a point where they are becoming a trip hazard. Replacement with mortar is recommended.

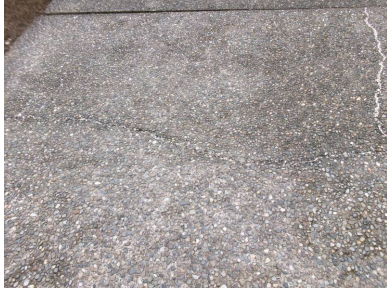
Cracks were observed in the concrete surface of the driveway. Minor cracks can be sealed to minimize moisture entry and further settlement of the concrete. Minor cracks are common and do not affect the serviceability of the concrete.

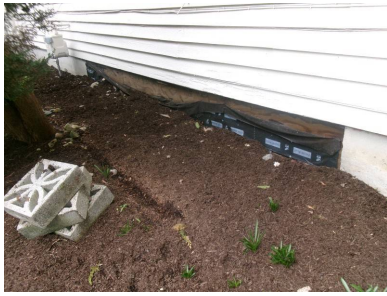
Soil is close to or in contact with siding in some areas around the building exterior. Good building practice requires that foundation walls or pier footings supporting wood frame construction, extend at least 8" above the finish grade with at least a 6" clearance between the top of the soil and the bottom of the wood finish materials. Soil in direct contact with wood creates a hospitable environment for wood destroying organisms. Establishing these minimum clearances is recommended.

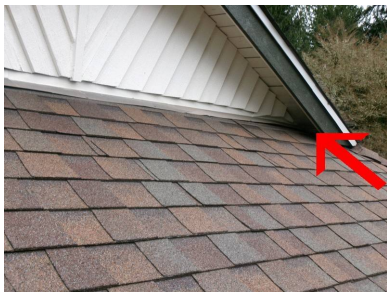
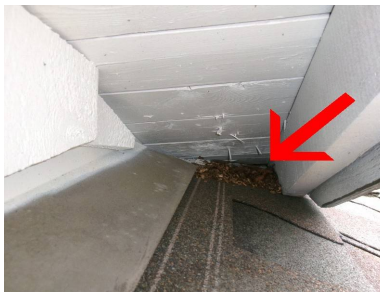
There are openings at the intersection between the overhang and the roof through which birds and rodents can enter into the attic. These openings should be covered with wood, wire mesh or filled with aerosol foam.

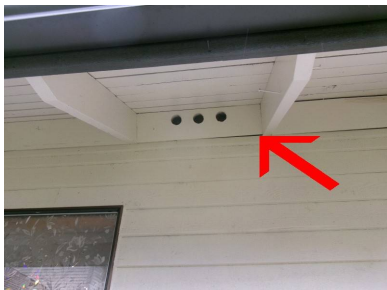
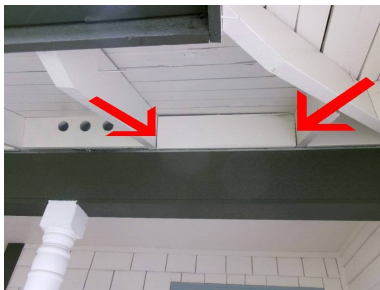
There are large gaps over 1/4" in size adjacent the soffit vent blocks. These gaps allow insects and rodents to enter the attic. Covering the gaps with screening, a strip of wood and/or caulking is recommended.

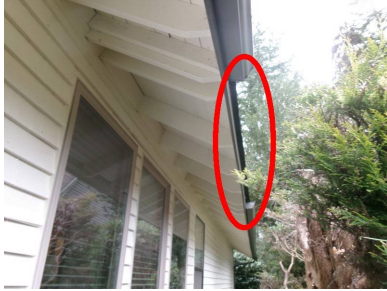
A large section of the gutters are missing on the south side of the building. Missing gutters should be replaced to prevent water splash on the siding.

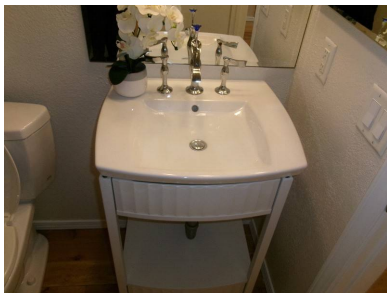
The cabinet and sink top are not securely fastened to the wall. Proper attachment of the cabinet to the wall is recommended.

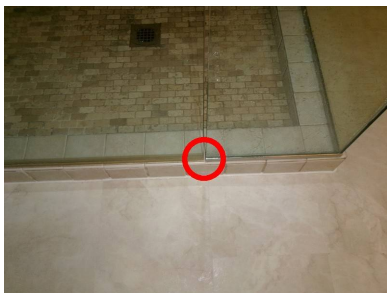
The splash strip is too short at the bottom of the shower door. This allows leakage of water onto the floor. Replacement of the splash strip is recommended.

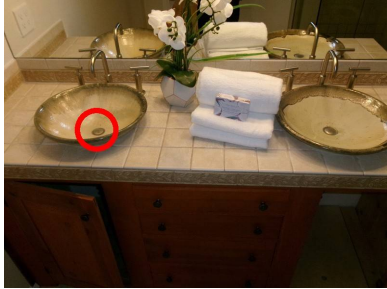
The left sink drain stop is not operational. It should be repaired or replaced.

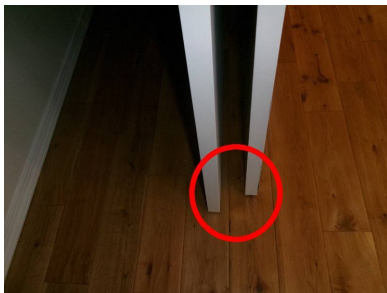
The floor guides are missing from the bypass closet doors in one of the bedrooms. Missing floor guides could result in damage to the doors. The installation of floor guides is recommended.

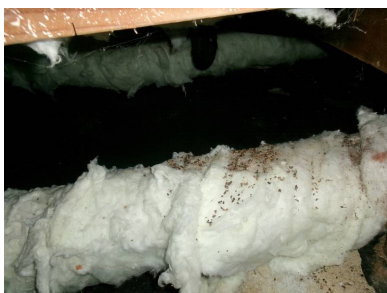
There is evidence of rodent activity in the crawlspace. The first step in eliminating rodents from the crawlspace is to seal all possible entry points using wire mesh, caulking, wood, stainless steel wool, aerosol foam or mortar. Careful work sealing cracks, holes, gaps, and covering ground water drain inlets will discourage rodent activity. Once this work is completed, snap traps baited with peanut butter should be installed and monitored. The absence of rodents in the traps typically means that the rodents have been excluded from the area.

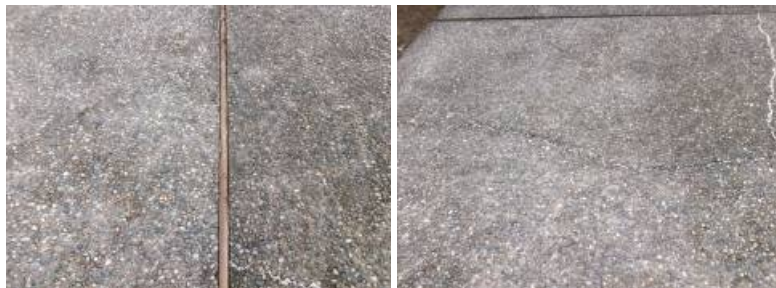
One or more of the wooden dividers separating the concrete driveway sections were infested by wood destroying organisms and have deteriorated to a point where they are becoming a trip hazard. Replacement with mortar is recommended.

Cracks were observed in the concrete surface of the driveway. Minor cracks can be sealed to minimize moisture entry and further settlement of the concrete. Minor cracks are common and do not affect the serviceability of the concrete.

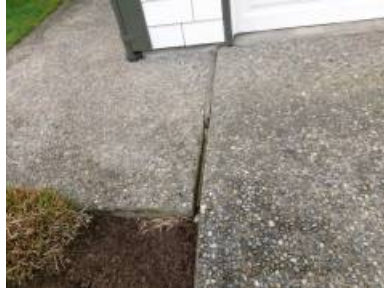
The walkway has cracked and settled differentially. The walkway remains functional despite this condition. However, the raised edges of the concrete can be a trip hazard for some people. Grinding down the raised edges of the concrete will mitigate the hazard. Repairs should be made as necessary.

The wooden dividers separating the concrete walkway sections have deteriorated to a point where the gaps are a trip hazard. Replacement with mortar is recommended.

Many legal and public works departments have defined a trip hazard as an irregularity in a walking surface exceeding one inch (1") in height. All walking surfaces should maintain, free of a vertical surface change of 3/4" or more, in the interest of public and personal safety.

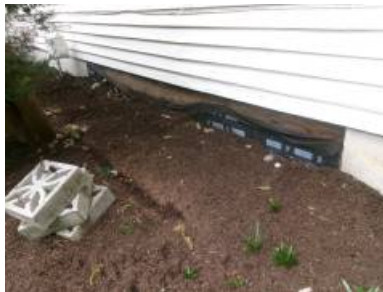
PEST CONTROL Soil is close to or in contact with siding in some areas around the building exterior. Good building practice requires that foundation walls or pier footings supporting wood frame construction, extend at least 8" above the finish grade with at least a 6" clearance between the top of the soil and the bottom of the wood finish materials. Soil in direct contact with wood creates a hospitable environment for wood destroying organisms. Establishing these minimum clearances is recommended.

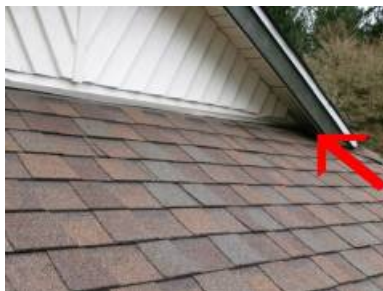
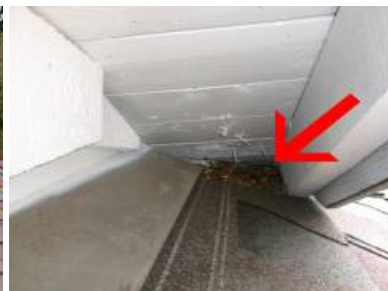
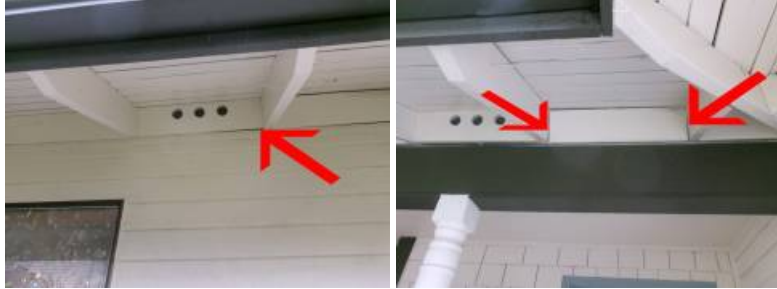
There are openings at the intersection between the overhang and the roof through which birds and rodents can enter into the attic. These openings should be covered with wood, wire mesh or filled with aerosol foam.

There are large gaps over 1/4" in size adjacent the soffit vent blocks. These gaps allow insects and rodents to enter the attic. Covering the gaps with screening, a strip of wood and/or caulking is recommended.

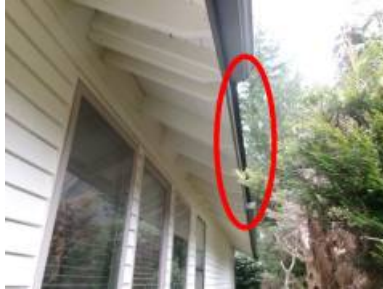
A large section of the gutters are missing on the south side of the building. Missing gutters should be replaced to prevent water splash on the siding.

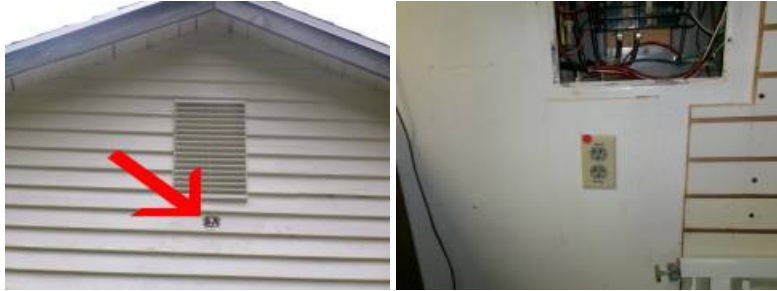
<i>WIRING</i>		There were no defects observed in the visible and accessible wiring.
<i>ALUMINUM WIRING</i>		This house uses stranded aluminum wire for service entrance conductors and for dedicated major appliance circuits. This type of aluminum wire circuitry is typically found in most houses and is considered safe and reliable when installed correctly.
<i>RECEPTACLES</i>		All of the readily accessible receptacles were tested. Testing revealed defects requiring repair. These defects are outlined below.
		The cover plate is missing from the exterior junction box at the east side of the house. This is a shock and fire hazard. The installation of a weather tight cover plate is recommended.
		There is a dead receptacle in the garage. Repairs should be made as necessary.

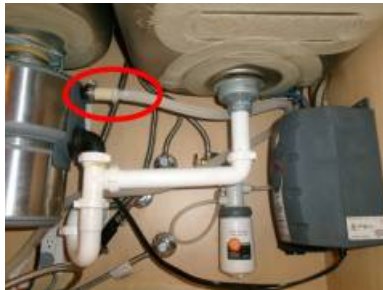
<i>COUNTERTOPS</i>	The countertops are covered with slab granite. The counter tops are properly installed and are in good condition.
<i>CABINETS</i>	The finish on the kitchen cabinets is slightly worn. The cabinets are otherwise in good condition.
<i>FLOORING MATERIAL</i>	The floor is covered with hardwood. The floor is properly installed and is in good condition.
<i>VENTILATION</i>	Ventilation in the kitchen is provided by a range hood over the stove. The vent is ducted to the exterior. The vent fan is properly installed and is performing its intended function.
<i>SINK FAUCET</i>	The sink faucet is properly installed and is in good condition.
<i>SINK</i>	The kitchen sink is properly installed and is in good condition.
<i>DRAINS, TRAPS AND TRAP ARMS</i>	The sink drain is properly installed and is performing its intended function.
<i>AIR GAP</i>	The dishwasher drain lacks an air gap. The dishwasher will function without one, but there is a risk of contamination of the inside of the dishwasher by waste water. The installation of an air gap above the flood rim of the sink is recommended or connecting to the existing Johnson Tee that is installed in the exterior kitchen wall. This (air gap) or Johnson Tee protects the dishwasher from contamination caused by a backflow of waste water.

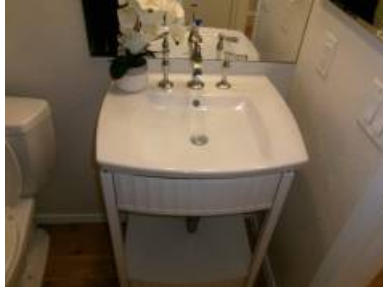
FAUCET FIXTURES	The faucet fixtures were tested and were functioning as intended.
CABINETS	The bathroom cabinet is in good condition.
	The cabinet and sink top are not securely fastened to the wall. Proper attachment of the cabinet to the wall is recommended.

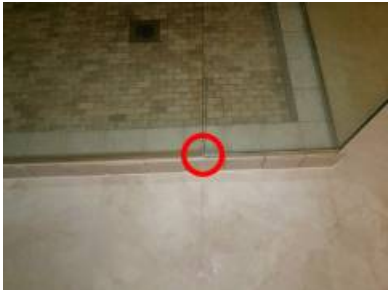
LOCATION	Primary Bedroom.
SHOWER	The shower walls are properly installed and are in good condition. Most ceramic tile is applied directly over gypsum board rather than on a concrete board such as "Durock" or "Wonder Board". Where the tile is applied directly over the gypsum board, it is critical that the tile grout be maintained to prevent water intrusion behind the tile. Missing or cracked grout should be repaired. Inside corners, and penetrations in the tile should be kept sealed with a high quality caulk.
GLASS ENCLOSURE	The glass shower enclosure is labeled as tempered safety glass, is properly installed and in good condition.
	The splash strip is too short at the bottom of the shower door. This allows leakage of water onto the floor. Replacement of the splash strip is recommended.

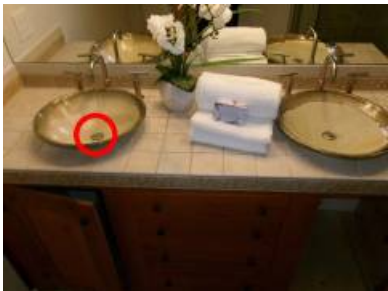
The left sink drain stop is not operational. It should be repaired or replaced.

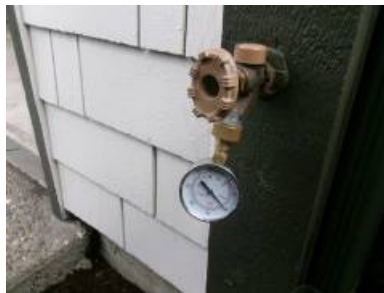
The water pressure at 100 PSI is excessive. The normal range is 30-80 PSI. High water pressure can result in leaking valves, detached supply tubes, water hammer and is hard on solenoid valves. The installation of a pressure reduction valve is recommended.

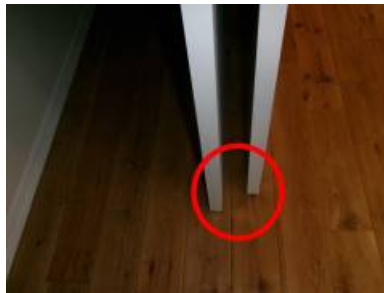
The floor guides are missing from the bypass closet doors in one of the bedrooms. Missing floor guides could result in damage to the doors. The installation of floor guides is recommended.

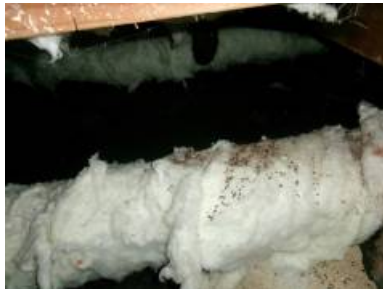
<i>PEST CONTROL</i>	There is evidence of rodent activity in the crawlspace. The first step in eliminating rodents from the crawlspace is to seal all possible entry points using wire mesh, caulking, wood, stainless steel wool, aerosol foam or mortar. Careful work sealing cracks, holes, gaps, and covering ground water drain inlets will discourage rodent activity. Once this work is completed, snap traps baited with peanut butter should be installed and monitored. The absence of rodents in the traps typically means that the rodents have been excluded from the area.
