## NOTICE TO BUYER: SELLER-PROCURED INSPECTION REPORT

Anthony and Christina Monsaas  
18109 NE 108<sup>th</sup> CT.  
Redmond WA 98052

At your request, a visual inspection of the above referenced property was conducted on 02/17/2025. We have inspected the major structural components, plumbing, heating and electrical systems for signs of significant non-performance, excessive or unusual wear and general state of repair.

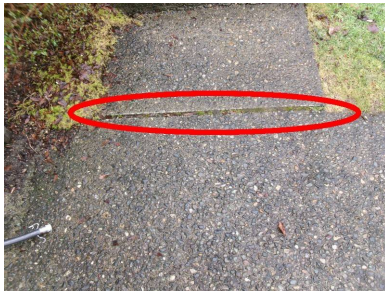
The wooden dividers separating the concrete walkway sections have deteriorated to a point where the gaps are a trip hazard. Replacement with mortar is recommended.

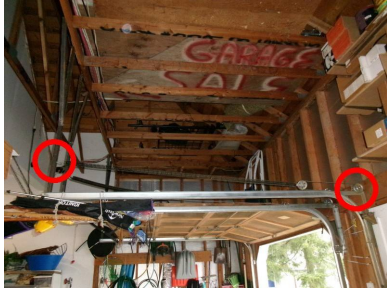
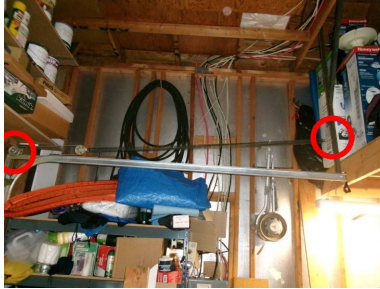
Safeties are cables run through the center of the garage door springs that prevent broken springs from becoming projectiles that can cause injury. There are no safeties installed. The installation of safeties is recommended.

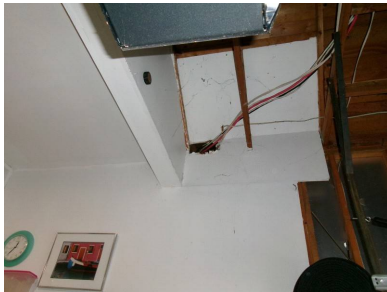
The opening is a breach in the fire resistive barrier in the garage. Patching the void with a piece of 5/8" gypsum type X board protecting the exposed wood is recommended.

Fire barrier in garage - gypsum board was added over the exposed wood.

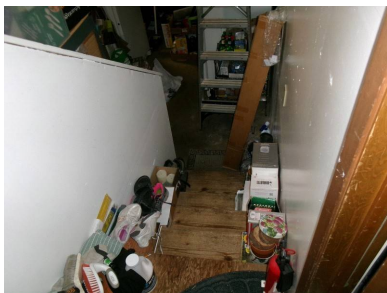
There is no handrail along the stairs. This is a safety hazard. The installation of a graspable handrail should be installed that conforms to present industry standards.

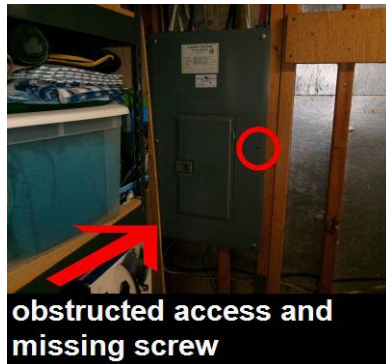
Screws that secure the panel cover to the panel box are missing. This is a potential hazard. Missing screws should be replaced with the original style blunt end screws.

Electrical panel box in garage missing screw – repaired.

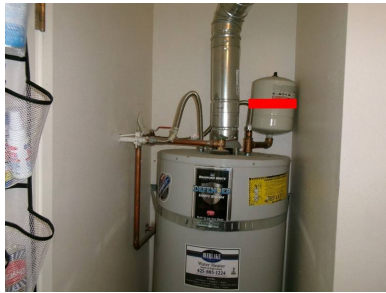
The expansion tank is not adequately secured to the wall. As code requirements start to call for engineered expansion tank supports we recommend the installation of seismic restraints to secure the expansion tank instead of allowing it to simply depend on piping connections that could result in damage to the water pipe and leakage during an earthquake.

Water heater expansion tank earthquake restraint – a strap was added.

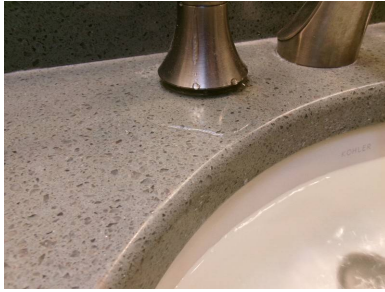
The right sink hot water faucet valve stem is leaking. Leaking faucets should be rebuilt or replaced.

Primary bathroom faucet leaks – both handles repaired (one was erroneously listed as in the hall bath)

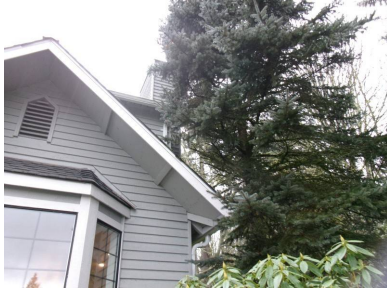
Trees are nearly touching the building on the northwest corner. Low hanging tree branches can damage the roof, siding, doors and windows. Tree branches should be trimmed back where necessary.

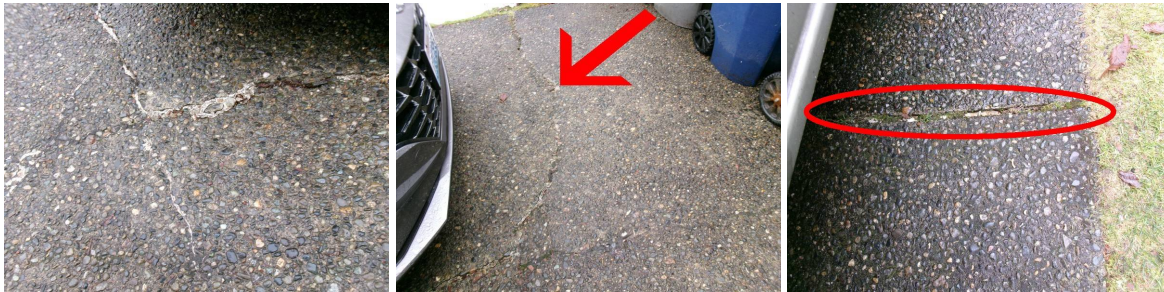
Cracks were observed in the concrete surface of the driveway. Minor cracks can be sealed to minimize moisture entry and further settlement of the concrete. Minor cracks are common and do not affect the serviceability of the concrete.

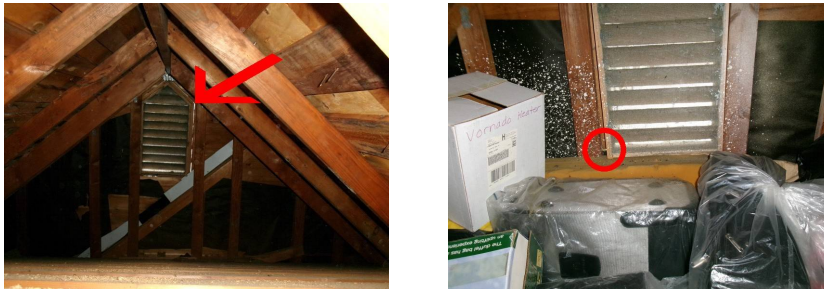
There are large gaps over 1/4" in size adjacent the west facing gable vents. These gaps allow insects and rodents to enter the attic. Covering the gaps with screening, a strip of wood and/or caulking is recommended.

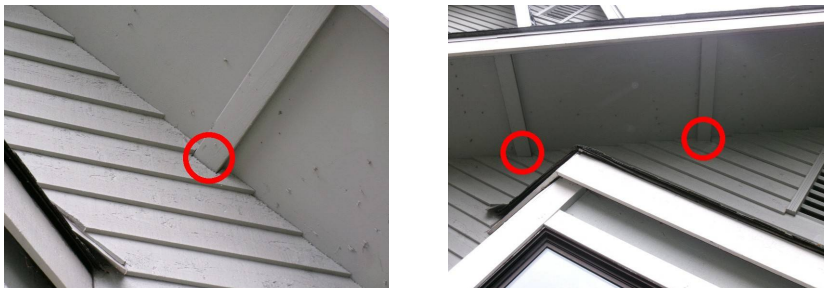
There are openings adjacent the ends of the outlook boards under the overhang through which insects and rodents can enter into the attic. These openings should be covered with wood, wire mesh or filled with aerosol foam.

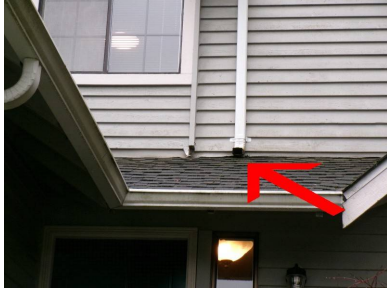
Downspouts draining directly onto the asphalt shingle surface causes excessive wear of the roofing material. Downspout extensions to the lower gutters should be installed to prevent excessive wear and tear of the roofing.

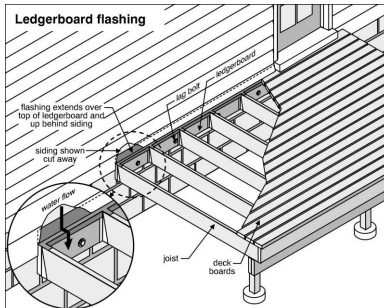
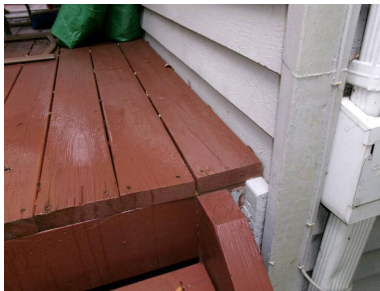
There is no flashing at the intersection between the deck and house. This will allow water to enter behind the siding. The installation of flashing in this area is recommended.

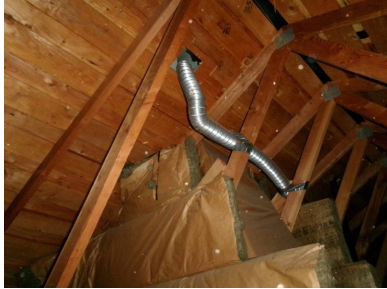
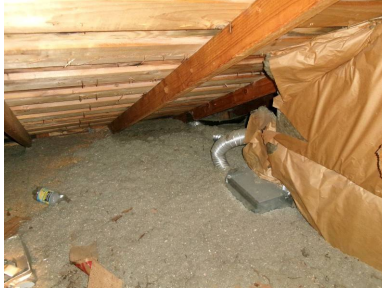
Flexible plastic duct is used to direct air from the vent fans to the exterior. This type of material is unreliable. Replacing the plastic duct with 4" smooth-wall sheet metal duct is recommended.

Attic vent fan – replace flexible plastic duct with sheet metal duct. Current venting was added by a contractor per code at that time. It has worked reliably without any problems

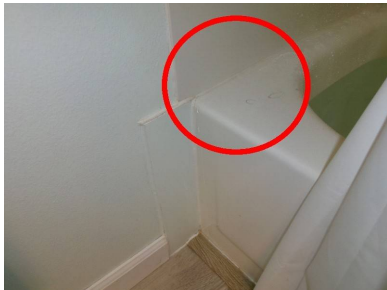
The bathtub is not installed level in accordance with the manufacturer's specifications. This has resulted in water draining off the edge of the bathtub onto the floor. The tub should be leveled. Splash guards or shower doors could be installed.

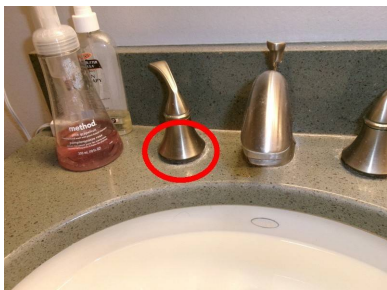
The left sink hot water fixture is loose at the base. The fixture should be adequately secured.

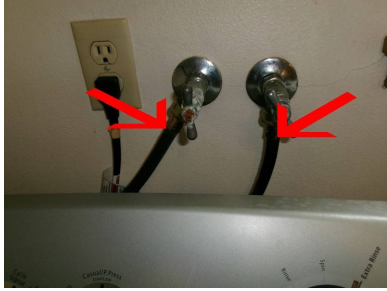
High pressure (steel braided) washer line connections is recommended.

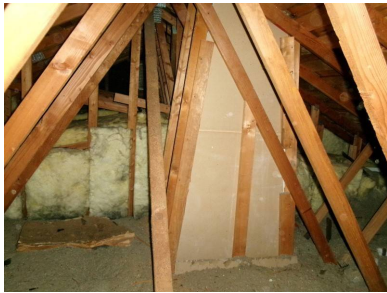
One of the skylight shafts is not insulated. This condition will result in significant heat loss. The installation of additional attic insulation around the skylight shafts is recommended.

Skylight insulation missing on one - insulation was added.

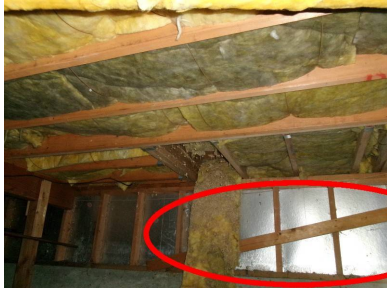
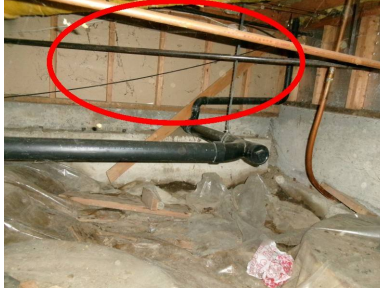
Shear panels are plywood or OSB panels that are mechanically fastened to both vertical and horizontal framing members in critical structural areas of the building. They prevent lateral movement of the structure during an earthquake. Shear panels are often visible in the crawlspace on cripple walls between the first floor and foundation. They may also be installed on interior walls that are covered with drywall. An examination of the crawlspace revealed the absence of shear panels on the cripple walls. The installation of shear panels on the cripple walls is recommended as an upgrade.

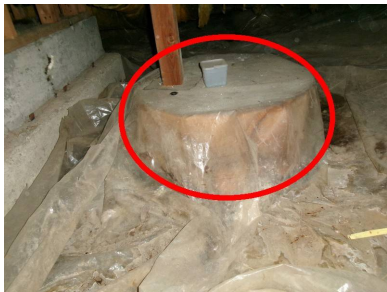
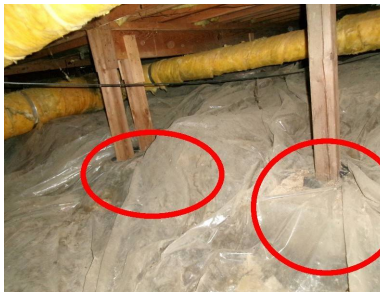
The support post concrete piers are covered with the plastic vapor retarder. This allows the transmission of water vapor from the soil up and into the floor framing. The plastic vapor retarder should be removed from the pier so that it covers at least 85% of the entire surface of the soil only.

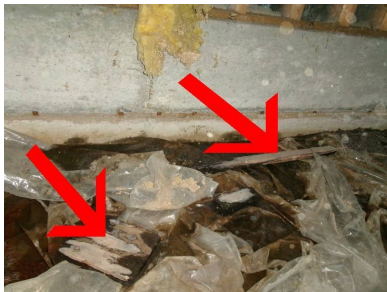
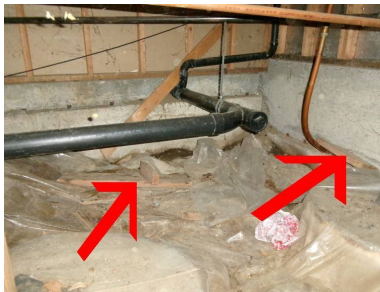
Cellulose forms were left in place on the pier footings. This cellulose is conducive to the infestation of various wood destroying organisms. The removal of the cellulose is recommended.

Scrap-wood and other cellulose debris was observed on the crawl floor. This wood debris creates conducive conditions for wood boring insects. The removal of all cellulose debris is recommended.

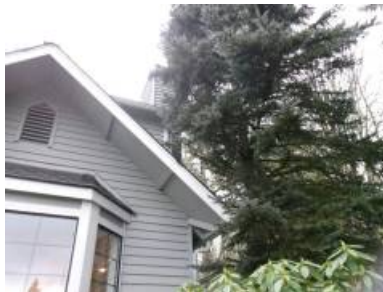
Trees are nearly touching the building on the northwest corner. Low hanging tree branches can damage the roof, siding, doors and windows. Tree branches should be trimmed back where necessary.

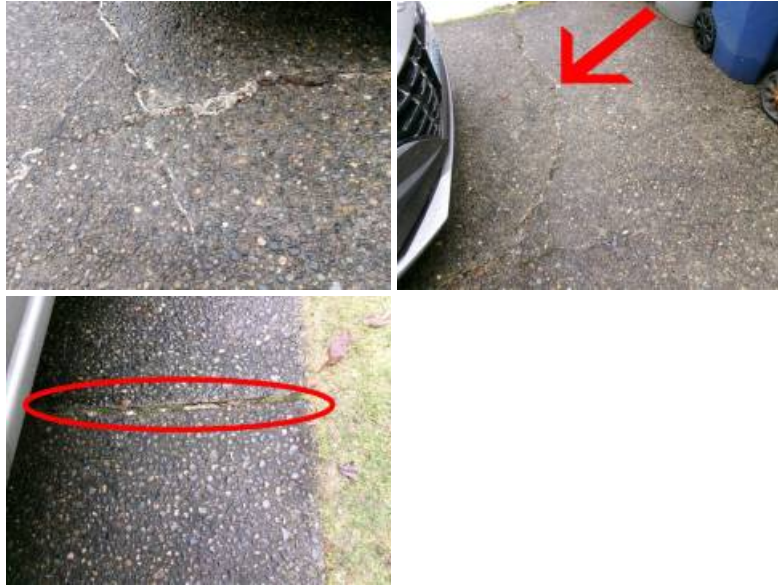
Cracks were observed in the concrete surface of the driveway. Minor cracks can be sealed to minimize moisture entry and further settlement of the concrete. Minor cracks are common and do not affect the serviceability of the concrete.

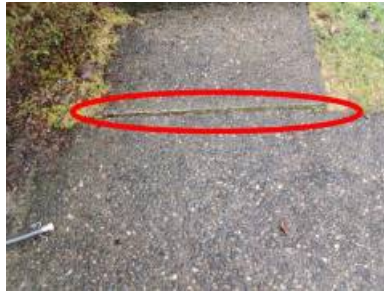
Many legal and public works departments have defined a trip hazard as an irregularity in a walking surface exceeding one inch (1") in height. All walking surfaces should maintain, free of a vertical surface change of 3/4" or more, in the interest of public and personal safety.

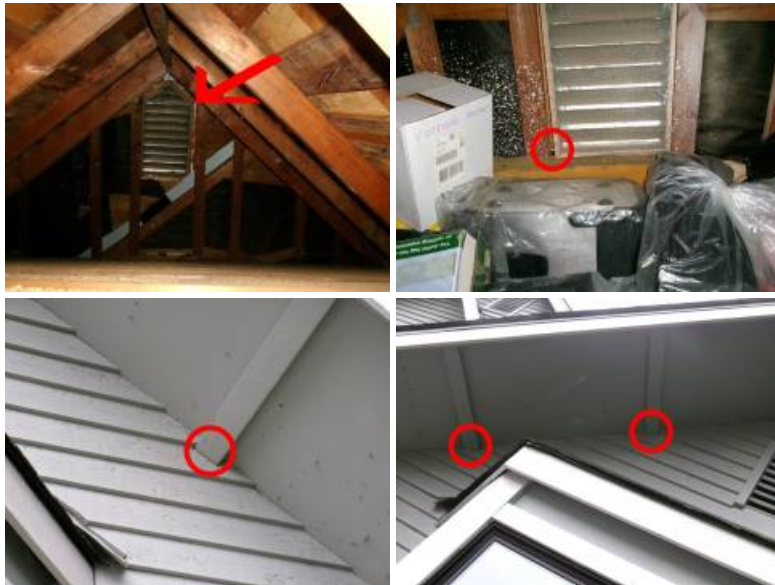
There are openings adjacent the ends of the outlook boards under the overhang through which insects and rodents can enter into the attic. These openings should be covered with wood, wire mesh or filled with aerosol foam.

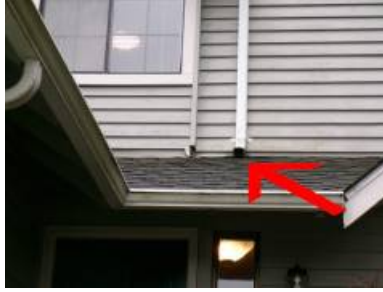
Downspouts draining directly onto the asphalt shingle surface causes excessive wear of the roofing material. Downspout extensions to the lower gutters should be installed to prevent excessive wear and tear of the roofing.

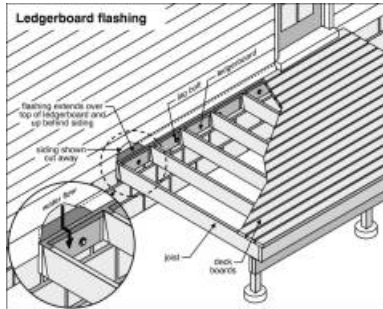
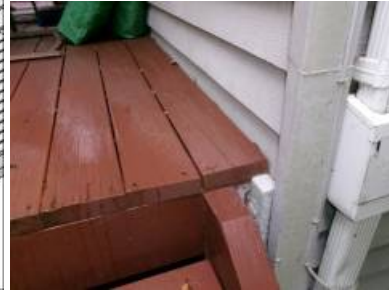
There is no flashing at the intersection between the deck and house. This will allow water to enter behind the siding. The installation of flashing in this area is recommended.

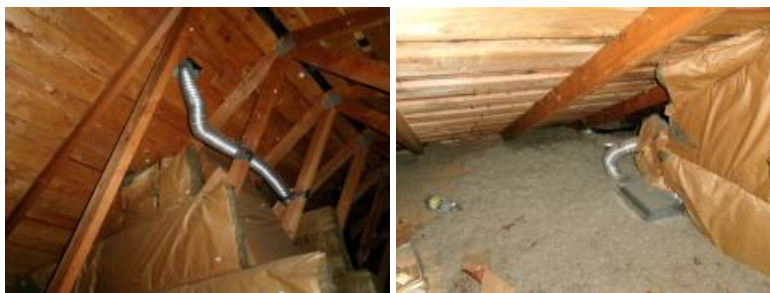
Flexible plastic duct is used to direct air from the vent fans to the exterior. This type of material is unreliable. Replacing the plastic duct with 4" smooth-wall sheet metal duct is recommended.

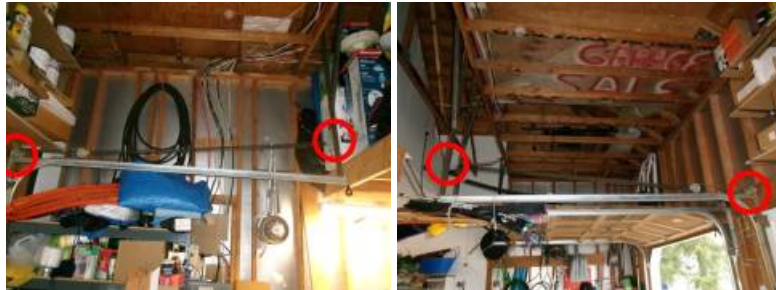
There is no automatic garage door opener for the east door. The door must be opened manually.

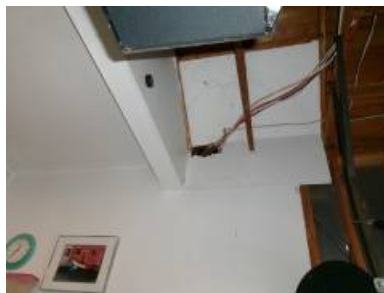
The opening is a breach in the fire resistive barrier in the garage. Patching the void with a piece of 5/8" gypsum type X board protecting the exposed wood is recommended.

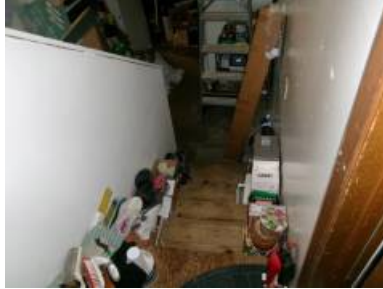
There is no handrail along the stairs. This is a safety hazard. The installation of a graspable handrail should be installed that conforms to present industry standards.

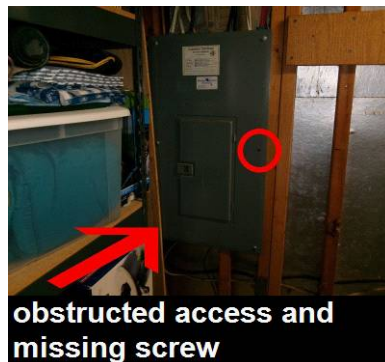
Screws that secure the panel cover to the panel box are missing. This is a potential hazard. Missing screws should be replaced with the original style blunt end screws.

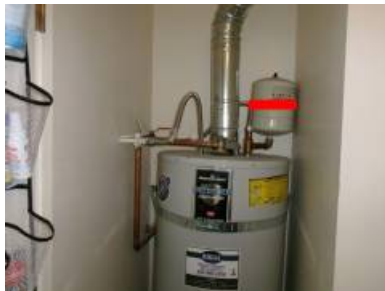
| EXPANSION TANK | The expansion tank is not adequately secured to the wall. As code requirements start to call for engineered expansion tank supports we recommend the installation of seismic restraints to secure the expansion tank instead of allowing it to simply depend on piping connections that could result in damage to the water pipe and leakage during an earthquake. |

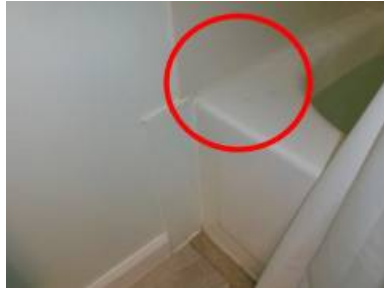
The bathtub is not installed level in accordance with the manufacturer's specifications. This has resulted in water draining off the edge of the bathtub onto the floor. The tub should be leveled. Splash guards or shower doors could be installed.

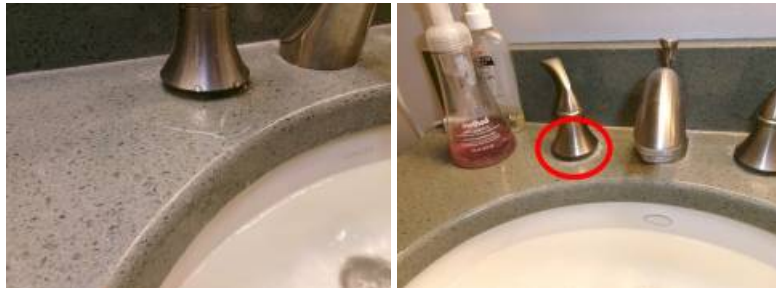
The left sink hot water fixture is loose at the base. The fixture should be adequately secured.

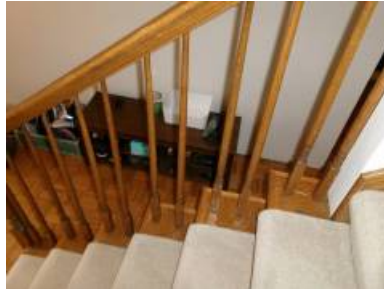
The stair railing baluster spacing is too wide. This is a hazard for small children. The baluster spacing should be reduced as a safety upgrade. Current standards require that a 4-3/8" sphere not pass through the railing.

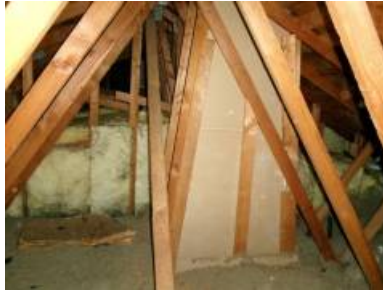
One of the skylight shafts is not insulated. This condition will result in significant heat loss. The installation of additional attic insulation around the skylight shafts is recommended.

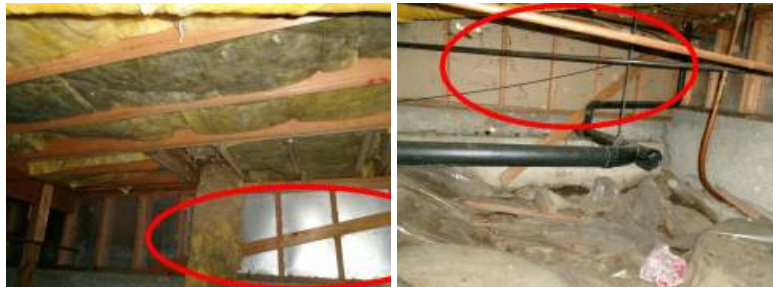
Shear panels are plywood or OSB panels that are mechanically fastened to both vertical and horizontal framing members in critical structural areas of the building. They prevent lateral movement of the structure during an earthquake. Shear panels are often visible in the crawlspace on cripple walls between the first floor and foundation. They may also be installed on interior walls that are covered with drywall. An examination of the crawlspace revealed the absence of shear panels on the cripple walls. The installation of shear panels on the cripple walls is recommended as an upgrade.

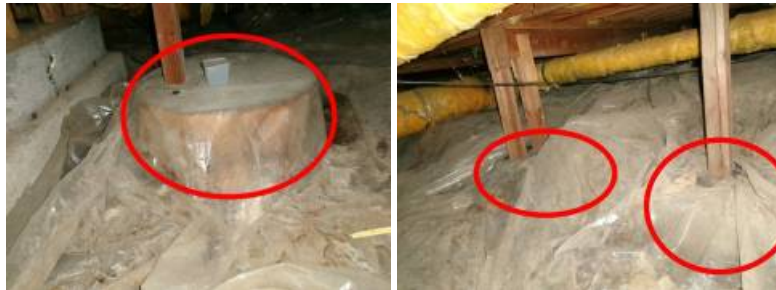
The support post concrete piers are covered with the plastic vapor retarder. This allows the transmission of water vapor from the soil up and into the floor framing. The plastic vapor retarder should be removed from the pier so that it covers at least 85% of the entire surface of the soil only.

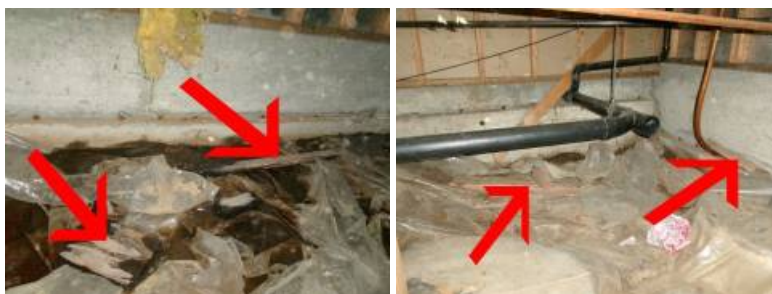
Scrap-wood and other cellulose debris was observed on the crawl floor. This wood debris creates conducive conditions for wood boring insects. The removal of all cellulose debris is recommended.
