## NOTICE TO BUYER: SELLER-PROCURED INSPECTION REPORT

The following notice is given with respect to the Purchase and Sale Agreement dated \_\_\_\_\_  
between \_\_\_\_\_ ("Buyer")  
and **Yuan Ping** **Yue Zhang** ("Seller")  
concerning **17507 Ne 142nd St Redmond WA 98052** ("the Property").

DATE OF INSPECTION: 3/13/2025.  
INSPECTOR'S NAME: Terry Clark.  
CLIENT NAME: Mr. Ian Ping & Ms. Jenny Zhang.  
MAILING ADDRESS: 17507 NE 142nd St.  
Redmond Wa.  
CLIENT E-MAIL ADDRESS: ggtdddgg@gmail.com; [doule2024@outlook.com](mailto:doule2024@outlook.com).  
ADDRESS OF PROPERTY INSPECTED: 17507 NE 142nd St.  
Redmond, WA.

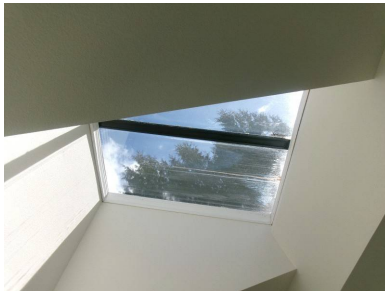
The seal between the glass panes has failed in the skylight above the primary bedroom bathroom. Repairs should be made as necessary.

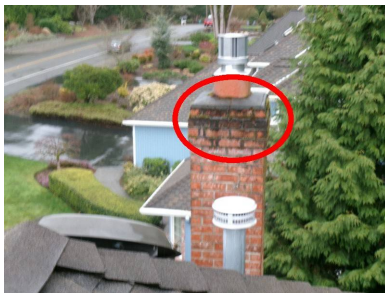
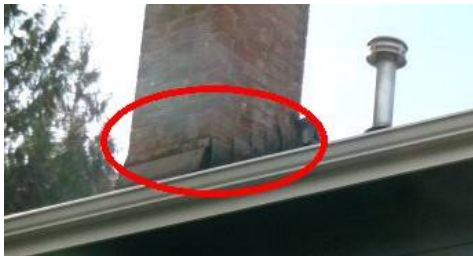
Moss/vegetation was observed in several areas around portions of the east chimney above the roof line. This will lead to accelerated deterioration of the brick masonry mortar. We recommend removal of all organic growth. Damaged areas can be repaired by filling in cutout or defective mortar joints with fresh mortar. (Tuck pointing)

The chimney crown is cracked and deteriorated. The mortar chimney crown prevents water from entering and damaging the masonry. Repairing or replacing the chimney crown will extend the service life of the chimney.

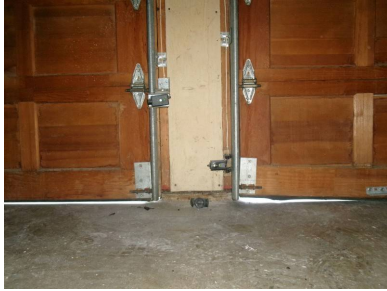
The Photo-eye beam was installed to high above the floor of the garage to adequately offer protection for small children and/or pets. We recommend that the photo-eye be lowered to within 4-6" of the floor.

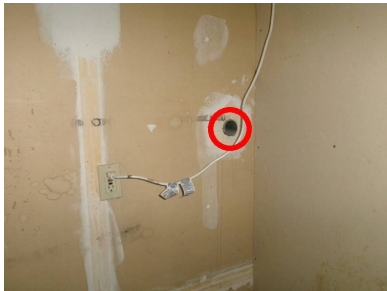
There is a void in the fire resistive barrier between the living space and garage that will allow flames to penetrate. The gypsum barrier slows the spread of a fire from the garage to the structure and/or living space. Patching the voids with a fire retardant caulk is recommended.

- Fire Separation: repaired – the voids are patched with fire retardant caulk
- Passage Door: repaired – new self-closing hinge is installed

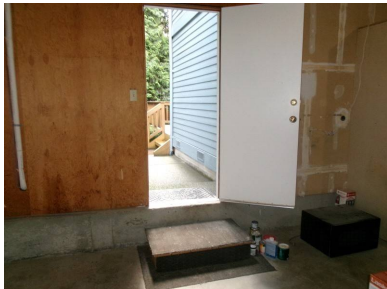
The landing for the door is missing. This is a hazard. Each side of every exterior door (including egress and non-egress doors) needs a landing or floor. The landing must have a minimum dimension of 36 inches (914 mm) measured in the direction of travel.

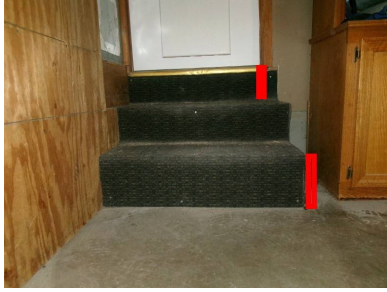
The garage steps are non-conforming due to the variable rise. Stair design standards require that stair risers do not exceed 8" and that the variation in rise not exceed 3/8" in order to reduce falls from tripping. To increase the margin of safety, consideration should be given to reconfiguring the stairs so that rise and run do not vary by more than 3/8". If this proves to be too impractical or expensive, then we recommend exercising caution when

using these stairs.

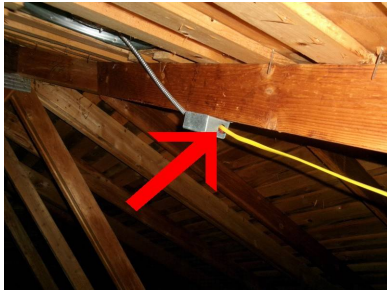
The Romex cable is not clamped where it enters the junction box in the attic. This could result in a short circuit or fire. A Romex clamp should be installed at the point where the cable enters the light fixture.

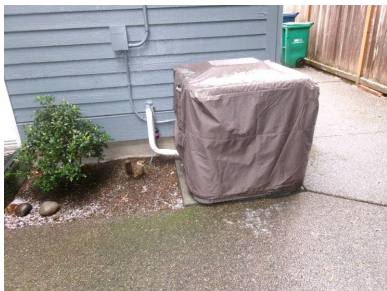
Testing the air conditioner/heat pump in cold weather when the compressor has not been run for a weeks or months could damage the compressor. Therefore the air conditioner/heat pump was not tested. You should review the maintenance records. Having the air conditioner/heat pump serviced before the start of the next cooling season is recommended.

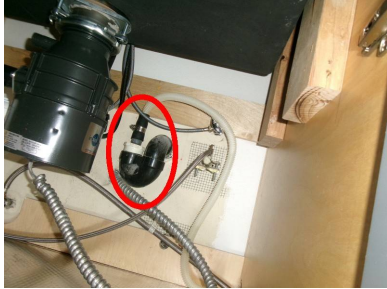
The dishwasher drain lacks an air gap. The dishwasher will function without one, but there is a risk of contamination of the inside of the dishwasher by waste water. The installation of an air gap above the flood rim of the sink is recommended.

- Air Gap: alternate solution of a high loop is installed as there is no space to install an air gap
- Garbage Disposal: repaired – the conduit protecting the cable to the garbage disposal is repaired
- Receptacles: repaired – the receptacle above the sink is replaced with a GFCI protected receptacle

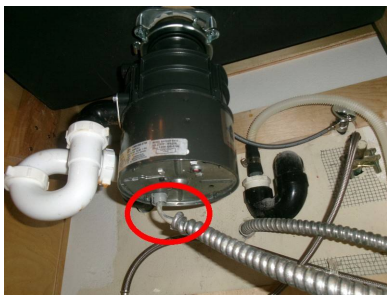
The flex conduit protecting the cable to the garbage disposal is damaged. This could result in damage to the cable and is a potential hazard. The cable should be protected by metal conduit in accordance with industry standards.

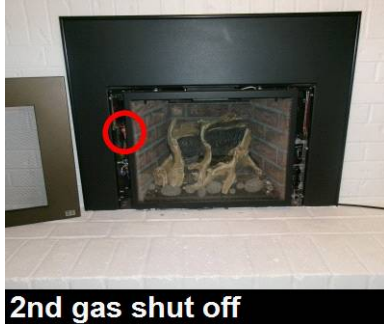
**2nd gas shut off**

The gas supply for the fireplace is located on the floor adjacent to the hearth and another is located on the side of the appliance. The key that turns on this valve should be kept out of the reach of children.

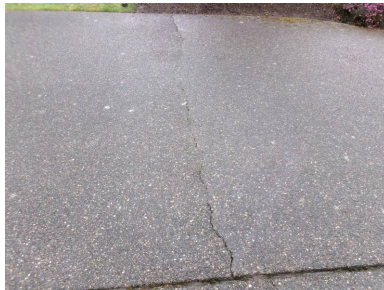
Cracks were observed in the concrete surface of the driveway. Minor cracks can be sealed to minimize moisture entry and further settlement of the concrete. Minor cracks are common and do not affect the serviceability of the concrete.

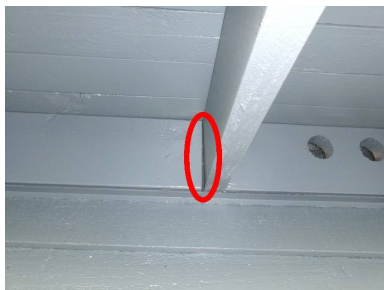
There are large gaps over 1/4" in size adjacent the soffit vent blocks. These gaps allow insects and rodents to enter the attic. Covering the gaps with screening, a strip of wood and/or caulking is recommended.

- Soffits and Overhangs: gaps fixed

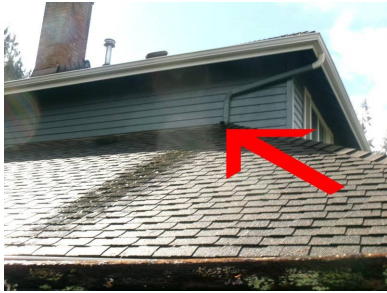
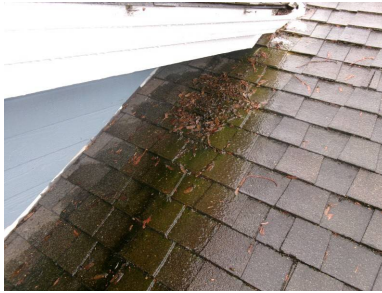
Downspouts draining directly onto the asphalt shingle surface causes excessive wear of the roofing material. Downspout extensions to the lower gutters should be installed to prevent excessive wear and tear of the roofing.

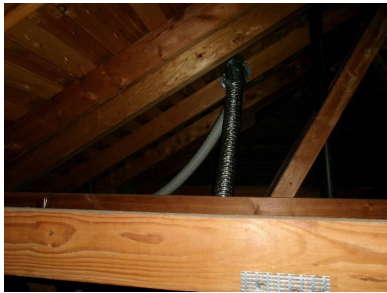
Flexible plastic duct is used to direct air from the vent fans to the exterior. This type of material is unreliable. Replacing the plastic duct with 4" smooth-wall sheet metal duct is recommended.

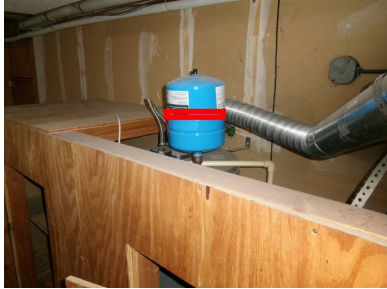
The expansion tank is not adequately secured to the wall. As code requirements start to call for engineered expansion tank supports we recommend the installation of seismic restraints to secure the expansion tank instead of allowing it to simply depend on piping connections that could result in damage to the water pipe and leakage during an earthquake.

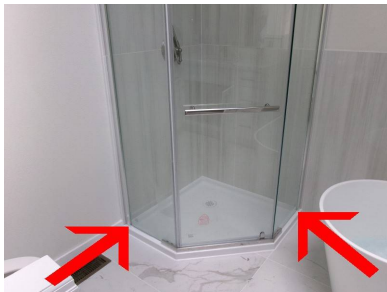
The glass enclosure has been leaking at the lower corners. No damage was visible, but resealing or repairing the enclosure is recommended as preventive maintenance.

- Glass Enclosure of the Primary Bedroom Bathroom: repaired – resealing is done
- Tub Walls of Upper Floor Hallway Bathroom: repaired – tile sealer is reapplied

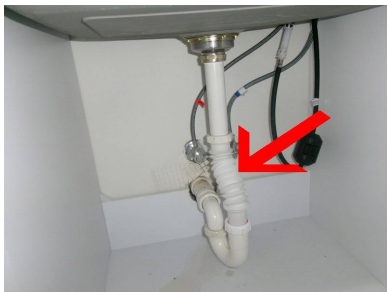
Improper, non-conforming material has been used for the drain pipe fitting. This material will not function reliably. Replacement with industry standard fittings is recommended.

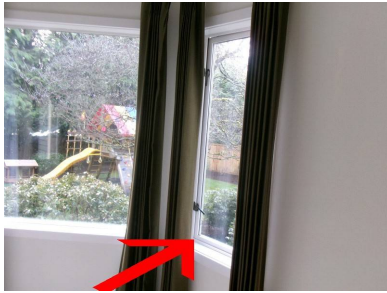
One of the windows is stuck. The window should be adjusted or repaired as necessary to restore proper operation.

- Windows: repaired – the window is operational in normal ways

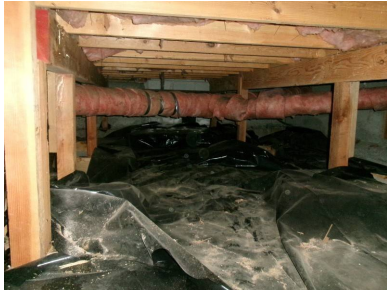
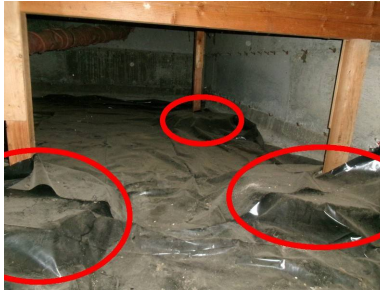
The support post concrete piers are covered with the plastic vapor retarder. This allows the transmission of water vapor from the soil up and into the floor framing. The plastic vapor retarder should be removed from the pier so that it covers at least 85% of the entire surface of the soil only.

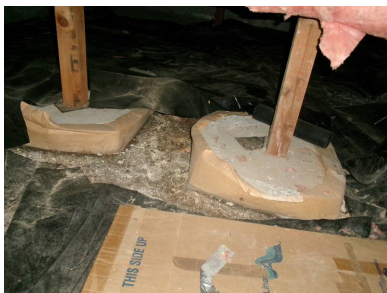
Scrap-wood and other cellulose debris was observed on the crawl floor. This wood debris creates conducive conditions for wood boring insects. The removal of all cellulose debris is recommended.

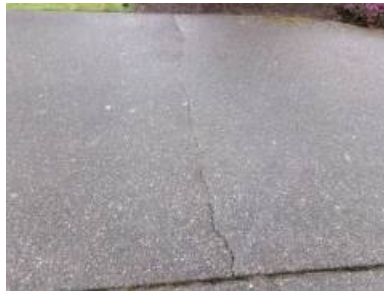
Cracks were observed in the concrete surface of the driveway. Minor cracks can be sealed to minimize moisture entry and further settlement of the concrete. Minor cracks are common and do not affect the serviceability of the concrete.

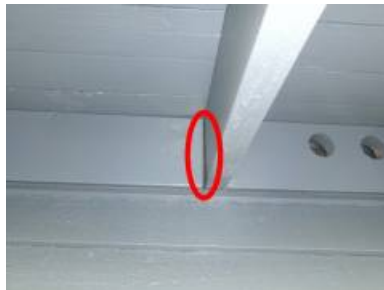
There are large gaps over 1/4" in size adjacent the soffit vent blocks. These gaps allow insects and rodents to enter the attic. Covering the gaps with screening, a strip of wood and/or caulking is recommended.

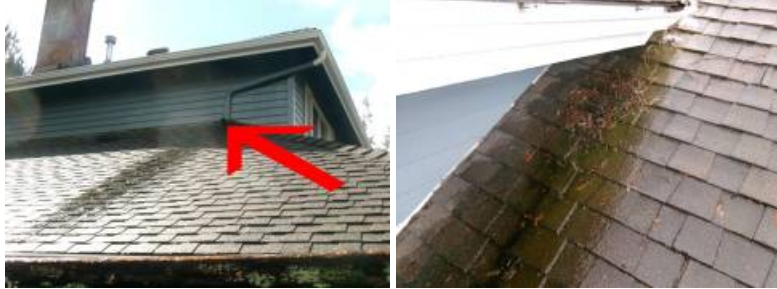
Downspouts draining directly onto the asphalt shingle surface causes excessive wear of the roofing material. Downspout extensions to the lower gutters should be installed to prevent excessive wear and tear of the roofing.

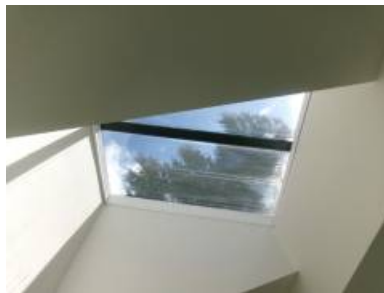
The seal between the glass panes has failed in the skylight above the primary bedroom bathroom. Repairs should be made as necessary.

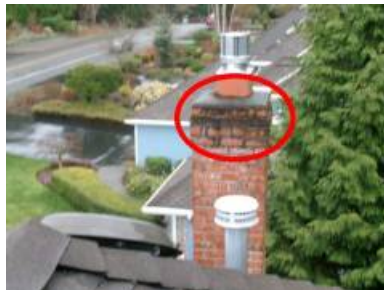
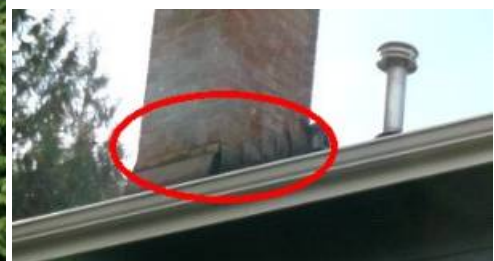
The chimney crown is cracked and deteriorated. The mortar chimney crown prevents water from entering and damaging the masonry. Repairing or replacing the chimney crown will extend the service life of the chimney.

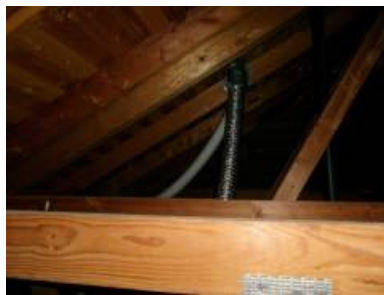
Flexible plastic duct is used to direct air from the vent fans to the exterior. This type of material is unreliable. Replacing the plastic duct with 4" smooth-wall sheet metal duct is recommended.

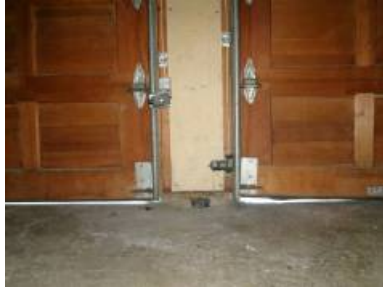
The Photo-eye beam was installed too high above the floor of the garage to adequately offer protection for small children and/or pets. We recommend that the photo-eye be lowered to within 4-6" of the floor.

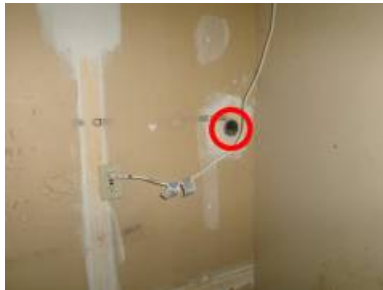
There is a void in the fire resistive barrier between the living space and garage that will allow flames to penetrate. The gypsum barrier slows the spread of a fire from the garage to the structure and/or living space. Patching the voids with a fire retardant caulk is recommended.

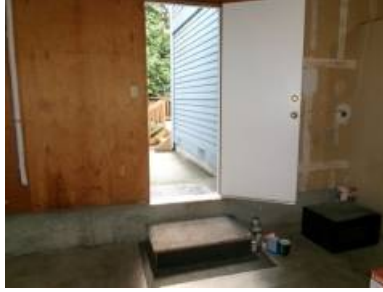
The landing for the door is missing. This is a hazard. Each side of every exterior door (including egress and non-egress doors) needs a landing or floor. The landing must have a minimum dimension of 36 inches (914 mm) measured in the direction of travel.

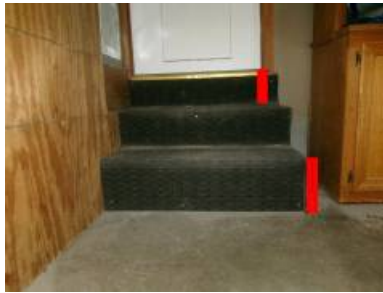
The garage steps are non-conforming due to the variable rise. Stair design standards require that stair risers do not exceed 8" and that the variation in rise not exceed 3/8" in order to reduce falls from tripping. To increase the margin of safety, consideration should be given to reconfiguring the stairs so that rise and run do not vary by more than 3/8". If this proves to be too impractical or expensive, then we recommend exercising caution when using these stairs.

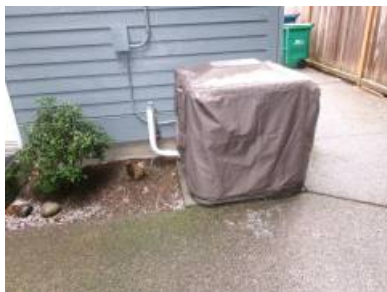
Testing the air conditioner/heat pump in cold weather when the compressor has not been run for a weeks or months could damage the compressor. Therefore the air conditioner/heat pump was not tested. You should review the maintenance records. Having the air conditioner/heat pump serviced before the start of the next cooling season is recommended.

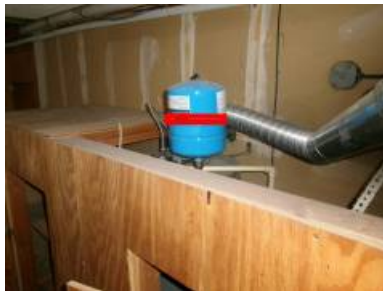
| EXPANSION TANK | The expansion tank is not adequately secured to the wall. As code requirements start to call for engineered expansion tank supports we recommend the installation of seismic restraints to secure the expansion tank instead of allowing it to simply depend on piping connections that could result in damage to the water pipe and leakage during an earthquake. |

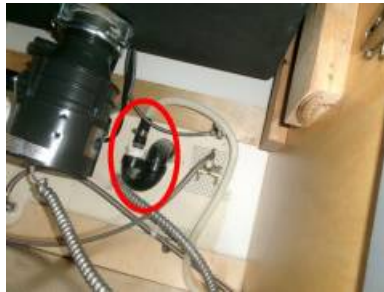
The dishwasher drain lacks an air gap. The dishwasher will function without one, but there is a risk of contamination of the inside of the dishwasher by waste water. The installation of an air gap above the flood rim of the sink is recommended.

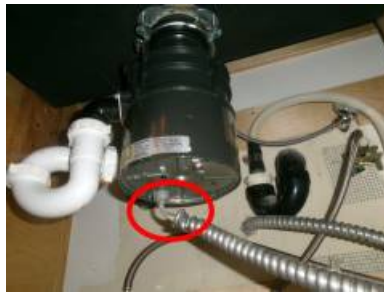
The flex conduit protecting the cable to the garbage disposal is damaged. This could result in damage to the cable and is a potential hazard. The cable should be protected by metal conduit in accordance with industry standards.

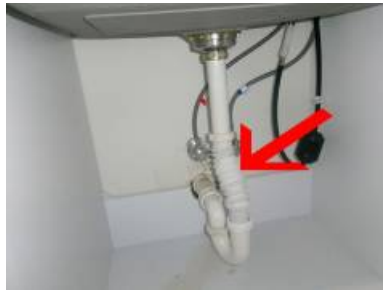
Improper, non-conforming material has been used for the drain pipe fitting. This material will not function reliably. Replacement with industry standard fittings is recommended.

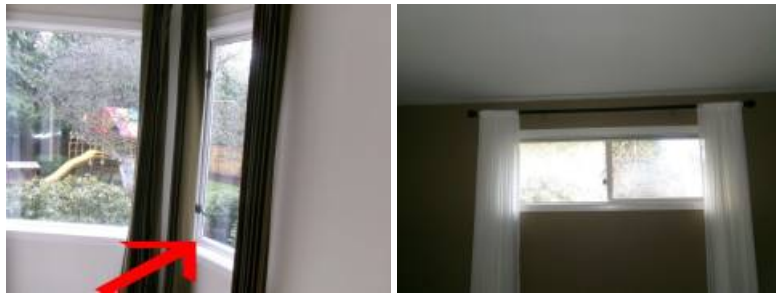
There is condensation or mineral deposits between the panes of glass in one of the insulated glass window panes. This indicates a failed seal. The glass assembly should be replaced, which is the only method for correcting this deficiency.

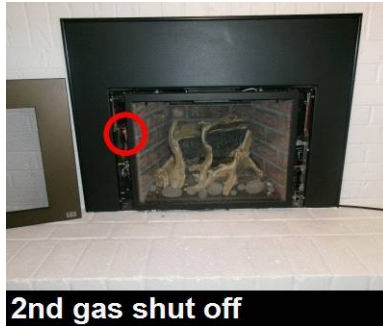
The gas supply for the fireplace is located on the floor adjacent to the hearth and another is located on the side of the appliance. The key that turns on this valve should be kept out of the reach of children.

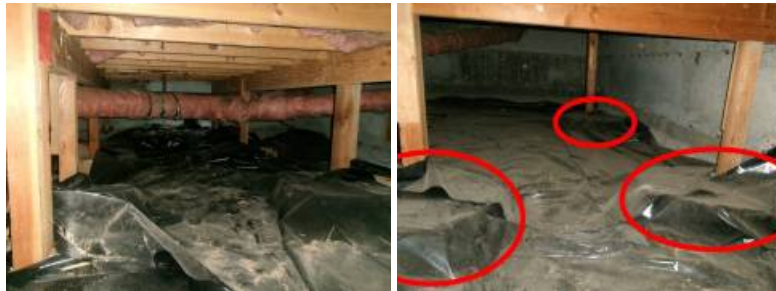
The support post concrete piers are covered with the plastic vapor retarder. This allows the transmission of water vapor from the soil up and into the floor framing. The plastic vapor retarder should be removed from the pier so that it covers at least 85% of the entire surface of the soil only.

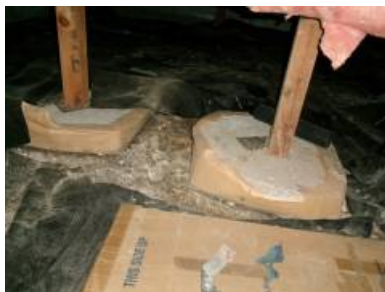
Scrap-wood and other cellulose debris was observed on the crawl floor. This wood debris creates conducive conditions for wood boring insects. The removal of all cellulose debris is recommended.
