NOTICE TO BUYER: SELLER-PROCURED INSPECTION REPORT

**Nasim Milani and Amir Davoodi
17407 NE 138TH ST
Redmond, WA 98052**

May 6, 2025

DATE OF INSPECTION: 5/5/2025.
 INSPECTOR'S NAME: Terry Clark.
 CLIENT NAME: Mr. Amir Davoodi & Nasim Milani.
 MAILING ADDRESS: 17407 NE 138th St.
 Redmond, WA.
 CLIENT E-MAIL ADDRESS: nasimhaleh@gmail.com; Amir_davoodi@hotmail.com.
 ADDRESS OF PROPERTY INSPECTED: 17407 NE 138th St.
 Redmond, WA.

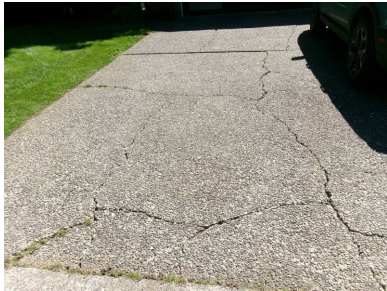
The driveway has cracked and settled differentially. This was probably caused by inadequate preparation of the soil prior to the placement of the concrete. This condition can be repaired by pressure grouting the sunken portion of the driveway or by removing and replacing it. The driveway remains functional despite this condition.

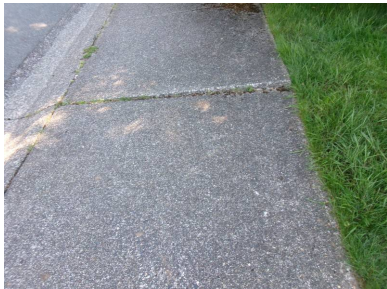
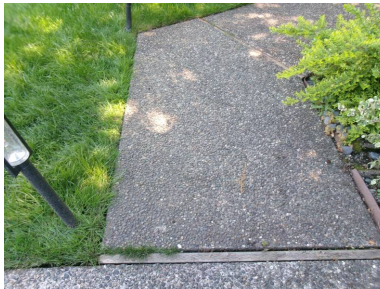
The walkway has cracked and settled differentially. The walkway remains functional despite this condition. However, the raised edges of the concrete can be a trip hazard for some people. Grinding down the raised edges of the concrete will mitigate the hazard. Repairs should be made as necessary.

When the wooden dividers separating the concrete walkway sections have deteriorated to a point where they become a trip hazard. Replacement with mortar is recommended.

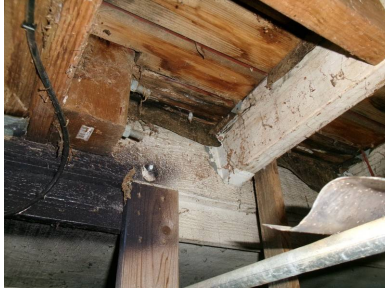
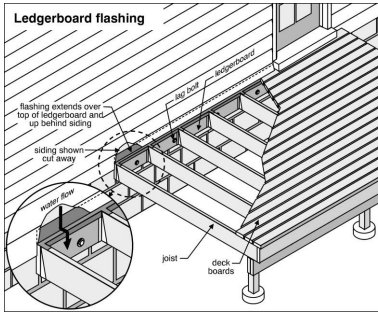
There is no flashing at the intersection between the deck and house. This will allow water to enter behind the siding. The installation of flashing in this area is recommended.

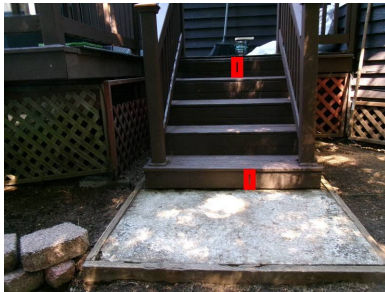
The deck stairs are non-conforming due to the variable rise. Deck stair/step design standards require that step risers do not exceed 8" and that the variation in rise not exceed 3/8" in order to reduce falls from tripping. To increase the margin of safety, consideration should be given to reconfiguring the steps so that rise and run do not vary by more than 3/8". If this proves to be too impractical or expensive, then we recommend exercising caution when using these steps.

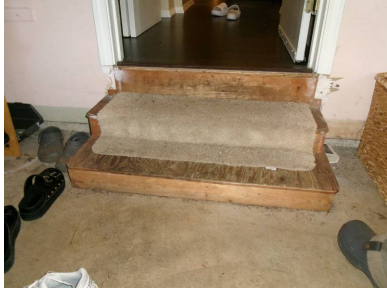
The garage steps are non-conforming due to the variable and/or excessive rise. Stair/step design standards require that step risers do not exceed 8" and that the variation in rise not exceed 3/8" in order to reduce falls from tripping. To increase the margin of safety, consideration should be given to reconfiguring the steps so that rise and run do not vary by more than 3/8". If this proves to be too impractical or expensive, then we recommend exercising caution when using these steps.

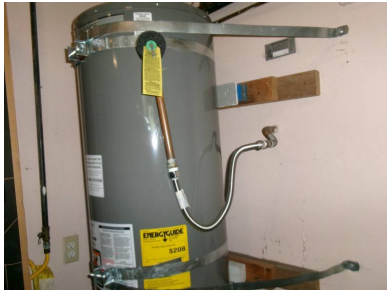
The pressure relief valve drain pipe has a reverse slope which traps water in the pipe. This can result in failure of the pressure relief valve. The drain pipe should be reconfigured so that it slopes 1/4" per foot to the drain outlet. If this is not possible or practical, a small (1/16") drain hole can be drilled in the bottom of the pipe at the lowest point.

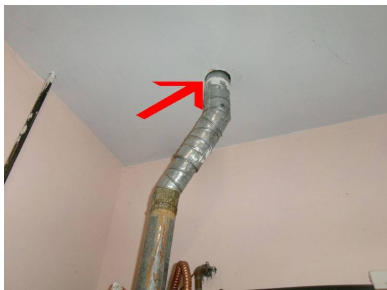
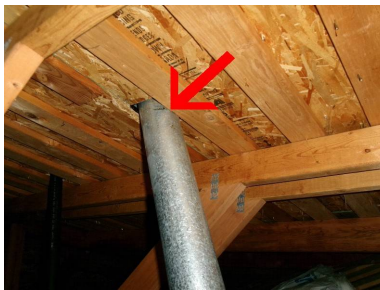
The water heater vent connector is too close to combustible material. The minimum clearance of 6" is required between the single wall vent connector and the combustible surface. The double wall type B vent requires only 1" of clearance.

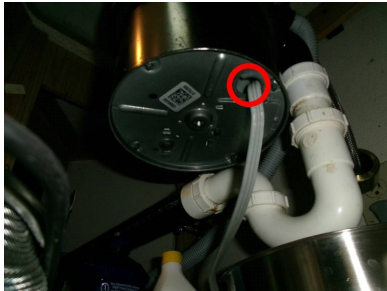
The cord is not clamped where it enters the disposal. This could damage the wires or cause a ground fault. The cord should be clamped in accordance with industry standards.

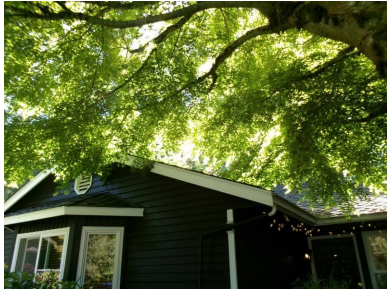
Trees are touching the building on the north side. Low hanging tree branches can damage the roof, gutters, siding, doors and/or windows. Tree branches should be trimmed back where necessary.

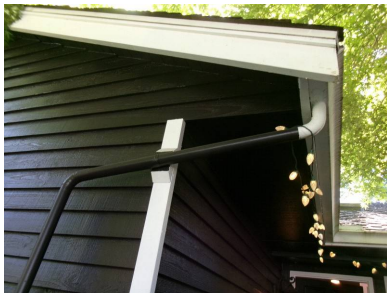
The 2" round downspouts are too small and are more vulnerable to clogging than the larger rectangular ones. Consideration should be given to upgrading the downspouts.

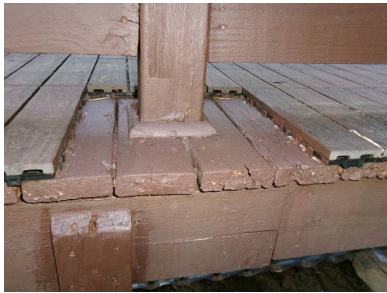
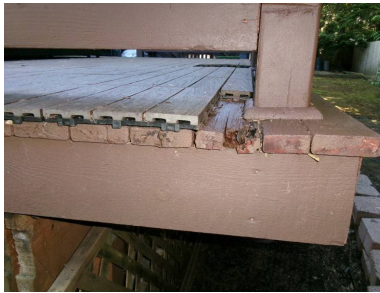
Localized areas of rot damaged wood and rot fungi was observed in the decking boards. Rot weakens the wood and can result in catastrophic failure of the structure. Replacement of all rotted wood is recommended.

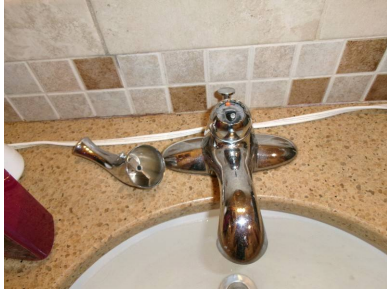
The sink faucet handle is loose. It should be repaired or replaced.

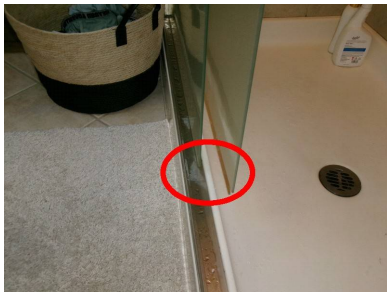
The glass door is in serviceable condition. However, the bottom guides are missing. Missing guides could result in damage to the doors. The installation of floor guides is recommended.

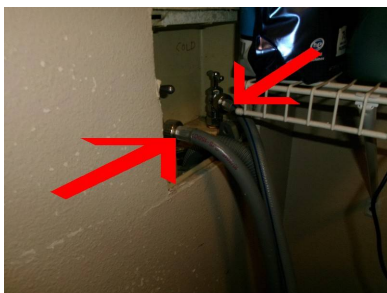
Upgrading the washer connections to high pressure (steel braided) lines is recommended.

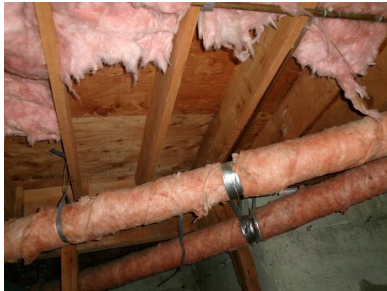
The floors are insulated with 6" R-19 fiberglass batts. Some of the insulation batts are missing. The missing batts should be replaced .

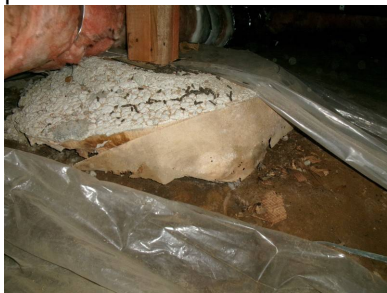
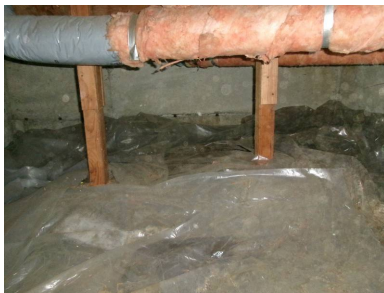
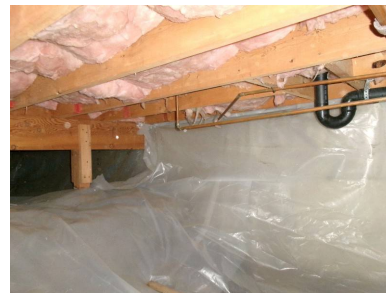
The foundation walls are covered with the plastic vapor retarder. This allows the transmission of water vapor from the soil up and into the exterior wall framing. The plastic vapor retarder should be removed from the foundation.

The support post concrete piers are covered with the plastic vapor retarder. This allows the transmission of water vapor from the soil up and into the floor framing. The plastic vapor retarder should be removed from the piers.

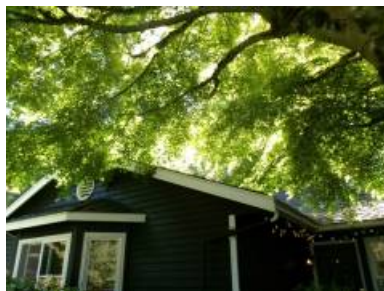
Trees are touching the building on the north side. Low hanging tree branches can damage the roof, gutters, siding, doors and/or windows. Tree branches should be trimmed back where necessary.

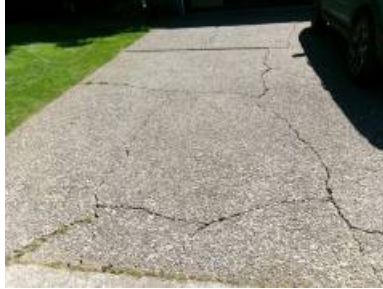
The driveway has cracked and settled differentially. This was probably caused by inadequate preparation of the soil prior to the placement of the concrete. This condition can be repaired by pressure grouting the sunken portion of the driveway or by removing and replacing it. The driveway remains functional despite this condition.

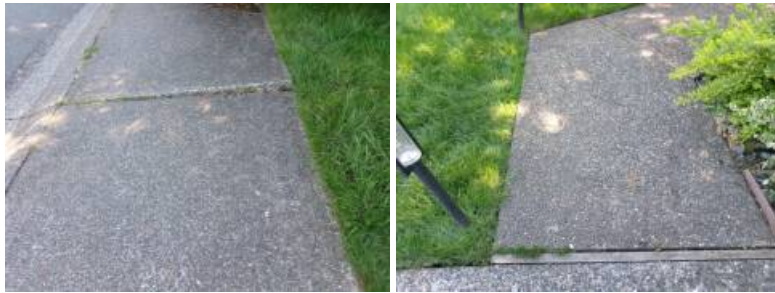
When the wooden dividers separating the concrete walkway sections have deteriorated to a point where they become a trip hazard. Replacement with mortar is recommended.

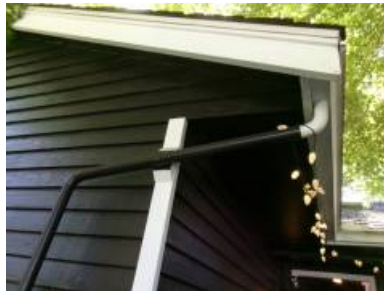
The 2" round downspouts are too small and are more vulnerable to clogging than the larger rectangular ones. Consideration should be given to upgrading the downspouts.

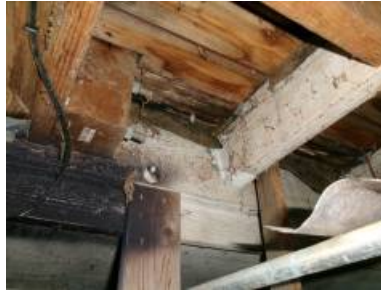
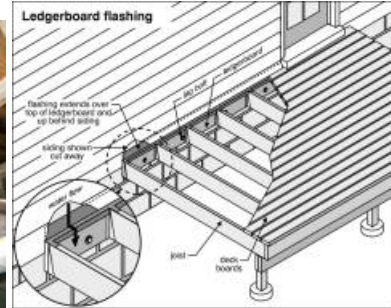
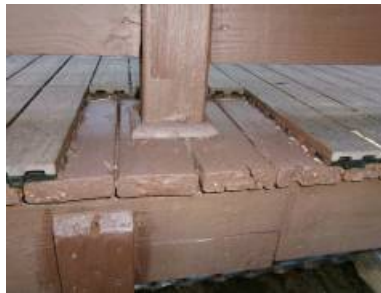
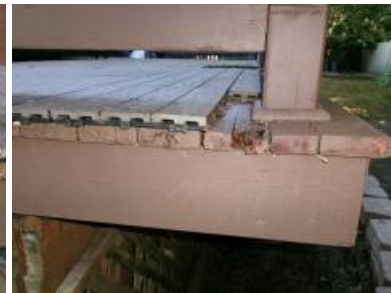
There is no flashing at the intersection between the deck and house. This will allow water to enter behind the siding. The installation of flashing in this area is recommended.

Localized areas of rot damaged wood and rot fungi was observed in the decking boards. Rot weakens the wood and can result in catastrophic failure of the structure. Replacement of all rotted wood is recommended.

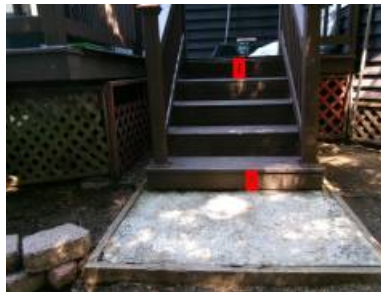
The deck stairs are non-conforming due to the variable rise. Deck stair/step design standards require that step risers do not exceed 8" and that the variation in rise not exceed 3/8" in order to reduce falls from tripping. To increase the margin of safety, consideration should be given to reconfiguring the steps so that rise and run do not vary by more than 3/8". If this proves to be too impractical or expensive, then we recommend exercising caution when using these steps.

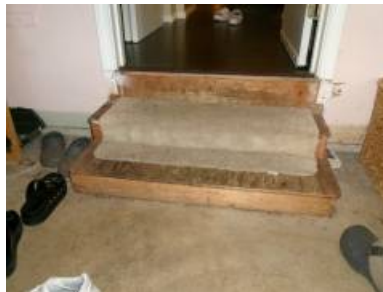
The garage steps are non-conforming due to the variable and/or excessive rise. Stair/step design standards require that step risers do not exceed 8" and that the variation in rise not exceed 3/8" in order to reduce falls from tripping. To increase the margin of safety, consideration should be given to reconfiguring the steps so that rise and run do not vary by more than 3/8". If this proves to be too impractical or expensive, then we recommend exercising caution when using these steps.

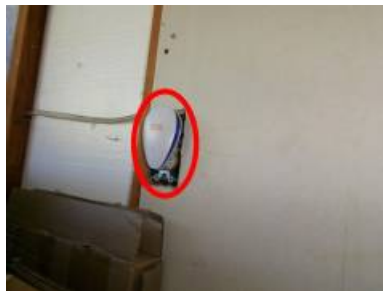
The cover plate is missing from a receptacle in the garage. This is a shock and fire hazard. The installation of a cover plate is recommended.

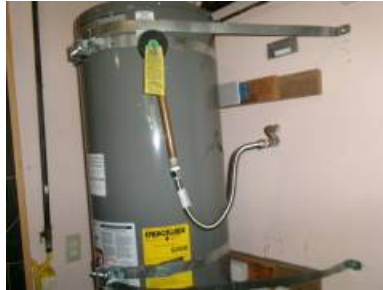
The pressure relief valve drain pipe has a reverse slope which traps water in the pipe. This can result in failure of the pressure relief valve. The drain pipe should be reconfigured so that it slopes 1/4" per foot to the drain outlet. If this is not possible or practical, a small (1/16") drain hole can be drilled in the bottom of the pipe at the lowest point.

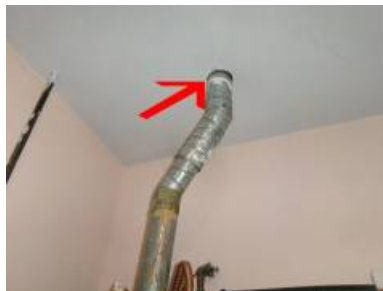
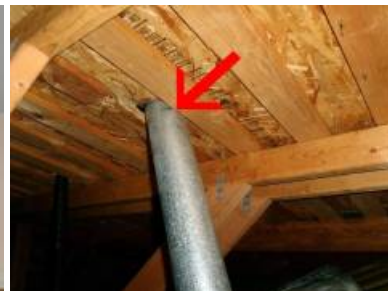
The water heater vent connector is too close to combustible material. The minimum clearance of 6" is required between the single wall vent connector and the combustible surface. The double wall type B vent requires only 1" of clearance.

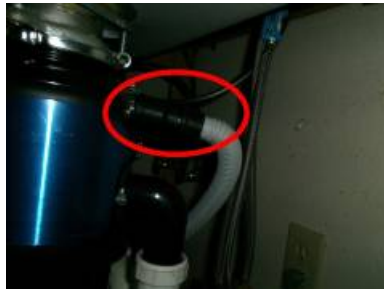
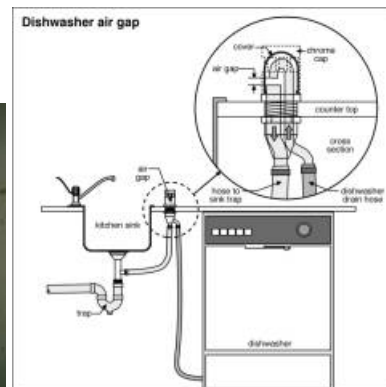
<i>AIR GAP</i>	The dishwasher drain lacks an air gap. The dishwasher will function without one, but there is a risk of contamination of the inside of the dishwasher by waste water. The installation of an air gap above the flood rim of the sink is recommended.

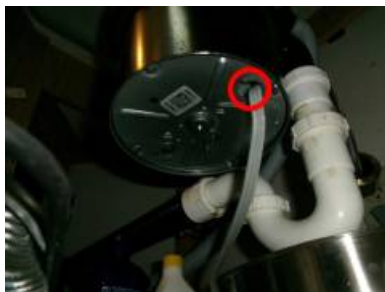
The cord is not clamped where it enters the disposal. This could damage the wires or cause a ground fault. The cord should be clamped in accordance with industry standards.

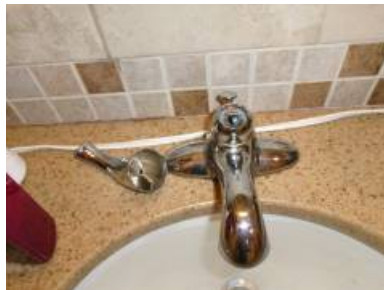
The sink faucet handle is loose. It should be repaired or replaced.

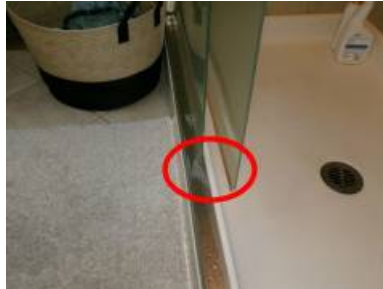
The glass door is in serviceable condition. However, the bottom guides are missing. Missing guides could result in damage to the doors. The installation of floor guides is recommended.

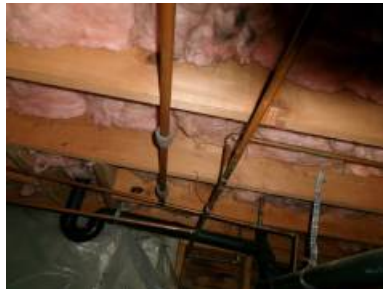
There are water pipes in the crawlspace that are not adequately insulated and could freeze. The installation of foam pipe insulation on all exposed water pipes is recommended.

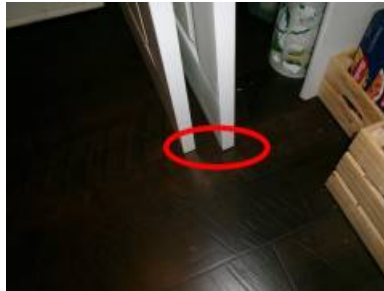
The floor guides are missing from the bypass closet doors in the hallway. Missing floor guides could result in damage to the doors. The installation of floor guides is recommended.

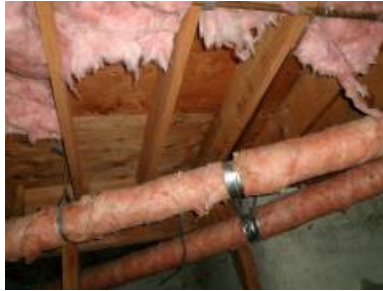
The floors are insulated with 6" R-19 fiberglass batts. Some of the insulation batts are missing. The missing batts should be replaced .

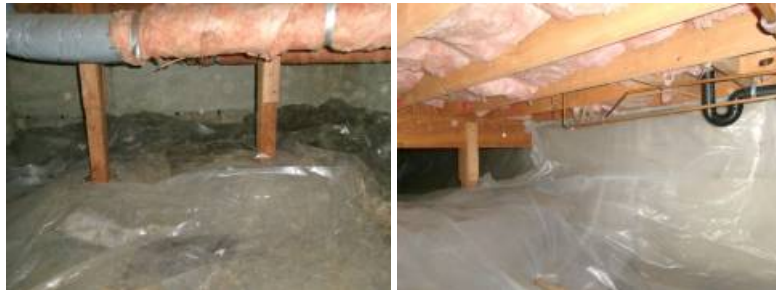
The support post concrete piers are covered with the plastic vapor retarder. This allows the transmission of water vapor from the soil up and into the floor framing. The plastic vapor retarder should be removed from the piers.

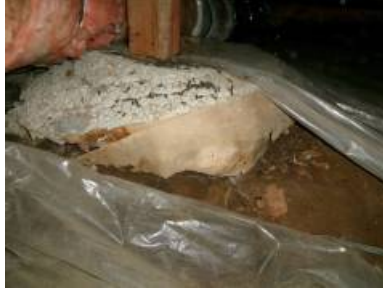
Cellulose forms were left in place on the pier footings. This cellulose is conducive to the infestation of various wood destroying organisms. The removal of the cellulose is recommended.
