NOTICE TO BUYER: SELLER-PROCURED INSPECTION REPORT

The following notice is given with respect to the Purchase and Sale Agreement dated _____
between _____ (“Buyer”)
and **Tom Stimach** **Lisa Stimach** (“Seller”)
concerning **24225 Ne 10th St Sammamish WA 98074** (“the Property”).

Tom & Lisa Stimach
24225 NE 10th Street
Sammamish, WA 98074

At your request, a visual inspection of the above referenced property was conducted on 08/21/2025. We have inspected the major structural components, plumbing, heating and electrical systems for signs of significant non-performance, excessive or unusual wear and general state of repair.

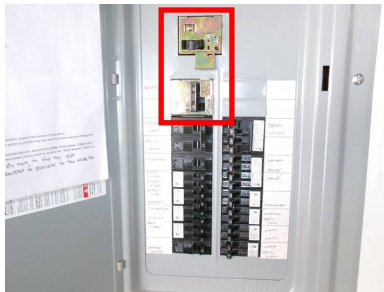
SERVICE PANEL

Access to the service panel was constricted by the inter lock installed on the panel cover. The condition of the wiring to the breakers and the bus bar(s) within the panel was not verified.

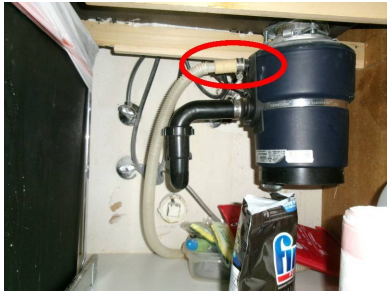
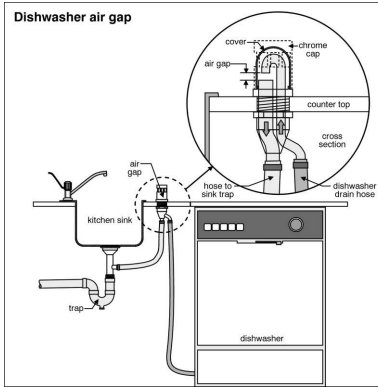
KITCHEN**AIR GAP**

The dishwasher drain lacks an air gap. The dishwasher will function without one, but there is a risk of contamination of the inside of the dishwasher by waste water. The installation of an air gap above the flood rim of the sink is recommended.

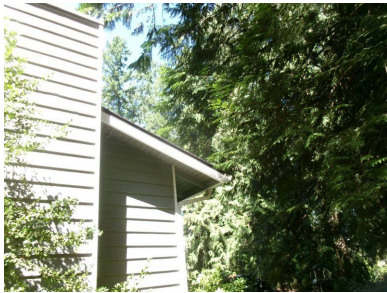
VEGETATION

Trees are nearly touching the building on the northeast corner. Low hanging tree branches can damage the roof, siding, doors and windows. Tree branches should be trimmed back where necessary.

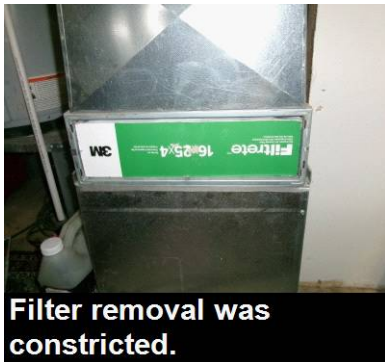
AIR FILTER

The air filter is ill-fitting. The filter should be fitted correctly.

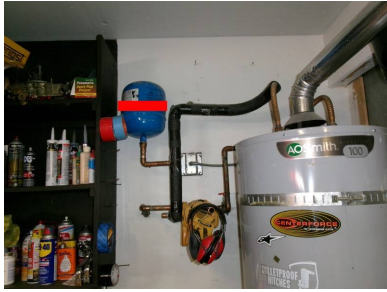
EXPANSION TANK

The expansion tank is not adequately secured to the wall. As code requirements start to call for engineered expansion tank supports we recommend the installation of seismic restraints to secure the expansion tank instead of allowing it to simply depend on piping connections that could result in damage to the water pipe and leakage during an earthquake.

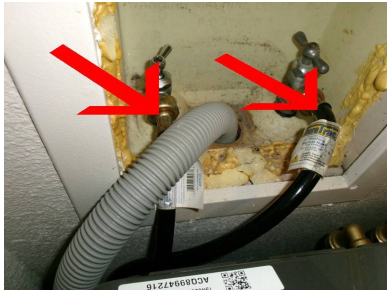
High pressure (steel braided) washer line connections is recommended.

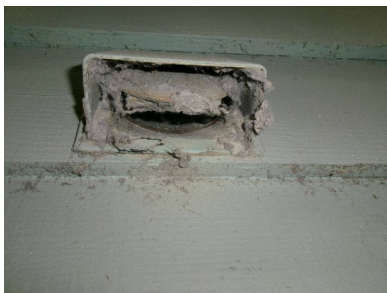
DRYER VENT

The dryer vent damper has become clogged with lint. The damper should be cleaned of obstructions to prevent entry by rodents, birds insects, etc.

- 11. BATHROOMS: LOWER FLOOR BATHROOM SINK** - Drain stop is fixed and operational.
- 12. LAUNDRY ROOM: DRYER VENT** – Dryer vent cleaned per recommendation.

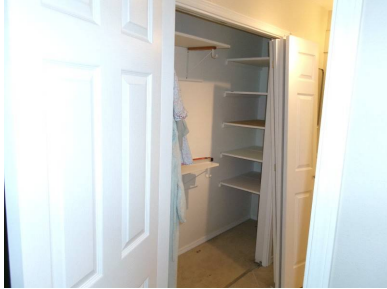
CLOSET DOORS

The primary bedroom bathroom closet doors are not installed.

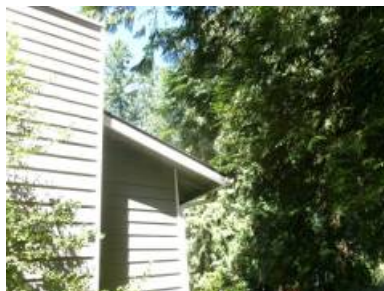
Trees are nearly touching the building on the northeast corner. Low hanging tree branches can damage the roof, siding, doors and windows. Tree branches should be trimmed back where necessary.

- 7. INTERIOR: SMOKE DETECTORS** – Smoke detectors have been installed in each bedroom near the door.
- 8. BUILDING SITE: VEGETATION** – Branches that were “nearly touching” the building on the northeast corner have been trimmed.

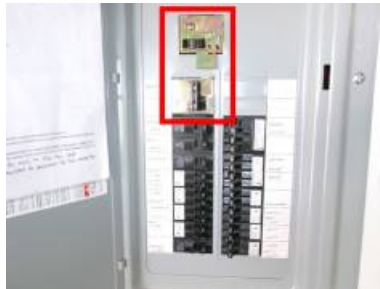
The circuits are labeled. The accuracy of the labeling was not verified. Do not assume the labeled circuit is off unless it has been checked with a voltage tester.

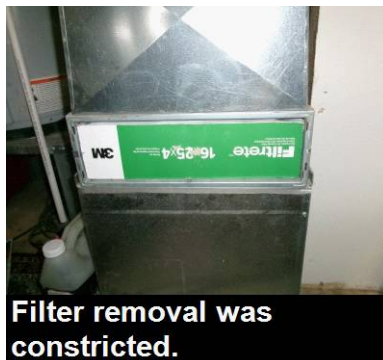
The air filter is ill-fitting. The filter should be fitted correctly.

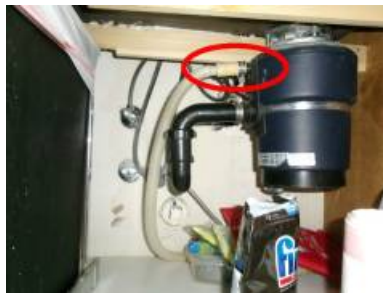
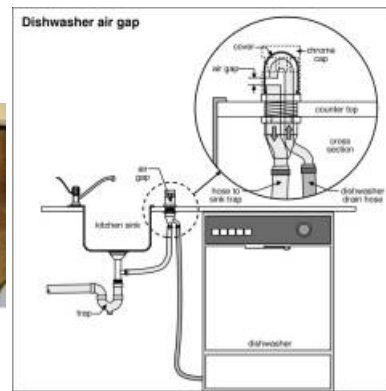
AIR GAP

The dishwasher drain lacks an air gap. The dishwasher will function without one, but there is a risk of contamination of the inside of the dishwasher by waste water. The installation of an air gap above the flood rim of the sink is recommended.

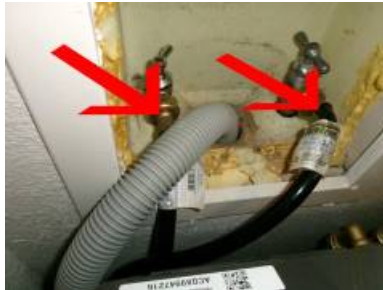
High pressure (steel braided) washer line connections is recommended.

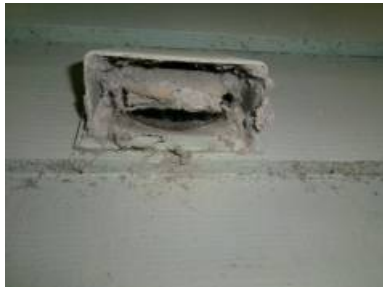
DRYER VENT

The dryer vent damper has become clogged with lint. The damper should be cleaned of obstructions to prevent entry by rodents, birds insects, etc.

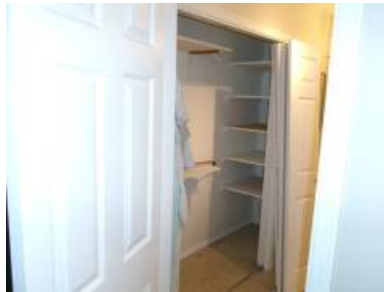
CLOSET DOORS

The primary bedroom bathroom closet doors are not installed.
