## NOTICE TO BUYER: SELLER-PROCURED INSPECTION REPORT

**Adam and Julia Young  
12425 NE 146<sup>th</sup> PI  
Woodinville, WA 98072**

At your request, a visual inspection of the above referenced property was conducted on 09/10/2025. We have inspected the major structural components, plumbing, heating and electrical systems for signs of significant non-performance, excessive or unusual wear and general state of repair.

DATE OF INSPECTION: 9/10/2025.  
INSPECTOR'S NAME: Terry Clark.  
CLIENT NAME: Mr. & Mrs. Adam & Julia Young.  
CLIENT E-MAIL ADDRESS: adamwestleyyoung@gmail.com; [julialoxdale@gmail.com](mailto:julialoxdale@gmail.com).  
ADDRESS OF PROPERTY INSPECTED: 12425 NE 146th Pl.  
Woodinville, WA.

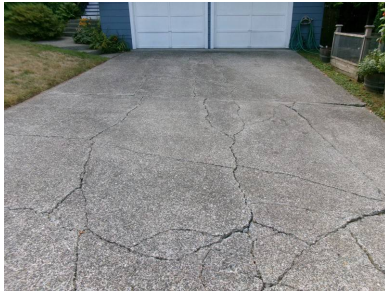
The driveway has cracked and settled differentially. This was probably caused by inadequate preparation of the soil prior to the placement of the concrete. We recommend removing and replacing it. The driveway remains functional despite this condition.

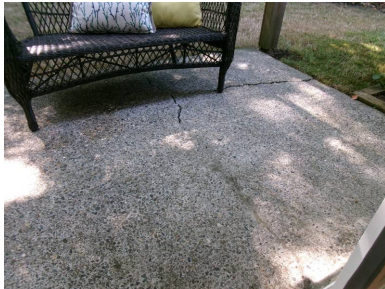
#### PATIO

The patio has settled differentially. This was probably caused by inadequate preparation of the soil prior to the placement of the concrete. This condition can be repaired by pressure grouting the sunken portion of the patio or by removing and replacing it. The patio remains functional despite this condition. However, the raised edges of the concrete can be a trip hazard for some people. Repairs should be made as necessary.

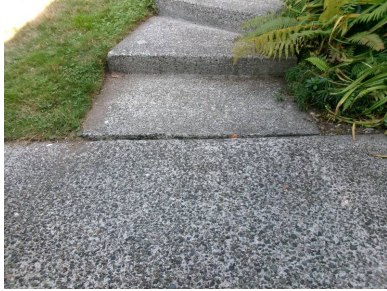
#### WALKWAY

The walkway has settled differentially. The walkway remains functional despite this condition. However, the

raised edges of the concrete can be a trip hazard for some people. Grinding down the raised edges of the concrete will mitigate the hazard. Repairs should be made as necessary.

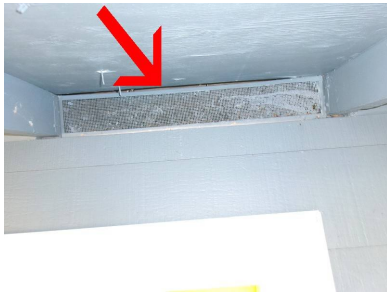
### ***SOFFITS AND OVERHANGS***

Gaps over 1/4" in size adjacent the soffit vent screens will allow insects and rodents to enter the attic. Covering any gaps with screening, a strip of wood and/or caulking is recommended.

- **BUILDING EXTERIOR > SOFFITS AND OVERHANGS**
  - Gaps surrounding all soffit vents have been caulked.
- **GARAGE > GARAGE DOOR OPENER**
  - The Photo-eye beams have been lowered to within 4-6" of the floor.

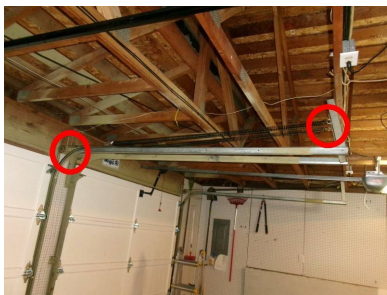
Safeties are cables run through the center of the garage door springs that prevent broken springs from becoming projectiles that can cause injury. There are no safeties installed. The installation of safeties is recommended.

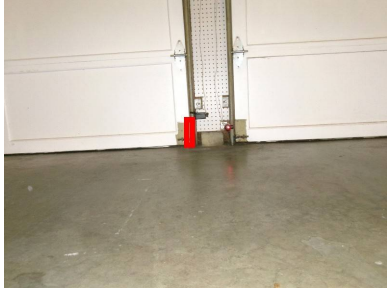
#### ***GARAGE DOOR OPENER***

The Photo-eye beam was installed too high above the floor of the garage to adequately offer protection for small children and/or pets. We recommend that the photo-eye be lowered to within 4-6" of the floor.

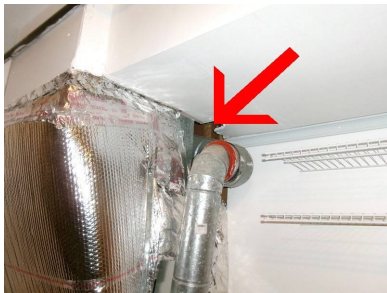
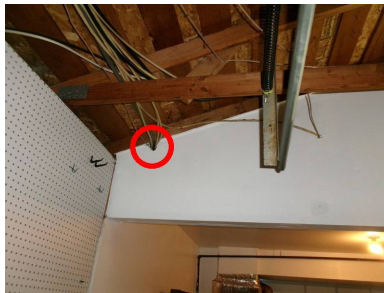
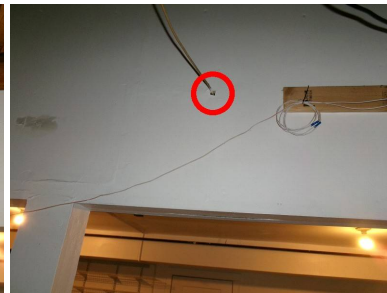
#### ***FIRE SEPARATION***

There are voids in the fire resistive barrier between the living space and garage that will allow flames to penetrate. The gypsum barrier slows the spread of a fire from the garage to the structure and/or living space. Patching the voids with a fire retardant caulk is recommended.

- **GARAGE > FIRE SEPARATION**
  - Voids in the fire resistive barrier have been patched with fire resistant materials.
- **ELECTRICAL SYSTEM > SERVICE PANEL**

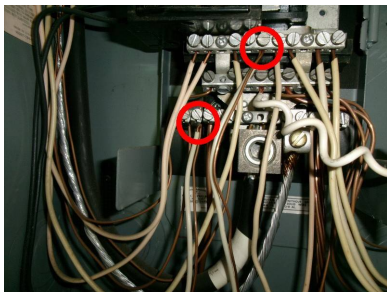
##### ***SERVICE PANEL***

Several of the neutral wires are double tapped on the buss bar. Double tapping means that two conductors share a single terminal. Double tapped terminals can loosen and overheat and therefore are not permitted unless the terminal is specifically listed for multiple wires. This defect is easily repaired by connecting the two wires to a "pig tail", securing them with a wire cap, and then inserting the pig tail conductor under the terminal.

- An electrician has repaired the double-tapping
- **ELECTRICAL SYSTEM > RECEPTACLES**
  - An electrician has repaired/replaced the receptacles
- **ELECTRICAL SYSTEM > GFCI RECEPTACLES**

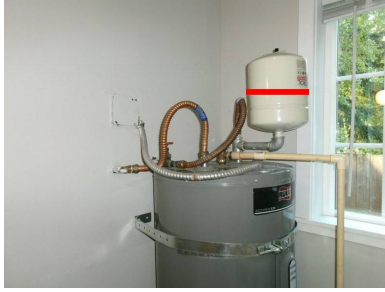
The expansion tank is not adequately secured to the wall. As code requirements start to call for engineered expansion tank supports we recommend the installation of seismic restraints to secure the expansion tank instead of allowing it to simply depend on piping connections that could result in damage to the water pipe and

leakage during an earthquake.

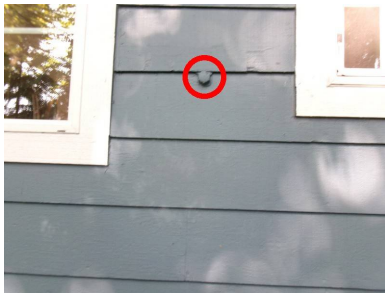
An air gap called a Johnson Tee is installed in the kitchen wall. This air gap protects the dishwasher from contamination caused by a backflow of waste water. The cap protruding on the exterior wall opposite the dishwasher is not drilled. This renders the air gap non-functional. Drilling a 1/4" hole in the end of the cap will restore its function. The remaining visible portions of the Johnson Tee were properly installed and functioning as intended.

- An electrician made changes to ensure there are no redundant GFCI outlets
- **KITCHEN > AIR GAP**
  - A hole has been drilled in the end of the cap.
- **BATHROOM > SINK**

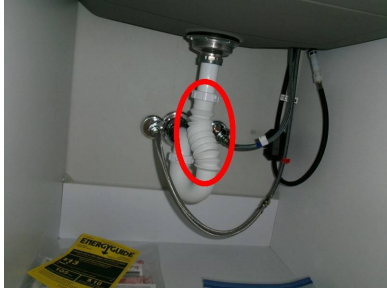
Improper, non-conforming material has been used for the laundry sink drain pipe fitting. This material will not function reliably. Replacement with industry standard fittings is recommended.

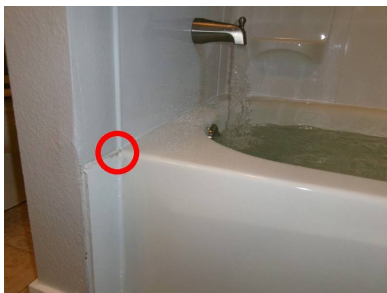
Testing of the water pipes included running water at multiple fixtures simultaneously. This test revealed a leak adjacent the bathtub. Repairs by a qualified plumbing contractor are recommended.

- The drain stops were added to both bathroom sinks.
- **PLUMBING SYSTEM > INTERIOR WATER SUPPLY LINES**
  - The bathtub leak has been repaired by the contractor that installed the bathtub surround

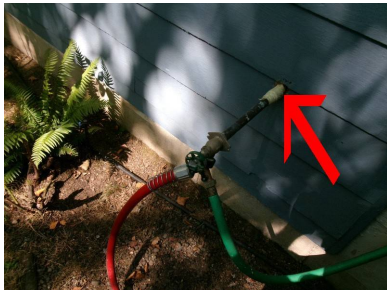
We observed a leak at the exterior hose bibb pipe. Repairs by a qualified plumbing contractor are recommended.

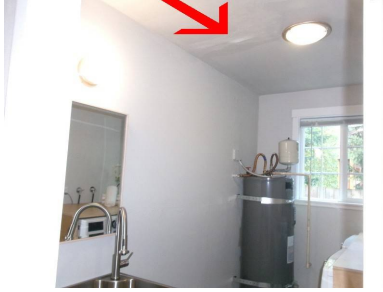
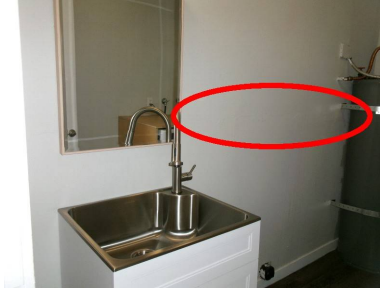
There are damages observed on the laundry room ceiling and wall from active plumbing leaks. A high level of moisture up to 6 inches above the surface of the floor was detected with the use of a non-invasive moisture meter at the time of the inspection. Removal of the wallboard to expose extent of damages and to allow for drying before repairs are performed is recommended.

- The ceiling and wall damage caused by the bathtub leak has been dried and repaired
- **BUILDING SITE > VEGETATION**
  - The vines have been removed from the siding but left on the chimney. Virginia creeper does not damage masonry like ivy does.

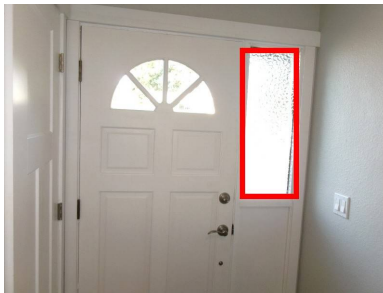
### WINDOWS

The glass adjacent the front door is not tempered safety glass. Tempered glass can be identified by the etched emblem in one corner of each pane. A higher margin of safety could be achieved if the glass was approved safety glass. Consideration should be given to replacing the glass as a safety upgrade.

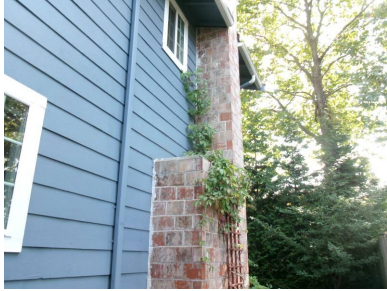
Vines are touching the building adjacent to the chimney. Vines can damage the roof, windows and other exterior

building components. Consideration should be given to removing vines that are attached to the house. Vines could be trellised away from the structure to allow for air flow.

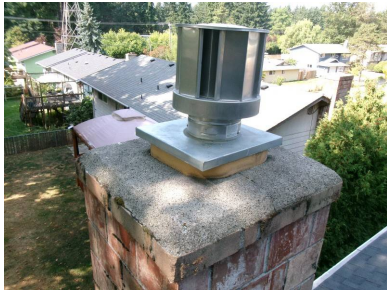
The chimney crown is cracked and moss was observed in several areas around the upper portion of the chimney. The mortar chimney crown prevents water from entering and damaging the masonry. We recommend removal of all organic growth. Repairing the chimney crown cracks will extend the service life of the chimney.

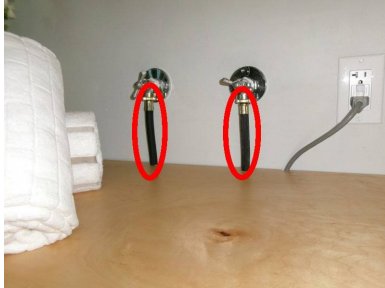
Upgrading the washer connections to high pressure (steel braided) lines is recommended.

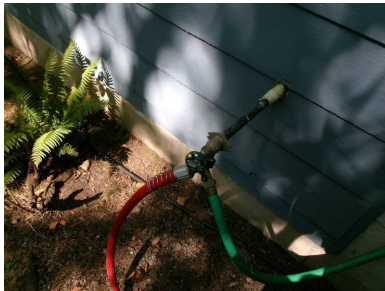
There are water pipes on the exterior of the house that will freeze in cold weather. These water pipes should be shut off and drained or protected via a thermostatically installed heat tape.

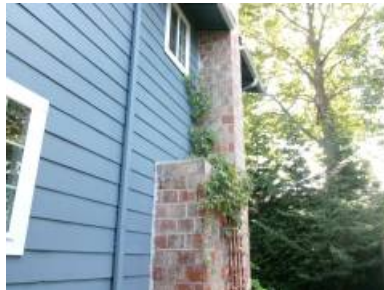
Vines are touching the building adjacent to the chimney. Vines can damage the roof, windows and other exterior building components. Consideration should be given to removing vines that are attached to the house. Vines could be trellised away from the structure to allow for air flow.

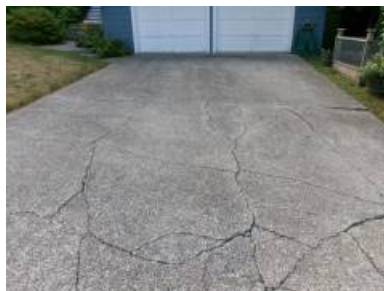
**DRIVEWAY** The driveway has cracked and settled differentially. This was probably caused by inadequate preparation of the soil prior to the placement of the concrete. We recommend removing and replacing it. The driveway remains functional despite this condition.

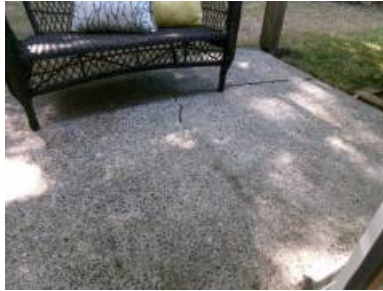
**PATIO** The patio has settled differentially. This was probably caused by inadequate preparation

of the soil prior to the placement of the concrete. This condition can be repaired by pressure grouting the sunken portion of the patio or by removing and replacing it. The patio remains functional despite this condition. However, the raised edges of the concrete can be a trip hazard for some people. Repairs should be made as necessary.

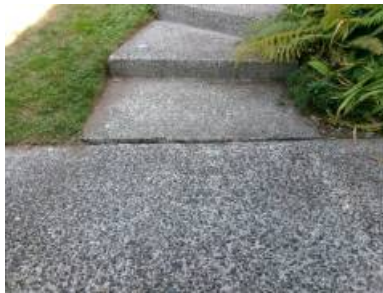
#### *WALKWAY*

The walkway has settled differentially. The walkway remains functional despite this condition. However, the raised edges of the concrete can be a trip hazard for some people. Grinding down the raised edges of the concrete will mitigate the hazard. Repairs should be made as necessary.

Many legal and public works departments have defined a trip hazard as an irregularity in a walking surface exceeding one inch (1") in height. All walking surfaces should maintain, free of a vertical surface change of 3/4" or more, in the interest of public and personal safety.

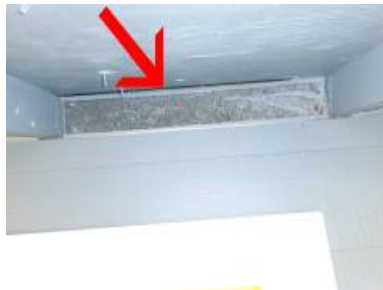
Gaps over 1/4" in size adjacent the soffit vent screens will allow insects and rodents to enter the attic. Covering any gaps with screening, a strip of wood and/or caulking is recommended.

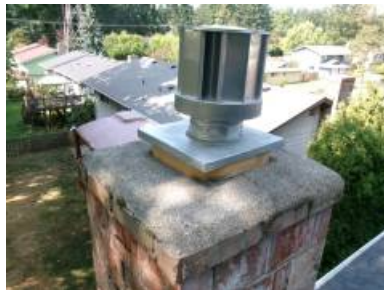
The chimney crown is cracked and moss was observed in several areas around the upper portion of the chimney. The mortar chimney crown prevents water from entering and damaging the masonry. We recommend removal of all organic growth. Repairing the chimney crown cracks will extend the service life of the chimney.

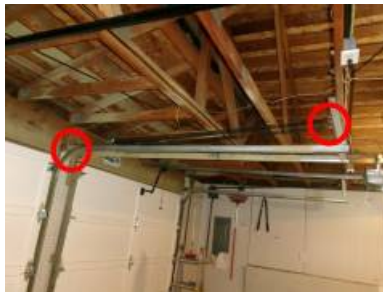
Safeties are cables run through the center of the garage door springs that prevent broken springs from becoming projectiles that can cause injury. There are no safeties installed. The installation of safeties is recommended.

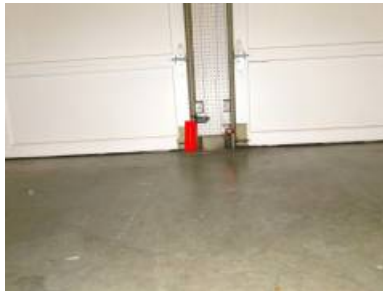
The Photo-eye beam was installed too high above the floor of the garage to adequately offer protection for small children and/or pets. We recommend that the photo-eye be lowered to within 4-6" of the floor.

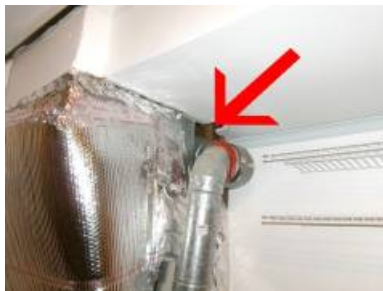
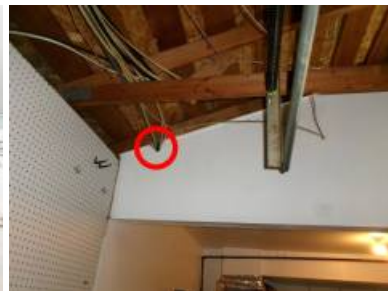
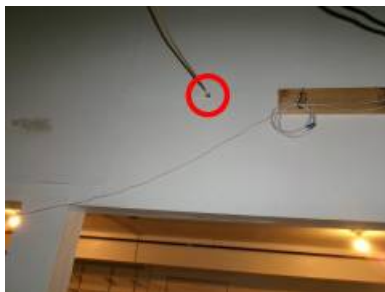
#### *FIRE SEPARATION*

There are voids in the fire resistive barrier between the living space and garage that will allow flames to penetrate. The gypsum barrier slows the spread of a fire from the garage to the structure and/or living space. Patching the voids with a fire retardant caulk is recommended.

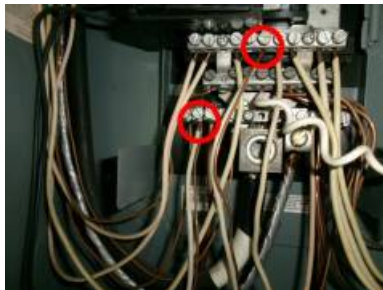
Several of the neutral wires are double tapped on the buss bar. Double tapping means that two conductors share a single terminal. Double tapped terminals can loosen and overheat and therefore are not permitted unless the terminal is specifically listed for multiple wires. This defect is easily repaired by connecting the two wires to a "pig tail", securing them with a wire cap, and then inserting the pig tail conductor under the terminal.

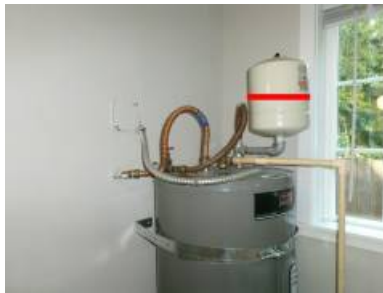
LOCATION OF UNIT	The water heater is located in the laundry room.
GENERAL INFORMATION	The water heater is electric. The capacity of the water heater is 50 gallons. The water heater is approximately 9 years old. Water heaters of this type typically last about 10-15 years.
PRESSURE RELIEF VALVE	The pressure relief valve is properly installed. The valve was not tested, as this could cause the valve to leak.
SHUTOFF VALVE	The shutoff valve for the water supply to the water heater is properly installed and is functioning as intended.
WATER CONNECTIONS TANK	AT The water connections at the tank are properly installed and are performing their intended function.
EXPANSION TANK	The expansion tank is not adequately secured to the wall. As code requirements start to call for engineered expansion tank supports we recommend the installation of seismic restraints to secure the expansion tank instead of allowing it to simply depend on piping connections that could result in damage to the water pipe and leakage during an earthquake.

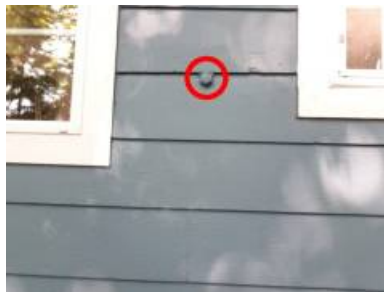
An air gap called a Johnson Tee is installed in the kitchen wall. This air gap protects the dishwasher from contamination caused by a backflow of waste water. The cap protruding on the exterior wall opposite the dishwasher is not drilled. This renders the air gap non-functional. Drilling a 1/4" hole in the end of the cap will restore its function. The remaining visible portions of the Johnson Tee were properly installed and functioning as intended.

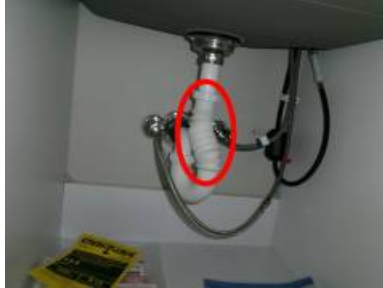
Improper, non-conforming material has been used for the laundry sink drain pipe fitting. This material will not function reliably. Replacement with industry standard fittings is recommended.

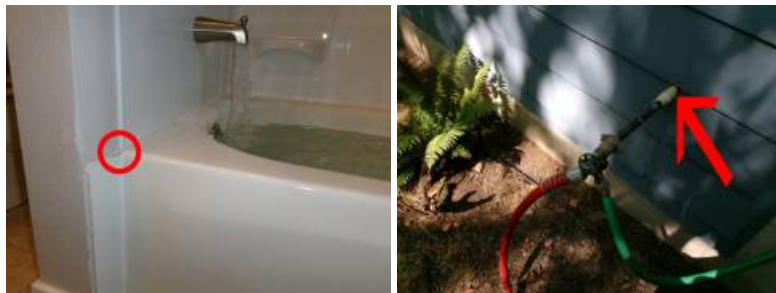
We observed a leak at the exterior hose bibb pipe. Repairs by a qualified plumbing contractor are recommended.

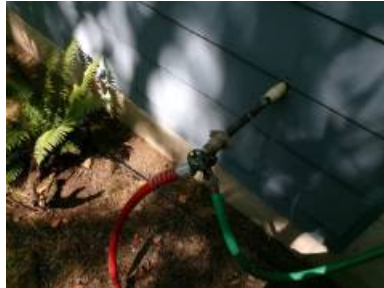
There are water pipes on the exterior of the house that will freeze in cold weather. These water pipes should be shut off and drained or protected via a thermostatically installed heat tape.

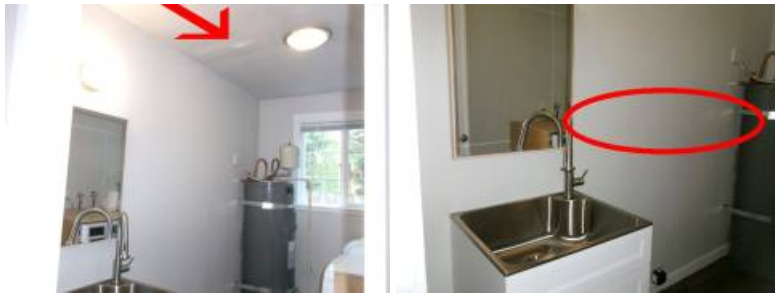
There are damages observed on the laundry room ceiling and wall from active plumbing leaks. A high level of moisture up to 6 inches above the surface of the floor was detected with the use of a non-invasive moisture meter at the time of the inspection. Removal of the wallboard to expose extent of damages and to allow for drying before repairs are performed is recommended.

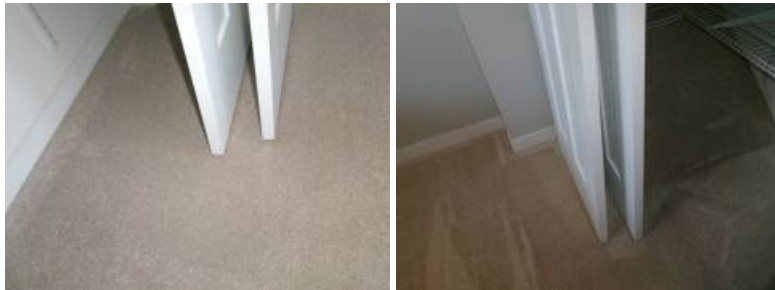
The floor guides are missing from the bypass closet doors in the bedroom. Missing floor guides could result in damage to the doors. The installation of floor guides is recommended.

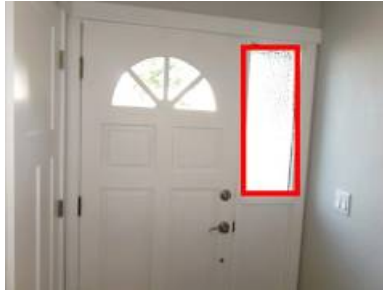
to replacing the glass as a safety upgrade.
