September 9, 2025

Re: 12900 182nd Ave. NE
Redmond, WA.

At your request, a visual inspection of the above referenced property was conducted on 09/08/2025. We have inspected the major structural components, plumbing, heating and electrical systems for signs of significant non-performance, excessive or unusual wear and general state of repair.

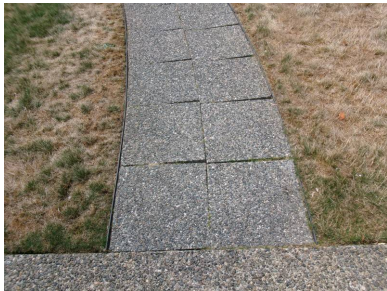
WALKWAY

The gaps adjacent the walkway pavers are trip hazards. This was probably caused by placement of the masonry. This condition can be repaired by filling the gaps, modifying the pavers or removing and replacing them. The walkway remains functional despite this condition. However, the gaps adjacent the concrete pavers can be a trip hazard for some people. Repairs should be made as necessary.

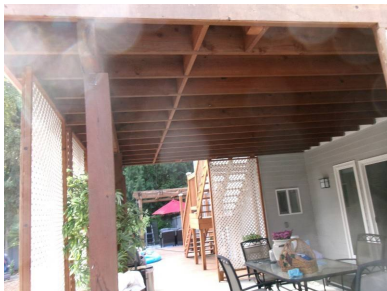
The deck structure lacks lateral bracing. The installation of a diagonal brace underneath the deck is recommended.'

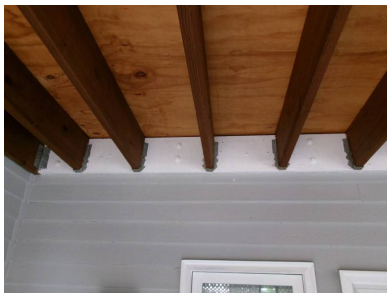
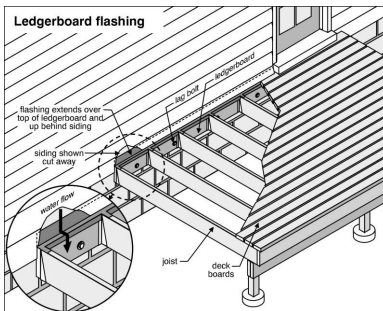
There is no flashing at the intersection between the deck and house. This will allow water to enter behind the siding. The installation of flashing in this area is recommended.

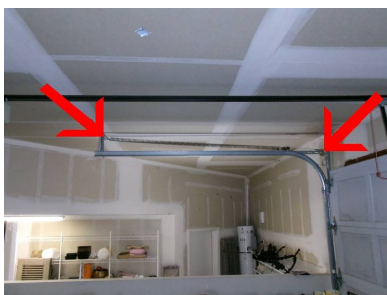
Safeties are cables run through the center of the garage door springs that prevent broken springs from becoming projectiles that can cause injury. There are no safeties installed. The installation of safeties is recommended.

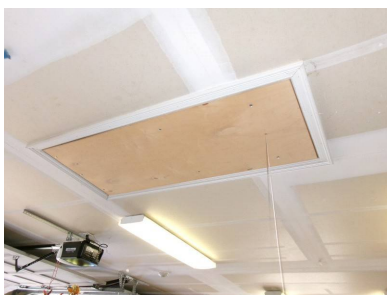
The cover for the attic access is missing. This is a safety concern. The gypsum barrier on the ceiling slows the spread of a fire from the garage to the attic. The installation of an access cover is recommended.

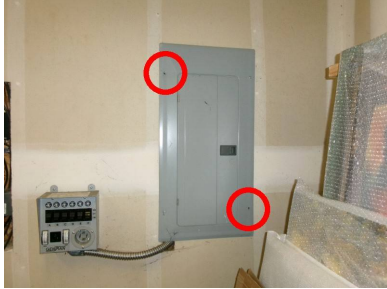
Screws that secure the panel cover to the panel box are missing. This is a potential hazard. Missing screws should be replaced with the original style blunt end screws.

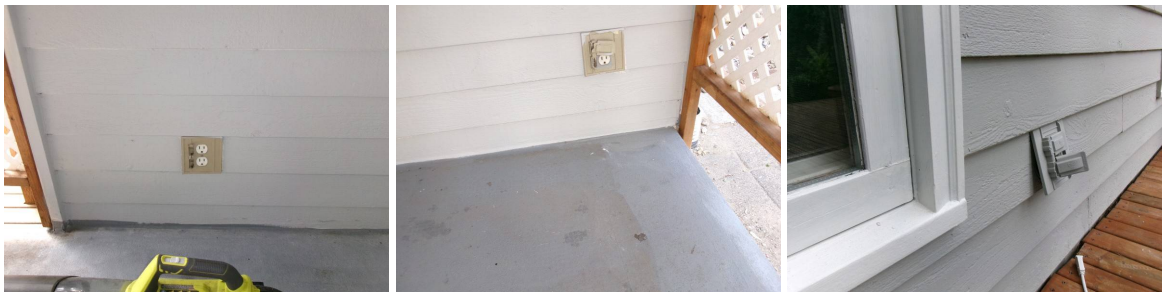
Several of the cover plates are damaged at exterior receptacles. This is a shock and fire hazard. The installation of weather tight cover plates is recommended.

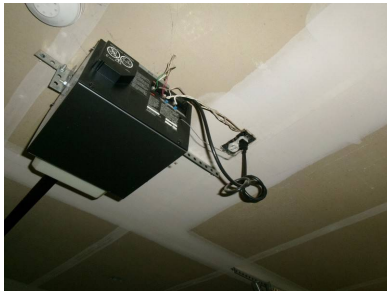
The cover plate is missing from a receptacle in the garage ceiling. This is a shock and fire hazard. The installation of a cover plate is recommended.

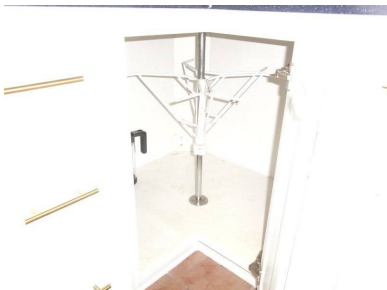
The lazy susan is damaged and in need of repair.

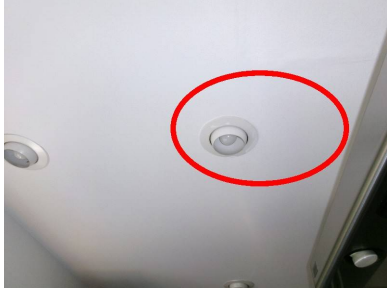
The overflow drain for the bathtub is leaking and draining thru one of the kitchen ceiling luminaries. This can cause damage to the framing and/or finished surfaces. Repairs should be performed before the tub is used.

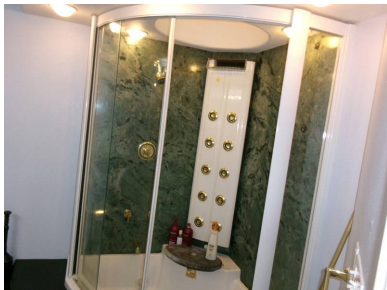
The glass door is in serviceable condition. However a panel is missing. Repair or replacement of the enclosure is recommended.

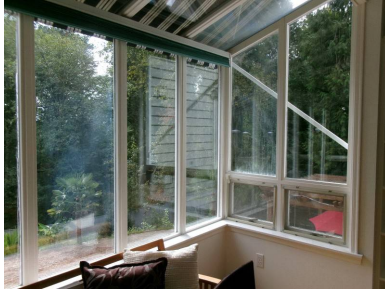
There is condensation or mineral deposits between the panes of glass in several of the insulated glass windows. This indicates failed seals. The glass assemblies should be replaced, which is the only method for correcting this deficiency.

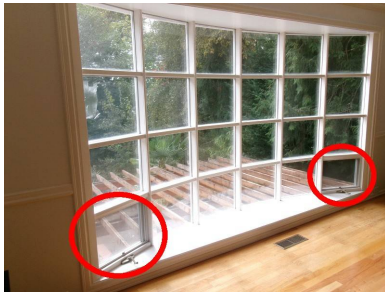
The lower window glass is not labeled as tempered safety glass. The existing glass is nonconforming by current building standards and would be hazardous if broken. The installation of safety glass is recommended as a safety upgrade for all windows less than 18" from the walking surface.

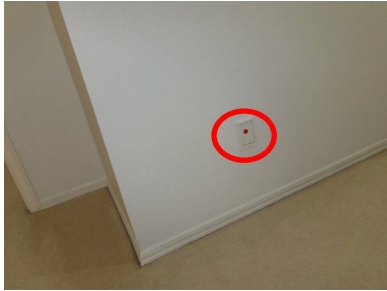
Each inlet of the built-in vacuum system was tested. Reasonable suction was observed at each inlet, all except one in the upper floor hallway were functioning as intended.

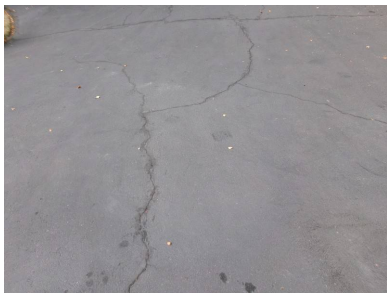
Cracks were observed in the asphalt surface of the driveway. Minor cracks can be sealed to minimize vegetation establishment, moisture entry, and further settlement of the asphalt. Minor cracks are common and do not affect the serviceability of the asphalt.

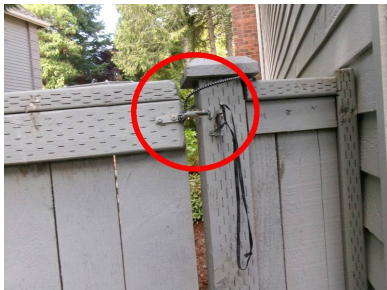
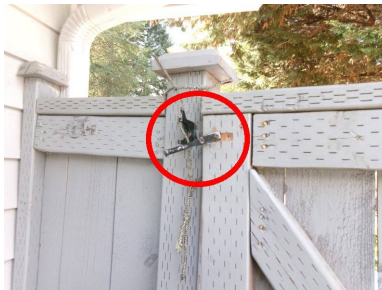
The gates need repair, hardware should be adjusted or replaced as necessary to restore full function.

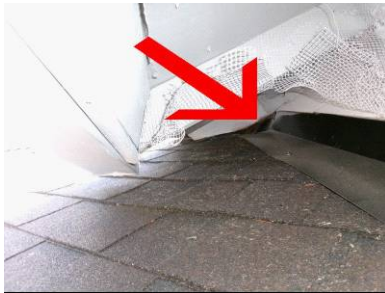
Gaps over 1/4" in size adjacent the soffit vent blocks will allow insects and rodents to enter the attic. Covering the gaps with screening, a strip of wood and/or caulking is recommended.

Gap at the house overhang above the garage

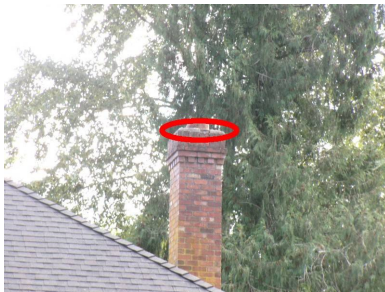
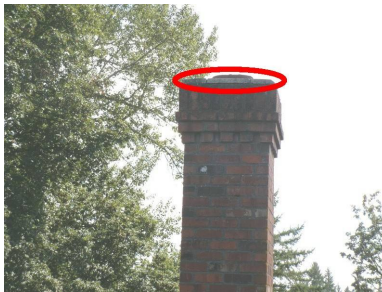
The chimney crowns are cracked and deteriorated. The mortar chimney crowns prevent water from entering and damaging the masonry. Repairing or replacing the chimney crowns will extend the service life of the chimneys.

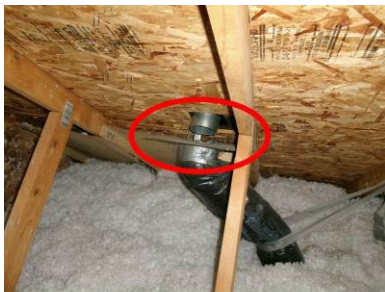
We observed two of the duct collars for the bathroom vent fans have become detached in the attic. This allows for pest entry and/or moisture laden air to be discharged in the attic rather than outside. This is an undesirable condition that causes excessive moisture in the attic and can result in mold or fungus growth. The ducts should be reconnected and secured.

Vent collar unsecured

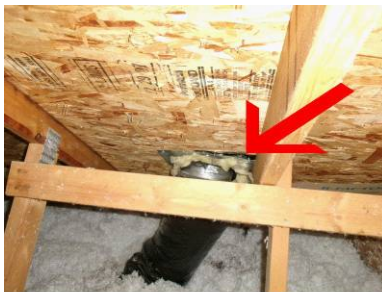
Vent collar detached

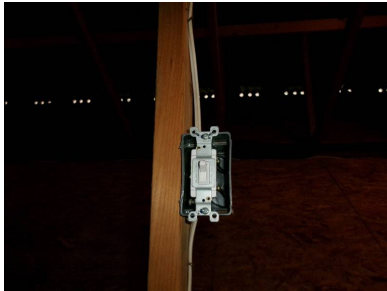
The cover plate is missing from the wall switch in the garage attic. This is a shock and fire hazard. The installation of a cover plate is recommended.

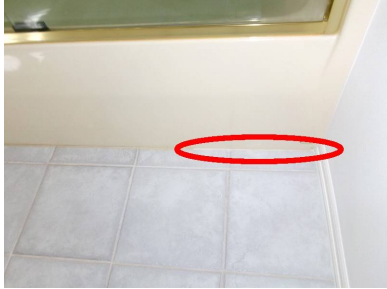
A portion of the caulking is missing at the intersection between the tub/shower and floor. Cracking of the grout can lead to water damage to the flooring and substrate. Caulking this area is recommended.

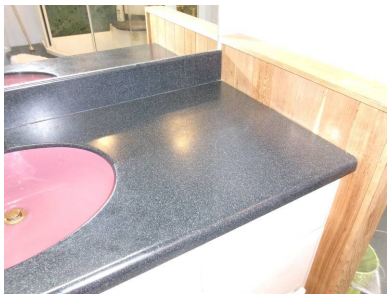
The side backsplash is missing. The installation of a backsplash is recommended.

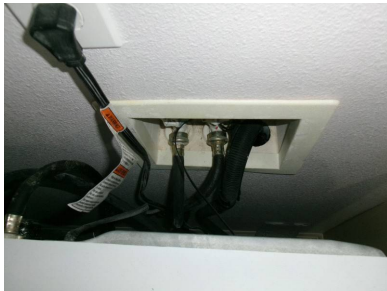
Upgrading the washer connections to high pressure (steel braided) lines is recommended.

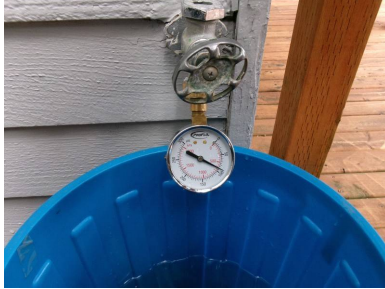
The water pressure at 90 PSI is excessive. The normal range is 30-80 PSI. High water pressure can result in leaking valves, detached supply tubes, water hammer and is hard on solenoid valves. Consideration should be given to the installation of a pressure reduction valve.

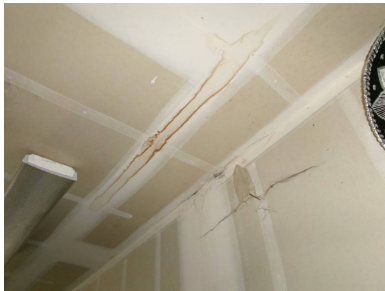
We observed damage to the surface of the ceiling in the garage. Testing the observed areas with a moisture meter revealed no moisture present at the time of the inspection. The damages to the surfaces appear to be from old roof leaks. Damages are cosmetic and repairs are optional.

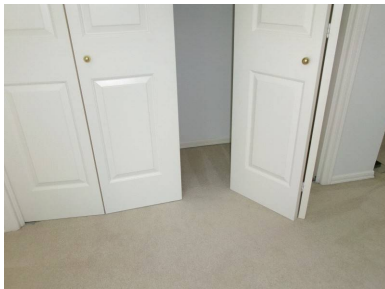
The bifold closet doors rub on the carpet. This can damage the carpet or bifold hardware and prevents air circulation under the door. Doors should be undercut 3/4".

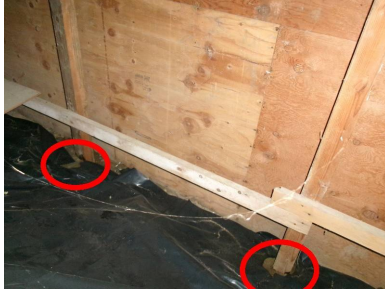
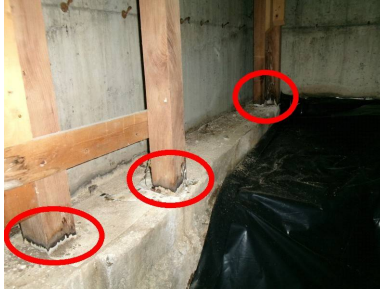
Water seeping into the crawlspace over the footing saturates the bottoms of the support posts. This has caused the bottoms of some of the posts to rot. Damaged posts should be replaced. The remaining posts should be treated with wood preservative.

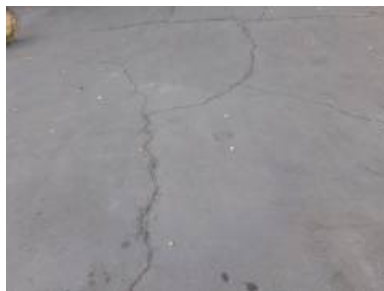
Cracks were observed in the asphalt surface of the driveway. Minor cracks can be sealed to minimize vegetation establishment, moisture entry, and further settlement of the asphalt. Minor cracks are common and do not affect the serviceability of the asphalt.

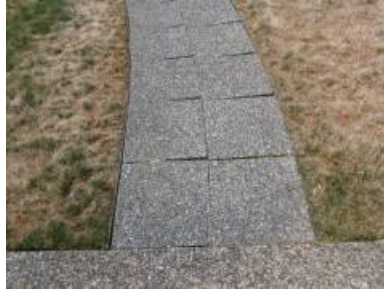
Many legal and public works departments have defined a trip hazard as an irregularity in a walking surface exceeding one inch (1") in height. All walking surfaces should maintain, free of a vertical surface change of 3/4" or more, in the interest of public and personal safety.

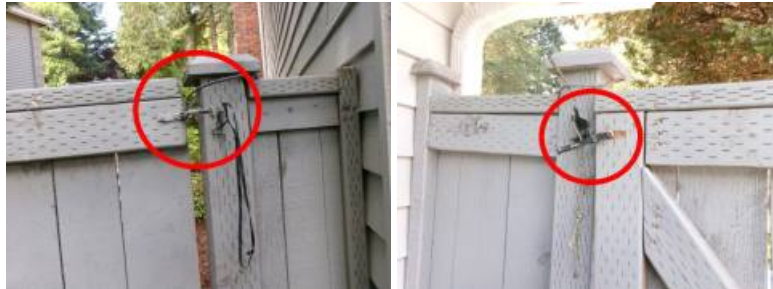
The gates need repair, hardware should be adjusted or replaced as necessary to restore full function.

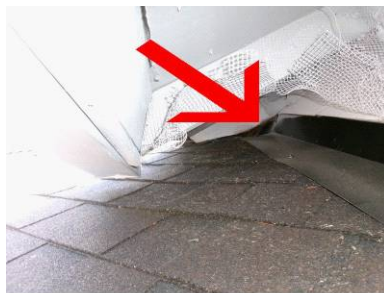
Gaps over 1/4" in size adjacent the soffit vent blocks will allow insects and rodents to enter the attic. Covering the gaps with screening, a strip of wood and/or caulking is recommended.

Gap at the house overhang above the garage

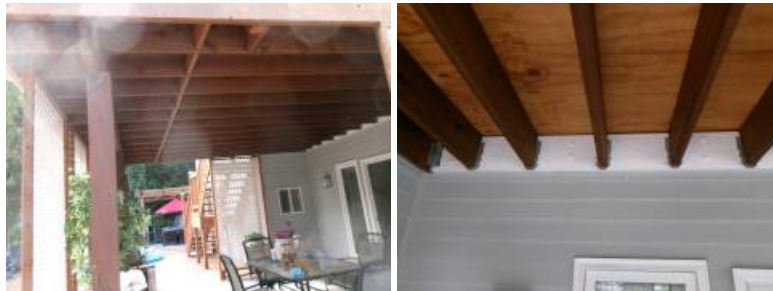
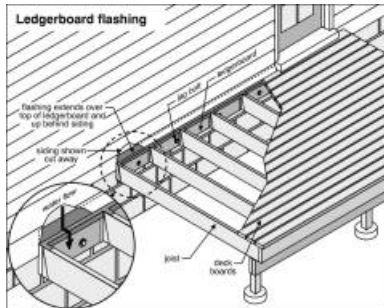
The lower deck is installed close to the ground making it more vulnerable to deterioration. The proximity of the deck to the ground also prevented an inspection of the deck framing. The visible portions of the deck are in good condition.

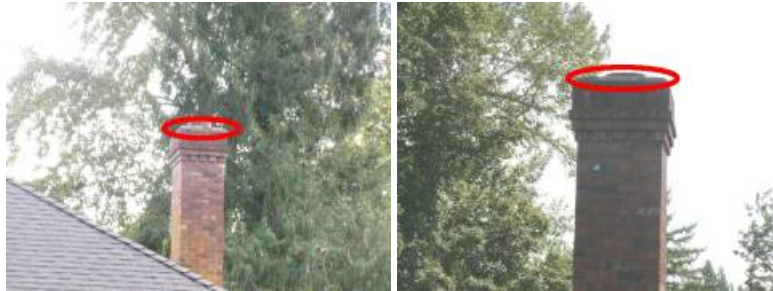
The chimney crowns are cracked and deteriorated. The mortar chimney crowns prevent water from entering and damaging the masonry. Repairing or replacing the chimney crowns will extend the service life of the chimneys.

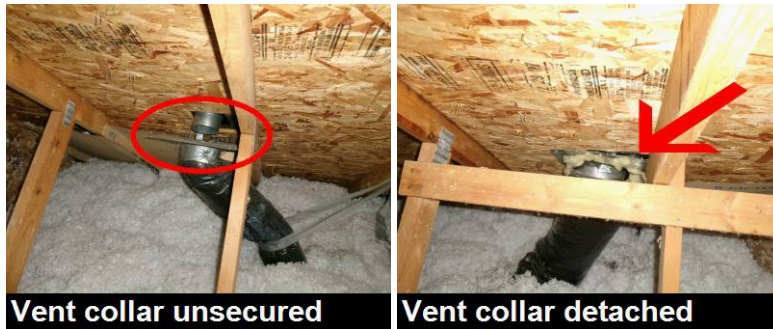
We observed two of the duct collars for the bathroom vent fans have become detached in the attic. This allows for pest entry and/or moisture laden air to be discharged in the attic rather than outside. This is an undesirable condition that causes excessive moisture in the attic and can result in mold or fungus growth. The ducts should be reconnected and secured.

Vent collar unsecured

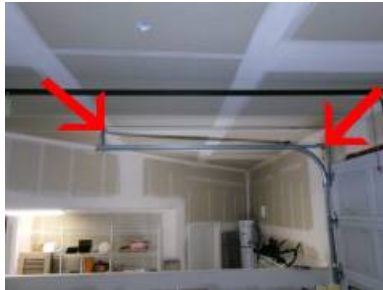
Safeties are cables run through the center of the garage door springs that prevent broken springs from becoming projectiles that can cause injury. There are no safeties installed. The installation of safeties is recommended.

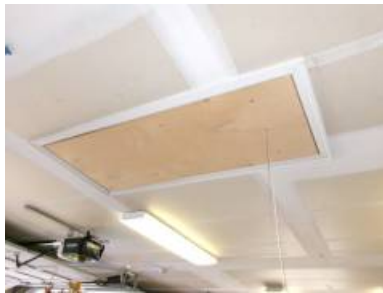
The cover for the attic access is missing. This is a safety concern. The gypsum barrier on the ceiling slows the spread of a fire from the garage to the attic. The installation of an access cover is recommended.

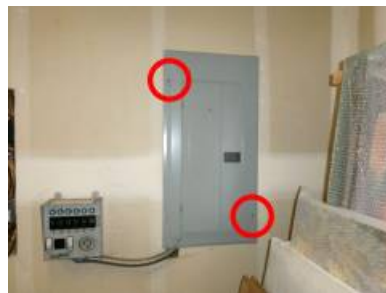
Screws that secure the panel cover to the panel box are missing. This is a potential hazard. Missing screws should be replaced with the original style blunt end screws.

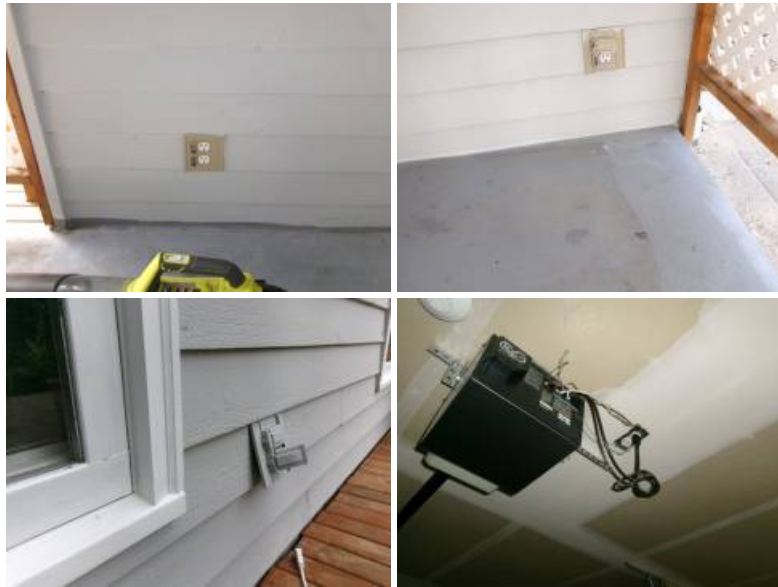
The cover plate is missing from a receptacle in the garage ceiling This is a shock and fire hazard. The installation of a cover plate is recommended.

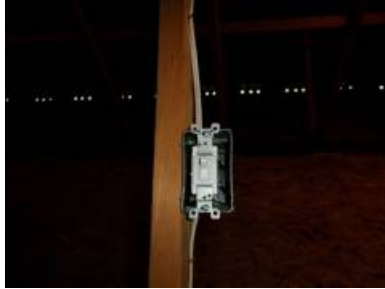
The cover plate is missing from the wall switch in the garage attic. This is a shock and fire hazard. The installation of a cover plate is recommended.

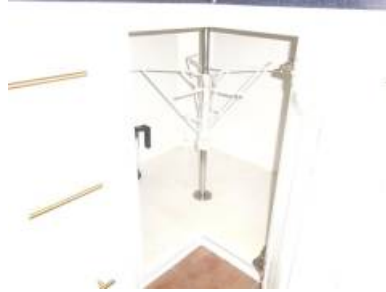
The lazy susan is damaged and in need of repair.

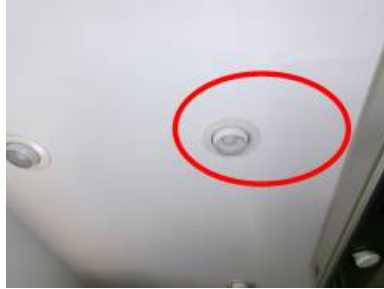
The overflow drain for the bathtub is leaking and draining thru one of the kitchen ceiling luminaries. This can cause damage to the framing and/or finished surfaces. Repairs should be performed before the tub is used.

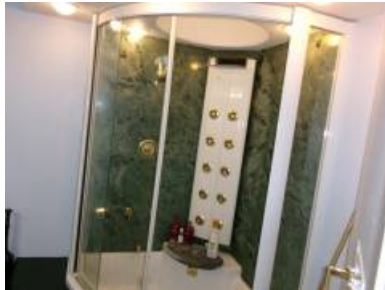
The glass door is in serviceable condition. However a panel is missing. Repair or replacement of the enclosure is recommended.

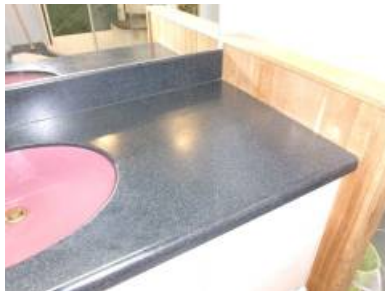
The side backsplash is missing. The installation of a backsplash is recommended.

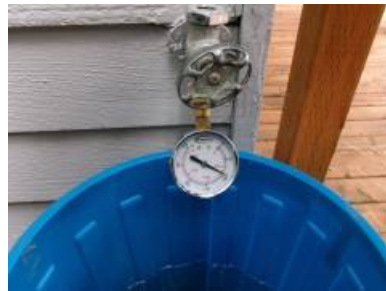
- WATER PRESSURE* The water pressure at 90 PSI is excessive. The normal range is 30-80 PSI. High water pressure can result in leaking valves, detached supply tubes, water hammer and is hard on solenoid valves. Consideration should be given to the installation of a pressure reduction valve.

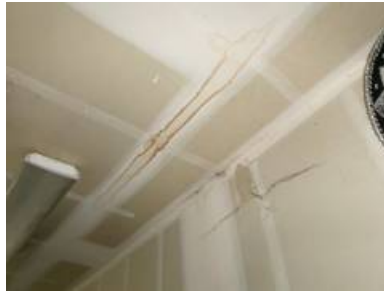
We observed damage to the surface of the ceiling in the garage. Testing the observed areas with a moisture meter revealed no moisture present at the time of the inspection. The damages to the surfaces appear to be from old roof leaks. Damages are cosmetic and repairs are optional.

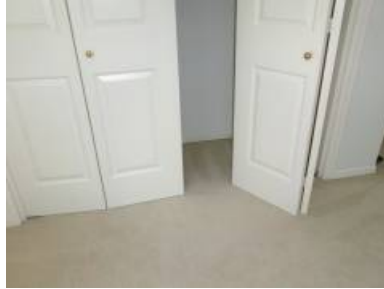
The bifold closet doors rub on the carpet. This can damage the carpet or bifold hardware and prevents air circulation under the door. Doors should be undercut 3/4".

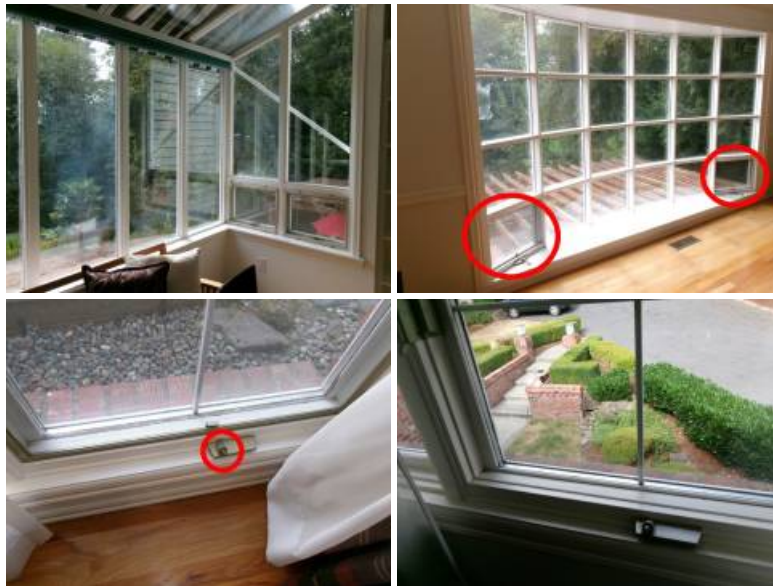
Several of the windows are missing cranks. Missing cranks should be replaced so that the window can be opened and closed.

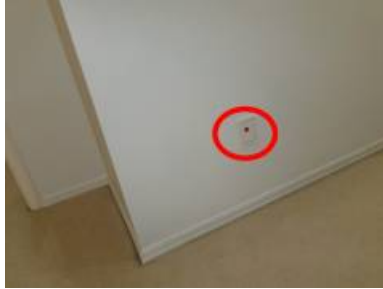
Each inlet of the built-in vacuum system was tested. Reasonable suction was observed at each inlet, all except one in the upper floor hallway were functioning as intended.

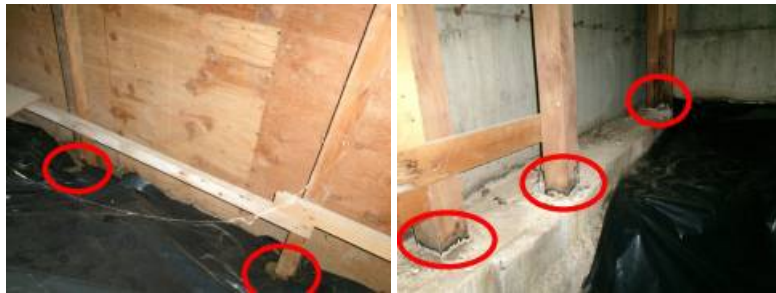
Water seeping into the crawlspace over the footing saturates the bottoms of the support posts. This has caused the bottoms of some of the posts to rot. Damaged posts should be replaced. The remaining posts should be treated with wood preservative.
