NOTICE TO BUYER: SELLER-PROCURED INSPECTION REPORT

Lauren and Jan Smrcina
2232 168th AVE NE
Bellevue, WA 98008

At your request, a visual inspection of the above referenced property was conducted on 10/03/2025. We have inspected the major structural components, plumbing, heating and electrical systems for signs of significant non-performance, excessive or unusual wear and general state of repair.

DATE OF INSPECTION: 10/3/2025.
 INSPECTOR'S NAME: Terry Clark.
 CLIENT NAME: Mr. & Ms. Lauren & Jan Smrcine.
 CLIENT E-MAIL ADDRESS: thesmrcinas@gmail.com laurenkatherina@gmail.com.
 ADDRESS OF PROPERTY: 2232 168th Ave NE
 INSPECTED: Bellevue, WA.

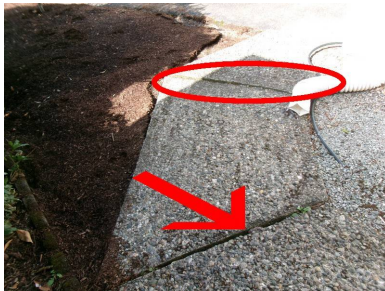
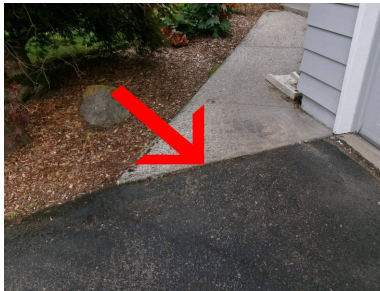
The gaps separating the concrete walkway sections are a trip hazard. Replacement with mortar is recommended.

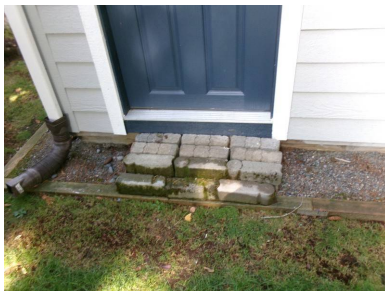
The outbuilding door step is loose. This is a potential safety hazard. Steps should be installed as necessary to prevent settlement and/or tipping of the steps.

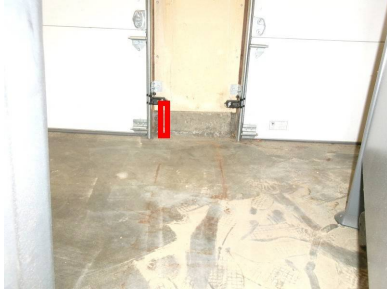
The Photo-eye beams were installed too high above the floor of the garage to adequately offer protection for small children and/or pets. We recommend that the photo-eyes be lowered to within 4-6" of the floor.

Garage door sensors - Photo beam sensors are 4-6" above floor and are operating per spec

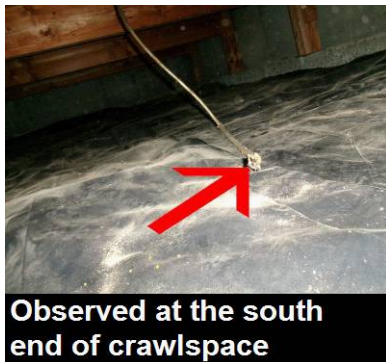
There is an abandoned electrical cable in the crawlspace and several above the service panel in the garage. The cables are not energized however they should be terminated in a covered junction boxes or removed.

Electrical - removal of non-energized cable in crawl space, replacement of power source for garage door. Repaired GFCI receptacle in kitchen.

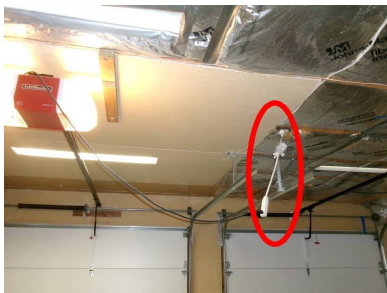
An extension cord is used as a temporary power source for the garage door openers. An extension cord is not suitable as a permanent wiring method. The installation of a receptacle within cords length of the motors is recommended.

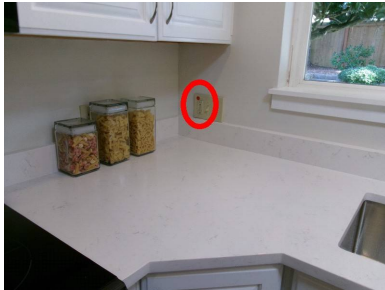
The GFCI receptacle in the kitchen on the east wall does reset when a ground fault is introduced. This is caused by an improperly wired or defective GFCI. Repair or replacement of this GFCI is recommended.

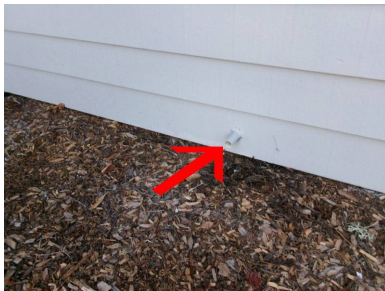
The end of the pressure relief valve drain pipe terminates horizontally rather than vertically. This is a hazard. The installation of an elbow on the end of the drain pipe that directs discharge towards the ground is recommended.

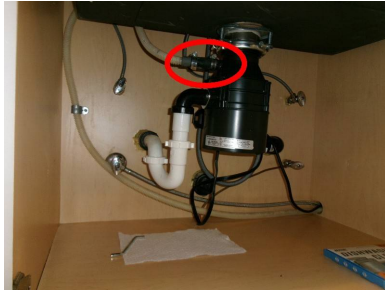
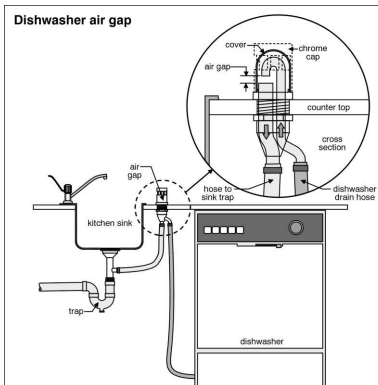
The dishwasher drain lacks an air gap. The dishwasher will function without one, but there is a risk of contamination of the inside of the dishwasher by waste water. The installation of an air gap above the flood rim of the sink is recommended.

Dishwasher air gap - installation above sink

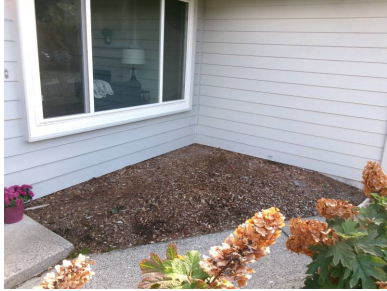
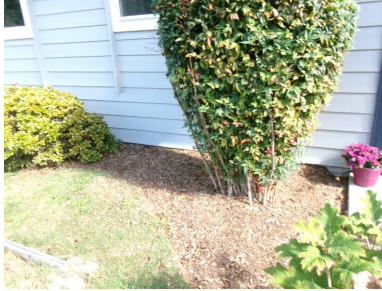
Landscaping soils are close to or in contact with siding in some areas around the building exterior. Good building practice requires that foundation walls or pier footings supporting wood frame construction, extend at least 8" above the finish grade with at least a 6" clearance between the top of the soil and the bottom of the wood finish materials. Soil in direct contact with wood creates a hospitable environment for wood destroying organisms. Establishing these minimum clearances is recommended.

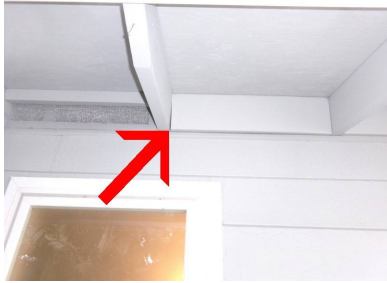
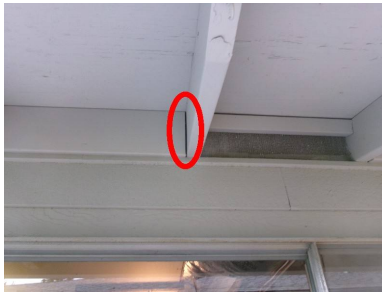
There are large gaps over 1/4" in size adjacent the soffit vent blocks. These gaps allow insects and rodents to enter the attic. Covering the gaps with screening, a strip of wood and/or caulking is recommended.

Soffits- caulking and covering gaps

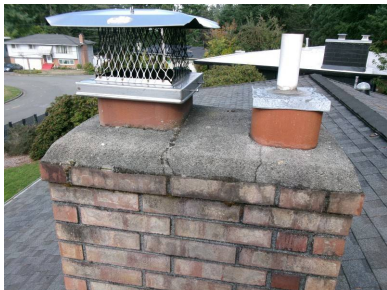
The chimney crown is cracked. The mortar chimney crown prevents water from entering and damaging the masonry. Repairing or replacing the chimney crown will extend the service life of the chimney.

Moss/vegetation was observed in several areas around the upper portion of the chimney. This will lead to accelerated deterioration of the brick masonry mortar. We recommend removal of all organic growth.

Chimney - replacement of cracked crown, removal of moss/vegetation

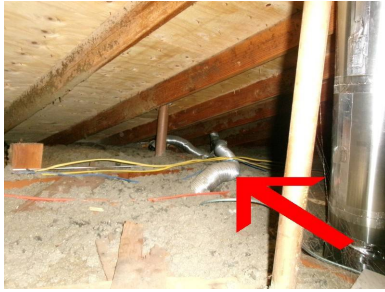
Flexible plastic duct is used to direct air from the vent fan to the exterior. This type of material is unreliable. Replacing the plastic duct with 4" smooth-wall sheet metal duct is recommended.

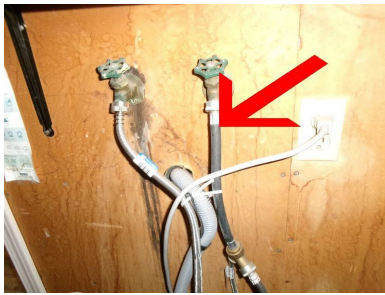
Upgrading both of the washer connections to high pressure (steel braided) lines is recommended.

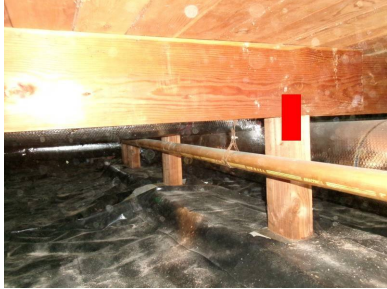
There are no visible positive connections tying the center posts and beams together. The installation of gusset plates is recommend to reduce the likelihood of damage during an earthquake.

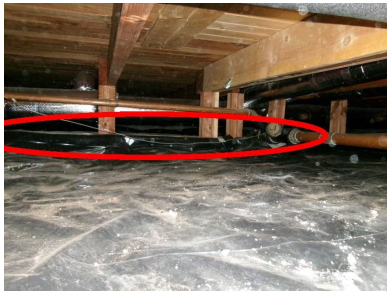
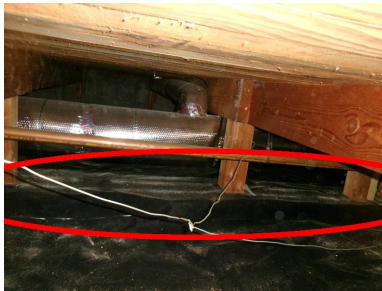
The support post concrete piers are covered with the plastic vapor retarder. This allows the transmission of water vapor from the soil up and into the floor framing. The plastic vapor retarder should be removed from the pier so that it covers at least 85% of the entire surface of the soil only.

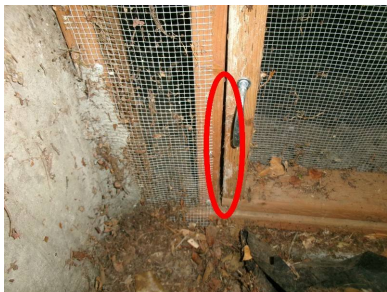
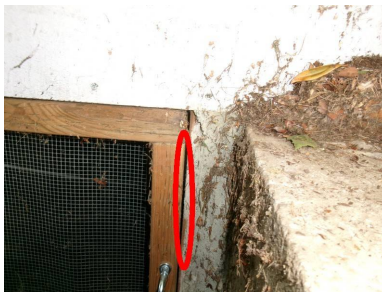
The crawlspace access door is not rodent proof. The installation of a tight fitting access door is recommended to exclude rodents from the crawlspace.

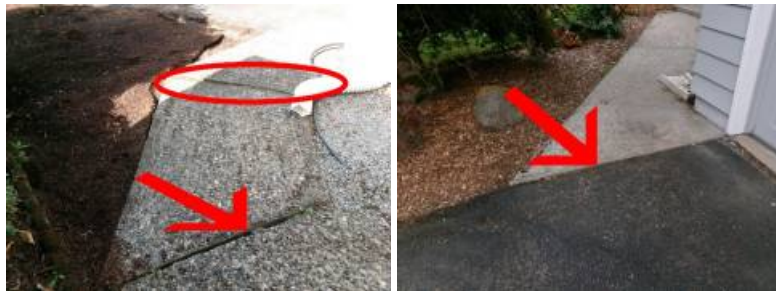
The gap separating the concrete walkway and asphalt driveway is a trip hazard. Filling the gap with mortar would mitigate the hazard.

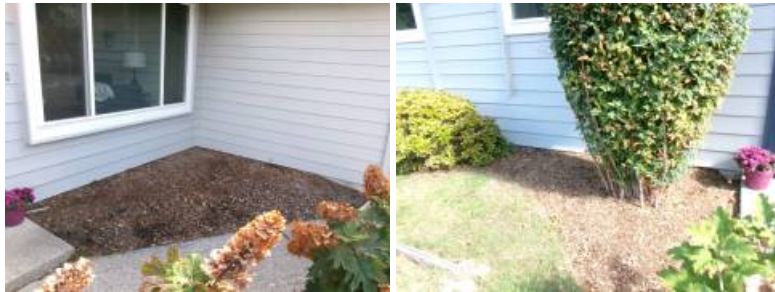
PEST CONTROL Landscaping soils are close to or in contact with siding in some areas around the building exterior. Good building practice requires that foundation walls or pier footings supporting wood frame construction, extend at least 8" above the finish grade with at least a 6" clearance between the top of the soil and the bottom of the wood finish materials. Soil in direct contact with wood creates a hospitable environment for wood destroying organisms. Establishing these minimum clearances is recommended.

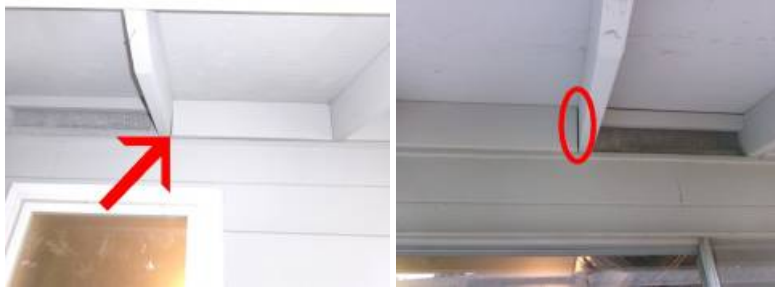
There are large gaps over 1/4" in size adjacent the soffit vent blocks. These gaps allow insects and rodents to enter the attic. Covering the gaps with screening, a strip of wood and/or caulking is recommended.

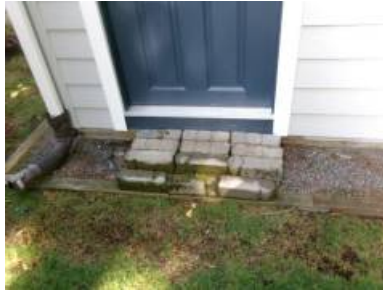
The outbuilding door step is loose. This is a potential safety hazard. Steps should be installed as necessary to prevent settlement and/or tipping of the steps.

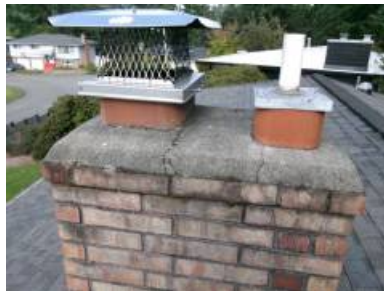
Moss/vegetation was observed in several areas around the upper portion of the chimney. This will lead to accelerated deterioration of the brick masonry mortar. We recommend removal of all organic growth.

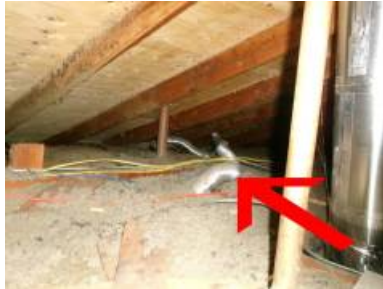
Flexible plastic duct is used to direct air from the vent fan to the exterior. This type of material is unreliable. Replacing the plastic duct with 4" smooth-wall sheet metal duct is recommended.

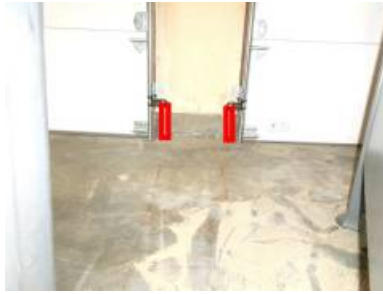
The Photo-eye beams were installed to high above the floor of the garage to adequately offer protection for small children and/or pets. We recommend that the photo-eyes be lowered to within 4-6" of the floor.

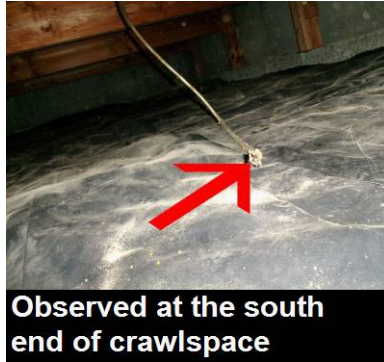
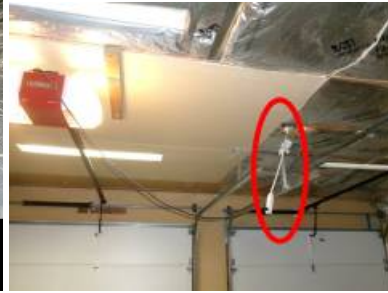
<i>SUBPANEL</i>		The subpanel is properly installed and in serviceable condition. The circuits are labeled. The accuracy of the labeling was not verified. Do not assume the labeled circuit is off unless it has been checked with a voltage tester.
<i>OVER CURRENT PROTECTION</i>		Circuit breakers are used for over current protection. The circuit breakers are properly installed and the ampacity of the connected wires is compatible with that of the circuit breakers. The circuit breakers were not tested.
<i>WIRING</i>		The visible portions of the wiring are properly installed except where noted below. There is an abandoned electrical cable in the crawlspace and several above the service panel in the garage. The cables are not energized however they should be terminated in a covered junction boxes or removed. An extension cord is used as a temporary power source for the garage door openers. An extension cord is not suitable as a permanent wiring method. The installation of a receptacle within cords length of the motors is recommended.

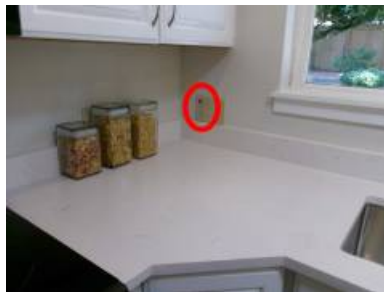
The GFCI receptacle in the kitchen on the east wall does reset when a ground fault is introduced. This is caused by an improperly wired or defective GFCI. Repair or replacement of this GFCI is recommended.

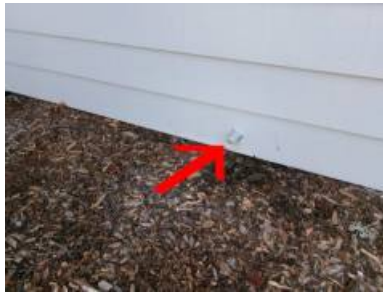
The end of the pressure relief valve drain pipe terminates horizontally rather than vertically. This is a hazard. The installation of an elbow on the end of the drain pipe that directs discharge towards the ground is recommended.

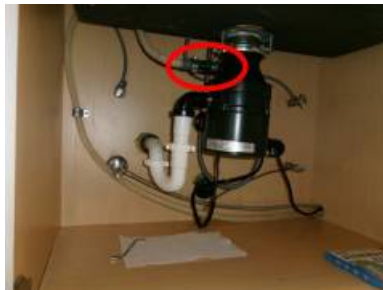
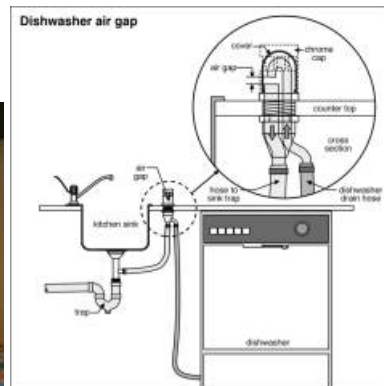
<i>AIR GAP</i>	The dishwasher drain lacks an air gap. The dishwasher will function without one, but there is a risk of contamination of the inside of the dishwasher by waste water. The installation of an air gap above the flood rim of the sink is recommended.

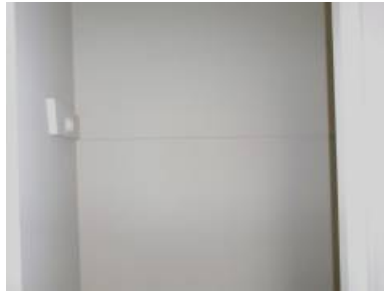
The closet package is missing from the bedrooms. Replacement of the missing closet rod(s) and/or shelves is recommended.

Closet doors - installation of closet rods and/or shelves

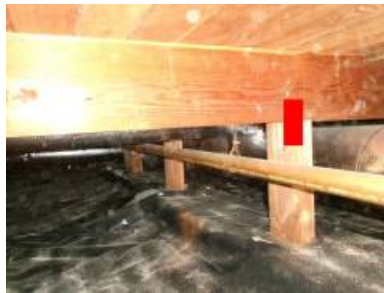
There are no visible positive connections tying the center posts and beams together. The installation of gusset plates is recommend to reduce the likelihood of damage during an earthquake.

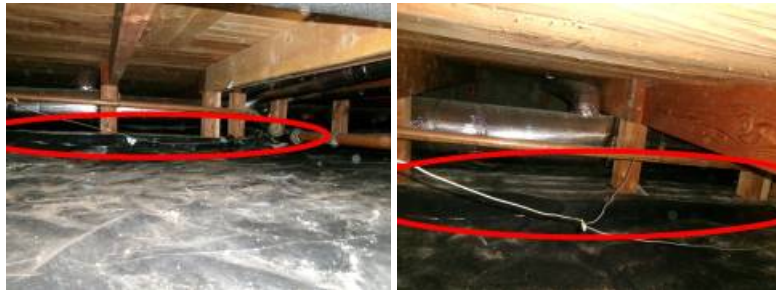
The support post concrete piers are covered with the plastic vapor retarder. This allows the transmission of water vapor from the soil up and into the floor framing. The plastic vapor retarder should be removed from the pier so that it covers at least 85% of the entire surface of the soil only.

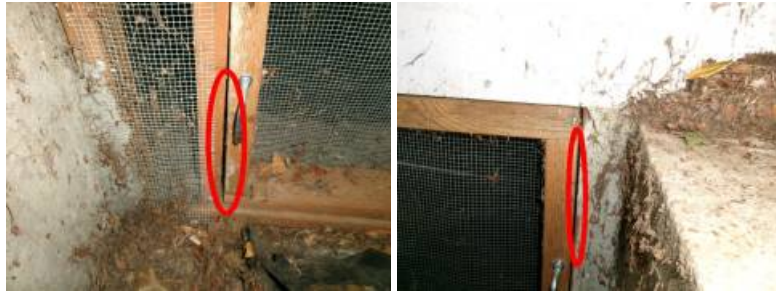
Good building practice requires that foundation walls or pier footings supporting wood frame construction, should extend at least 8" above the finish grade with at least a 6" clearance between the top of the soil and the bottom of the wood finish materials. Untreated wood should be raised 1-2" above surrounding flatwork and should have a moisture barrier such as 30 lb. asphalt impregnated felt installed between the concrete and wood. For additional information and treatment options, you should retain the services of a qualified pest control operator.
