February 10, 2021

Re: 13813 177th Pl. NE
Redmond, WA.

REPORT SUMMARY

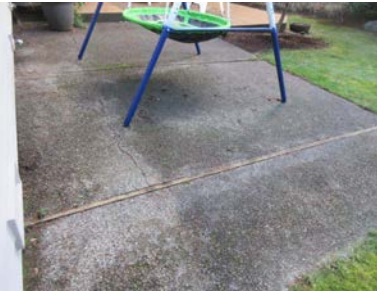
2.5 PATIO

One or more of the wooden dividers separating the concrete patio sections were infested by wood destroying organisms and have deteriorated to a point where they are becoming a trip hazard. Replacement with mortar is recommended.

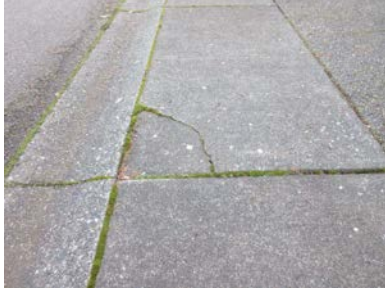
2.6 WALKWAY

One or more of the wooden dividers separating the concrete walkway sections were infested by wood destroying organisms and have deteriorated to a point where they are becoming a trip hazard. Replacement with mortar is recommended.

The front walkway has cracked and settled differentially. This was probably caused by inadequate preparation of the soil prior to the placement of the concrete. This condition can be repaired by pressure grouting the sunken portion of the walkway or by removing and replacing it. Grinding down the raised edges of the concrete will also mitigate the hazard. The walkway remains functional despite this condition. However, the raised edges of the concrete can be a trip hazard for some people. Repairs should be made as necessary.

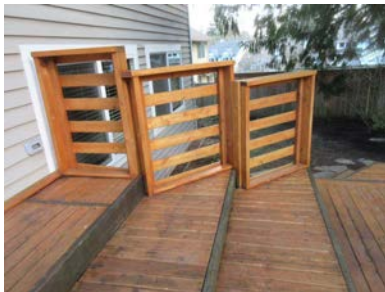
3.8 DECK RAILINGS

The spacing between the balusters is too wide. This is a hazard to small children. The balusters should be spaced close enough together so that a 4" sphere cannot pass through. Upgrading the deck railing is recommended if small children are present.

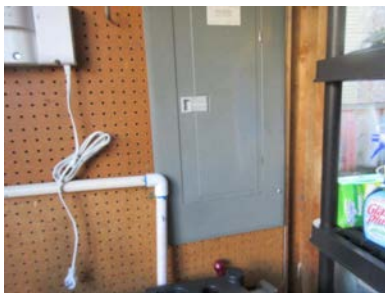
7.3 SERVICE PANEL LOCATION

Access to the electrical panel is blocked by water piping. Piping should be removed or modified so that there is a 30" wide by 36" deep by 7' tall clearance in front of the panel.

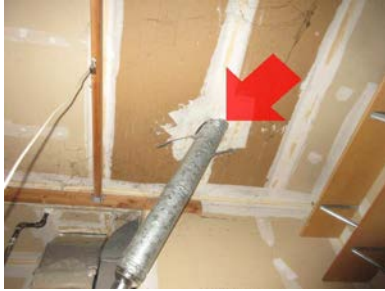
9.8 VENT

The water heater vent connector is too close to combustible material. The minimum clearance of 6" is required between the single wall vent connector and the combustible surface. The double wall type B vent requires only 1" of clearance.

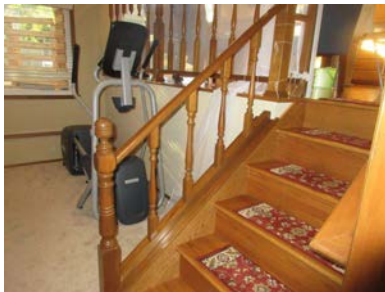
14.3 STAIRS

The stair railing baluster spacing is too wide. This is a hazard for small children. The baluster spacing should be reduced as a safety upgrade. Current standards require that a 4" sphere not pass through the railing.

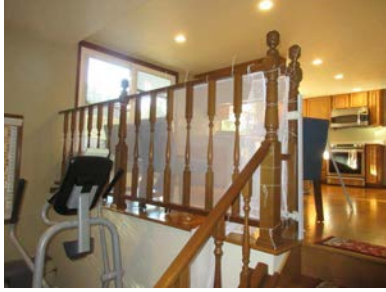
14.4 GUARD RAILINGS

The spacing between the balusters is too wide. This is a hazard to small children. The balusters should be spaced close enough together so that a 4" sphere cannot pass through. Upgrading the guard railing is recommended if small children are present.

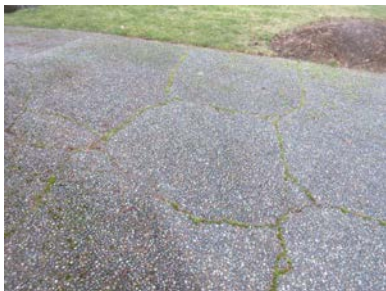
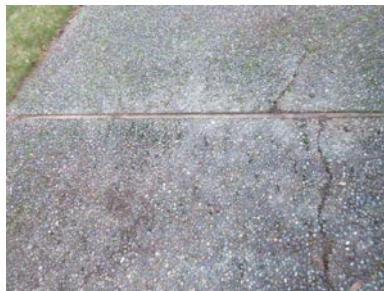
Cracks were observed in the concrete surface of the driveway. Minor cracks can be sealed to minimize moisture entry and further settlement of the concrete. Minor cracks are common and do not affect the serviceability of the concrete.

One or more of the wooden dividers separating the concrete driveway sections were infested by wood destroying organisms and have deteriorated to a point where they are becoming a trip hazard. Replacement with mortar is recommended.

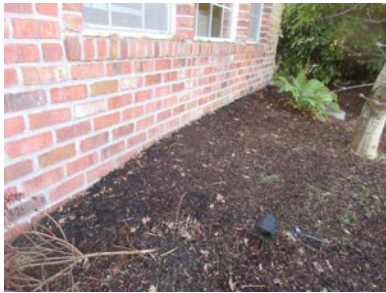
3.2 SECONDARY EXTERIOR WALL CLADDING

The brick is a veneer installed over the wood wall structure. It is not a structural component of the wall. Weep holes are missing or are covered at the bottom of the masonry wall. This allows moisture to become trapped behind the brick. Weep holes are recommended to mitigate moisture damage.

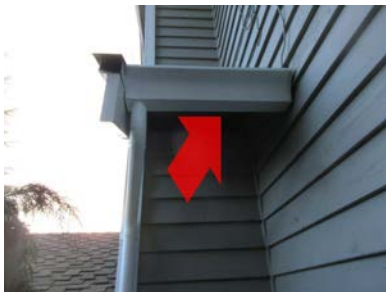
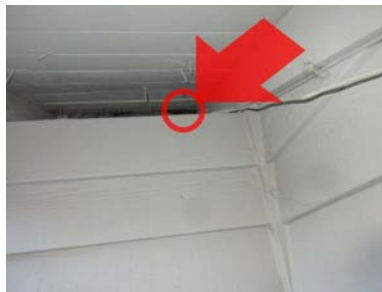
3.4 SOFFITS AND OVERHANGS

There are openings at the intersection between the overhang and the roof through which birds and rodents can enter into the attic. These openings should be covered with wood, wire mesh or filled with aerosol foam.

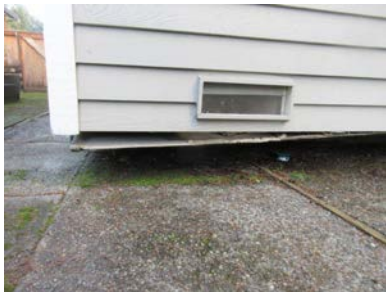
There is a loose soffit on the Northwest corner of the house. The vent cover should be resecured to prevent insect, bird and rodent entry.

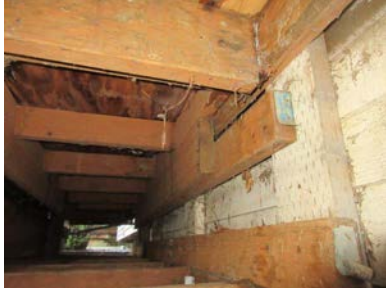
3.7 DECK

A plywood substrate of the deck boards is rotted. Rot weakens the wood and can result in further damage of the structure. Removal of the plywood portion of the deck structure is recommended.

There is no flashing at the intersection between the deck and house. This will allow water to enter behind the siding. The installation of flashing in this area is recommended.

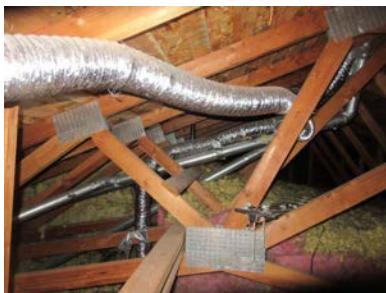
5.3 MECHANICAL VENTILATION SYSTEMS

Flexible plastic duct is used to direct air from the vent fans to the exterior. This type of material is unreliable. Replacing the plastic duct with 4" smooth-wall sheet metal duct is recommended.

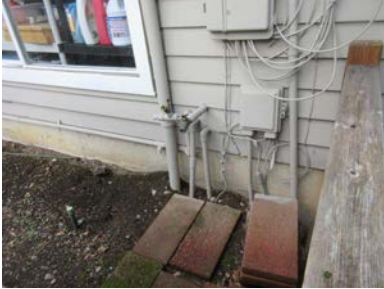
13.8 HOSE BIBBS AND EXTERIOR SUPPLY PIPES

There are water pipes on the south exterior wall of the garage that will freeze in cold weather. These water pipes should be shut off and drained or protected via a thermostatically installed heat tape.

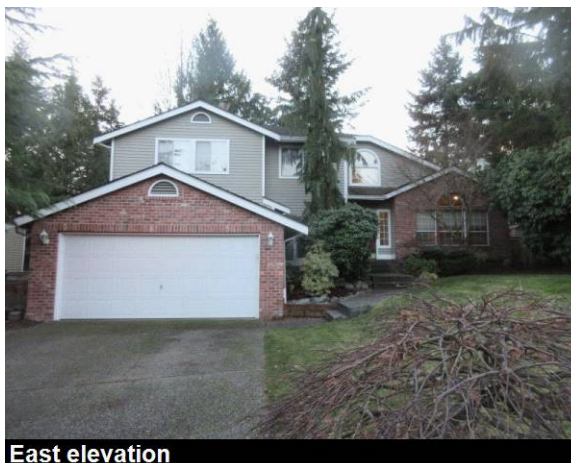
East elevation

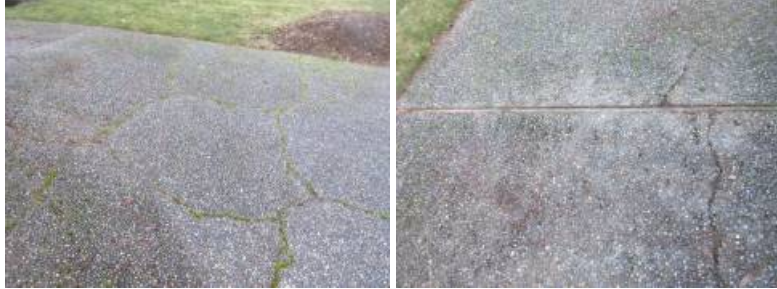
Cracks were observed in the concrete surface of the driveway. Minor cracks can be sealed to minimize moisture entry and further settlement of the concrete. Minor cracks are common and do not affect the serviceability of the concrete.

One or more of the wooden dividers separating the concrete driveway sections were infested by wood destroying organisms and have deteriorated to a point where they are becoming a trip hazard. Replacement with mortar is recommended.

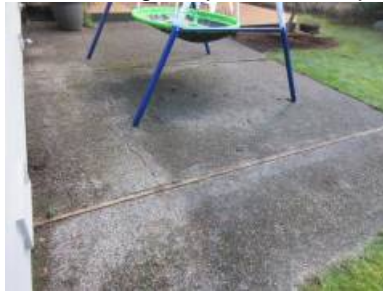
2.5 PATIO

One or more of the wooden dividers separating the concrete patio sections were infested by wood destroying organisms and have deteriorated to a point where they are becoming a trip hazard. Replacement with mortar is recommended.

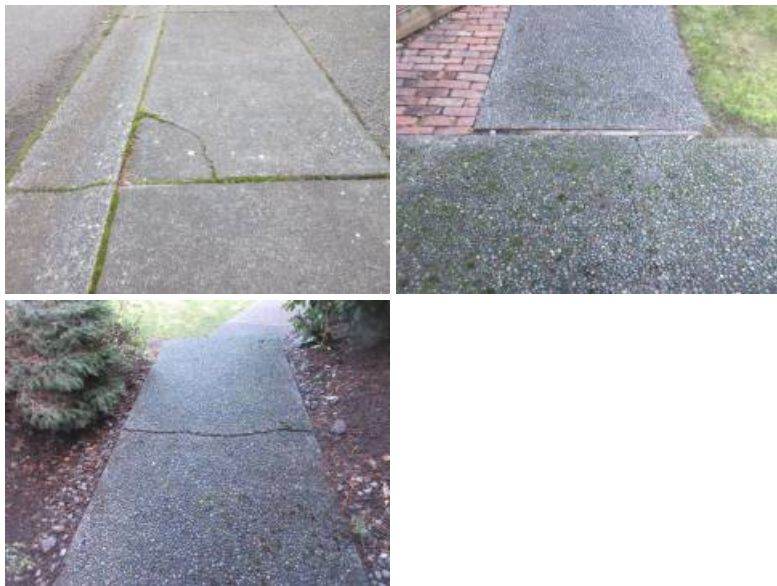
2.6 WALKWAY

One or more of the wooden dividers separating the concrete walkway sections were infested by wood destroying organisms and have deteriorated to a point where they are becoming a trip hazard. Replacement with mortar is recommended.

The front walkway has cracked and settled differentially. This was probably caused by inadequate preparation of the soil prior to the placement of the concrete. This condition can be repaired by pressure grouting the sunken portion of the walkway or by removing and replacing it. Grinding down the raised edges of the concrete will also mitigate the hazard. The walkway remains functional despite this condition. However, the raised edges of the concrete can be a trip hazard for some people. Repairs should be made as necessary.

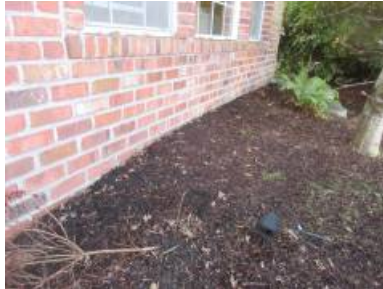
The brick is a veneer installed over the wood wall structure. It is not a structural component of the wall. Weep holes are missing or are covered at the bottom of the masonry wall. This allows moisture to become trapped behind the brick. Weep holes are recommended to mitigate moisture damage.

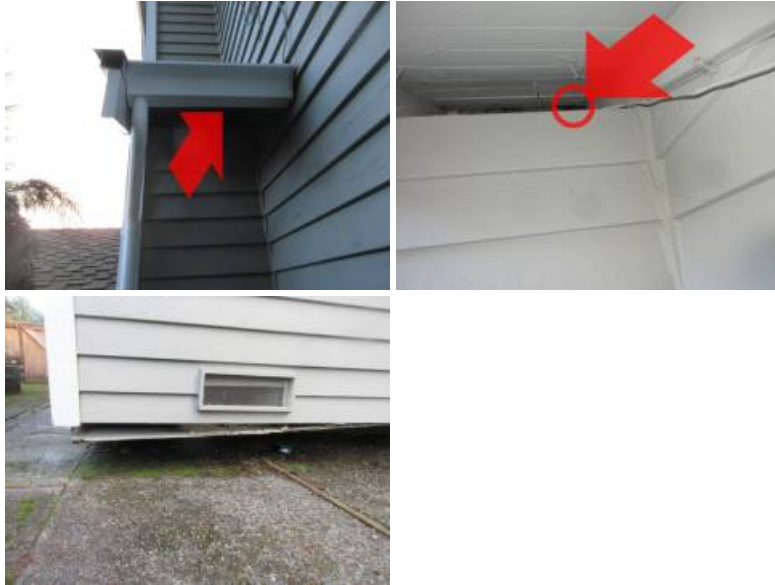
There are openings at the intersection between the overhang and the roof through which birds and rodents can enter into the attic. These openings should be covered with wood, wire mesh or filled with aerosol foam.

There is a loose soffit on the Northwest corner of the house. The vent cover should be resecured to prevent insect, bird and rodent entry.

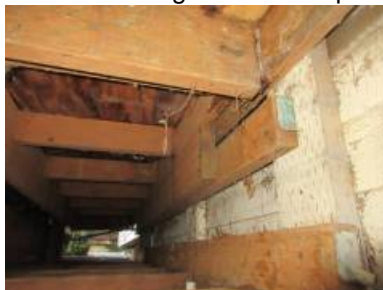
There is no flashing at the intersection between the deck and house. This will allow water to enter behind the siding. The installation of flashing in this area is recommended.

Most of the deck is installed close to the ground making it more vulnerable to deterioration. The proximity of the deck to the ground also prevented an inspection of the deck framing. The visible portions of the deck are in good condition.

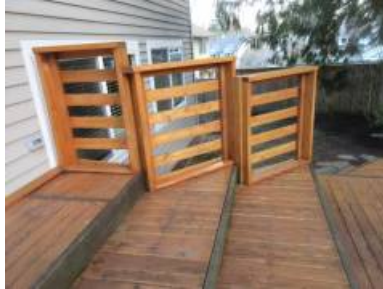
3.8 DECK RAILINGS

The spacing between the balusters is too wide. This is a hazard to small children. The balusters should be spaced close enough together so that a 4" sphere cannot pass through. Upgrading the deck railing is recommended if small children are present.

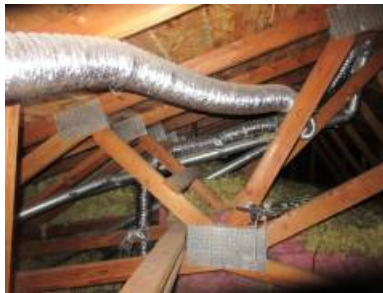
5.3 MECHANICAL VENTILATION SYSTEMS

Flexible plastic duct is used to direct air from the vent fans to the exterior. This type of material is unreliable. Replacing the plastic duct with 4" smooth-wall sheet metal duct is recommended.

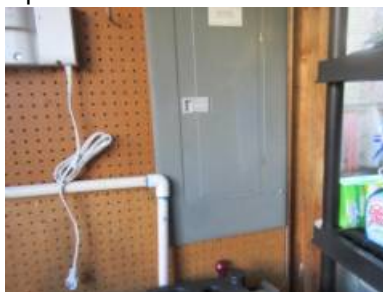
Access to the electrical panel is blocked by water piping. Piping should be removed or modified so that there is a 30" wide by 36" deep by 7' tall clearance in front of the panel.

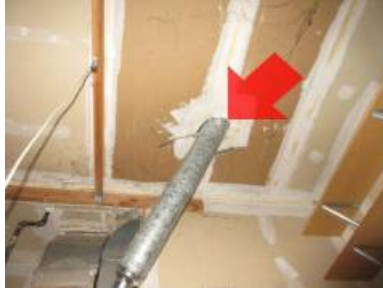
The water heater vent connector is too close to combustible material. The minimum clearance of 6" is required between the single wall vent connector and the combustible surface. The double wall type B vent requires only 1" of clearance.

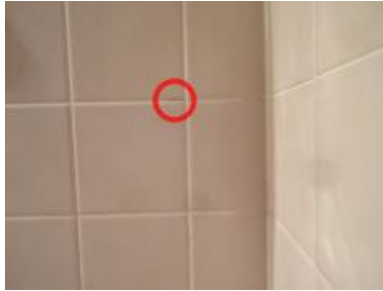
Grout is missing from between some of the wall tiles. This can allow water to enter through the tile and can damage the walls. Regrouting the wall tile is recommended.

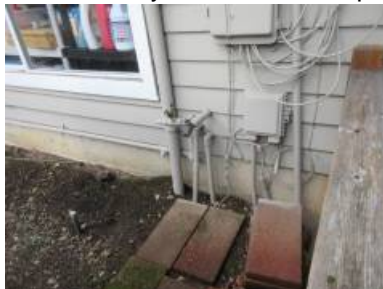
There are water pipes on the south exterior wall of the garage that will freeze in cold weather. These water pipes should be shut off and drained or protected via a thermostatically installed heat tape.

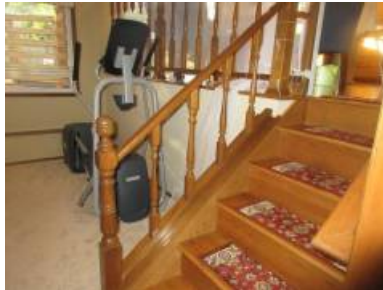
The stair railing baluster spacing is too wide. This is a hazard for small children. The baluster spacing should be reduced as a safety upgrade. Current standards require that a 4" sphere not pass through the railing.

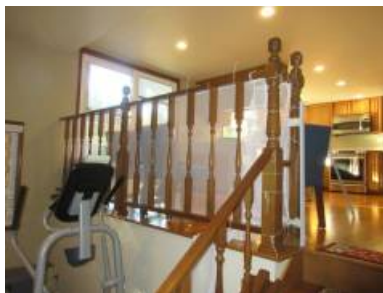
14.4 GUARD RAILINGS

The spacing between the balusters is too wide. This is a hazard to small children. The balusters should be spaced close enough together so that a 4" sphere cannot pass through. Upgrading the guard railing is recommended if small children are present.
