NOTICE TO BUYER: SELLER-PROCURED INSPECTION REPORT

Comments on Home Inspection Summary Items dated 7/15/2021

Prepared For: Jeffrey Linstad

Property Address: 13314 174th Ave NE, Redmond, WA 98052

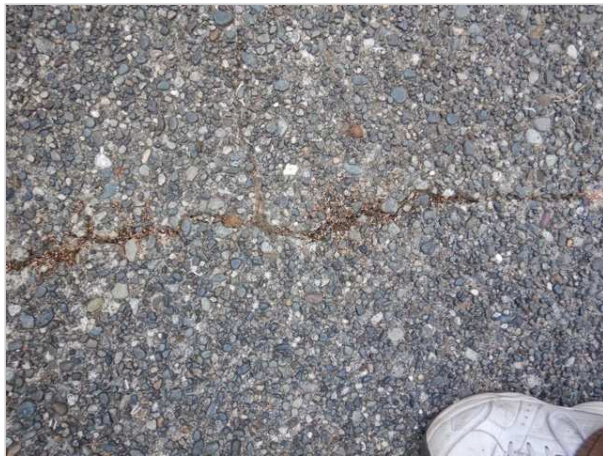
Cracking

The inspector noted that there is cracking of the driveway surface. It is recommended that these areas be sealed with mortar patch to prevent continued moisture penetration and subsequent deterioration. Contact a qualified professional to make the necessary repairs.

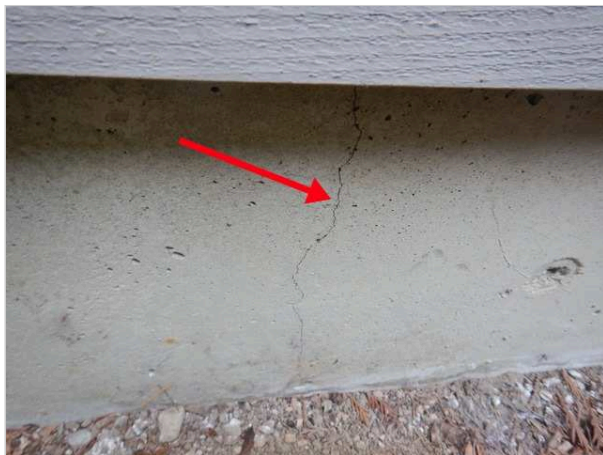
2. Structure Perimeter Exterior - Visible Cracks

Cracks - Visible

The inspector noted some minor cracking visible in the foundation wall at the exterior of the structure. Small cracks of this kind are commonly found and not unusual for this type of construction due to slight settlement or normal expansion or cure. It is recommended that this area be patched to prevent potential moisture penetration. Contact a qualified professional to perform this maintenance. Inspecting the cracks for widening on an annual basis is also recommended.

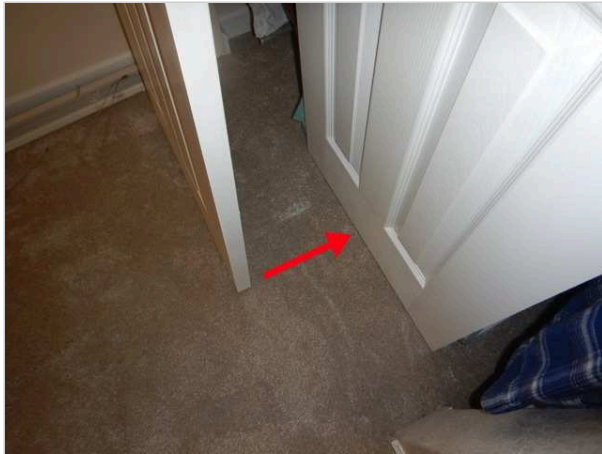
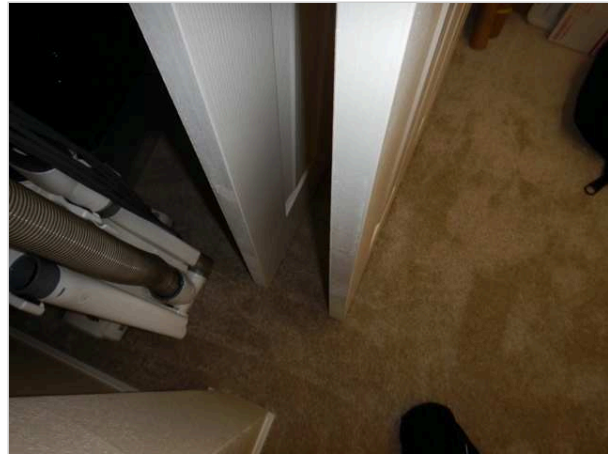
Missing Closet Door Guide(s)

The inspector noted that the bedroom closet door guide(s) was/were not in place at the time of the inspection. The owners were painting at the time of inspection. Confirm they have been replaced. If they need to be added, recommend you contact a qualified professional to make the necessary repairs.

Item #4 Missing closet door guides – Guides will be installed before closing.

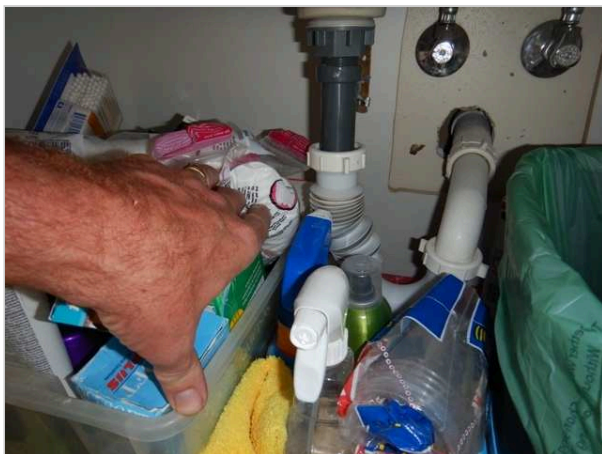
5. Bathroom(s)/Washroom(s) - Basin Drain

Corrugated Pipe

The inspector noted that a section of corrugated pipe was used in the drain system under the master bathroom sink. This type of pipe are prone to collect debris and clog. Replacing them with a rigid pipe with a smooth interior surface is recommended to provide the intended functionality. Contact a qualified professional to perform the necessary repair.

Item #5 Corrugated piping under sink in master bathroom – will be replaced if requested in purchase and sale agreement

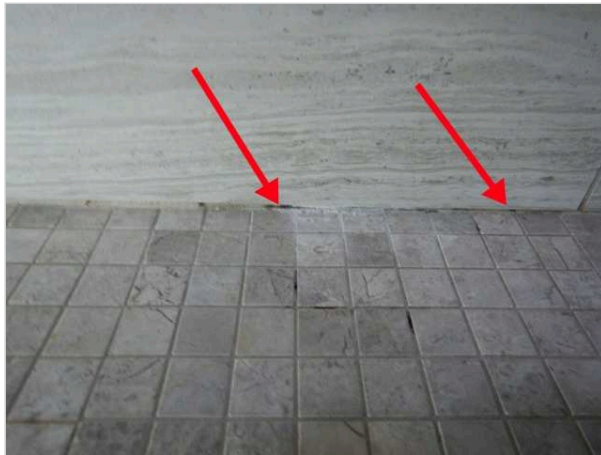
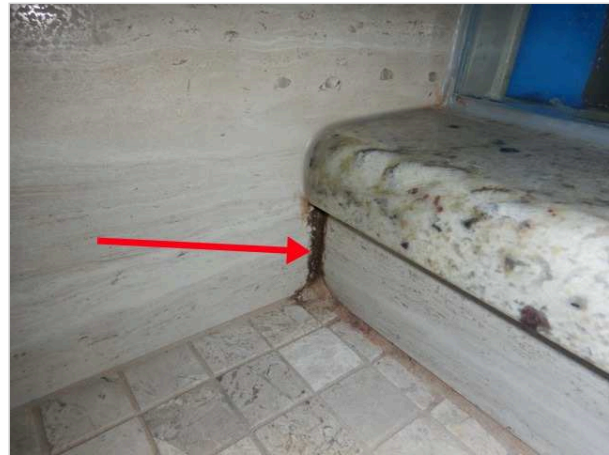
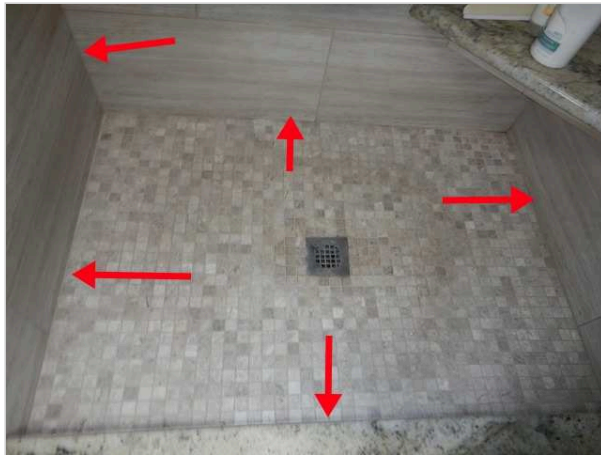
6. Bathroom(s)/Washroom(s) - Caulking - Water Exposed Area

Deterioration Tub/Shower

The inspector noted that there are areas of the master bathroom shower where the caulking has deteriorated and is in need of replacement. This area was tested for moisture in the walls and none was detected at the time of inspection. Water leaking through non-sealed areas is a major reason for structural damage in a bath area. It is recommended that this area be repaired with caulk and not grout by removing and replacing the old caulk with a water resistant silicone caulk to seal these areas to prevent moisture penetration. Due to the non-invasive nature of this inspection it was not possible to determine the extent of any damage to the wall structure in these areas. Additional investigation may be necessary to determine if any damage has occurred. Contact a qualified professional to perform this maintenance.

Item #7 No caulking in shower in the master bathroom – Caulking will be installed before closing.

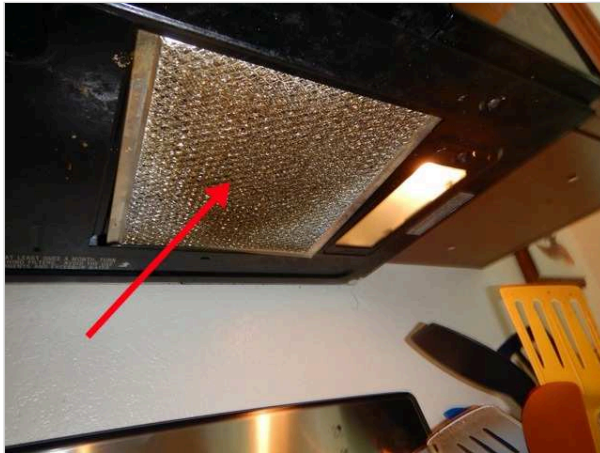
7. Kitchen(s) - Stove Exhaust Filter

Cleaning Needed

The stove top exhaust fan grease filter(s) on the cooktop exhaust fan is in need of cleaning or replacement. Periodically cleaning in the dishwasher will ensure functional service is provided.

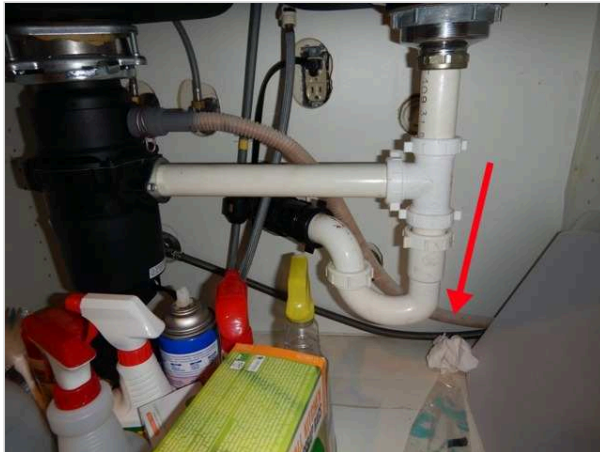
8. Kitchen(s) - Dishwasher

No Anti-Siphon

The inspector noted that the dishwasher drain is not connected to an anti-siphon valve or air gap device. These are recommended and to prevent grey water from backing up into the dishwasher in the event the sink plugs up. Installing an approved device is recommended for preventive considerations. If that is not possible, looping and attaching the dishwasher drain high up inside the cabinet under the kitchen sink will help alleviate this condition. Contact a qualified professional to perform this maintenance.

Item #8 No anti-siphon for the dishwasher – a Johnson Tee or equivalent will be installed in the dishwasher drain line before closing.

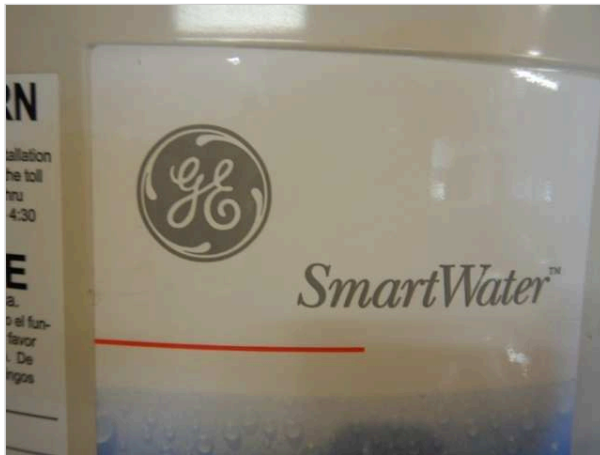
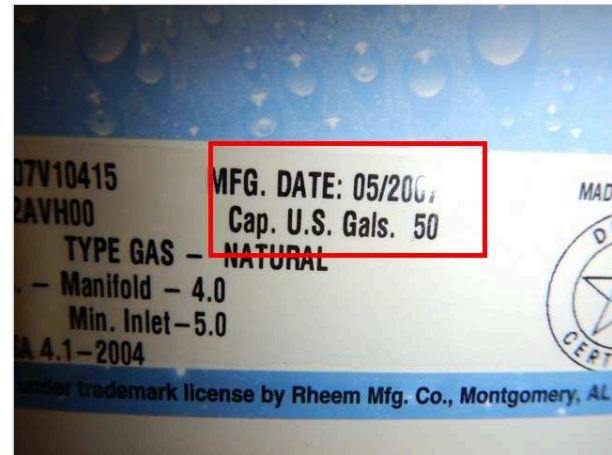
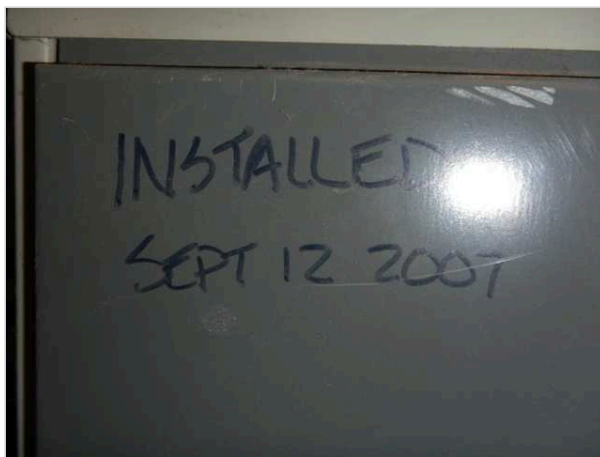
The Rheem gas water heater is an older unit that has a listed date of installation which read 2007. The life expectancy of a water heater is typically 8-12 years from the date of installation, although there are exceptions on both sides. Gas water heaters must have a continuous source of air and fuel. Items should not be stored against the water heater. Providing at least 2 feet of clearance around the water heater is recommended. Budgeting for replacement of water heaters that are over 8 years is recommended as failure could occur at any time due to their age.

Item #10 Water heater installation date of 2007 with no expansion tank – water heater will be replaced before closing.

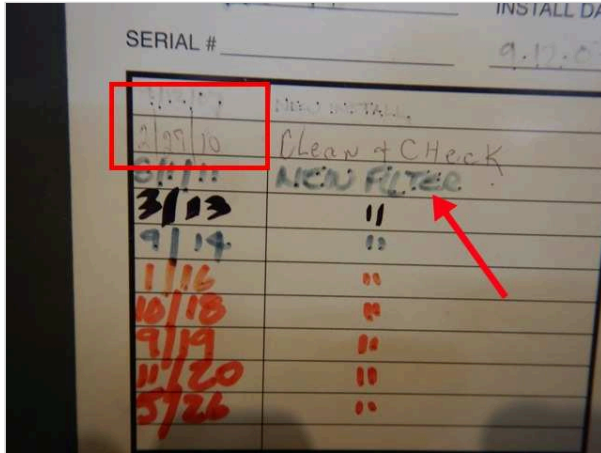
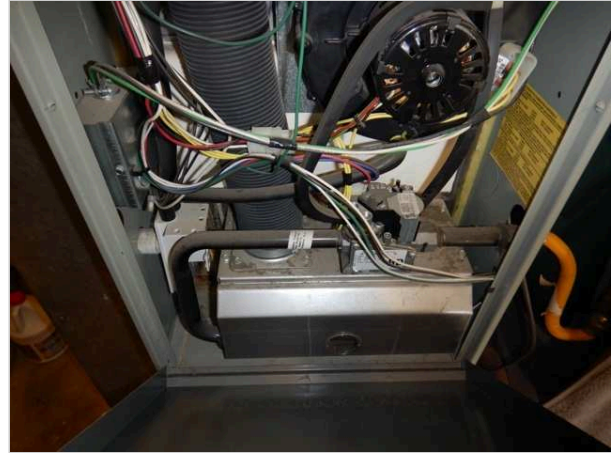
The inspector was unable to locate an apparent service record which would indicate the furnace has had a complete, technically exhaustive evaluation and service within the last year. It appears the last service was in 2010 with filter changes listed after that. Complete servicing by a professional is recommended annually prior to each heating season. Questioning the seller on available current service records is advised. If no service records are available within the last year showing a complete evaluation and service, the inspector would recommend that a qualified heating contractor provide a complete service on the system that includes an invasive inspection of the heat exchanger and evaluation of the burners, prior to closing, in order to ensure long term function is provided.

Item #12 No recent service on furnace – service on furnace will be done before closing.

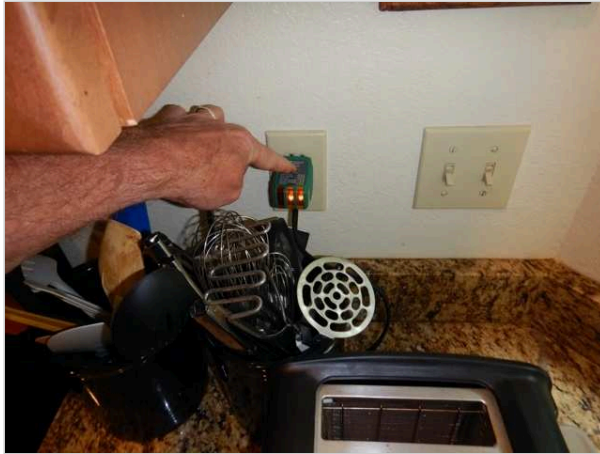
13. Electrical Service - G.F.C.I. Protection

Needed

The bathroom, kitchen and exterior outlets are GFCI protected and were functional at the time of the inspection, however the outlet to the left of the kitchen sink is GFCI protected. Current electrical requirements stipulate that Ground Fault Circuit Interrupters (GFCI) be located in areas where there is a higher potential danger of electrical shock (kitchen, bathroom, garage and exterior outlets - newer construction includes the laundry room). Consideration should be given to installing GFCI outlets where there is a higher potential for electrical shock. Contact a licensed electrician to make the necessary repairs.

No GFCI protection on the left side of the kitchen sink – A GFCI will be installed before closing

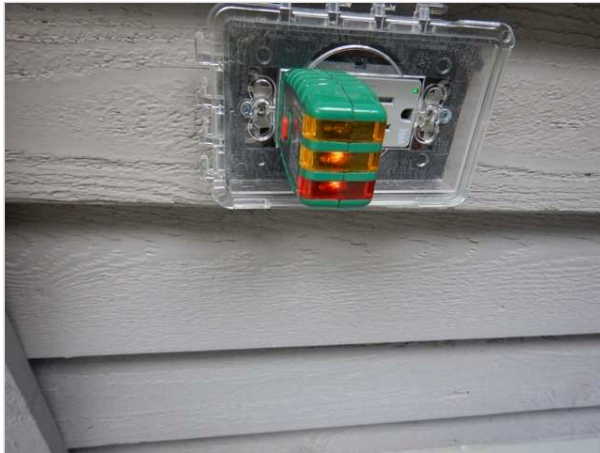
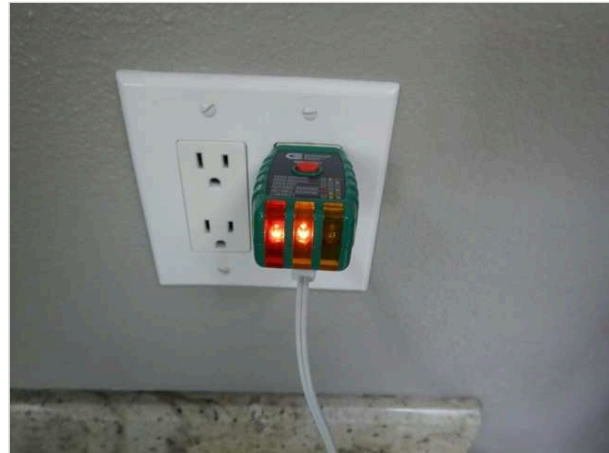
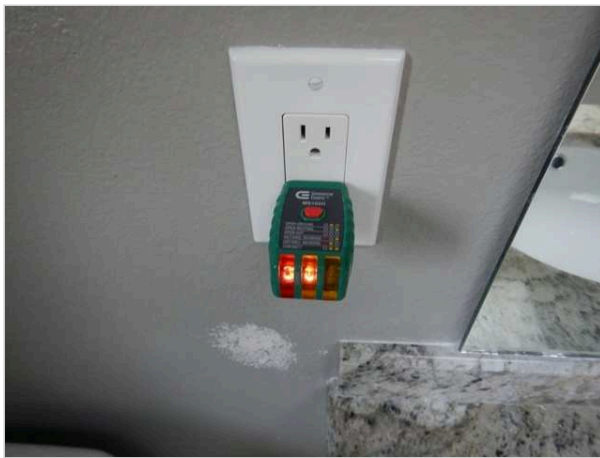
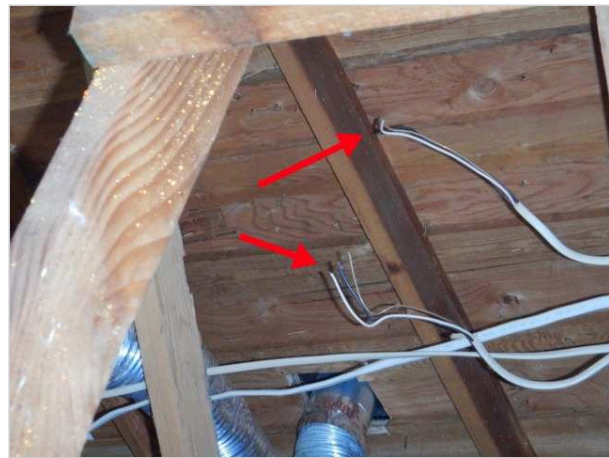
14. Electrical Service - Outlets, Switches, Junction Boxes, Lighting

Maintenance

There is a/are miscellaneous electrical issue(s) that is/are in need of evaluation by a licensed electrician with repairs made as necessary:

1. The inspector noted that the exterior deck and bathroom outlets all show a hot/neutral reversal.
2. There are exposed wires not terminated in a junction box that are intended for a future attic light. These should be terminated in a junction box if not being used.

Item #13 GFCI's in bathrooms found to be wired incorrectly (line-load wiring) – removed GFCI in upstairs bathrooms and installed standard outlets, main power supplied from powder room downstairs, CFCI trip test performed and status indicator light remains green. Powder room GFCI supplies power to both upstairs bathrooms.

Item #14 Exposed wires in the attic – wires in the attic were installed for future lighting that was not done – no wires are energized.

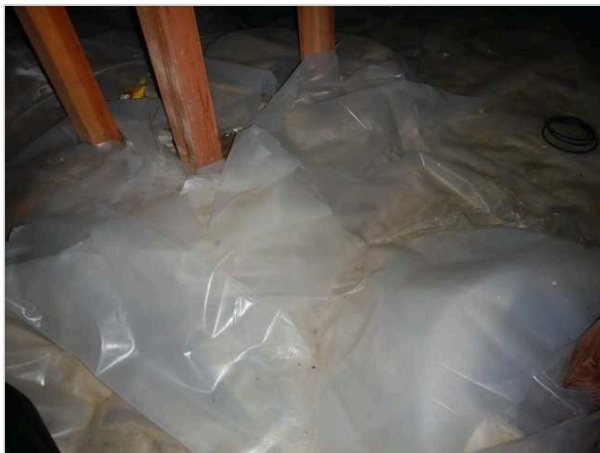
15. Raised Foundation - Vapor Barrier

Clear Plastic

The vapor barrier is the original clear plastic and in the opinion of the inspector is not adequate. It is recommended that the barrier be replaced with a 4-6 mil black plastic to limit moisture intrusion. The plastic should lay flat without bunching and not cover any wood members. Contact a qualified professional to perform this maintenance.

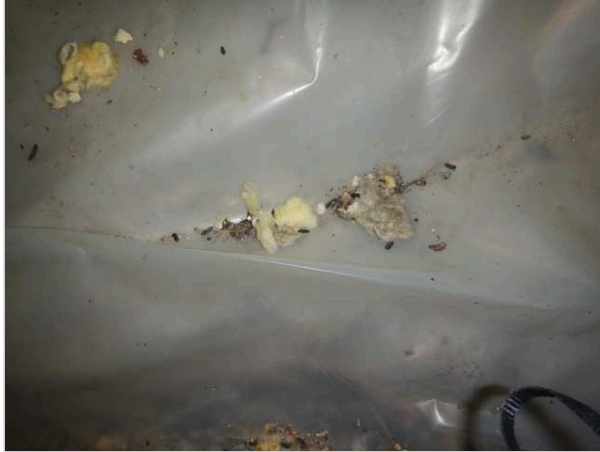
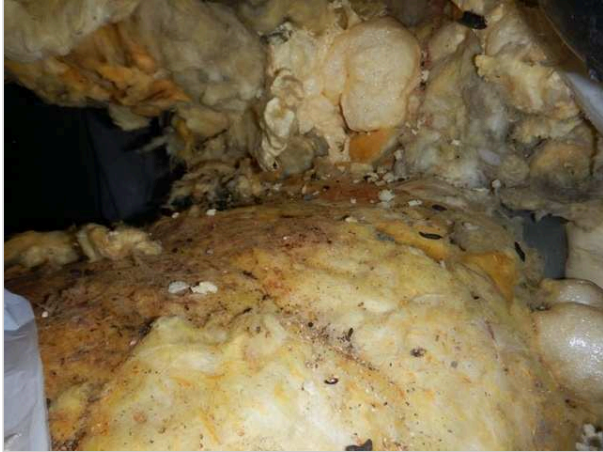
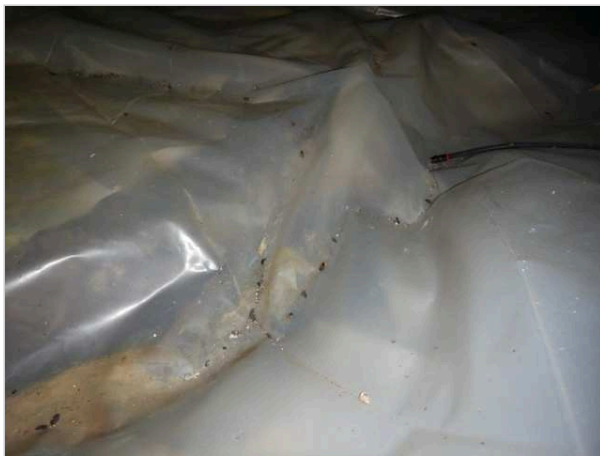
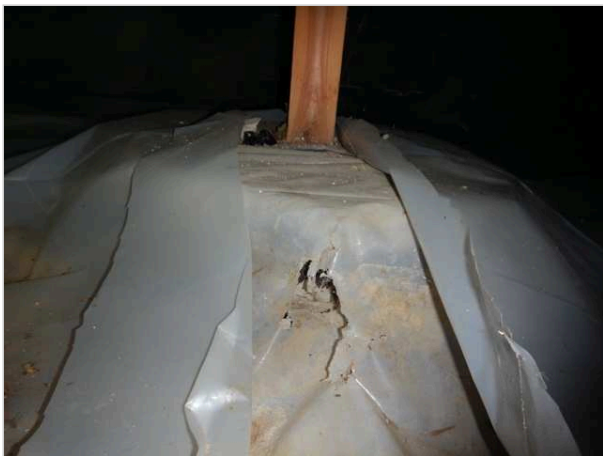
16. Raised Foundation - Evidence of Animals

Past Activity - No Control Measures

There is evidence of past rodent and other small animal activity in the crawl space area. The inspector noted feces, and chewed vapor barrier. Extermination and control measures should be considered to insure that there is no further infestation, and any access points should be sealed. Contact a licensed Pest Control Operation for evaluation and maintenance.

Item #16 Evidence of rodents in crawl space - Although the inspector said that no signs of present rodents were noticed, a pest control company will confirm status before closing.

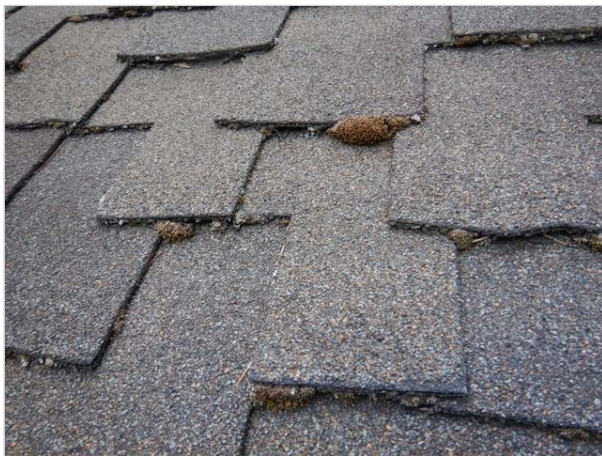
Moss - Small Amount

There is a small amount of moss growth on the roof. The amount of moss growth does not warrant immediate attention at this time. The inspector recommends removing the moss growth at some time within the next 2-3 months with a soft broom or brush and treating the shingles to prevent regrowth. The inspector does not recommend pressure washing of the roof as it will shorten the life of this type of roofing material. Chemicals for preventing moss growth can be purchased at a local home improvement center and should be applied on an annual basis. There are qualified professionals who will clean the roof and apply a treatment that will prevent regrowth for a number of years.
