**Re: 13828 180th Ave. NE  
Redmond, WA.**

At your request, a visual inspection of the above referenced property was conducted on 12/13/2021. We have inspected the major structural components, plumbing, heating and electrical systems for signs of significant non-performance, excessive or unusual wear and general state of repair.

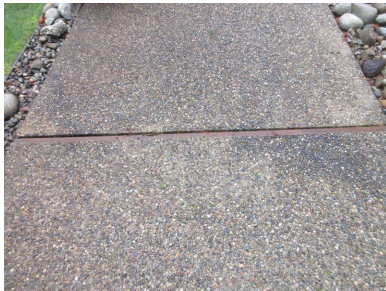
#### 2.6 WALKWAY

The wooden divider separating the concrete walkway sections has deteriorated to a point where the gap is a trip hazard. Replacement with mortar is recommended.

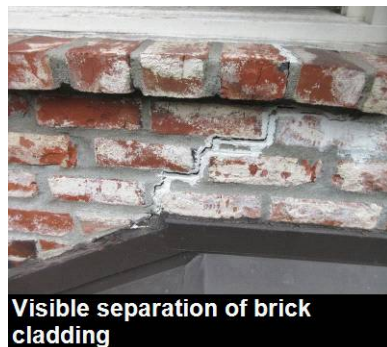
#### 3.2 SECONDARY EXTERIOR WALL CLADDING

The brick cladding and window sills above the bay windows show cracking and separation of the brick cladding. Counter flashings at the roof to wall intersection are missing and the flashings are not properly sealed allowing moisture penetration into the structure. We recommend repairs to the separated sections of the brick cladding and flashings. We recommend repairs be performed by a licensed masonry contractor.

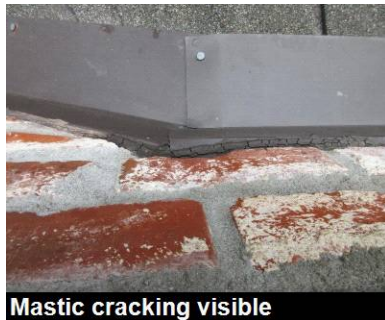
**Mastic cracking visible**

Mastic is used to seal around the roof to wall flashings. Exterior roof to wall intersections sealed with roofing mastic will shrink, crack and eventually leak, resealing the flashings with mastic will extend their service life.

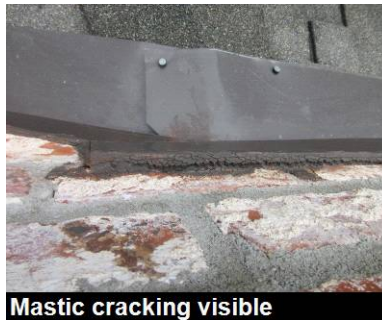
**Mastic cracking visible**

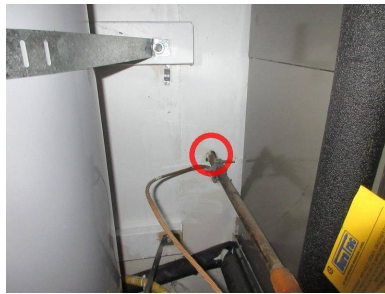
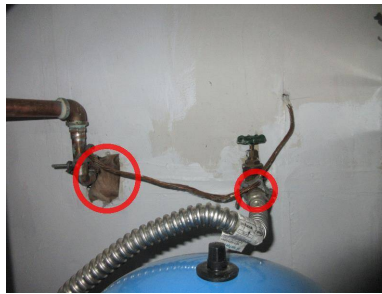
#### 6.4 FIRE SEPARATION

There are voids in the fire resistive barrier between the living space and garage that will allow flames to penetrate. The gypsum barrier slows the spread of a fire from the garage to the structure and/or living space. Patching the voids with a fire retardant caulk is recommended.

6.4 Fire Separation - wall voids filled with fire retardant caulk  
6.5 Passage Door - Self Closing hinge installed  
6.7 Receptacles - GFCI was installed in the garage

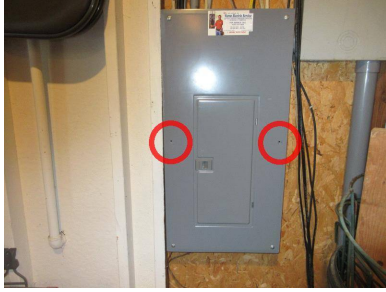
#### 7.8 SERVICE PANEL

Screws that secure the panel cover to the panel box are missing. This is a potential hazard. Missing screws should be replaced with the original style blunt end screws.

7.8 Service Panel - Additional screws installed  
7.12 Receptacles - loose receptacles were repaired  
8.11 Air Heating System - Unit was last serviced on 3/24/21 by All Climate - issue of blower door switch was not raised

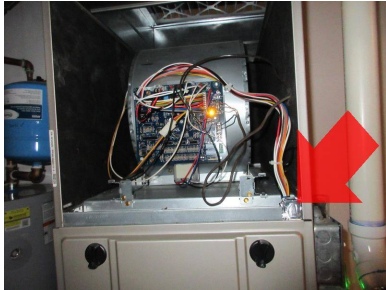
##### 8.11 BLOWER

The blower door cut-out switch has been disabled. This is a potential hazard. The cut-out switch should be unrestricted.

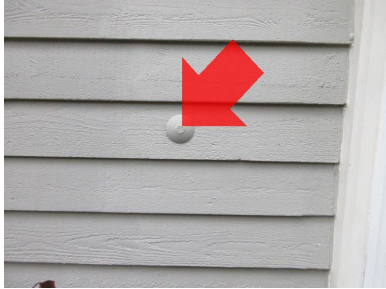
#### 11.8 AIR GAP

The holes in the cap protruding on the exterior wall opposite the dishwasher are blocked. This air gap protects the dishwasher from contamination caused by a backflow of waste water when in use. Opening of the holes in the end of the cap will restore its function.

11.4 Ventilation - Down draft vent system working as intended  
11.8 Air Gap - vent holes unblocked  
15.7 Smoke Detectors - Smoke detectors installed in all bedrooms. Carbon monoxide monitors installed on each floor

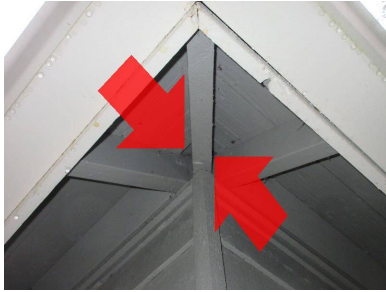
There are large gaps over 1/4" in size adjacent the soffit vent blocks. These gaps allow insects and rodents to

enter the attic. Covering the gaps with screening, a strip of wood and/or caulking is recommended.

3.5 Soffits and Overhangs - Soffit vent gaps covered with wire mesh  
9.2 Condenser - Cover removed from condensing unit  
12.18 Bathtub - Drain stop installed

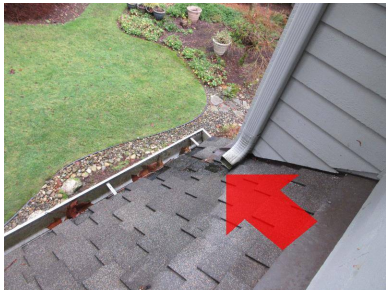
### 3.6 GUTTERS AND DOWNSPOUTS

Downspouts draining directly onto the asphalt shingle surface causes excessive wear of the roofing material. Downspout extensions to the lower gutters should be installed to prevent excessive wear and tear of the roofing.

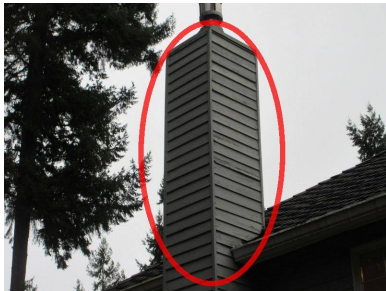
### 3.7 PAINT

The paint on the high exposure areas of the exterior is deteriorated. Paint protects the wood from cupping, checking, warping and rot. Repainting the exposed areas is recommended.

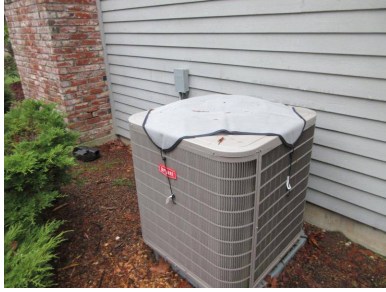
### 9.2 CONDENSER

A cover is blocking the air circulation around the condensing unit. This will affect the efficiency of the unit. The cover should be removed to provide three feet of clearance around the condenser.

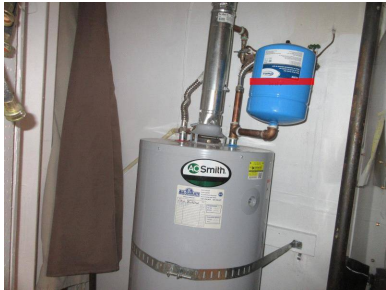
### **10.6 EXPANSION TANK**

The expansion tank is not adequately secured to the wall. As code requirements start to call for engineered expansion tank supports we recommend the installation of seismic restraints to secure the expansion tank instead of allowing it to simply depend on piping connections that could result in damage to the water pipe and leakage during an earthquake.

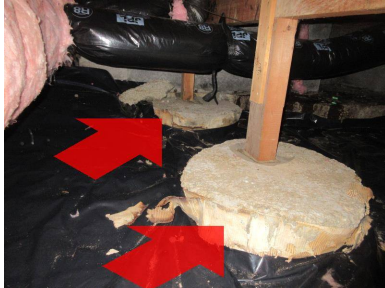
### **20.5 PEST CONTROL**

Cellulose forms were left in place on the pier footings. This cellulose is conducive to the infestation of various wood destroying organisms. The removal of the cellulose is recommended.

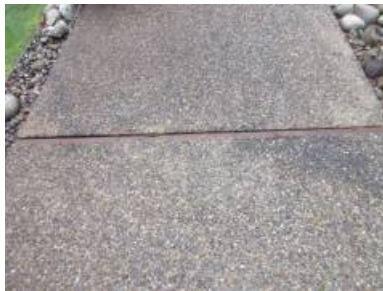
The wooden divider separating the concrete walkway sections has deteriorated to a point where the gap is a trip hazard. Replacement with mortar is recommended.

Many legal and public works departments have defined a trip hazard as an irregularity in a walking surface exceeding one inch (1") in height. All walking surfaces should maintain, free of a vertical surface change of 3/4" or more, in the interest of public and personal safety.

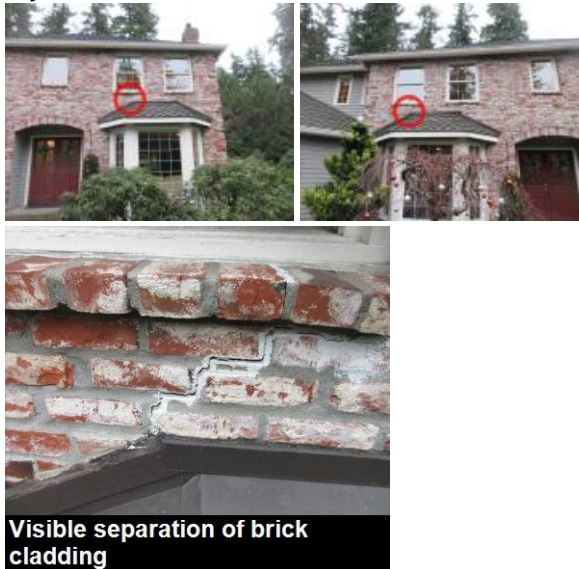
The brick cladding and window sills above the bay windows show cracking and separation of the brick cladding. Counter flashings at the roof to wall intersection are missing and the flashings are not properly sealed allowing moisture penetration into the structure. We recommend repairs to the separated sections of the brick cladding and flashings. We recommend repairs be performed by a licensed masonry contractor.

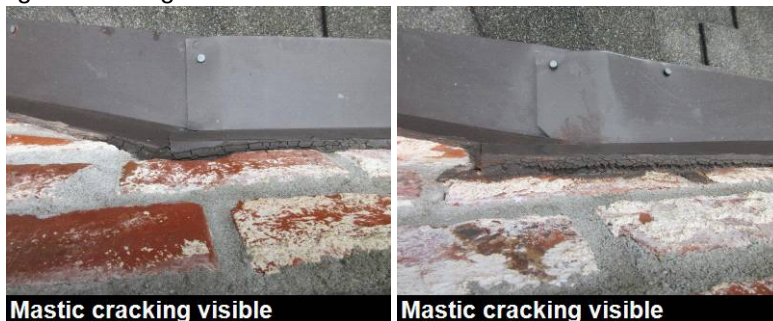
### 3.3 FLASHINGS

Counter flashings are missing around the roof to wall intersection adjacent the bay windows. This is allowing leakage to occur. The installation of counter flashings is recommended.

Mastic is used to seal around the roof to wall flashings. Exterior roof to wall intersections sealed with roofing mastic will shrink, crack and eventually leak, resealing the flashings with mastic will extend their service life.

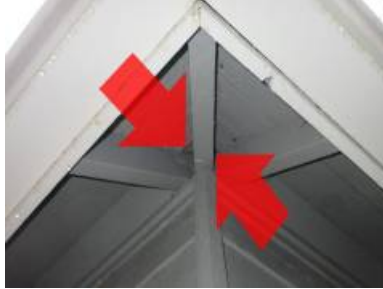
There are large gaps over 1/4" in size adjacent the soffit vent blocks. These gaps allow insects and rodents to enter the attic. Covering the gaps with screening, a strip of wood and/or caulking is recommended.

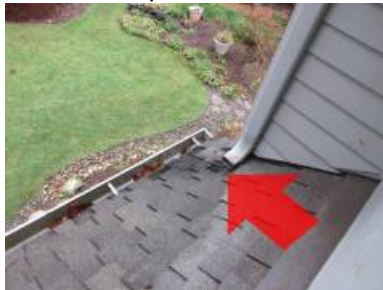
### 3.6 GUTTERS AND DOWNSPOUTS

Downspouts draining directly onto the asphalt shingle surface causes excessive wear of the roofing material. Downspout extensions to the lower gutters should be installed to prevent excessive wear and tear of the roofing.

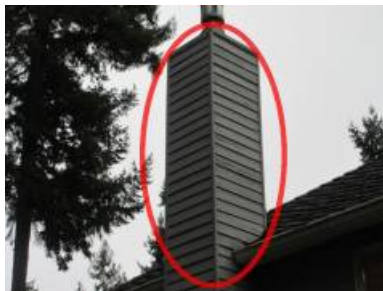
### 3.7 PAINT

The paint on the high exposure areas of the exterior is deteriorated. Paint protects the wood from cupping, checking, warping and rot. Repainting the exposed areas is recommended.

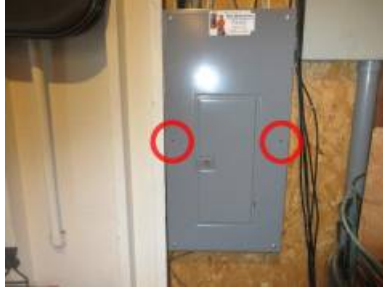
Screws that secure the panel cover to the panel box are missing. This is a potential hazard. Missing screws should be replaced with the original style blunt end screws.

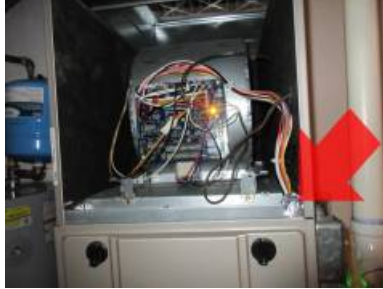
The blower door cut-out switch has been disabled. This is a potential hazard. The cut-out switch should be unrestricted.

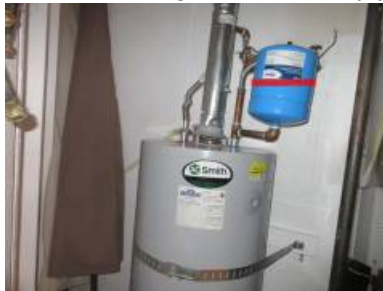
The expansion tank is not adequately secured to the wall. As code requirements start to call for engineered expansion tank supports we recommend the installation of seismic restraints to secure the expansion tank instead of allowing it to simply depend on piping connections that could result in damage to the water pipe and leakage during an earthquake.

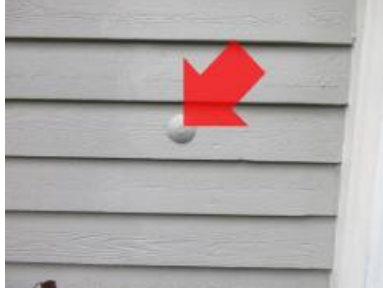
**11.8 AIR GAP**

The holes in the cap protruding on the exterior wall opposite the dishwasher are blocked. This air gap protects the dishwasher from contamination caused by a backflow of waste water when in use. Opening of the holes in the end of the cap will restore its function.

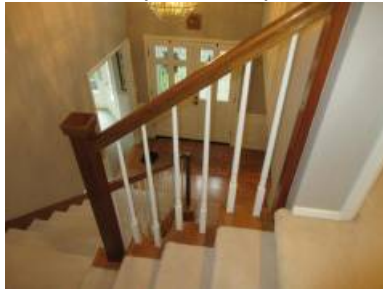
The stair railing baluster spacing is too wide. This is a hazard for small children. The baluster spacing should be reduced as a safety upgrade. Current standards require that a 4" sphere not pass through the railing.

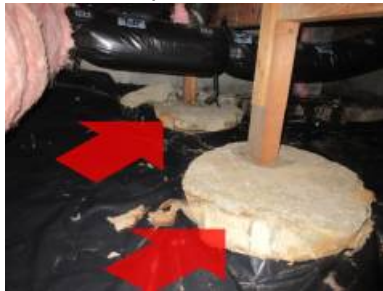
Good building practice requires that foundation walls or pier footings supporting wood frame construction, should extend at least 8" above the finish grade with at least a 6" clearance between the top of the soil and the bottom of the wood finish materials. Untreated wood should be raised 1-2" above surrounding flatwork and should have a moisture barrier such as 30 lb. asphalt impregnated felt installed between the concrete and wood. For additional information and treatment options, you should retain the services of a qualified pest control operator.
