NOTICE TO BUYER: SELLER-PROCURED INSPECTION REPORT

The following notice is given with respect to the Purchase and Sale Agreement dated _____ between _____ (“Buyer”) and **Bonnie Yourzak** **Gary Yourzak** (“Seller”) concerning **13815 176th PINE** **Redmond** **WA 98052** (“the Property”).

Clark Inspections performed a Pre-Inspection on 06/02/2020. Upon receipt of the report, we asked our Licensed Contractor to examine the items detailed in the report, and to correct selected items.

At your request, a visual inspection of the above referenced property was conducted on 06/02/2020. We have inspected the major structural components, plumbing, heating and electrical systems for signs of significant non-performance, excessive or unusual wear and general state of repair.

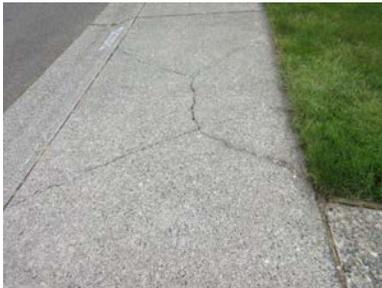
2.6 WALKWAY

Cracks were observed in the concrete surface of the sidewalk. Minor cracks can be sealed to minimize moisture entry and further settlement of the concrete.

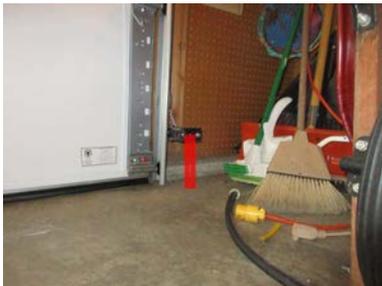
6.3 GARAGE DOOR OPENER

The Photo-eye beam for the east garage door was installed too high above the floor of the garage to adequately offer protection for small children and/or pets. We recommend that the photo-eye be lowered to within 4-6" of the floor.

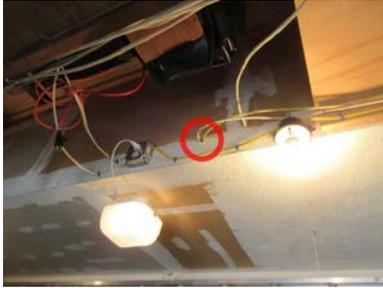
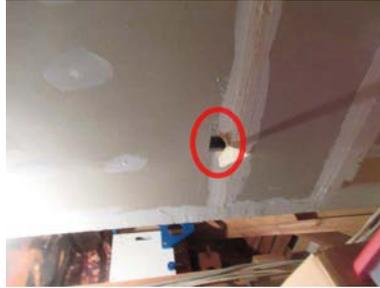
6.4 FIRE SEPARATION

There are voids in the fire resistive barrier between the living space and garage that will allow flames to

penetrate. The gypsum barrier slows the spread of a fire from the garage to the structure and/or living space. Patching the voids with a fire retardant caulk is recommended.

- 6.4 Fire Separation – Our contractor sealed the two voids detailed in the report, plus one additional void that was not apparent until we moved a shelving unit out of the garage.
- 6.5 Passage Door – Our contractor installed a new self-closing hinge.
- 7.8 Service Panel – Our contractor installed metal plugs where noted.
- 7.12 Receptacles – Our contractor went around the house looking for loose receptacles. When he found one, he either tightened it or replaced it.
- 7.12 + 11.28 Receptacles – Our contractor installed cover plates on all of the receptacles. (He had removed several temporarily while doing work to prepare our home for sale.)
- 7.13 GFCI Receptacles – Our contractor installed two GFCI receptacles in the kitchen.
- 7.15 Lights – We replaced the burned-out light bulb.
- 14.7 Smoke Detectors – Our contractor installed smoke detectors in each of the four bedrooms.

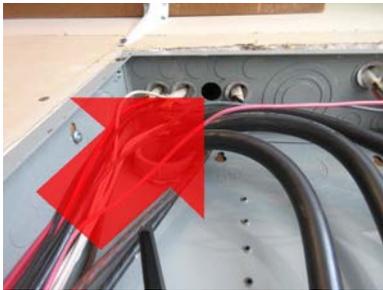
7.8 SERVICE PANEL

There are openings in the panel box where knock-outs have been removed. Missing knock-outs should be replaced with snap in metal plugs.

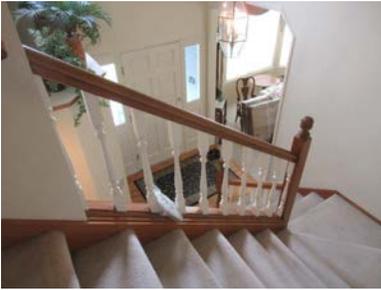
14.2 STAIRS

The stair railing baluster spacing is too wide. This is a hazard for small children. The baluster spacing should be reduced as a safety upgrade. Current standards require that a 4" sphere not pass through the railing.

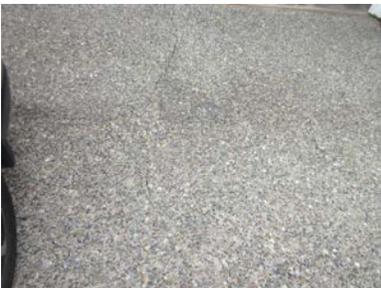
2.4 DRIVEWAY

Cracks were observed in the concrete surface of the driveway. Minor cracks can be sealed to minimize moisture entry and further settlement of the concrete. Minor cracks are common and do not affect the serviceability of the concrete.

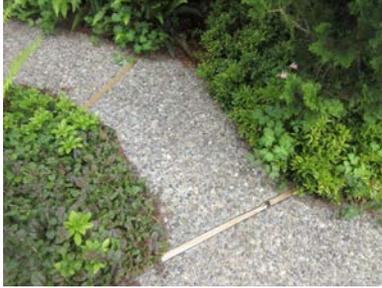
2.6 WALKWAY

The wooden dividers separating the concrete walkway sections have deteriorated to a point where the gaps are a trip hazard. Replacement with mortar is recommended.

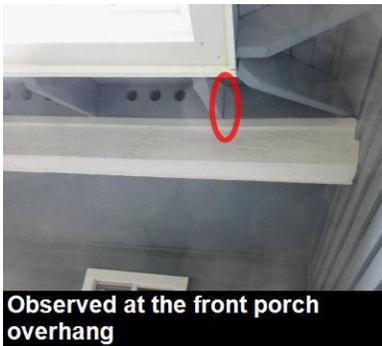
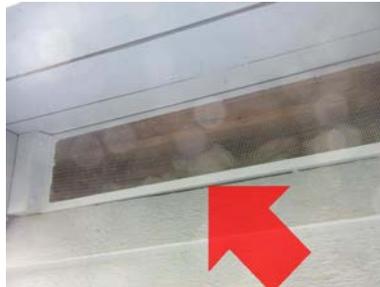
3.3 SOFFITS AND OVERHANGS

There are large gaps over 1/4" in size adjacent the soffit vent blocks and screens. These gaps allow insects and rodents to enter the attic. Covering the gaps with screening, a strip of wood and/or caulking is recommended.

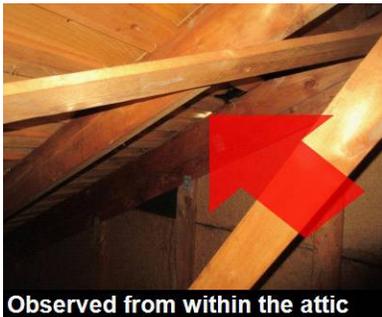
There are openings between the ends of the skip sheathing boards under the overhang through which birds and rodents can enter into the attic. These openings should be covered with wood, wire mesh or filled with aerosol foam.

- 3.3 Soffits and Overhangs – Our contractor sealed the “openings between the ends of the skip sheathing boards” that he could locate.
- 18.6 Shear Panels – Our contractor examined the cripple walls in the crawlspace. He determined that the exterior walls are made of plywood, not particle board. As such, these plywood exterior walls fully act as shear panels.

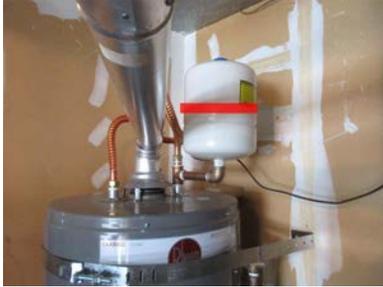
9.6 EXPANSION TANK

The expansion tank is not adequately secured to the wall. This could result in damage to the water pipe and leakage during an earth quake. A seismic restraint should be installed to secure the expansion tank.

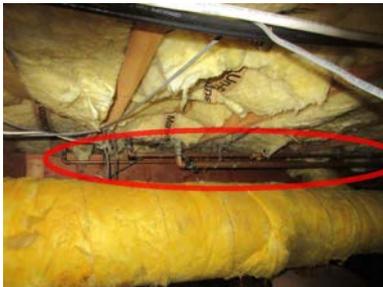
13.4 INTERIOR WATER SUPPLY PIPES

There are water pipes in the crawlspace that are not adequately insulated and could freeze. The installation of foam pipe insulation on all exposed water pipes is recommended.

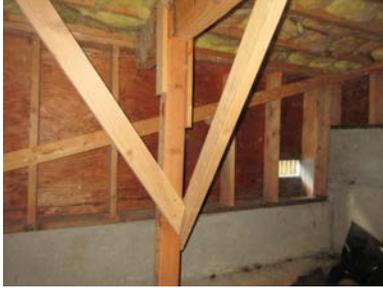
Shear panels are plywood or OSB panels that are mechanically fastened to both vertical and horizontal framing members in critical structural areas of the building. They prevent lateral movement of the structure

during an earthquake. Shear panels are often visible in the crawlspace on cripple walls between the first floor and foundation. They may also be installed on interior walls that are covered with drywall. An examination of the crawlspace revealed the absence of shear panels on the cripple walls. The installation of shear panels on the cripple walls is recommended as an upgrade.

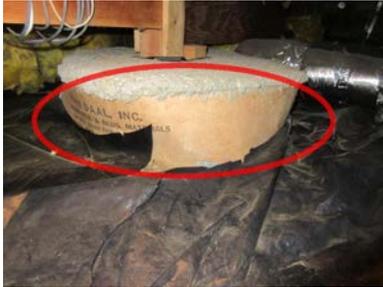
19.5 PEST CONTROL

Cellulose forms were left in place on the pier footings. This cellulose is conducive to the infestation of various wood destroying organisms. The removal of the cellulose is recommended.

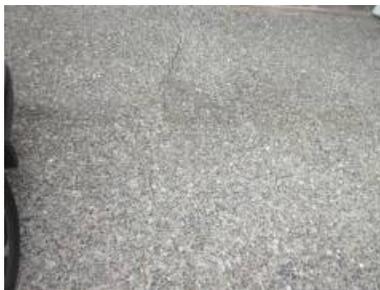
2.4 DRIVEWAY

Cracks were observed in the concrete surface of the driveway. Minor cracks can be sealed to minimize moisture entry and further settlement of the concrete. Minor cracks are common and do not affect the serviceability of the concrete.

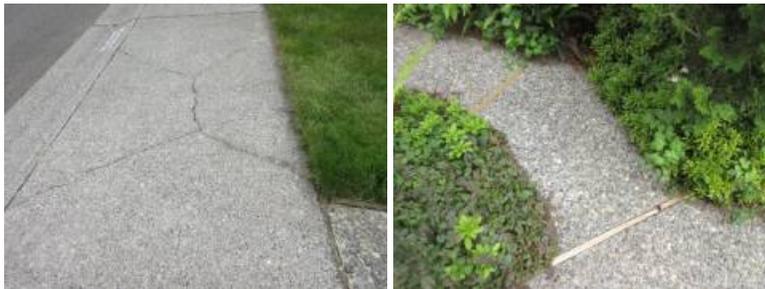
The wooden dividers separating the concrete walkway sections have deteriorated to a point where the gaps are a trip hazard. Replacement with mortar is recommended.

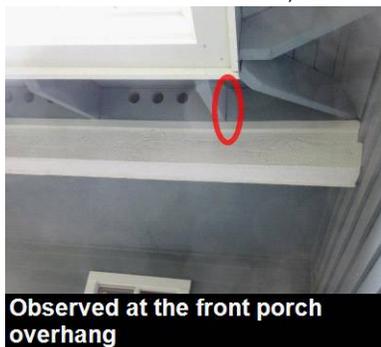
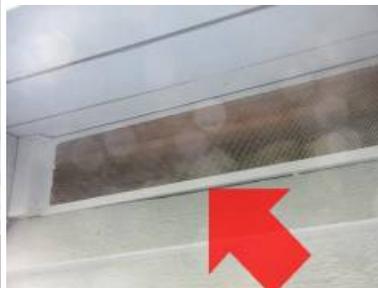
There are large gaps over 1/4" in size adjacent the soffit vent blocks and screens. These gaps allow insects and rodents to enter the attic. Covering the gaps with screening, a strip of wood and/or caulking is recommended.

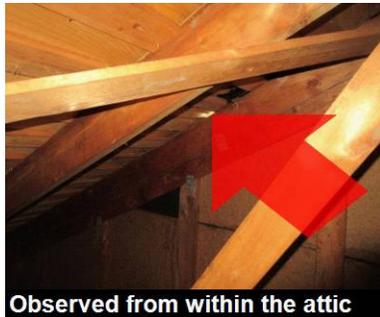
There are openings between the ends of the skip sheathing boards under the overhang through which birds and rodents can enter into the attic. These openings should be covered with wood, wire mesh or filled with aerosol foam.

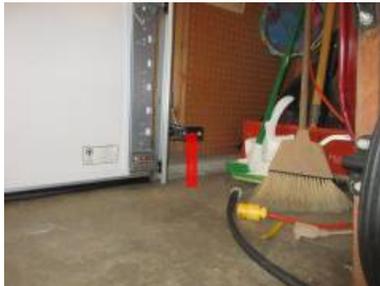
The Photo-eye beam for the east garage door was installed to high above the floor of the garage to adequately offer protection for small children and/or pets. We recommend that the photo-eye be lowered to within 4-6" of the floor.

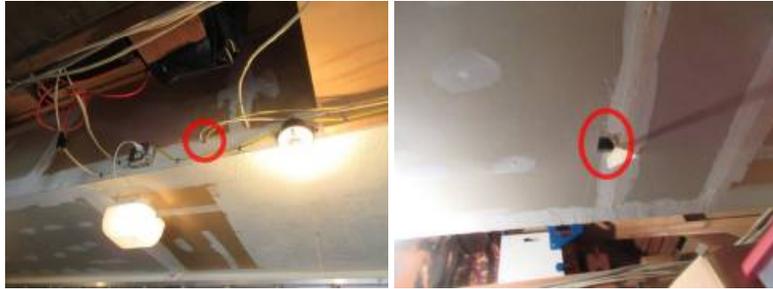
6.4 FIRE SEPARATION

There are voids in the fire resistive barrier between the living space and garage that will allow flames to penetrate. The gypsum barrier slows the spread of a fire from the garage to the structure and/or living space. Patching the voids with a fire retardant caulk is recommended.

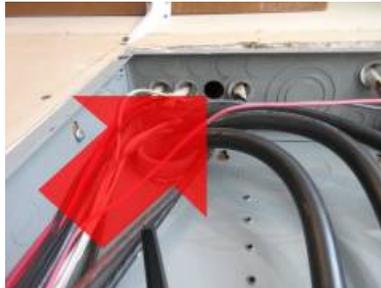
There are openings in the panel box where knock-outs have been removed. Missing knock-outs should be replaced with snap in metal plugs.

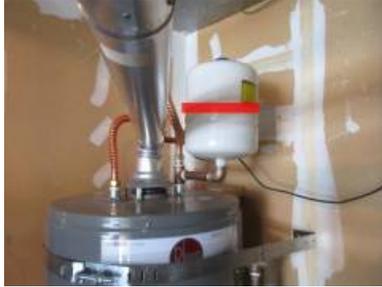
The expansion tank is not adequately secured to the wall. This could result in damage to the water pipe and leakage during an earth quake. A seismic restraint should be installed to secure the expansion tank.

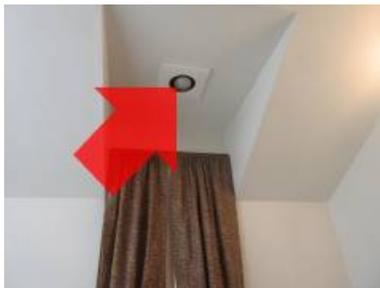
11.14 LIGHTS

One of the ceiling lights in this bathroom was not working. The bulb should be replaced in non-functional light fixtures and then they should be tested for proper operation.

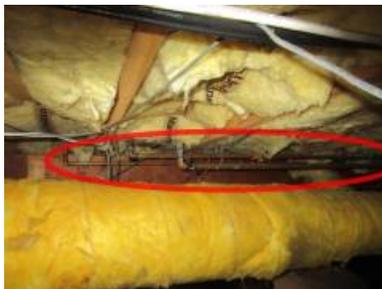
There are water pipes in the crawlspace that are not adequately insulated and could freeze. The installation of foam pipe insulation on all exposed water pipes is recommended.

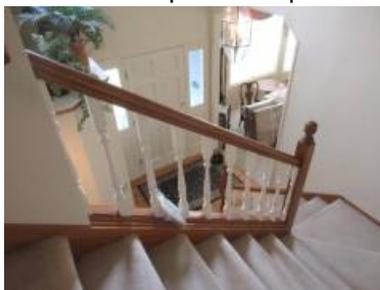
The stair railing baluster spacing is too wide. This is a hazard for small children. The baluster spacing should be reduced as a safety upgrade. Current standards require that a 4" sphere not pass through the railing.

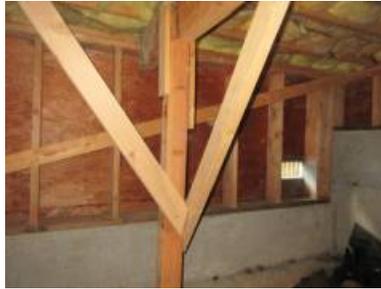
18.6 SHEAR PANELS

Shear panels are plywood or OSB panels that are mechanically fastened to both vertical and horizontal framing members in critical structural areas of the building. They prevent lateral movement of the structure during an earthquake. Shear panels are often visible in the crawlspace on cripple walls between the first floor and foundation. They may also be installed on interior walls that are covered with drywall. An examination of the crawlspace revealed the absence of shear panels on the cripple walls. The installation of shear panels on the cripple walls is recommended as an upgrade.

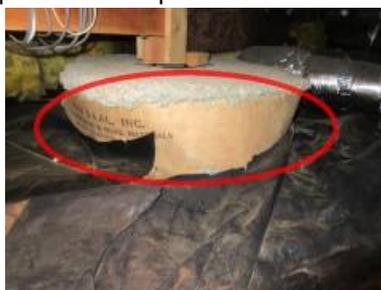
There should be no soil to wood contact in any part of the building exterior or crawlspace, unless that wood is pressure treated. For the greatest safety to permanent structures there should be no soil to wood contact of any kind. Untreated wood in direct contact with exterior flatwork should also be avoided.

Good building practice requires that foundation walls or pier footings supporting wood frame construction, should extend at least 8" above the finish grade with at least a 6" clearance between the top of the soil and the bottom of the wood finish materials. Untreated wood should be raised 1-2" above surrounding flatwork and should have a moisture barrier such as 30 lb. asphalt impregnated felt installed between the concrete and wood. For additional information and treatment options, you should retain the services of a qualified pest control operator.
