NOTICE TO BUYER: SELLER-PROCURED INSPECTION REPORT

George and Kellie Anderson
14145 177TH AVE NE
Redmond, WA 98052

At your request, a visual inspection of the above referenced property was conducted on 03/03/2022. We have inspected the major structural components, plumbing, heating and electrical systems for signs of significant non-performance, excessive or unusual wear and general state of repair.

14145 177th Ave. NE
Redmond WA.

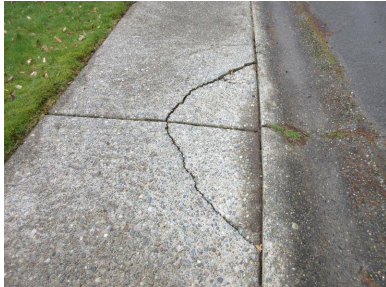
The walkway has cracked and settled differentially. This was probably caused by inadequate preparation of the soil prior to the placement of the concrete. This condition can be repaired by pressure grouting the sunken portion of the walkway or by removing and replacing it. Grinding down the raised edges of the concrete will also mitigate the hazard. The walkway remains functional despite this condition. However, the raised edges of the concrete can be a trip hazard for some people. Repairs should be made as necessary.

- 2.5 WALKWAY – Repaired
- 4.4 GAS APPLIANCE VENTS - Repaired
- 6.3 GARAGE DOOR OPENER - Photo beam sensors are 5" above floor and are operating per spec.

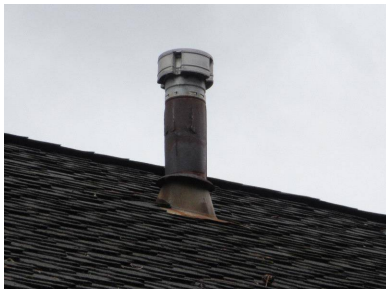
4.4 GAS APPLIANCE VENTS

The portion of the gas appliance vent above the roof is deteriorated. This section of vent should be replaced.

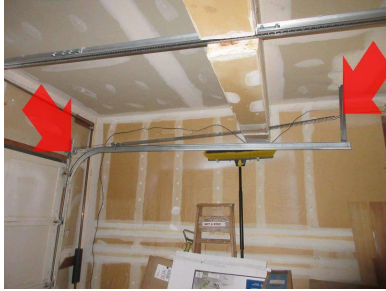
Safeties are cables run through the center of the garage door springs that prevent broken springs from becoming projectiles that can cause injury. There are no safeties installed. The installation of safeties is recommended.

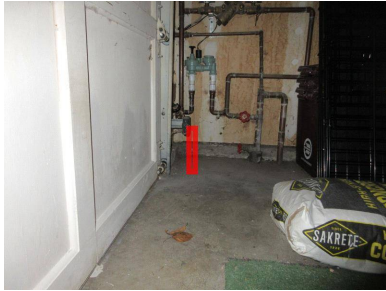
6.3 GARAGE DOOR OPENER

The Photo-eye beam was installed too high above the floor of the garage to adequately offer protection for small children and/or pets. We recommend that the photo-eye be lowered to within 4-6" of the floor.

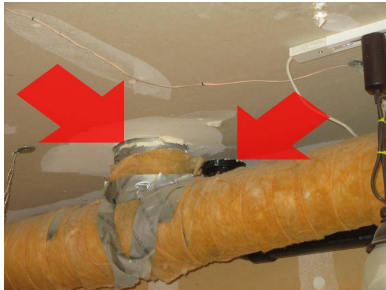
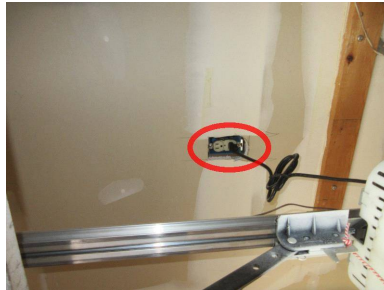
There are voids in the fire resistive barrier between the living space and garage that will allow flames to penetrate. The gypsum barrier slows the spread of a fire from the garage to the structure and/or living space.

The exposed wood is a breach in the fire resistive barrier in the garage. This is a safety concern. The gypsum barrier slows the spread of a fire from the garage to the structure. Patching the voids with a fire retardant caulk is recommended.

- 6.4 FIRE SEPARATION - Voids in the fire resistive barrier filled with approved fireproof material.
- 7.8 SERVICE PANEL – The missing cover screw was found and reinstalled.

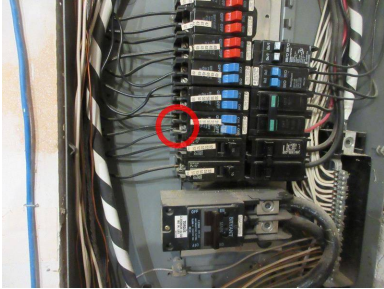
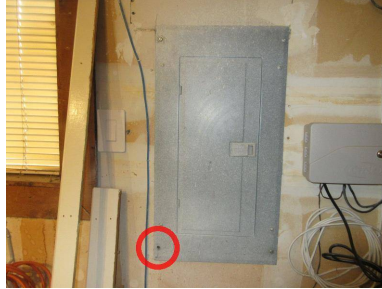
Screws that secure the panel cover to the panel box are missing. This is a potential hazard. Missing screws should be replaced with the original style blunt end screws.

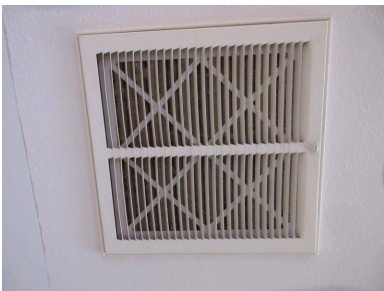
The air filter is clogged with dust. This reduces air flow and furnace efficiency. Removal and replacement of the air filter is recommended. Pleated style air filters are recommended as they offer better filtration of dust than the coarser hogs hair or fiberglass filters.

- 8.11 AIR FILTER – All three air filters have been replaced with pleated, MERV 13 filters.
- 11.17 TOILET – Toilet was removed, a new wax seal installed, and then the toilet was securely mounted to the floor.

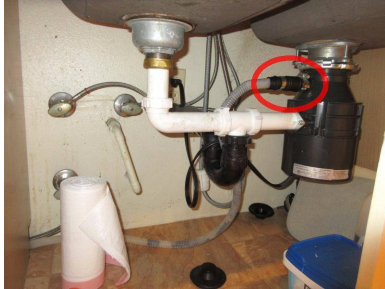
The dishwasher drain lacks an air gap. The dishwasher will function without one, but there is a risk of contamination of the inside of the dishwasher by waste water. The installation of an air gap is recommended.

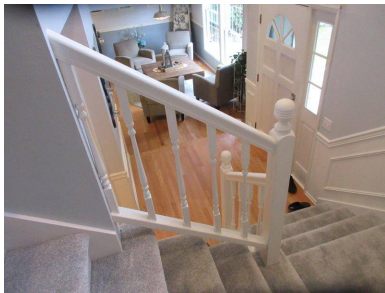
The stair railing baluster spacing is too wide. This is a hazard for small children. The baluster spacing should be reduced as a safety upgrade. Current standards require that a 4" sphere not pass through the railing.

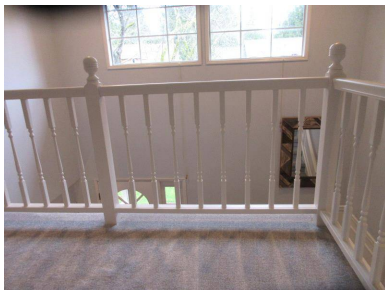
14.3 GUARD RAILINGS

The spacing between the balusters is too wide. This is a hazard to small children. The balusters should be spaced close enough together so that a 4" sphere cannot pass through. Upgrading the guard railing is recommended if small children are present.

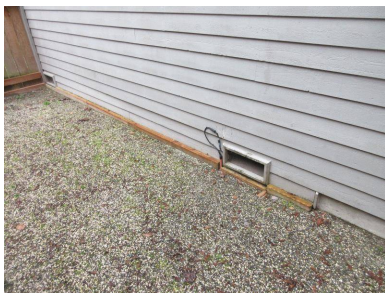
Soil is close to or in contact with siding at the south side of the buildings north exterior. Good building practice requires that foundation walls or pier footings supporting wood frame construction, extend at least 8" above the finish grade with at least a 6" clearance between the top of the soil and the bottom of the wood finish materials. Soil in direct contact with wood creates a hospitable environment for wood destroying organisms. Establishing these minimum clearances is recommended.

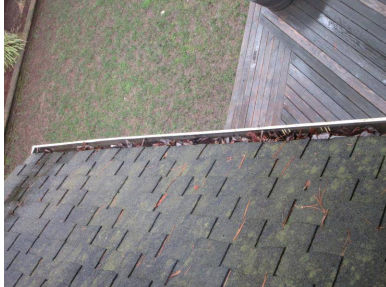
There is a build-up of organic debris inside the gutters. Proper maintenance of gutters and downspouts is essential and should be performed routinely in order to prevent clogging. Maintenance consists primarily of keeping leaves and other organic debris out of the system. Failure to clean the gutters will result in water splash on the building when they overflow. Gutters can be damaged under the weight of the water and organic matter inside the gutter. Gutters should be cleaned as necessary to maintain a free flow of water into the downspouts.

- 2.4 DRIVEWAY – Surface of the driveway has been repaired.
- 3.4 GUTTERS AND DOWNSPOUTS – The gutters have been cleaned.
- 6.7 SINK - The laundry tub is now attached to the wall.

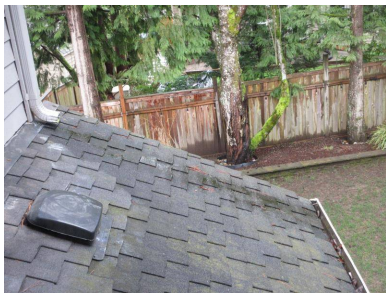
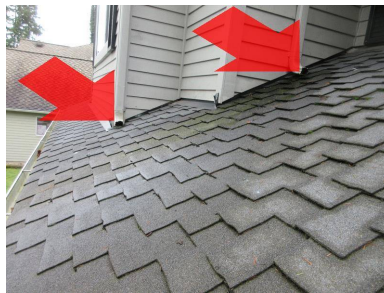
Downspouts draining directly onto the asphalt shingle surface causes excessive wear of the roofing material. Downspout extensions to the lower gutters should be installed to prevent excessive wear and tear of the roofing.

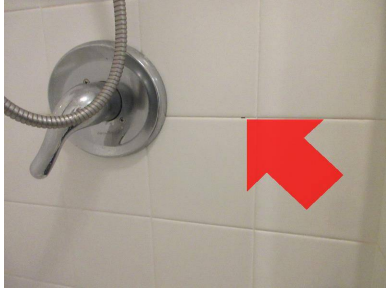
Grout is missing from between some of the wall tiles. This can allow water to enter through the tile and can damage the walls. Regrouting the wall tile is recommended.

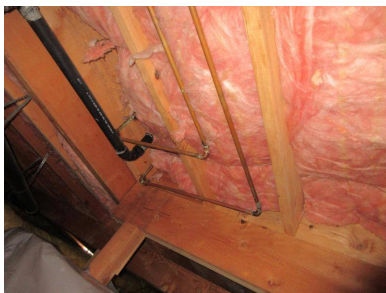
13.4 INTERIOR WATER SUPPLY PIPES

There are water pipes in the crawlspace that are not adequately insulated and could freeze. The installation of foam pipe insulation on all exposed water pipes is recommended.

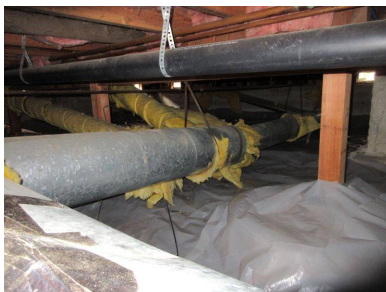
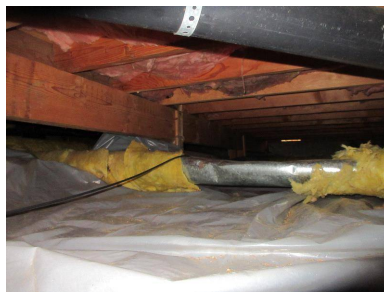
Some of the duct insulation is missing or has fallen off the ducts. This increases the amount of heat loss. The installation of new duct insulation is recommended in areas where insulation is missing.

- 17.4 DUCT INSULATION – Missing duct insulation will be replaced.

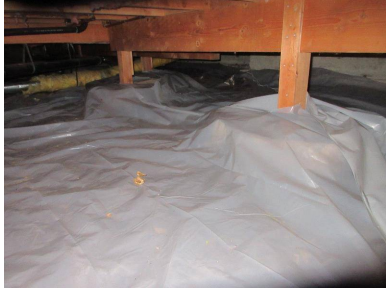
pier so that it covers at least 85% of the entire surface of the soil only.

- 14.7 WINDOWS – Repair difficult to operate windows by installing new block and tackle balances.
- 19.4 VAPOR RETARDER – The plastic vapor retarder can be removed from the support post concrete piers.

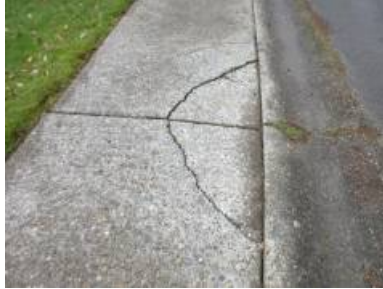
Many legal and public works departments have defined a trip hazard as an irregularity in a walking surface exceeding one inch (1") in height. All walking surfaces should maintain, free of a vertical surface change of 3/4" or more, in the interest of public and personal safety.

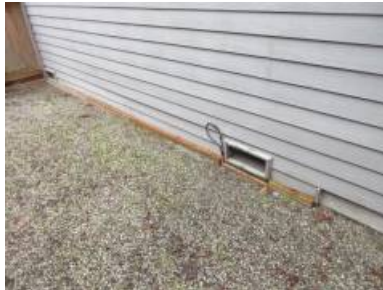
Soil is close to or in contact with siding in some areas at the buildings north exterior. Good building practice requires that foundation walls or pier footings supporting wood frame construction, extend at least 8" above the finish grade with at least a 6" clearance between the top of the soil and the bottom of the wood finish materials. Soil in direct contact with wood creates a hospitable environment for wood destroying organisms. Establishing these minimum clearances is recommended.

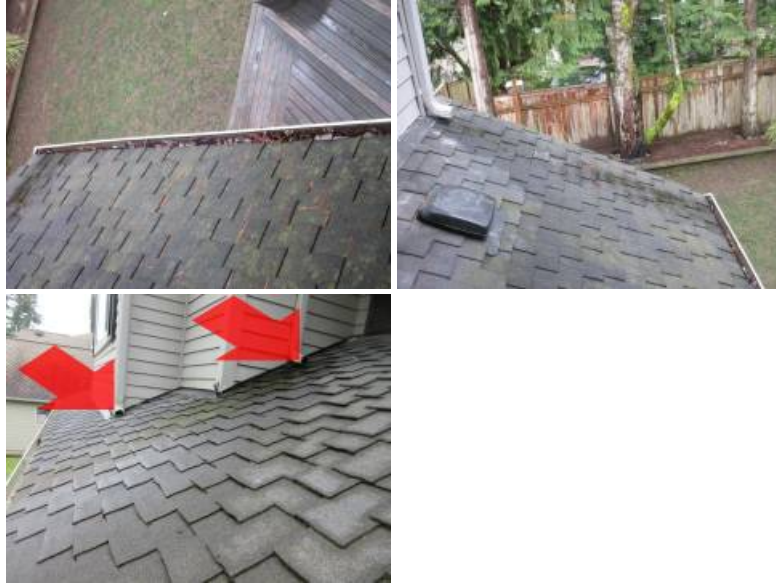
Downspouts draining directly onto the asphalt shingle surface causes excessive wear of the roofing material. Downspout extensions to the lower gutters should be installed to prevent excessive wear and tear of the roofing.

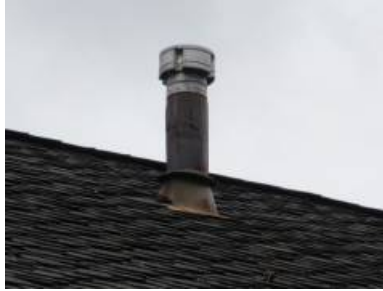
The portion of the gas appliance vent above the roof is deteriorated. This section of vent should be replaced.

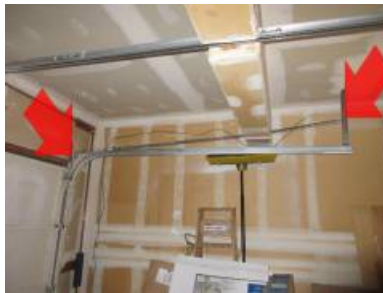
There is no automatic garage door opener for the north garage door. The door must be opened manually. This door was blocked by contents and its operation was not verified.

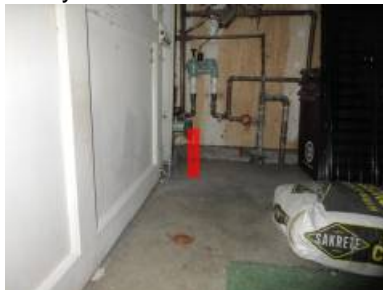
6.3 GARAGE DOOR OPENER

The Photo-eye beam was installed to high above the floor of the garage to adequately offer protection for small children and/or pets. We recommend that the photo-eye be lowered to within 4-6" of the floor.

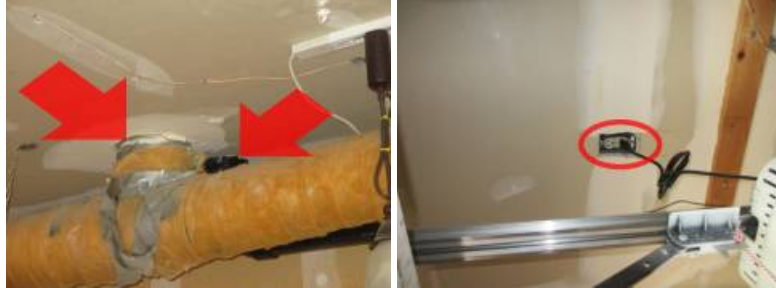
6.4 FIRE SEPARATION

There are voids in the fire resistive barrier between the living space and garage that will allow flames to penetrate. The gypsum barrier slows the spread of a fire from the garage to the structure and/or living space. Patching the voids with a fire retardant caulk is recommended.

The exposed wood is a breach in the fire resistive barrier in the garage. This is a safety concern. The gypsum barrier slows the spread of a fire from the garage to the structure. The installation of a layer of 5/8" gypsum type X board over the exposed wood is recommended.

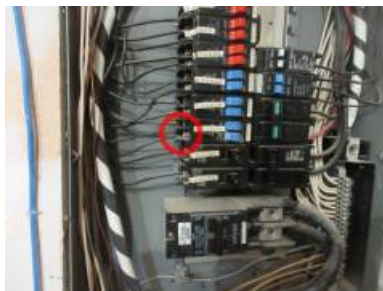
One of the circuits is double tapped. Double tapping means that two conductors share a single terminal. Double tapped terminals can loosen and overheat and therefore are not permitted unless the terminal is specifically listed for multiple wires. This defect is easily repaired by connecting the two wires to a "pig tail", securing them with a wire cap, and then inserting the pig tail conductor under the terminal.

- 7.9 OVER CURRENT PROTECTION - The defect was repaired by connecting the two wires to a "pig tail", securing them with a wire cap, and then inserting the pig tail conductor under the terminal.

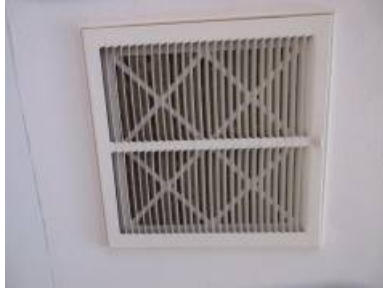
The air filter is clogged with dust. This reduces air flow and furnace efficiency. Removal and replacement of the air filter is recommended. Pleated style air filters are recommended as they offer better filtration of dust than the coarser hogs hair or fiberglass filters.

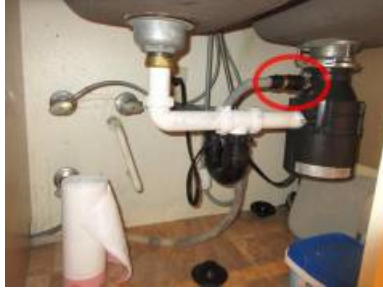
The dishwasher drain lacks an air gap. The dishwasher will function without one, but there is a risk of contamination of the inside of the dishwasher by waste water. The installation of an air gap is recommended.

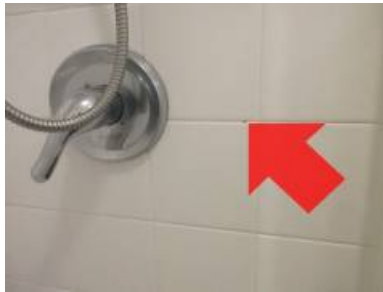
Grout is missing from between some of the wall tiles. This can allow water to enter through the tile and can damage the walls. Regrouting the wall tile is recommended.

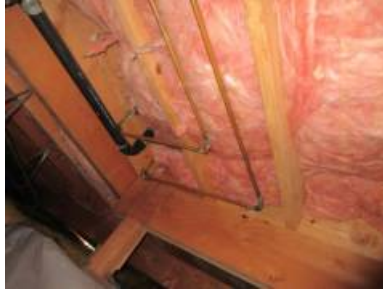
insulation on all exposed water pipes is recommended.

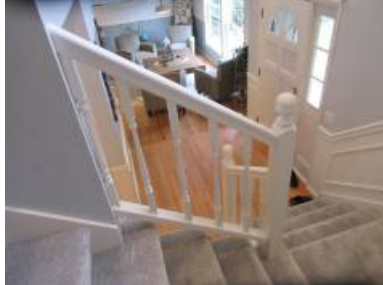
The stair railing baluster spacing is too wide. This is a hazard for small children. The baluster spacing should be reduced as a safety upgrade. Current standards require that a 4" sphere not pass through the railing.

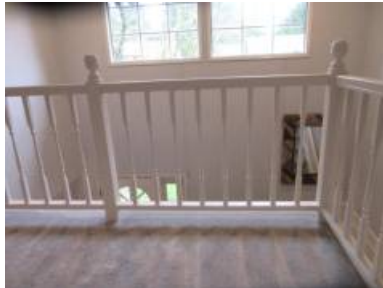
**14.3 GUARD RAILINGS**

The spacing between the balusters is too wide. This is a hazard to small children. The balusters should be spaced close enough together so that a 4" sphere cannot pass through. Upgrading the guard railing is recommended if small children are present.

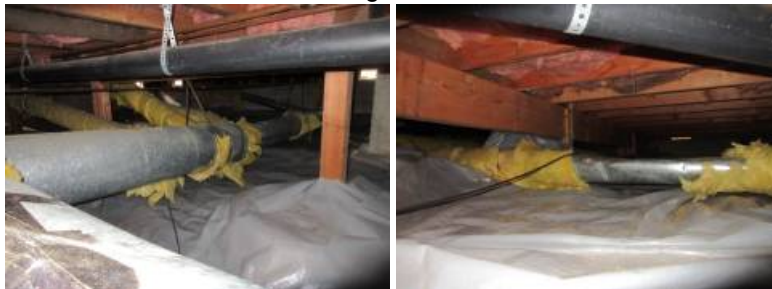
Some of the duct insulation is missing or has fallen off the ducts. This increases the amount of heat loss. The installation of new duct insulation is recommended in areas where insulation is missing.

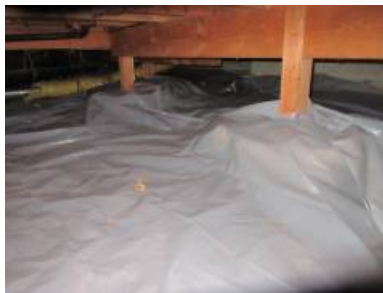
The support post concrete piers are covered with the plastic vapor retarder. This allows the transmission of water vapor from the soil up and into the floor framing. The plastic vapor retarder should be removed from the pier so that it covers at least 85% of the entire surface of the soil only.
