**NOTICE TO BUYER: SELLER-PROCURED INSPECTION REPORT**

The following notice is given with respect to the Purchase and Sale Agreement dated \_\_\_\_\_  
between \_\_\_\_\_ ("Buyer")  
and **Duffy Revocable Trust** \_\_\_\_\_ ("Seller")  
concerning **13500 171st Ave NE Redmond WA 98052** ("the Property").

February 14, 2022

**Mr. & Mrs. Tim & Jackie Duffy  
13500 171st Ave NE  
Redmond, WA.**

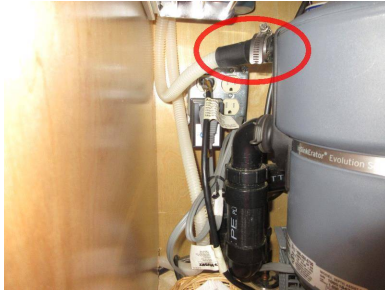
#### 10.8 AIR GAP

The dishwasher drain lacks an air gap. The dishwasher will function without one, but there is a risk of contamination of the inside of the dishwasher by waste water. The installation of an air gap is recommended.

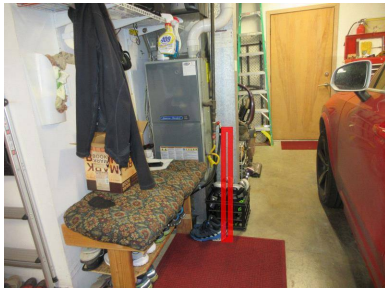
#### 13.10 GAS PIPING

The gas pipes in front of the furnace and water heater are not protected by a bumper stop. A vertical steel pipe, bolted to the floor, is typically installed in front of the water heater to prevent a car bumper from damaging the gas lines.

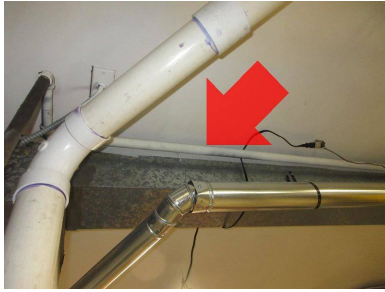
The gas pipe in the garage was not adequately secured. This can damage the pipe. The gas pipe should be secured in accordance with industry standards.

- 13.10 Gas piping is secured per code
- 15.4 Damper – C-clamp has been installed
- 3.3 Pest Control – Terminix performs an inspection and treatment for pests inside and out on a quarterly basis

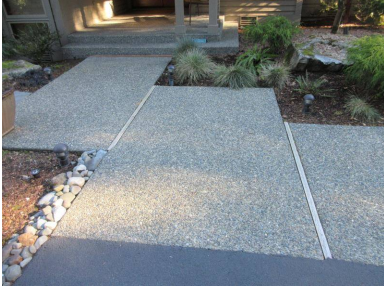
### 2.5 WALKWAY

When the wooden dividers separating the concrete walkway sections have deteriorated to a point where they become a trip hazard. Replacement with mortar is recommended.

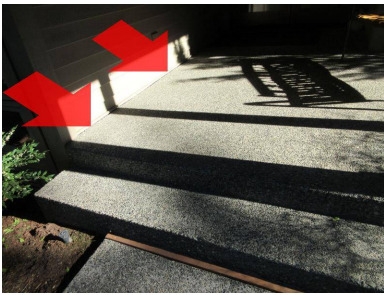
### 3.3 PEST CONTROL

Untreated wood in direct contact with concrete was observed along the porch stoop. Untreated wood should be raised 1-2" above the concrete. Treating the wood with a preservative sometimes will prevent wood destroy organism damage.

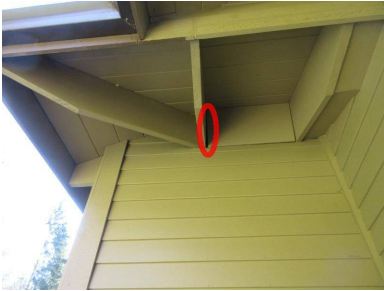
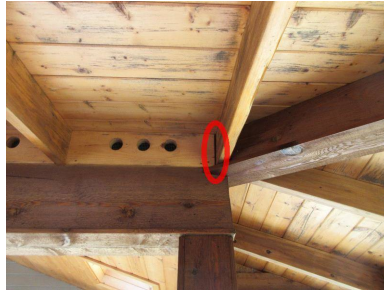
### 3.4 SOFFITS AND OVERHANGS

There are large gaps over 1/4" in size adjacent the soffit vent blocks. These gaps allow insects and rodents to enter the attic. Covering the gaps with screening, a strip of wood and/or caulking is recommended.

- 3.4 Soffits – All gaps have been sealed with caulking as recommended
- 4.3 Skylights – Skylights have been secured with stainless steel screws
- 9.5 Expansion Tank – Expansion tank inspected by Pioneer Plumbing on February 21, 2022. The expansion tank is installed per code. Seismic strapping is not recommended, nor available for tanks of less than 5 gallons. Please see the comments in their report following the inspection report.

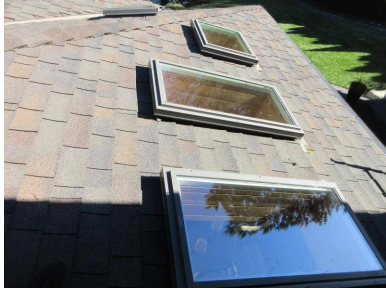
### 4.3 SKYLIGHTS

The skylights over the deck are not secured to the roof. Skylights can get blown off roofs during high winds if they are not secured. Fastening the skylights to the curb with plated or stainless screws is recommended.

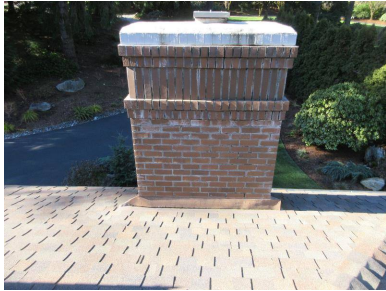
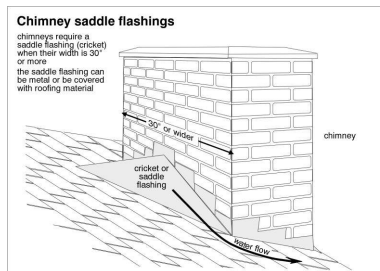
#### 4.4 CHIMNEYS

There is no cricket on the up-slope side of the living room fireplace chimney. This is conducive to leakage. Consideration should be given to installing a cricket to divert water around the chimney.

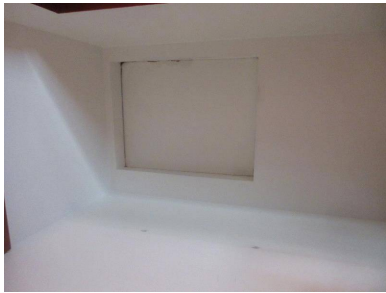
#### 5.1 ACCESS

The access opening to the attic is too small by today's standards. The rough framed opening should not be less than 22 inches by 30 inches. Modification of the access opening is recommended for inspection and servicing of components in the attic.

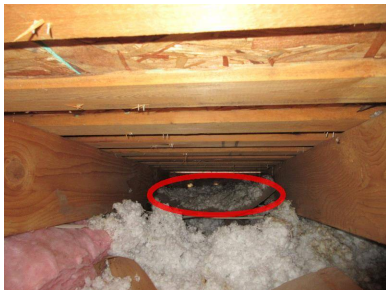
#### 5.2 VENTILATION

Wind baffles locations are compromised in some areas of the attic. The proper placement of wind baffles in front of all soffit vents is recommended.

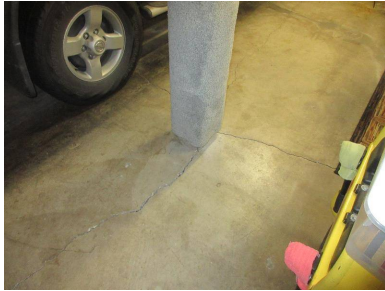
There are large cracks and some vertical displacement of the garage floor slab. This type of defect is usually caused by a lack of proper soil preparation (compacting) prior to the placement of the concrete. This is primarily an aesthetic defect, since the floor slab is not a structural component.

There is a noticeable slope to the garage floor. The garage floor should slope towards the door opening so that water and spilled flammable liquids will flow out of the garage. Consideration should be given to pressure grouting the floor up to slope towards the door or removing and replacing it.

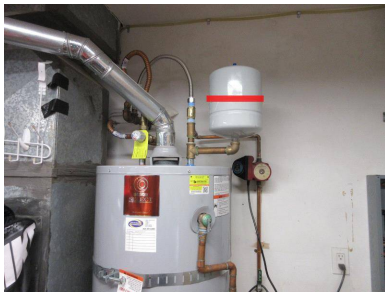
The expansion tank is not adequately secured to the wall. As code requirements start to call for engineered expansion tank supports we recommend the installation of seismic restraints to secure the expansion tank instead of allowing it to simply depend on piping connections that could result in damage to the water pipe and leakage during an earthquake.

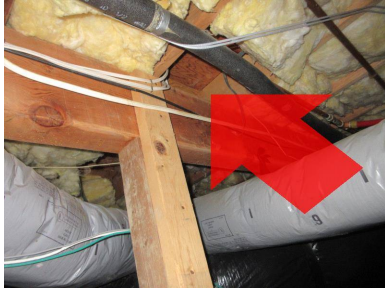
The floors are insulated with 9" R-21 fiberglass batt insulation. The floor insulation has been properly installed and is in good condition. One missing batt was observed, missing batts should be replaced.

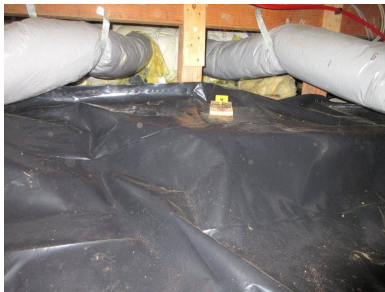
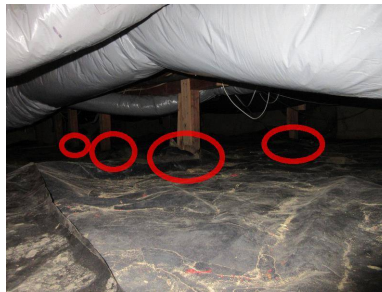
### 19.4 VAPOR RETARDER

The support post concrete piers are covered with the plastic vapor retarder. This allows the transmission of water vapor from the soil up and into the floor framing. The plastic vapor retarder should be removed from the pier so that it covers at least 85% of the entire surface of the soil only.

- 19.4 Vapor Barrier – Vapor barrier issue will be addressed and repaired by Terminix on March 15, 2022
- 19.5 Pest control – See 3.3

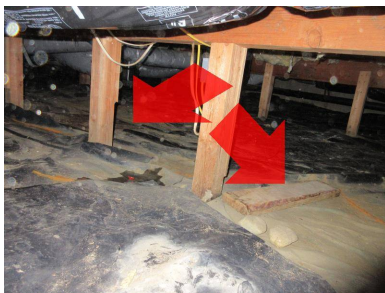
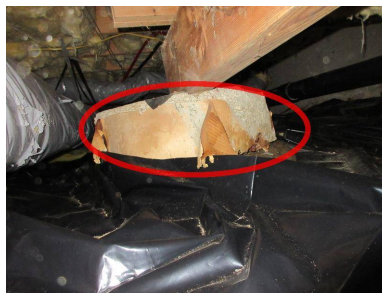
### 19.5 PEST CONTROL

There is evidence of rodent activity in the crawlspace. The first step in eliminating rodents from the crawlspace is to seal all possible entry points using wire mesh, caulking, wood, stainless steel wool, aerosol foam or mortar. Careful work sealing cracks, holes, gaps, and covering ground water drain inlets will discourage rodent activity. Once this work is completed, snap traps baited with peanut butter should be installed and monitored. The absence of rodents in the traps typically means that the rodents have been excluded from the area.

Cellulose forms were left in place on the pier footings. This cellulose is conducive to the infestation of various wood destroying organisms. The removal of the cellulose is recommended.

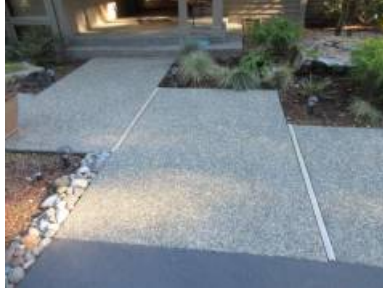
Many legal and public works departments have defined a trip hazard as an irregularity in a walking surface exceeding one inch (1") in height. All walking surfaces should maintain, free of a vertical surface change of 3/4" or more, in the interest of public and personal safety.

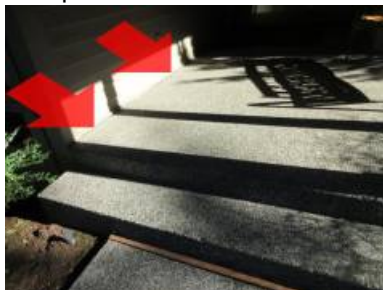
Untreated wood in direct contact with concrete was observed along the porch stoop. Untreated wood should be raised 1-2" above the concrete. Treating the wood with a preservative sometimes will prevent wood destroy organism damage.

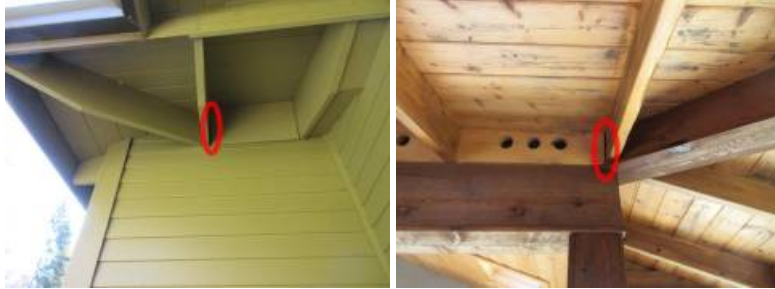
### 3.4 SOFFITS AND OVERHANGS

There are large gaps over 1/4" in size adjacent the soffit vent blocks. These gaps allow insects and rodents to enter the attic. Covering the gaps with screening, a strip of wood and/or caulking is recommended.

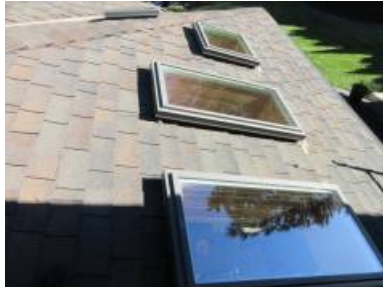
The skylights over the deck are not secured to the roof. Skylights can get blown off roofs during high winds if they are not secured. Fastening the skylights to the curb with plated or stainless screws is recommended.

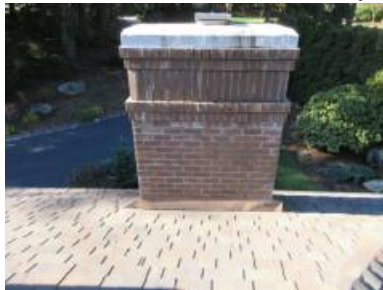
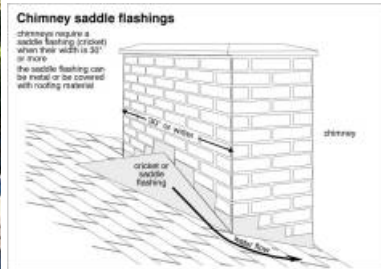
#### 4.4 CHIMNEYS

There is no cricket on the up-slope side of the living room fireplace chimney. This is conducive to leakage. Consideration should be given to installing a cricket to divert water around the chimney.

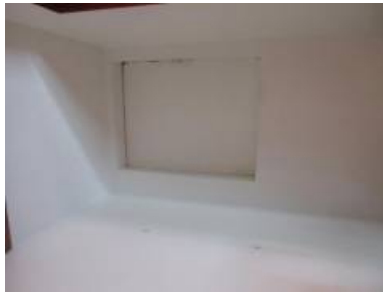
The access opening to the attic is too small by today's standards. The rough framed opening should not be less than 22 inches by 30 inches. Modification of the access opening is recommended for inspection and servicing of components in the attic.

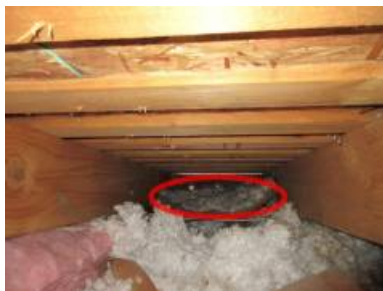
Wind baffles locations are compromised in some areas of the attic. The proper placement of wind baffles in front of all soffit vents is recommended.

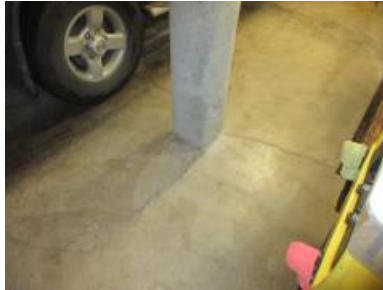
There is a noticeable slope to the garage floor. The garage floor should slope towards the door opening so that water and spilled flammable liquids will flow out of the garage. Consideration should be given to pressure grouting the floor up to slope towards the door or removing and replacing it.

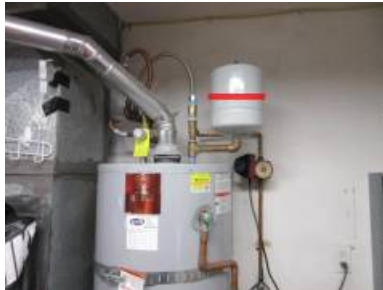
The expansion tank is not adequately secured to the wall. As code requirements start to call for engineered expansion tank supports we recommend the installation of seismic restraints to secure the expansion tank instead of allowing it to simply depend on piping connections that could result in damage to the water pipe and leakage during an earthquake.

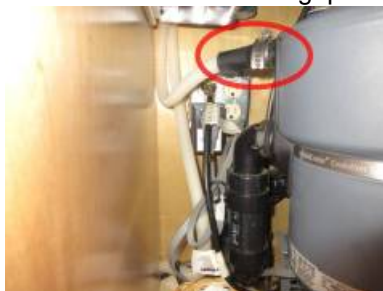
The dishwasher drain lacks an air gap. The dishwasher will function without one, but there is a risk of contamination of the inside of the dishwasher by waste water. The installation of an air gap is recommended.

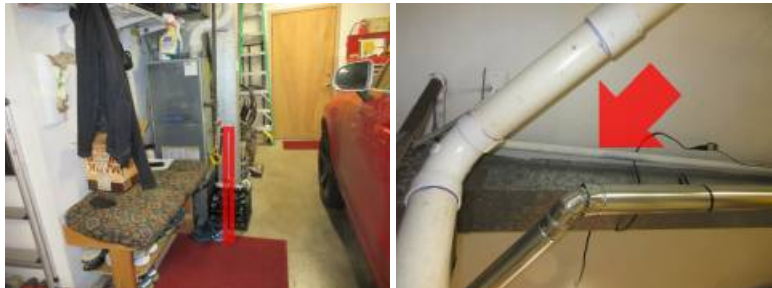
The gas pipe in the garage was not adequately secured. This can damage the pipe. The gas pipe should be secured in accordance with industry standards.

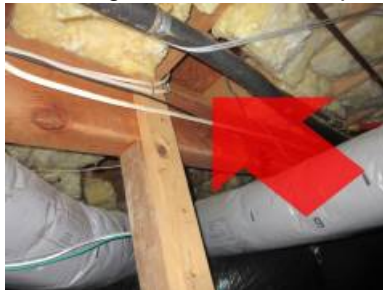
The floors are insulated with 9" R-21 fiberglass batt insulation. The floor insulation has been properly installed and is in good condition. One missing batt was observed, missing batts should be replaced.

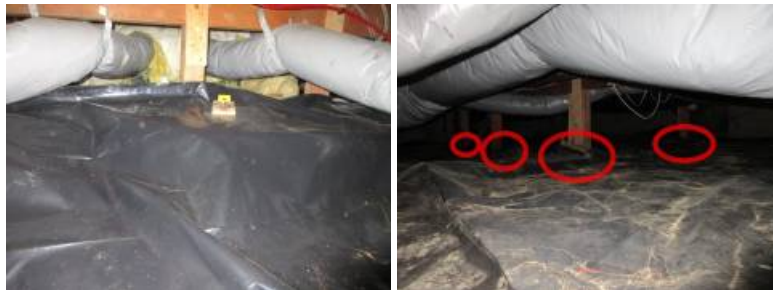
The support post concrete piers are covered with the plastic vapor retarder. This allows the transmission of water vapor from the soil up and into the floor framing. The plastic vapor retarder should be removed from the pier so that it covers at least 85% of the entire surface of the soil only.

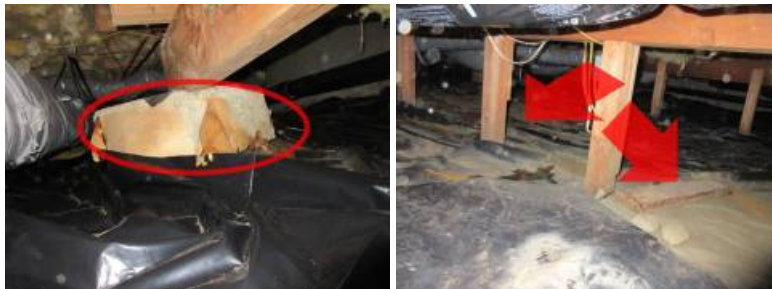
Scrap-wood and other cellulose debris was observed on the crawl floor. This wood debris creates conducive conditions for wood boring insects. The removal of all cellulose debris is recommended.
