NOTICE TO BUYER: SELLER-PROCURED INSPECTION REPORT

March 30, 2022

Re: 1811 172nd Ave. NE
Bellevue, WA.

1811 172nd Ave. NE
Bellevue WA.

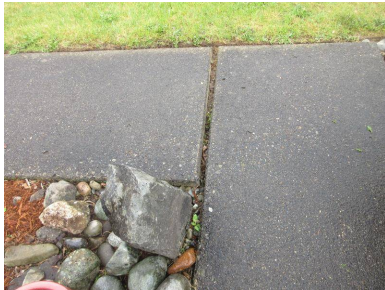
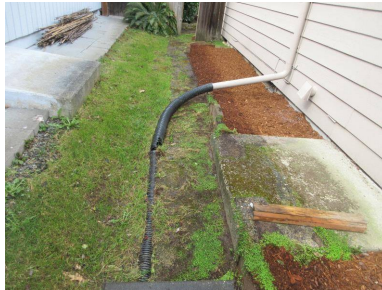
The gaps separating the concrete walkway sections are a trip hazard. Replacement with mortar is recommended.

Many legal and public works departments have defined a trip hazard as an irregularity in a walking surface exceeding one inch (1") in height. All walking surfaces should maintain, free of a vertical surface change of 3/4" or more, in the interest of public and personal safety.

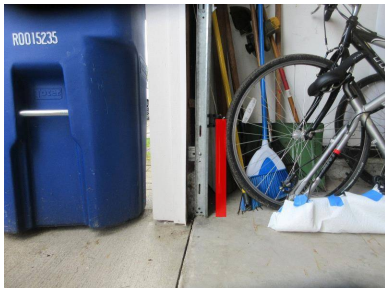
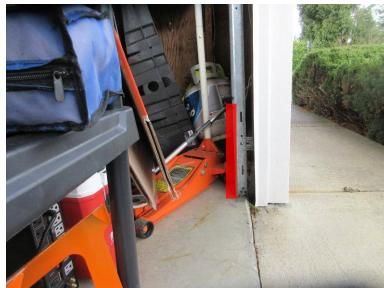
6.3 GARAGE DOOR OPENER

The Photo-eye beam was installed too high above the floor of the garage to adequately offer protection for small children and/or pets. We recommend that the photo-eye be lowered to within 4-6" of the floor.

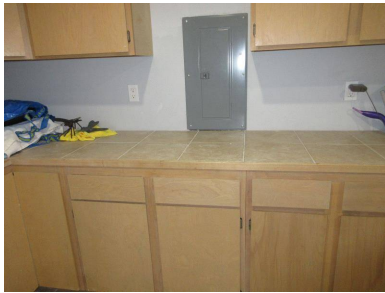
7.3 SERVICE PANEL LOCATION

Access to the electrical panel is blocked by cabinets. Cabinets should be removed or modified so that there is a 30" wide by 36" deep by 7' tall clearance in front of the panel.

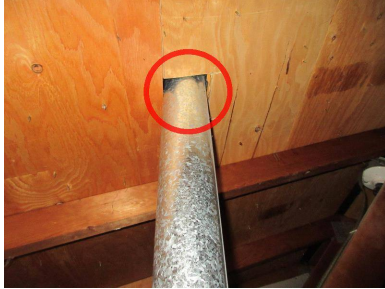
10.11 VENT

The water heater vent connector is too close to combustible material. The minimum clearance of 6" is required between the single wall vent connector and the combustible surface. The double wall type B vent requires only 1" of clearance. The B vent is properly installed and is functioning as intended.

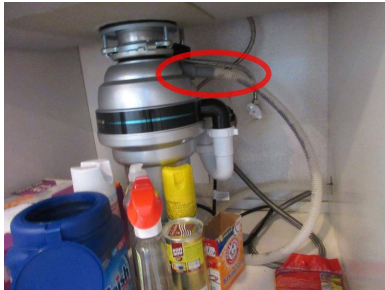
11.8 AIR GAP

The dishwasher drain lacks an air gap. The dishwasher will function without one, but there is a risk of contamination of the inside of the dishwasher by waste water. The installation of an air gap is recommended or connection to the existing Johnson Tee that is installed in the kitchen wall. This air gap or Johnson Tee protects the dishwasher from contamination caused by a backflow of waste water.

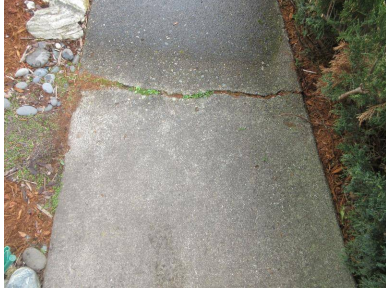
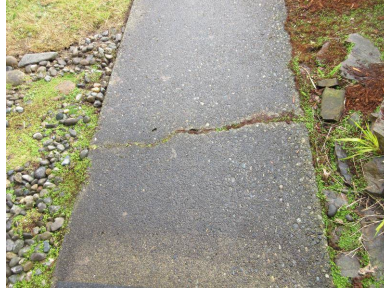
2.5 WALKWAY

Cracks were observed in the concrete surface of the walkway. Minor cracks can be sealed to minimize moisture entry and further settlement of the concrete.

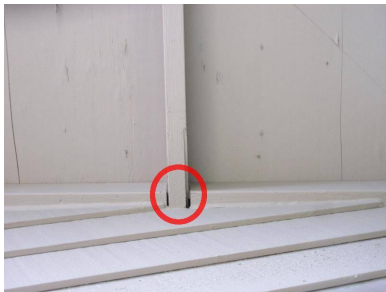
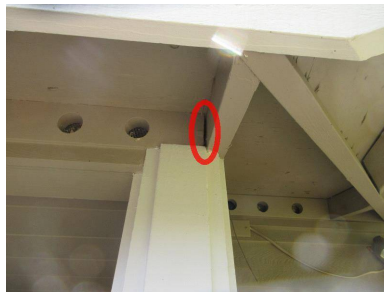
3.3 SOFFITS AND OVERHANGS

There are openings adjacent the ends of the outlook boards under the overhang through which insects and rodents can enter into the attic. These openings should be covered with wood, wire mesh or filled with aerosol foam.

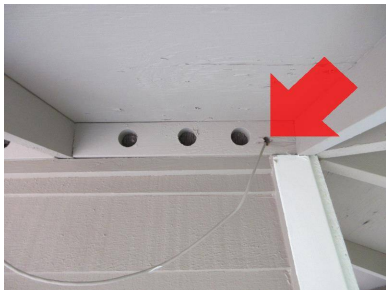
There are openings adjacent wire penetrations where rodents can enter into the attic. These openings should be covered with wood, wire mesh or filled with aerosol foam.

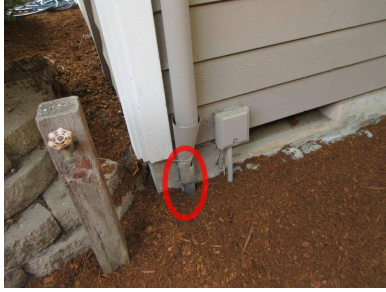
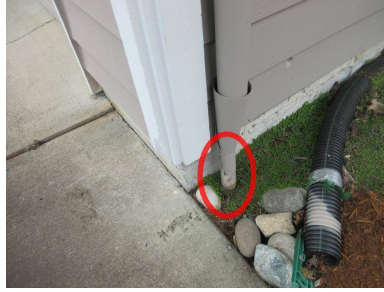
3.4 GUTTERS AND DOWNSPOUTS

The 2" round downspout drain inlets are too small and are more vulnerable to clogging than the larger ones. Consideration should be given to upgrading the downspout drain lines.

There is a build-up of organic debris in the gutters. Proper maintenance of gutters and downspouts is essential and should be performed routinely in order to prevent clogging. Maintenance consists primarily of keeping leaves and other organic debris out of the system. Failure to clean the gutters will result in water splash on the building when they overflow. Gutters can be damaged from the water build up and organic matter blocking the gutter. Gutters should be cleaned as necessary to maintain a free flow of water into the downspouts.

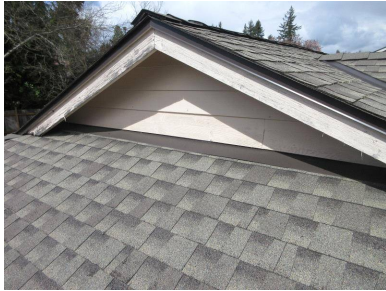
3.5 PAINT

Peeling paint was observed on trim boards above the roof. Paint protects the wood from cupping, checking, warping and rot. These areas should be scraped, primed and repainted.

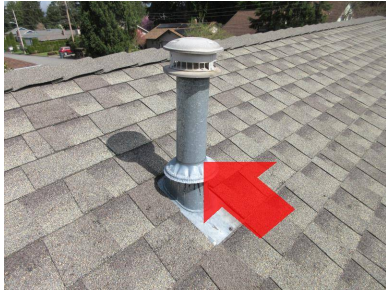
4.3 GAS APPLIANCE VENTS

The storm collar is not sealed. This is allowing leakage to occur. Sealing the storm collar is recommended.

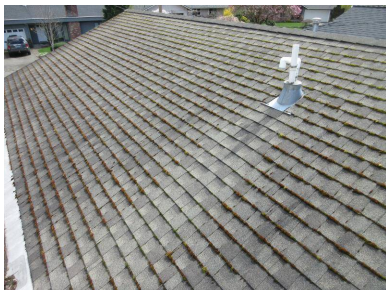
4.5 MAINTENANCE AND REPAIRS

The roof is in need of overdue maintenance. The surface should be treated for moss, lichen, and algae growth, then blown, brushed and washed off with a high volume low pressure hose to remove moss and organic debris. Performing this maintenance will improve the appearance and increase the life expectancy of the roof.

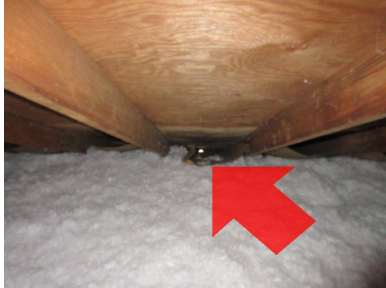
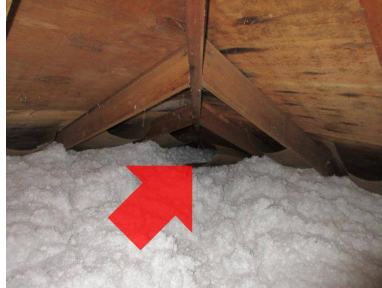
ATTIC**5.2 VENTILATION**

Wind baffles locations are compromised in some areas of the attic. The proper placement of wind baffles in front of all soffit vents is recommended.

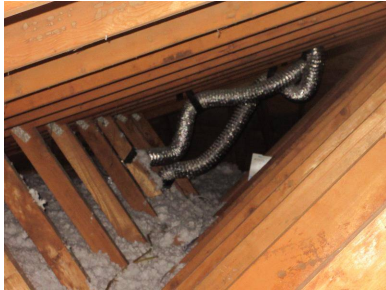
**5.3 MECHANICAL VENTILATION SYSTEMS**

Flexible plastic duct is used to direct air from the vent fans to the exterior. This type of material is unreliable. Replacing the plastic duct with 4" smooth-wall sheet metal duct is recommended.

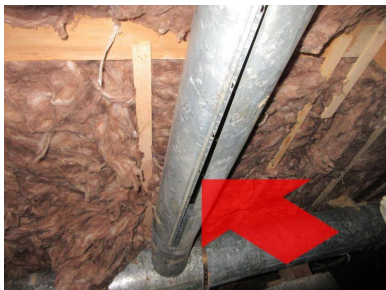
HEATING SYSTEM**FORCED AIR HEATING SYSTEM****8.12 DUCTS**

The heating duct in the crawlspace under the northeast bedroom has separated at the seam. It should be reattached or replaced.

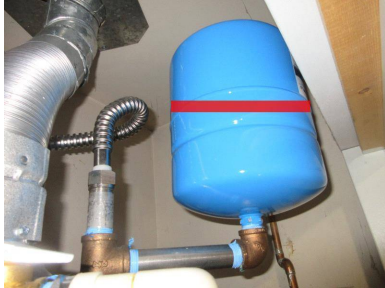
10.6 EXPANSION TANK

The expansion tank is not adequately secured to the wall. As code requirements start to call for engineered expansion tank supports we recommend the installation of seismic restraints to secure the expansion tank instead of allowing it to simply depend on piping connections that could result in damage to the water pipe and leakage during an earthquake.

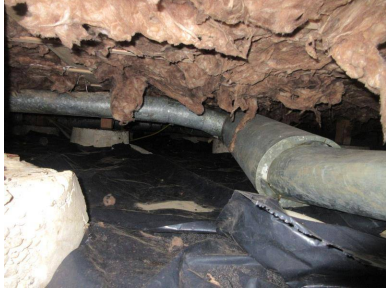
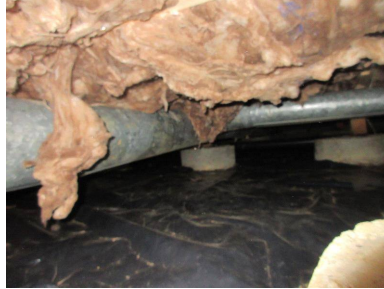
17.4 DUCT INSULATION

There is no duct insulation. This allows significant heat loss to occur. The installation of fiberglass duct insulation is recommended.

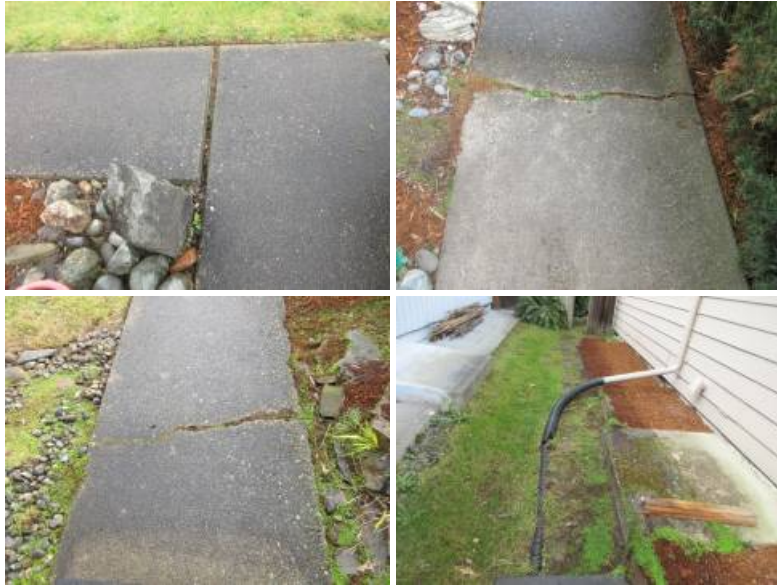
The gaps separating the concrete walkway sections are a trip hazard. Replacement with mortar is recommended.

Many legal and public works departments have defined a trip hazard as an irregularity in a walking surface exceeding one inch (1") in height. All walking surfaces should maintain, free of a vertical surface change of 3/4" or more, in the interest of public and personal safety.

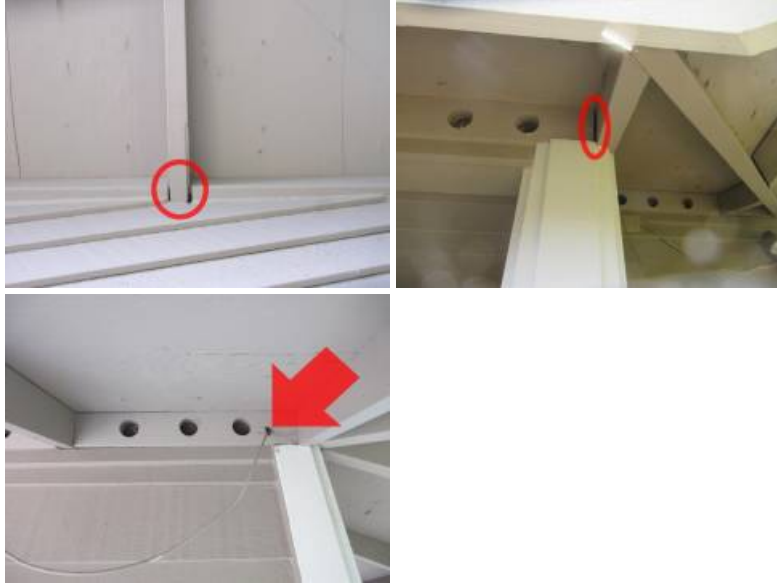
There are openings adjacent wire penetrations where rodents can enter into the attic. These openings should be covered with wood, wire mesh or filled with aerosol foam.

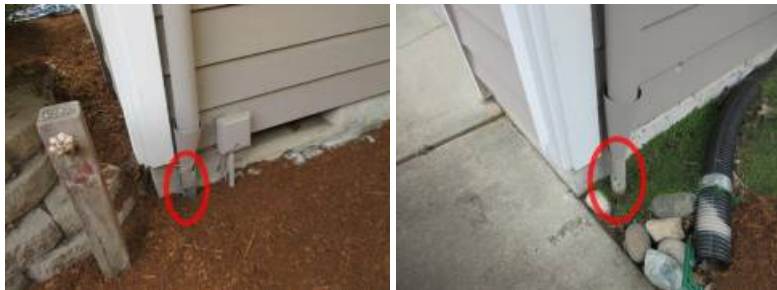
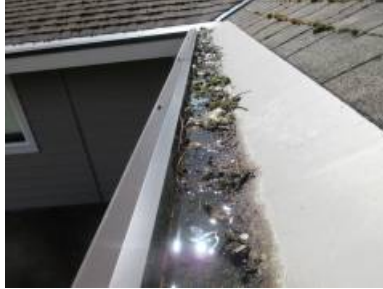
3.4 GUTTERS AND DOWNSPOUTS

The 2" round downspout drain inlets are too small and are more vulnerable to clogging than the larger ones. Consideration should be given to upgrading the downspout drain lines.

There is a build-up of organic debris in the gutters. Proper maintenance of gutters and downspouts is essential and should be performed routinely in order to prevent clogging. Maintenance consists primarily of keeping leaves and other organic debris out of the system. Failure to clean the gutters will result in water splash on the building when they overflow. Gutters can be damaged from the water build up and organic matter blocking the gutter. Gutters should be cleaned as necessary to maintain a free flow of water into the downspouts.

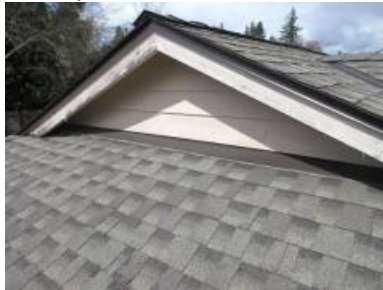
3.5 PAINT

Peeling paint was observed on trim boards above the roof. Paint protects the wood from cupping, checking, warping and rot. These areas should be scraped, primed and repainted.

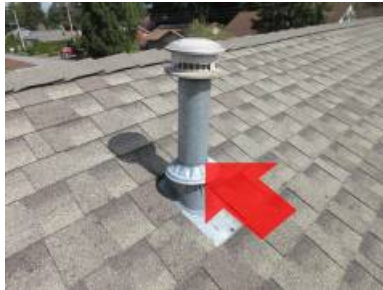
The storm collar is not sealed. This is allowing leakage to occur. Sealing the storm collar is recommended.

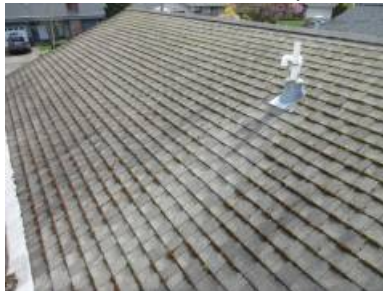
The roof is in need of overdue maintenance. The surface should be treated for moss, lichen, and algae growth, then blown, brushed and washed off with a high volume low pressure hose to remove moss and organic debris. Performing this maintenance will improve the appearance and increase the life expectancy of the roof.

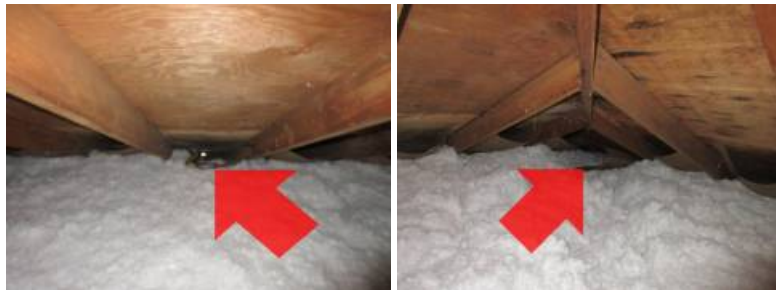
Wind baffles locations are compromised in some areas of the attic. The proper placement of wind baffles in front of all soffit vents is recommended.

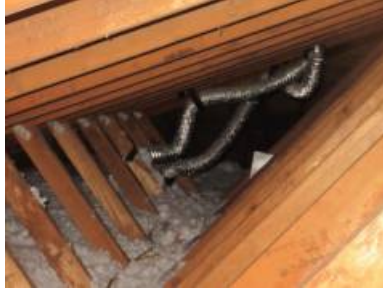
5.3 MECHANICAL VENTILATION SYSTEMS

Flexible plastic duct is used to direct air from the vent fans to the exterior. This type of material is unreliable. Replacing the plastic duct with 4" smooth-wall sheet metal duct is recommended.

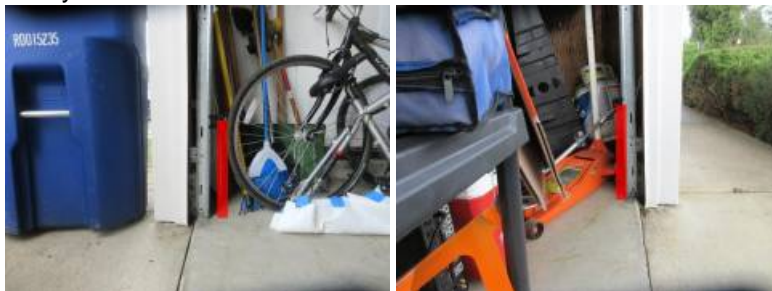
The Photo-eye beam was installed to high above the floor of the garage to adequately offer protection for small children and/or pets. We recommend that the photo-eye be lowered to within 4-6" of the floor.

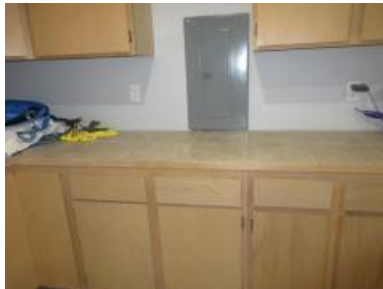
Access to the electrical panel is blocked by cabinets. Cabinets should be removed or modified so that there is a 30" wide by 36" deep by 7' tall clearance in front of the panel.

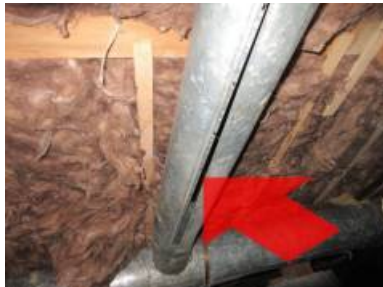
The heating duct in the crawlspace under the northeast bedroom has separated at the seam. It should be reattached or replaced.

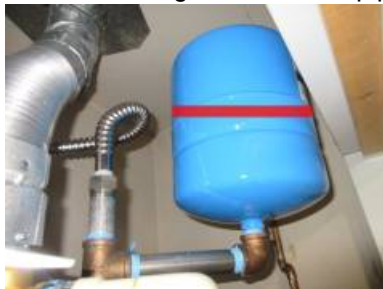
10.6 EXPANSION TANK

The expansion tank is not adequately secured to the wall. As code requirements start to call for engineered expansion tank supports we recommend the installation of seismic restraints to secure the expansion tank instead of allowing it to simply depend on piping connections that could result in damage to the water pipe and leakage during an earthquake.

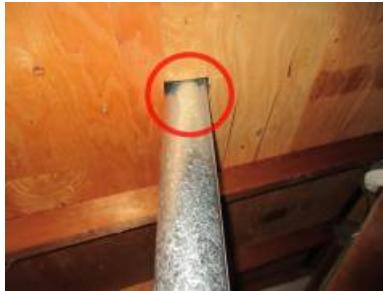
The water heater vent connector is too close to combustible material. The minimum clearance of 6" is required between the single wall vent connector and the combustible surface. The double wall type B vent requires only 1" of clearance. The B vent is properly installed and is functioning as intended.

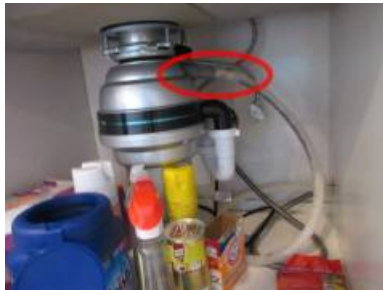
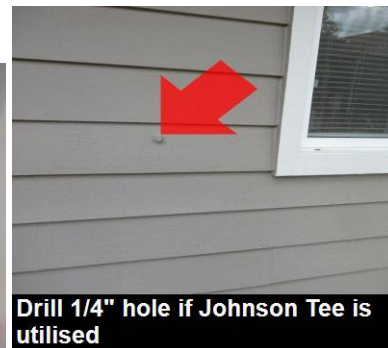
The dishwasher drain lacks an air gap. The dishwasher will function without one, but there is a risk of contamination of the inside of the dishwasher by waste water. The installation of an air gap is recommended or connection to the existing Johnson Tee that is installed in the kitchen wall. This air gap or Johnson Tee protects the dishwasher from contamination caused by a backflow of waste water.

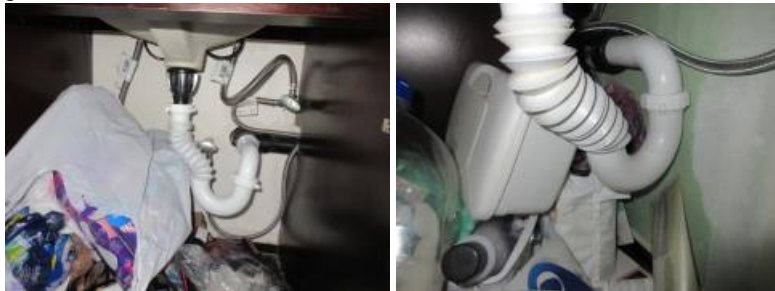
Improper, non-conforming material has been used for the drain pipe fitting. This material will not function reliably. Replacement with industry standard fittings is recommended.

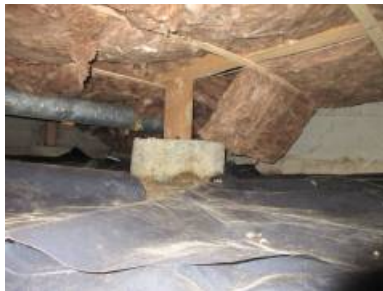
Some of the insulation batts were not properly secured and have falling down. The fallen batts should be reinstalled and secured.

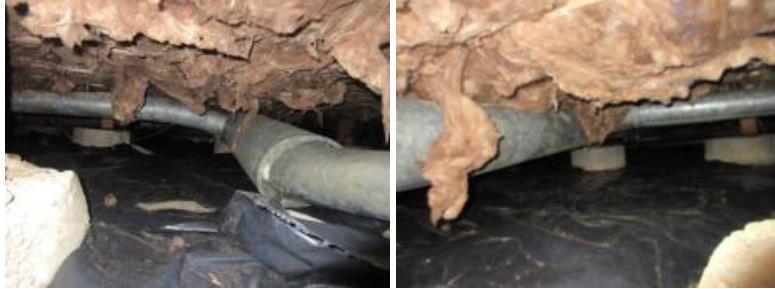
17.4 DUCT INSULATION

There is no duct insulation. This allows significant heat loss to occur. The installation of fiberglass duct insulation is recommended.
