NOTICE TO BUYER: SELLER-PROCURED INSPECTION REPORT

Rownak Islam & Faranaz Chowdhury
14110 177th Ct NE
Redmond WA 98052

April 11, 2022

Re: 14110 177th Ct. NE
Redmond, WA.

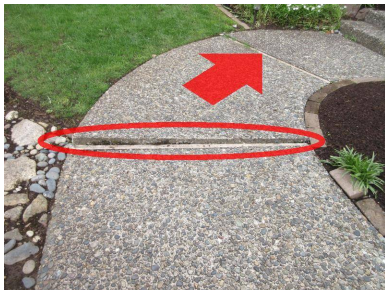
The walkway has cracked and settled differentially. This was probably caused by inadequate preparation of the soil prior to the placement of the concrete. This condition can be repaired by pressure grouting the sunken portion of the walkway or by removing and replacing it. Grinding down the raised edges of the concrete will also mitigate the hazard. The walkway remains functional despite this condition. However, the raised edges of the concrete can be a trip hazard for some people. Repairs should be made as necessary.

One or more of the wooden dividers separating the concrete walkway sections were infested by wood destroying organisms and have deteriorated to a point where they are becoming a trip hazard. Replacement with mortar is recommended.

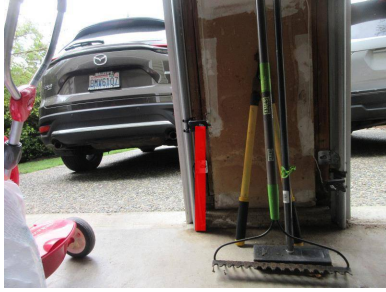
6.3 GARAGE DOOR OPENER

The Photo-eye beam for the south door was installed to high above the floor of the garage to adequately offer protection for small children and/or pets. We recommend that the photo-eye be lowered to within 4-6" of the floor.

- 6.3 Garage Door Opener - the photo-eye beam height on south door has been fixed.
- 6.4 Fire Separation - all of the voids in fire resistive barrier in garage has been patched.

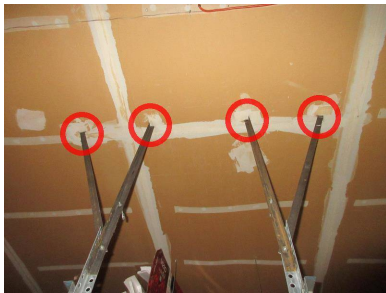
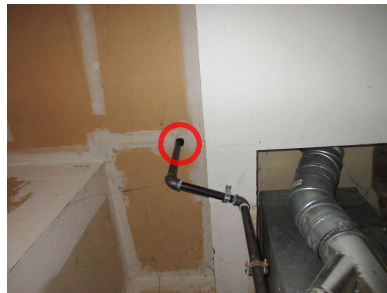
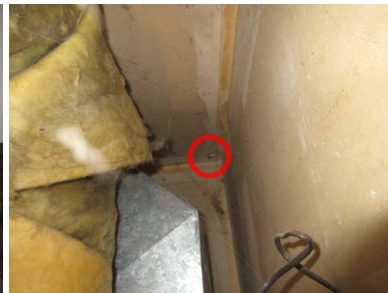
6.4 FIRE SEPARATION

There are voids in the fire resistive barrier between the living space and garage that will allow flames to penetrate. The gypsum barrier slows the spread of a fire from the garage to the structure and/or living space. Patching the voids with a fire retardant caulk is recommended.

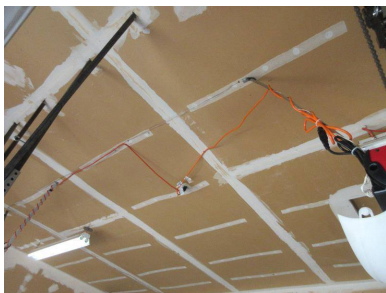
7.10 WIRING

Extension cords are used as a temporary power source for the garage door openers. Extension cords are not suitable as a permanent wiring method. The installation of a receptacle within cords length of each motor is recommended.

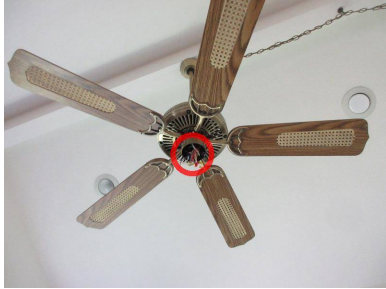
The family room ceiling fan was not working. It should be repaired or replaced as necessary.

- 6.5 Passage Door - the self-closing hinge on the fire rated door has been fixed.
- 7.12 Receptacles - all loose receptacles have been fixed.
- 7.17 Ceiling Fan - the family room ceiling fan has been fixed.

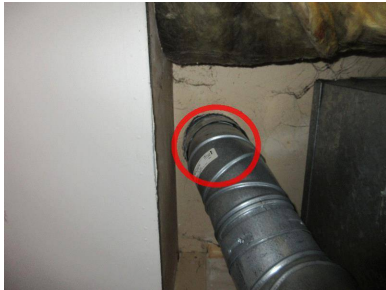
The furnace vent connector is too close to a combustible material. This is a hazard. A minimum clearance of 6" is required between the single wall vent connector and the combustible material. The double wall type B vent requires only 1" of clearance. Repairs are recommended.

- 8.10 Vent - the furnace vent connector has been further insulated and concealed.
- 10.8 Air Gap - the Johnson Tee air gap cap has been drilled to address the issue.

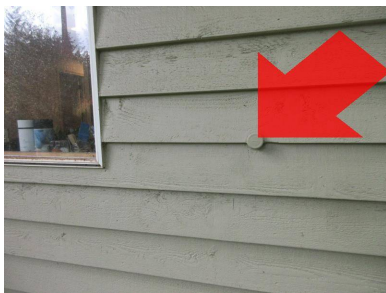
10.8 AIR GAP

An air gap called a Johnson Tee is installed in the kitchen wall. This air gap protects the dishwasher from contamination caused by a backflow of waste water. The cap protruding on the exterior wall opposite the dishwasher is not drilled. This renders the air gap non-functional. Drilling a 1/4" hole in the end of the cap will restore its function. The remaining visible portions of the Johnson Tee were properly installed and functioning as intended.

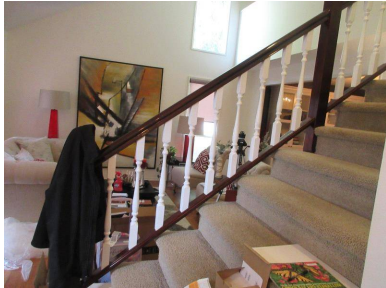
The stair railing baluster spacing is too wide. This is a hazard for small children. The baluster spacing should be reduced as a safety upgrade. Current standards require that a 4" sphere not pass through the railing.

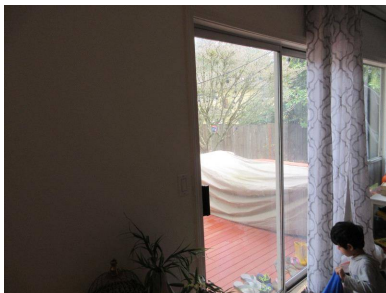
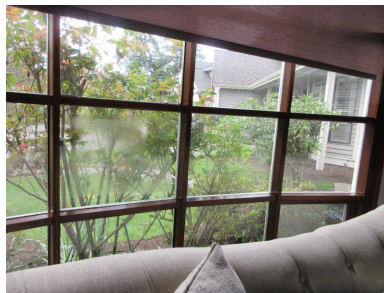
14.6 WINDOWS

There is condensation or mineral deposits between the panes of glass in at least two of the insulated glass windows and in the sliding glass door. This indicates failed seals. The glass assemblies should be replaced, which is the only method for correcting this deficiency.

One of the bedroom windows is stuck. The window should be adjusted or repaired as necessary to restore proper operation.

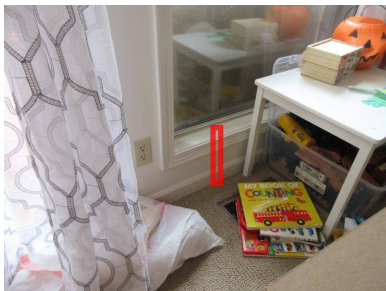
The lower window glass is not labeled as tempered safety glass. The existing glass is nonconforming by current building standards and would be hazardous if broken. The installation of safety glass is recommended as a safety upgrade for all windows less than 18" from the walking surface.

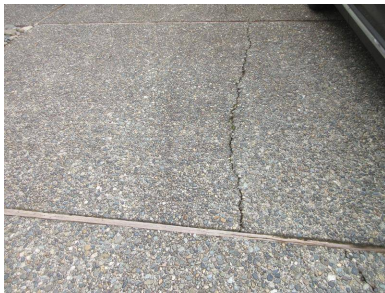
One or more of the wooden dividers separating the concrete driveway sections were infested by wood destroying organisms and have deteriorated to a point where they are becoming a trip hazard. Replacement with mortar is recommended.

Cracks were observed in the concrete surface of the driveway. Minor cracks can be sealed to minimize moisture entry and further settlement of the concrete. Minor cracks are common and do not affect the serviceability of the concrete.

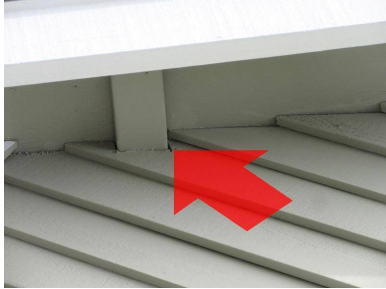
3.3 SOFFITS AND OVERHANGS

Gaps over 1/4" in size adjacent the soffit vent blocks will allow insects and rodents to enter the attic. Covering any gaps with screening, a strip of wood and/or caulking is recommended.

There are openings adjacent the ends of the outlook boards under the overhang through which insects and rodents can enter into the attic. These openings should be covered with wood, wire mesh or filled with aerosol foam.

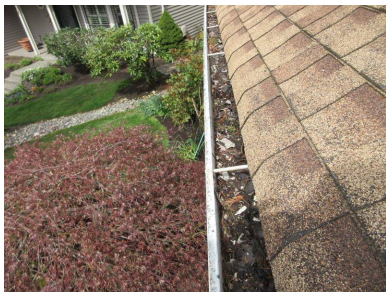
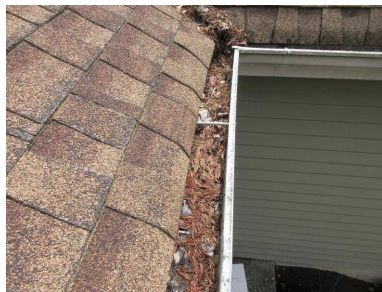
3.4 GUTTERS AND DOWNSPOUTS

There is a build-up of organic debris inside the gutters. Proper maintenance of gutters and downspouts is essential and should be performed routinely in order to prevent clogging. Maintenance consists primarily of keeping leaves and other organic debris out of the system. Failure to clean the gutters will result in water splash on the building when they overflow. Gutters can be damaged under the weight of the water and organic matter inside the gutter. Gutters should be cleaned as necessary to maintain a free flow of water into the downspouts.

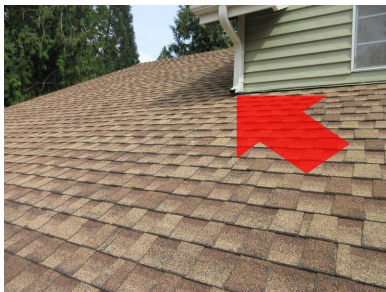
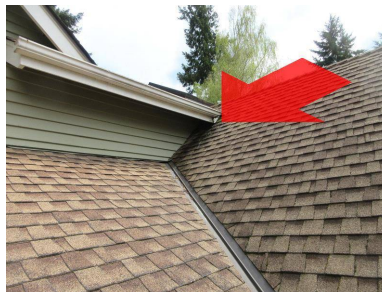
Downspouts draining directly onto the asphalt shingle surface causes excessive wear of the roofing material. Downspout extensions to the lower gutters should be installed to prevent excessive wear and tear of the roofing.

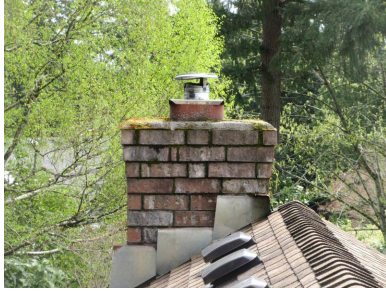
Moss/vegetation was observed in several areas around the upper portion of the chimney. This will lead to accelerated deterioration of the brick masonry mortar. We recommend removal of all organic growth. Damaged areas can be repaired by filling in cutout or defective mortar joints with fresh mortar. (Tuck pointing)

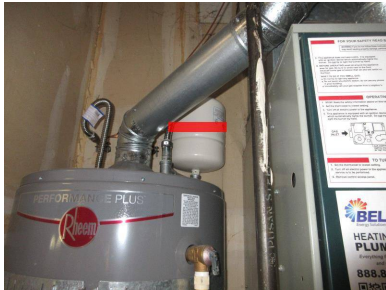
9.6 EXPANSION TANK

The expansion tank is not adequately secured to the wall. As code requirements start to call for engineered expansion tank supports we recommend the installation of seismic restraints to secure the expansion tank instead of allowing it to simply depend on piping connections that could result in damage to the water pipe and leakage during an earthquake.

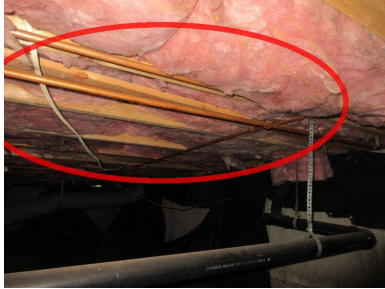
There are water pipes in the crawlspace that are not adequately insulated and could freeze. The installation of foam pipe insulation on all exposed water pipes is recommended.

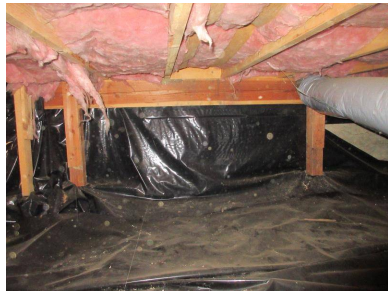
The foundation walls are covered with the plastic vapor retarder. This allows the transmission of water vapor from the soil up and into the exterior wall framing. The plastic vapor retarder should be removed from the foundation so that it covers at least 85% of the entire surface of the soil only.

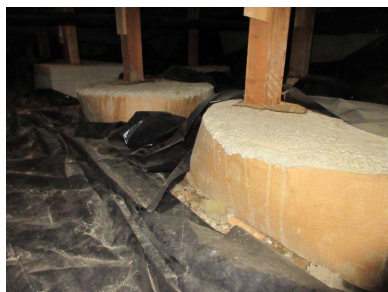
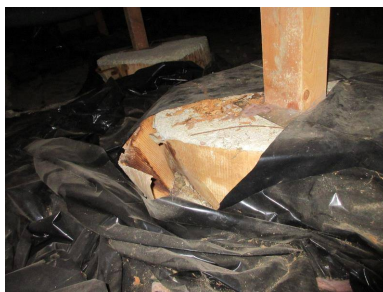
19.5 PEST CONTROL

Cellulose forms were left in place on the pier footings. This cellulose is conducive to the infestation of various wood destroying organisms. The removal of the cellulose is recommended.

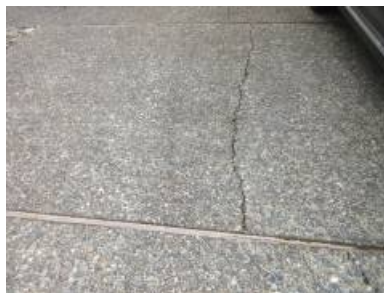
Cracks were observed in the concrete surface of the driveway. Minor cracks can be sealed to minimize moisture entry and further settlement of the concrete. Minor cracks are common and do not affect the serviceability of the concrete.

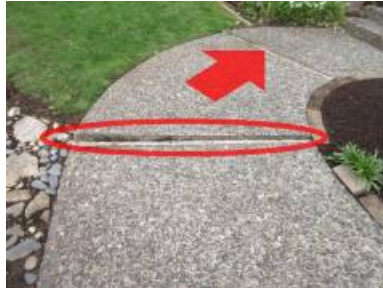
2.5 WALKWAY

The walkway has cracked and settled differentially. This was probably caused by inadequate preparation of the soil prior to the placement of the concrete. This condition can be repaired by pressure grouting the sunken portion of the walkway or by removing and replacing it. Grinding down the raised edges of the concrete will also mitigate the hazard. The walkway remains functional despite this condition. However, the raised edges of the concrete can be a trip hazard for some people. Repairs should be made as necessary.

Many legal and public works departments have defined a trip hazard as an irregularity in a walking surface exceeding one inch (1") in height. All walking surfaces should maintain, free of a vertical surface change of 3/4" or more, in the interest of public and personal safety.

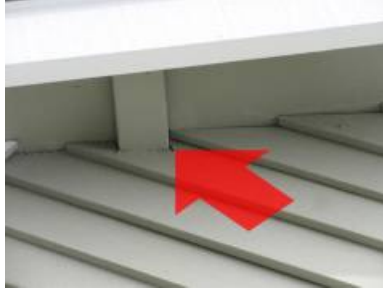
There are openings adjacent the ends of the outlook boards under the overhang through which insects and rodents can enter into the attic. These openings should be covered with wood, wire mesh or filled with aerosol foam.

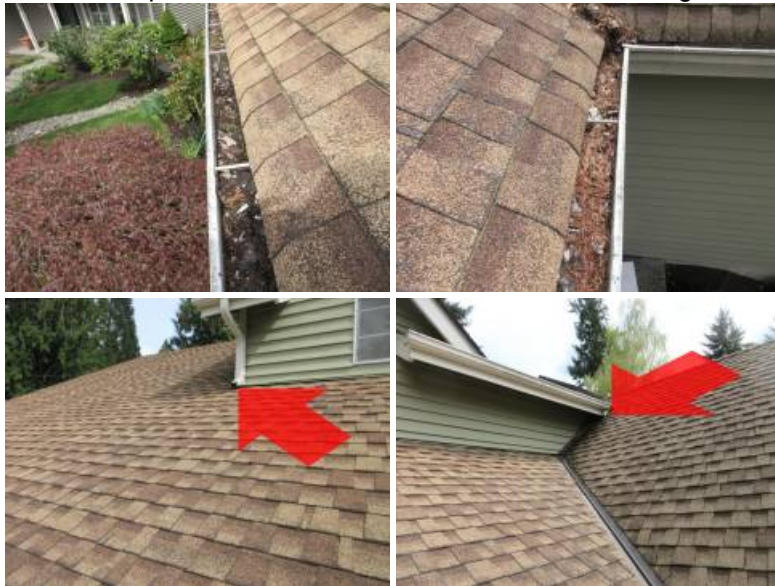
Downspouts draining directly onto the asphalt shingle surface causes excessive wear of the roofing material. Downspout extensions to the lower gutters should be installed to prevent excessive wear and tear of the roofing.

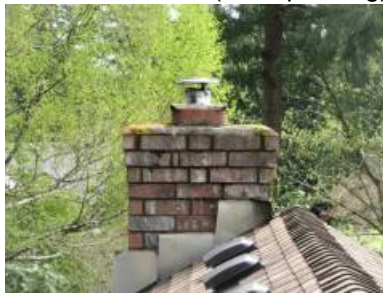
Moss/vegetation was observed in several areas around the upper portion of the chimney. This will lead to accelerated deterioration of the brick masonry mortar. We recommend removal of all organic growth. Damaged areas can be repaired by filling in cutout or defective mortar joints with fresh mortar. (Tuck pointing)

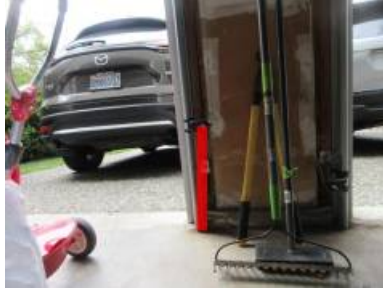
The Photo-eye beam for the south door was installed to high above the floor of the garage to adequately offer protection for small children and/or pets. We recommend that the photo-eye be lowered to within 4-6" of the floor.

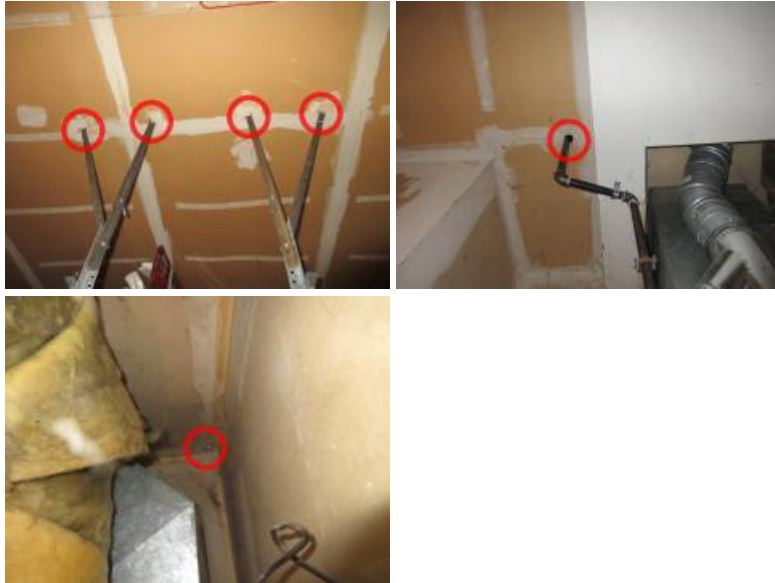
6.4 FIRE SEPARATION

There are voids in the fire resistive barrier between the living space and garage that will allow flames to penetrate. The gypsum barrier slows the spread of a fire from the garage to the structure and/or living space. Patching the voids with a fire retardant caulk is recommended.

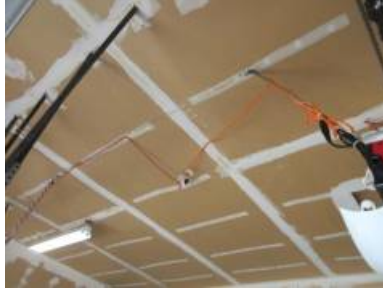
Extension cords are used as a temporary power source for the garage door openers. Extension cords are not suitable as a permanent wiring method. The installation of a receptacle within cords length of each motor is recommended.

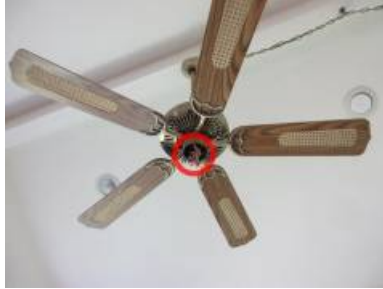
The family room ceiling fan was not working. It should be repaired or replaced as necessary.

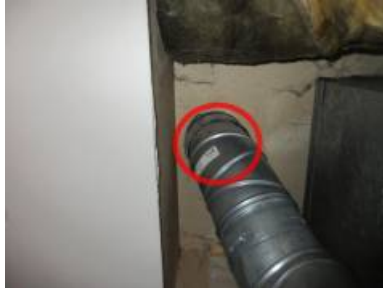
The furnace vent connector is too close to a combustible material. This is a hazard. A minimum clearance of 6" is required between the single wall vent connector and the combustible material. The double wall type B vent requires only 1" of clearance. Repairs are recommended.

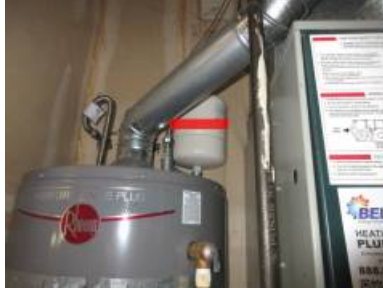
The expansion tank is not adequately secured to the wall. As code requirements start to call for engineered expansion tank supports we recommend the installation of seismic restraints to secure the expansion tank instead of allowing it to simply depend on piping connections that could result in damage to the water pipe and leakage during an earthquake.

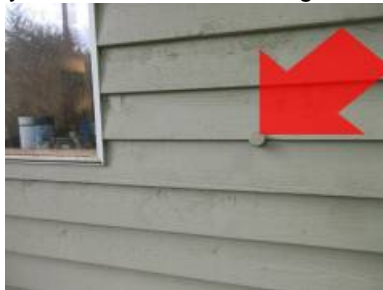
An air gap called a Johnson Tee is installed in the kitchen wall. This air gap protects the dishwasher from contamination caused by a backflow of waste water. The cap protruding on the exterior wall opposite the dishwasher is not drilled. This renders the air gap non-functional. Drilling a 1/4" hole in the end of the cap will restore its function. The remaining visible portions of the Johnson Tee were properly installed and functioning as intended.

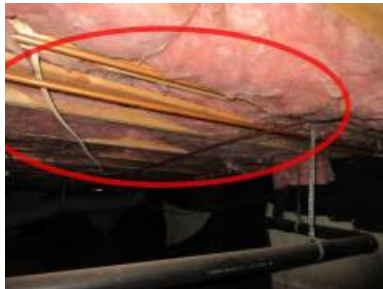
There are water pipes in the crawlspace that are not adequately insulated and could freeze. The installation of foam pipe insulation on all exposed water pipes is recommended.

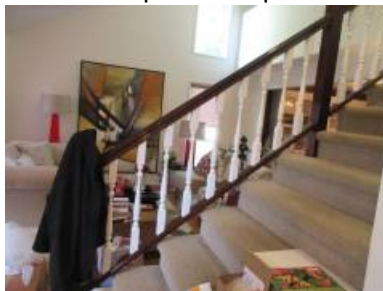
The stair railing baluster spacing is too wide. This is a hazard for small children. The baluster spacing should be reduced as a safety upgrade. Current standards require that a 4" sphere not pass through the railing.

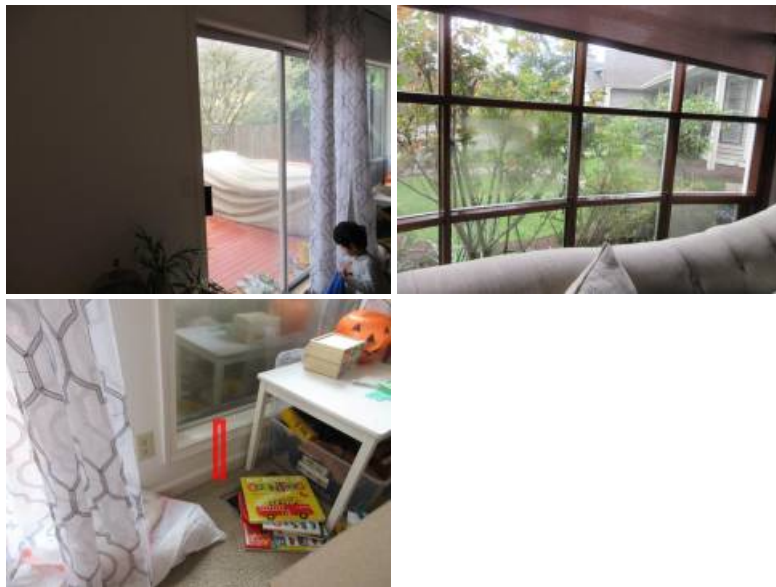
The lower window glass is not labeled as tempered safety glass. The existing glass is nonconforming by current building standards and would be hazardous if broken. The installation of safety glass is recommended as a safety upgrade for all windows less than 18" from the walking surface.

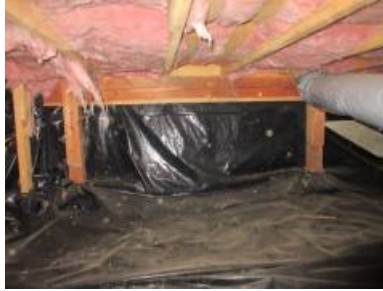
The foundation walls are covered with the plastic vapor retarder. This allows the transmission of water vapor from the soil up and into the exterior wall framing. The plastic vapor retarder should be removed from the foundation so that it covers at least 85% of the entire surface of the soil only.

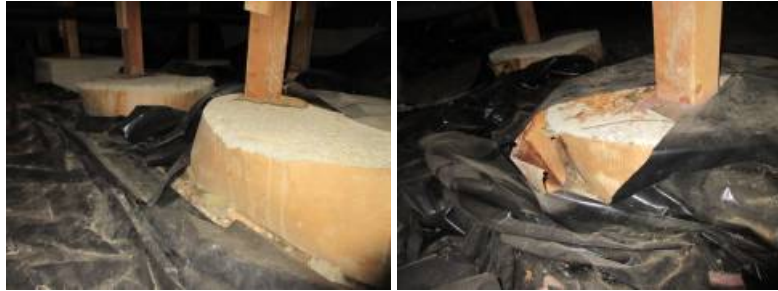
Good building practice requires that foundation walls or pier footings supporting wood frame construction, should extend at least 8" above the finish grade with at least a 6" clearance between the top of the soil and the bottom of the wood finish materials. Untreated wood should be raised 1-2" above surrounding flatwork and should have a moisture barrier such as 30 lb. asphalt impregnated felt installed between the concrete and wood. For additional information and treatment options, you should retain the services of a qualified pest control operator.
