NOTICE TO BUYER: SELLER-PROCURED INSPECTION REPORT

Mr.& Mrs. Lindsay & Baolu Korst
17407 NE 137th Street
Redmond, WA 98052

April 15, 2022

17407 NE 137th St.
Redmond WA.

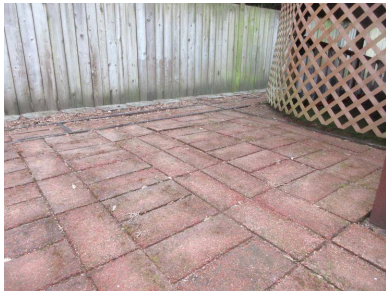
2.5 PATIO

The patio pavers have settled differentially. This was probably caused by inadequate preparation of the soil prior to the placement of the masonry. This condition can be repaired by removing and replacing them. The walkway remains functional despite this condition. However, the raised edges of the concrete pavers can be a trip hazard for some people. Repairs should be made as necessary.

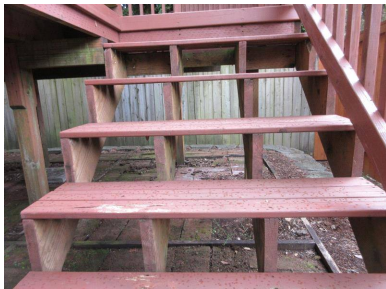
3.8 STAIRS

The stair rise spacing is too wide. This is a hazard for small children. The spacing should be reduced as a safety upgrade. Current standards require that a 4" sphere not pass through the opening.

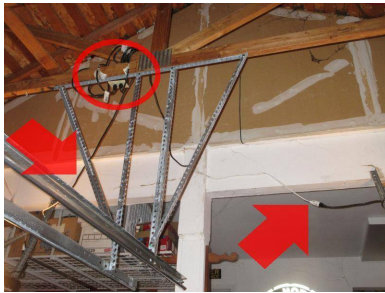
7.10 WIRING

Extension cords are used as a temporary power source for the garage door openers. Extension cords are not suitable as a permanent wiring method. The installation of receptacles within cords length of the motors is recommended.

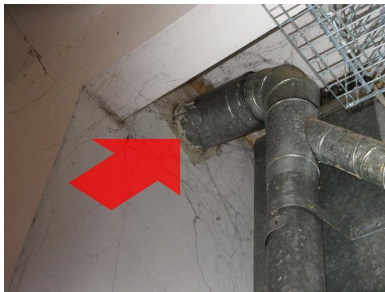
The furnace type B vent is in contact with combustible materials in the garage. This is a fire hazard. A minimum clearance of 1" is required between the type B vent and the combustible material. Repairs are recommended.

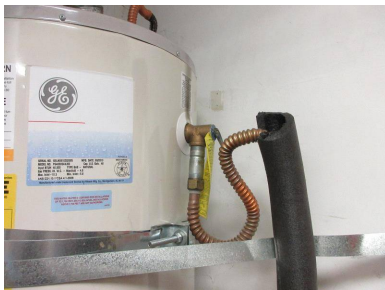
9.2 PRESSURE RELIEF VALVE

The pressure relief valve drain pipe has a reverse slope which traps water in the pipe. This can result in failure of the pressure relief valve. The drain pipe should be reconfigured so that it slopes 1/4" per foot to the drain outlet. If this is not possible or practical, a small (1/16") drain hole can be drilled in the bottom of the pipe at the lowest point.

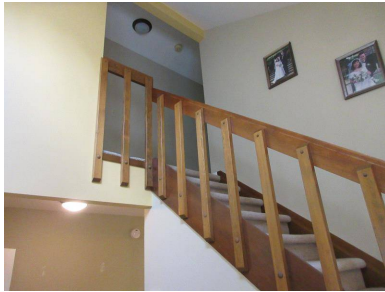
The stair railing baluster spacing is too wide. This is a hazard for small children. The baluster spacing should be reduced as a safety upgrade. Current standards require that a 4" sphere not pass through the railing.

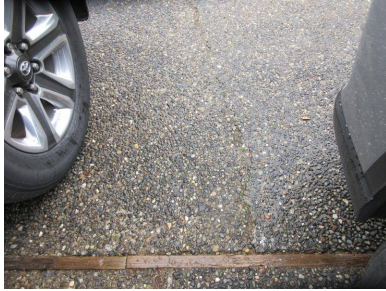
Cracks were observed in the concrete surface of the driveway. Minor cracks can be sealed to minimize moisture entry and further settlement of the concrete. Minor cracks are common and do not affect the serviceability of the concrete.

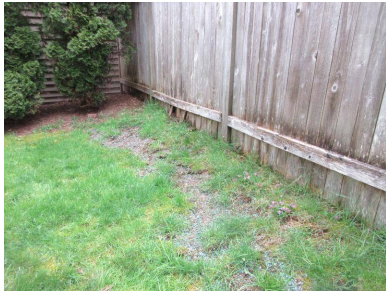
2.7 FENCES AND GATES

Portions of the fence are deteriorated. Fences should be repaired or replaced as necessary.

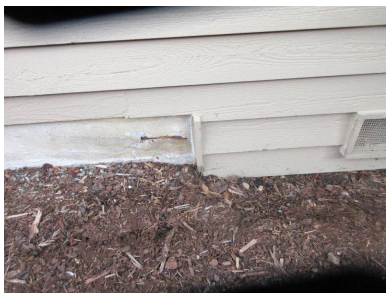
3.2 PEST CONTROL

Soil is close to or in contact with siding in some areas around the building exterior. Good building practice requires that foundation walls or pier footings supporting wood frame construction, extend at least 8" above the finish grade with at least a 6" clearance between the top of the soil and the bottom of the wood finish materials. Soil in direct contact with wood creates a hospitable environment for wood destroying organisms. Establishing these minimum clearances is recommended.

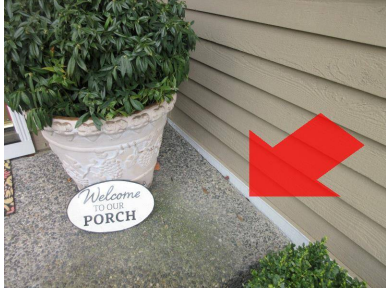
Untreated wood in direct contact with concrete was observed along the stoop. Untreated wood should be raised 1-2" above the concrete. Treating the wood with a preservative sometimes will prevent wood destroy organism damage.

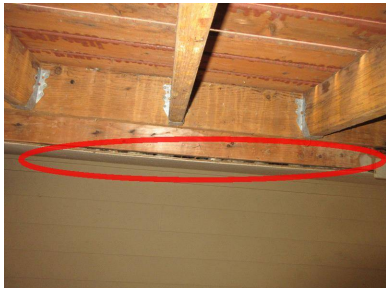
There are openings at the intersection between the wall and deck framing through which rodents and pests can enter into the structure. These openings should be covered with wood, wire mesh or filled with aerosol foam.

- 3.2 Cover openings at the intersection of wall and deck framing
- 11.5 Toilet securely mounted to the floor
- 11.22 Countertop backsplash to be re-caulked
- 17.3 Floor insulation to be secured
- 19.5 Cover openings at corner of the foundation wall

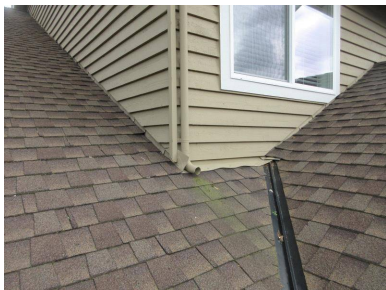
3.4 GUTTERS AND DOWNSPOUTS

Downspouts draining directly onto the asphalt shingle surface causes excessive wear of the roofing material. Downspout extensions to the lower gutters should be installed to prevent excessive wear and tear of the roofing.

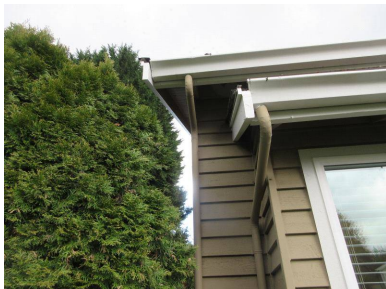
The 2" round downspouts are too small and are more vulnerable to clogging than the larger rectangular ones. Consideration should be given to upgrading the downspouts.

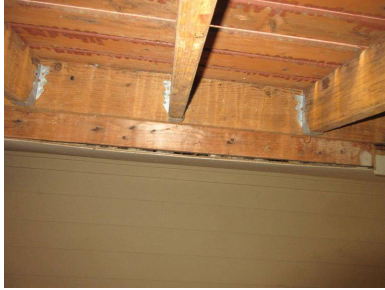
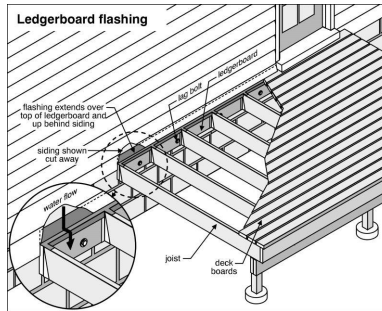
3.6 DECK

The deck is not adequately secured to the building. The installation of lag bolts through the ledger board into

the wall is recommended.

There is no flashing at the intersection between the deck and house. This will allow water to enter behind the siding. The installation of flashing in this area is recommended.

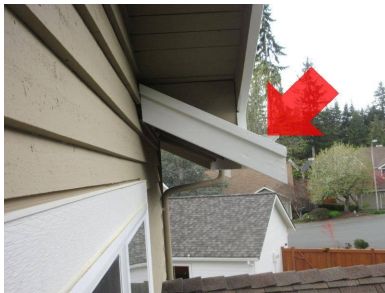
4.7 MAINTENANCE AND REPAIRS

The ends of the barge boards are exposed to the weather. This will eventually cause them to rot. To prevent damage to the barge board ends, they should be covered with roofing material or flashing.

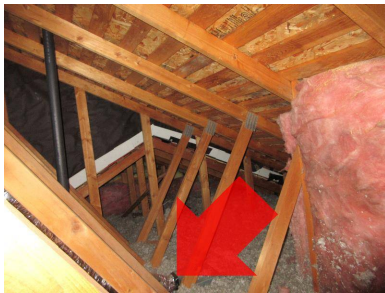
5.3 MECHANICAL VENTILATION SYSTEMS

Flexible plastic duct is used to direct air from the vent fan to the exterior. This type of material is unreliable. Replacing the plastic duct with 4" smooth-wall sheet metal duct is recommended.

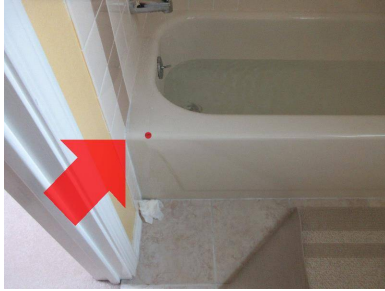
water draining off the edge of the bathtub onto the floor. The tub should be leveled or shower doors or splash guards could be installed.

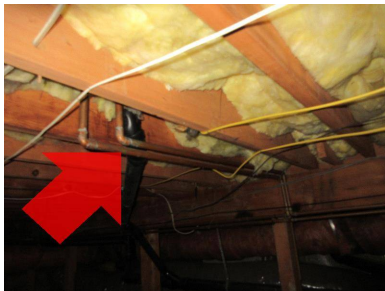
There are water pipes in the crawlspace that are not adequately insulated and could freeze. The installation of foam pipe insulation on all exposed water pipes is recommended.

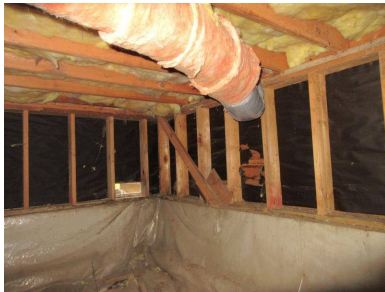
18.6 SHEAR PANELS

Shear panels are plywood or OSB panels that are mechanically fastened to both vertical and horizontal framing members in critical structural areas of the building. They prevent lateral movement of the structure during an earthquake. Shear panels are often visible in the crawlspace on cripple walls between the first floor and foundation. They may also be installed on interior walls that are covered with drywall. An examination of the crawlspace revealed the absence of shear panels on the cripple walls. The installation of shear panels on the cripple walls is recommended as an upgrade.

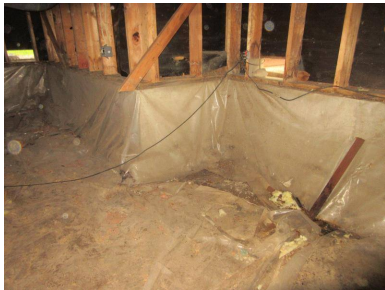
19.4 VAPOR RETARDER

The foundation walls are covered with the plastic vapor retarder. This allows the transmission of water vapor from the soil up and into the exterior wall framing. The plastic vapor retarder should be removed from the foundation.

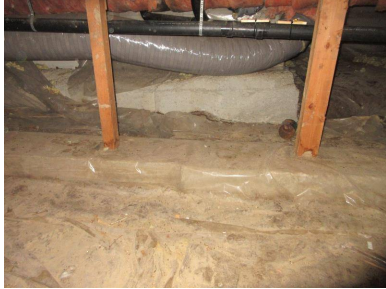
The support post concrete continuous footing is covered with the plastic vapor retarder. This allows the transmission of water vapor from the soil up and into the floor framing. The plastic vapor retarder should be removed from the piers.

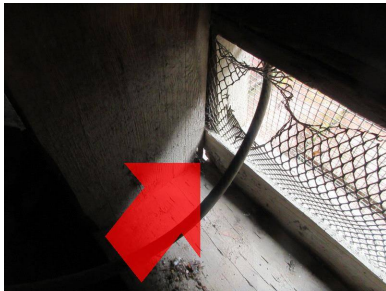
19.5 PEST CONTROL

There are openings at the corner of the foundation wall vent opening through which rodents and other pests can enter into the crawlspace. These openings should be covered with wood, wire mesh or filled with aerosol foam.

Scrap-wood and other cellulose debris was observed on the crawl floor. This wood debris creates conducive conditions for wood boring insects. The removal of all cellulose debris is recommended.

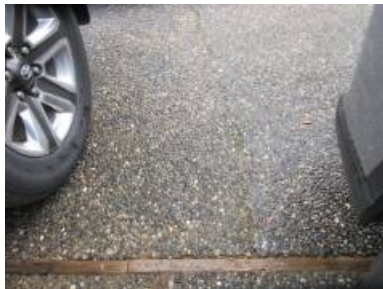
Cracks were observed in the concrete surface of the driveway. Minor cracks can be sealed to minimize moisture entry and further settlement of the concrete. Minor cracks are common and do not affect the serviceability of the concrete.

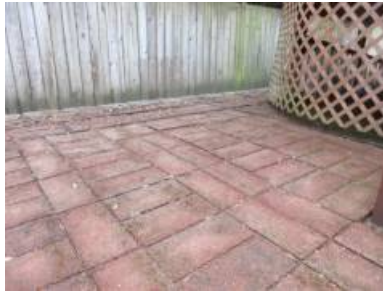
2.5 PATIO

The patio pavers have settled differentially. This was probably caused by inadequate preparation of the soil prior to the placement of the masonry. This condition can be repaired by removing and replacing them. The walkway remains functional despite this condition. However, the raised edges of the concrete pavers can be a trip hazard for some people. Repairs

should be made as necessary.

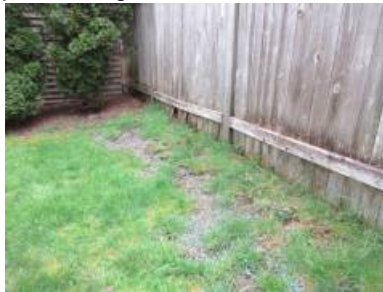
Portions of the fence are deteriorated. Fences should be repaired or replaced as necessary.

The gates are properly installed and are performing their intended function.

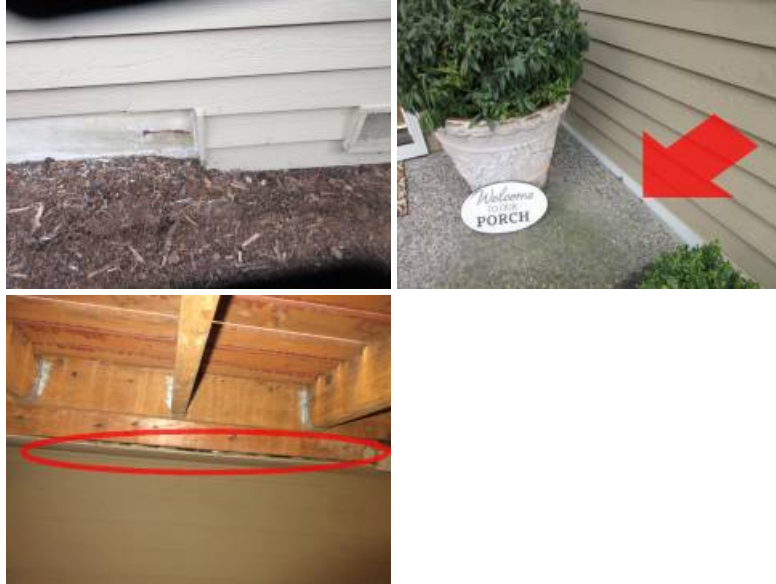
There are openings at the intersection between the wall and deck framing through which rodents and pests can enter into the structure. These openings should be covered with wood, wire mesh or filled with aerosol foam.

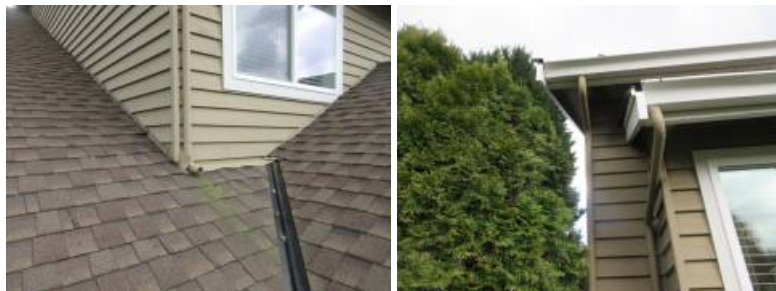
The 2" round downspouts are too small and are more vulnerable to clogging than the larger rectangular ones. Consideration should be given to upgrading the downspouts.

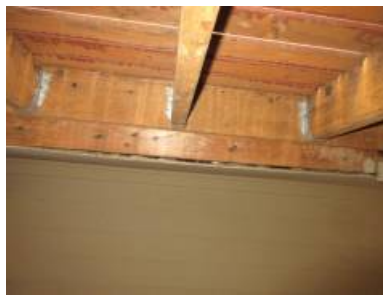
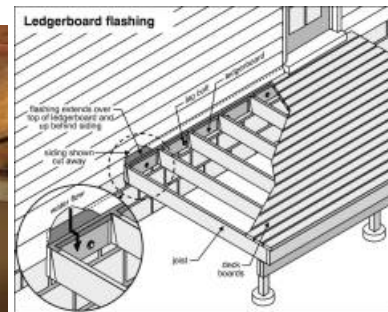
There is no flashing at the intersection between the deck and house. This will allow water to enter behind the siding. The installation of flashing in this area is recommended.

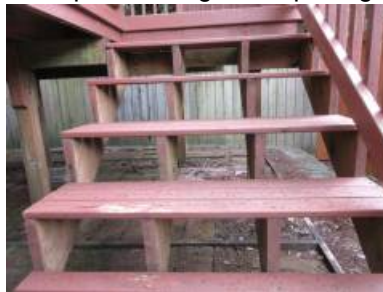
The stair rise spacing is too wide. This is a hazard for small children. The spacing should be reduced as a safety upgrade. Current standards require that a 4" sphere not pass through the opening.

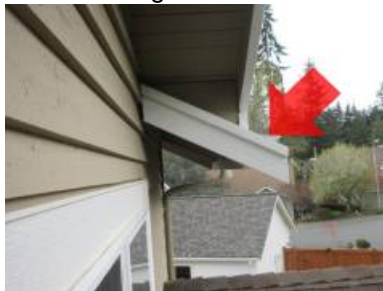
4.7 MAINTENANCE AND REPAIRS

The ends of the barge boards are exposed to the weather. This will eventually cause them to rot. To prevent damage to the barge board ends, they should be covered with roofing material or flashing.

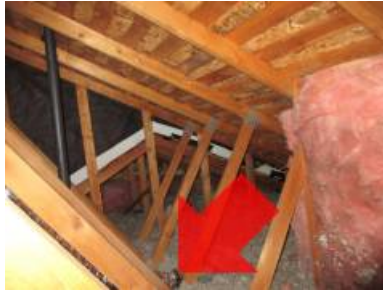
Flexible plastic duct is used to direct air from the vent fan to the exterior. This type of material is unreliable. Replacing the plastic duct with 4" smooth-wall sheet metal duct is recommended.

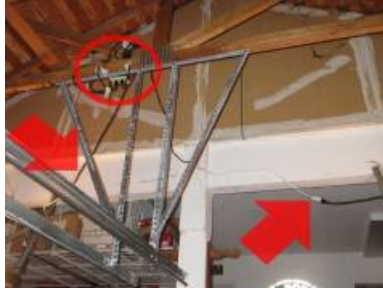
An extension cord is used as a temporary power source for the garage door openers. An extension cord is not suitable as a permanent wiring method. The installation of a receptacle within cords length of the motors is recommended.

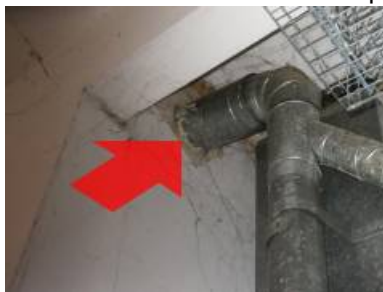
The furnace type B vent is in contact with combustible materials in the garage. This is a fire hazard. A minimum clearance of 1" is required between the type B vent and the combustible material. Repairs are recommended.

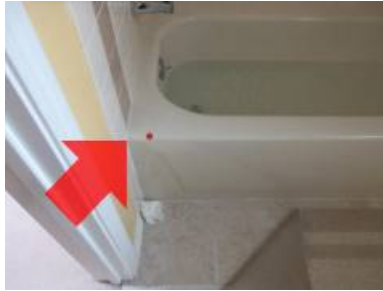
The bathtub is not installed level in accordance with the manufacturer's specifications. This has resulted in water draining off the edge of the bathtub onto the floor. The tub should be leveled or shower doors or splash guards could be installed.

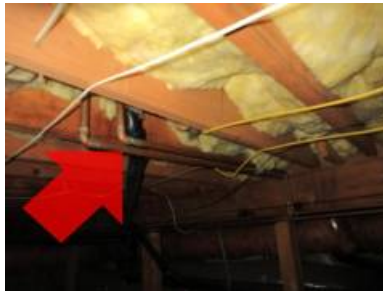
There are water pipes in the crawlspace that are not adequately insulated and could freeze. The installation of foam pipe insulation on all exposed water pipes is recommended.

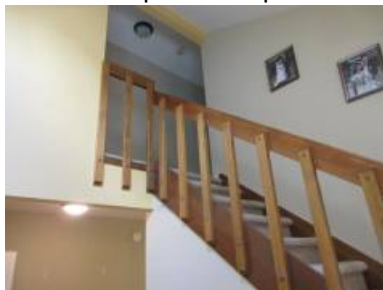
The stair railing baluster spacing is too wide. This is a hazard for small children. The baluster spacing should be reduced as a safety upgrade. Current standards require that a 4" sphere not pass through the railing.

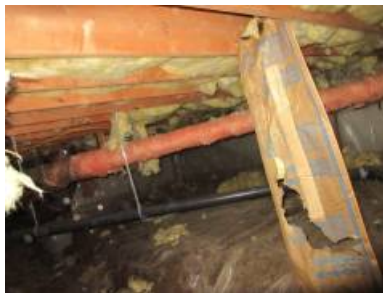
Some of the insulation batts were not properly secured and have falling down. The fallen batts should be reinstalled and secured.

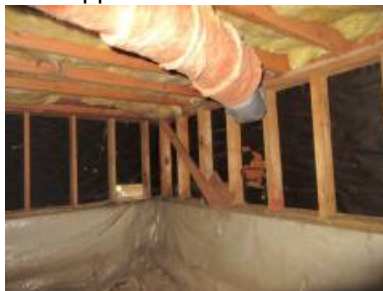
Shear panels are plywood or OSB panels that are mechanically fastened to both vertical and horizontal framing members in critical structural areas of the building. They prevent lateral movement of the structure during an earthquake. Shear panels are often visible in the crawlspace on cripple walls between the first floor and foundation. They may also be installed on interior walls that are covered with drywall. An examination of the crawlspace revealed the absence of shear panels on the cripple walls. The installation of shear panels on the cripple walls is recommended as an upgrade.

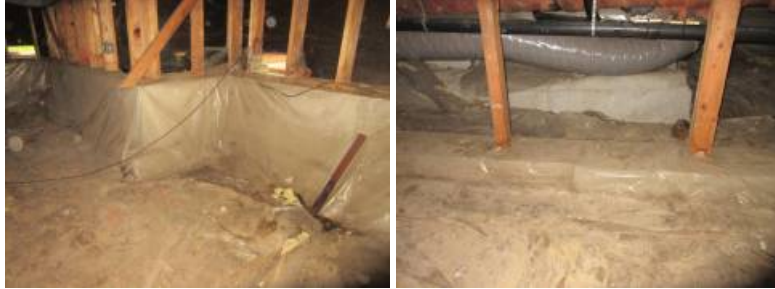
The support post concrete continuous footing is covered with the plastic vapor retarder. This allows the transmission of water vapor from the soil up and into the floor framing. The plastic vapor retarder should be removed from the piers.
