**James & Janice Strode
12503 179th Ave NE
Redmond WA 98052**

April 27, 2022

Re: 12503 179th Ave. NE
Redmond, WA.

At your request, a visual inspection of the above referenced property was conducted on 04/26/2022. We have inspected the major structural components, plumbing, heating and electrical systems for signs of significant non-performance, excessive or unusual wear and general state of repair.

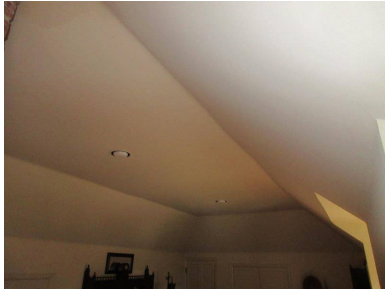
5.1 ACCESS

There is no access to the upper attic area(s). The installation of an attic access under the highest point of the roof is recommended for inspection and servicing of components in the attic. Defects or deficiencies may exist in inaccessible areas.

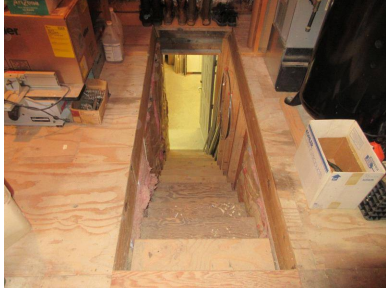
6.9 STAIRS

There is no handrail along the stairs. This is a safety hazard. The installation of a graspable handrail should be installed that conforms to present industry standards.

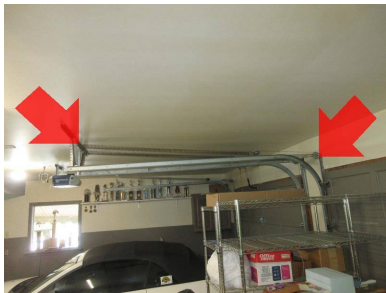
6.10 OVERHEAD GARAGE DOORS

Safeties are cables run through the center of the garage door springs that prevent broken springs from becoming projectiles that can cause injury. There are no safeties installed. The installation of safeties is recommended.

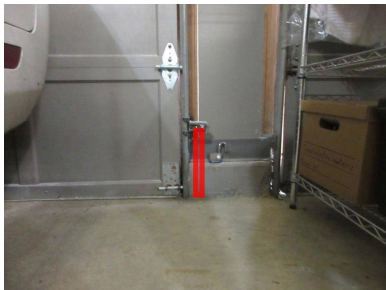
6.11 GARAGE DOOR OPENER

The Photo-eye beam was installed too high above the floor of the garage to adequately offer protection for small children and/or pets. We recommend that the photo-eye be lowered to within 4-6" of the floor.

- 6.11 Photo-eye beam has been corrected to 6.5 inches off floor.
- 7.9 & 7.14 Corrected by licensed Electrician.
- 8.27 Air filter has been installed.
- 10.11 Seismic straps installed
- 11.8 Air gap installed
- 12.3 Toilet has been secured
- 12.14 Glass enclosure has been sealed
- 14.15 Pressure reduction valve has been installed
- 15.4 The damage on the closet ceiling was from a plumbing vent flashing several years ago and has been repaired and painted.
- 20.4 Vapor barrier has been cut away from piers.

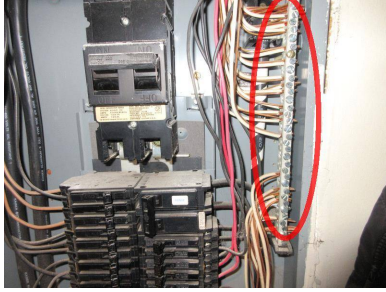
7.9 SERVICE PANEL

Neutral (white wire) and equipment grounding conductors (bare wire) terminate under the same lug. An individual terminal should be provided for the connection of each branch-circuit neutral conductor. When the neutral is disconnected, the objective is to still have the equipment ground connected. If both the neutral and grounded conductor is under the same terminal, this cannot be accomplished. The services of a qualified electrical contractor should be retained to repair the circuit(s).

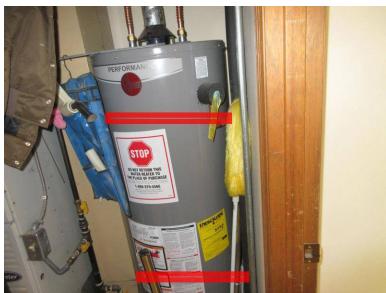
10.11 SEISMIC RESTRAINT

The seismic restraint for the water heater was minimal. Proper strapping is recommended to adequately secure the tank and provide potable water in the event of an earthquake.

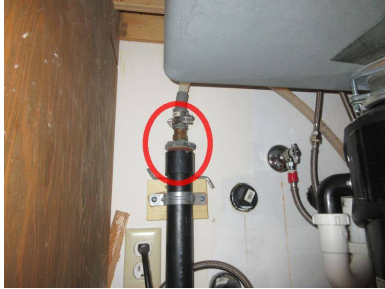
11.8 AIR GAP

The dishwasher drain lacks an air gap. The dishwasher will function without one, but there is a risk of contamination of the inside of the dishwasher by waste water. The installation of an air gap is recommended.

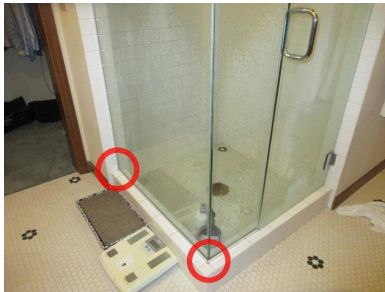
12.14 GLASS ENCLOSURE

The glass enclosure has been leaking at the lower corners. No damage was visible, but resealing or repairing the enclosure is recommended as preventive maintenance.

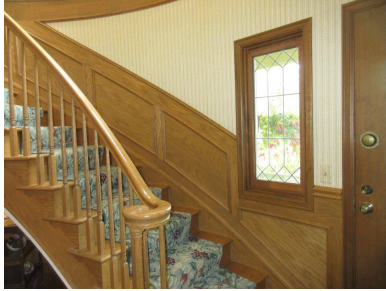
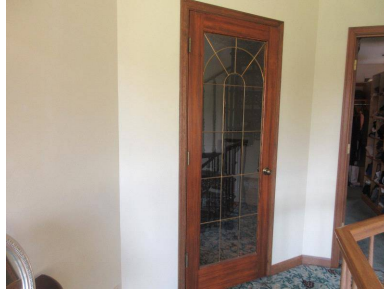
The glass adjacent the door is not tempered safety glass. Tempered glass can be identified by the etched emblem in one corner of each pane. A higher margin of safety could be achieved if the glass was approved safety glass. Consideration should be given to replacing the glass as a safety upgrade.

The spiral stair landing door glass is not labeled as tempered safety glass. The existing glass is nonconforming by current building standards and would be hazardous if broken. The installation of safety glass is recommended as a safety upgrade.

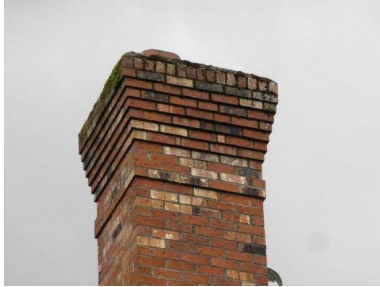
4.4 CHIMNEYS

Moss/vegetation was observed in several areas around the upper portion of the chimney. This will lead to accelerated deterioration of the brick masonry mortar. We recommend removal of all organic growth. Damaged areas can be repaired by filling in cutout or defective mortar joints with fresh mortar. (Tuck pointing)

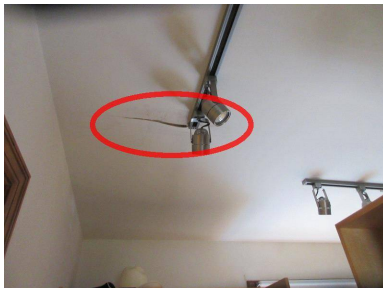
15.4 WALLS AND CEILINGS

We observed damage on the ceiling in the primary bedroom closet from what appear to be roof leaks. Testing the observed areas with a moisture meter revealed no moisture present at the time of the inspection. The damages to the surfaces appear to be from old roof leaks. Damages are cosmetic and repairs are optional.

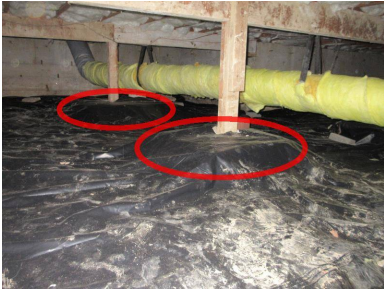
20.4 VAPOR RETARDER

The support post concrete piers are covered with the plastic vapor retarder. This allows the transmission of water vapor from the soil up and into the floor framing. The plastic vapor retarder should be removed from the pier so that it covers at least 85% of the entire surface of the soil only.

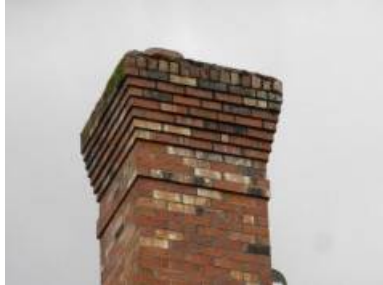
Moss/vegetation was observed in several areas around the upper portion of the chimney. This will lead to accelerated deterioration of the brick masonry mortar. We recommend removal of all organic growth. Damaged areas can be repaired by filling in cutout or defective mortar joints with fresh mortar. (Tuck pointing)

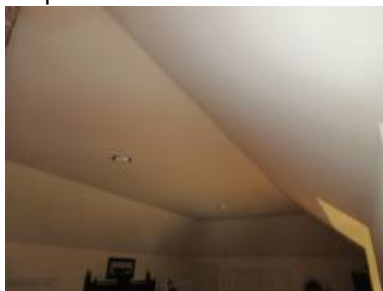
There is no access to the upper attic area(s). The installation of an attic access under the highest point of the roof is recommended for inspection and servicing of components in the attic. Defects or deficiencies may exist in inaccessible areas.

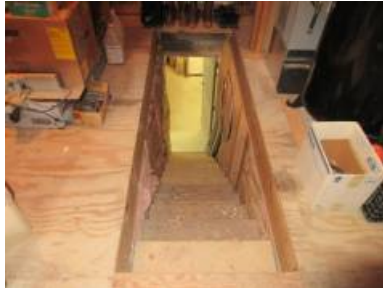
There is no handrail along the stairs. This is a safety hazard. The installation of a graspable handrail should be installed that conforms to present industry standards.

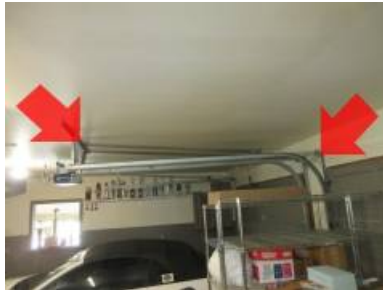
6.10 OVERHEAD GARAGE DOORS

Safeties are cables run through the center of the garage door springs that prevent broken springs from becoming projectiles that can cause injury. There are no safeties installed. The installation of safeties is recommended.

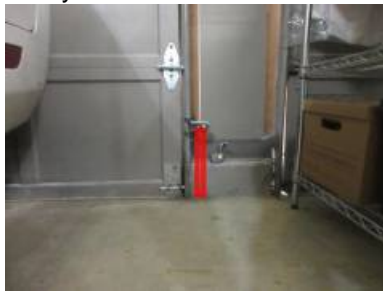
6.11 GARAGE DOOR OPENER

The Photo-eye beam was installed to high above the floor of the garage to adequately offer protection for small children and/or pets. We recommend that the photo-eye be lowered to within 4-6" of the floor.

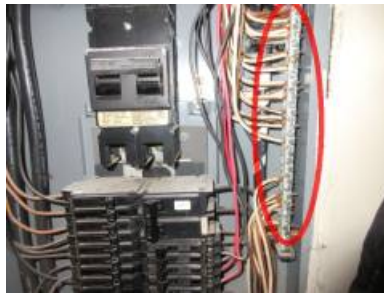
Neutral (white wire) and equipment grounding conductors (bare wire) terminate under the same lug. An individual terminal should be provided for the connection of each branch-circuit neutral conductor. When the neutral is disconnected, the objective is to still have the equipment ground connected. If both the neutral and grounded conductor is under the same terminal, this cannot be accomplished. The services of a qualified electrical contractor should be retained to repair the circuit(s).

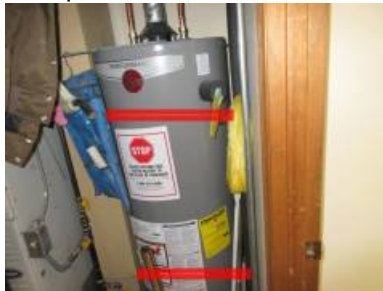
10.11 SEISMIC RESTRAINT

The seismic restraint for the water heater was minimal. Proper strapping is recommended to adequately secure the tank and provide potable water in the event of an earthquake.

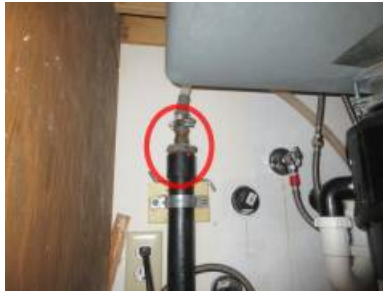
11.8 AIR GAP

The dishwasher drain lacks an air gap. The dishwasher will function without one, but there is a risk of contamination of the inside of the dishwasher by waste water. The installation of an air gap is recommended.

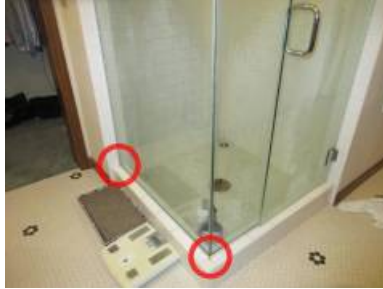
12.14 GLASS ENCLOSURE

The glass enclosure has been leaking at the lower corners. No damage was visible, but resealing or repairing the enclosure is recommended as preventive maintenance.

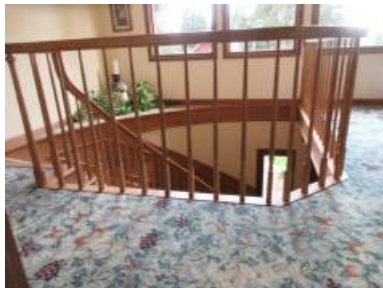
15.3 GUARD RAILINGS

The spacing between the balusters is too wide. This is a hazard to small children. The balusters should be spaced close enough together so that a 4" sphere cannot pass through. Upgrading the guard railing is recommended if small children are present.

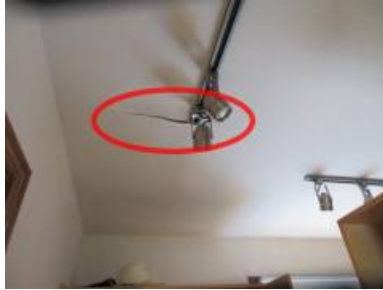
We observed damage on the ceiling in the primary bedroom closet from what appear to be roof leaks. Testing the observed areas with a moisture meter revealed no moisture present at the time of the inspection. The damages to the surfaces appear to be from old roof leaks. Damages are cosmetic and repairs are optional.

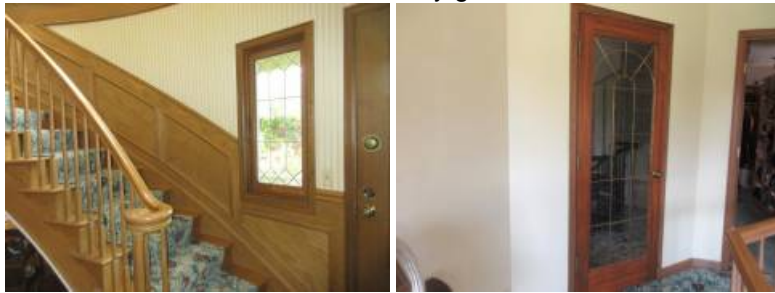
The glass adjacent the door is not tempered safety glass. Tempered glass can be identified by the etched emblem in one corner of each pane. A higher margin of safety could be achieved if the glass was approved safety glass. Consideration should be given to replacing the glass as a safety upgrade.

The spiral stair landing door glass is not labeled as tempered safety glass. The existing glass is nonconforming by current building standards and would be hazardous if broken. The installation of safety glass is recommended as a safety upgrade.

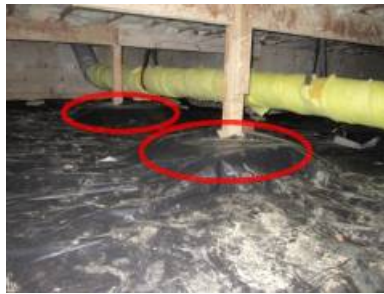
The support post concrete piers are covered with the plastic vapor retarder. This allows the transmission of water vapor from the soil up and into the floor framing. The plastic vapor retarder should be removed from the pier so that it covers at least 85% of the entire surface of the soil only.
