Home Inspection - MCI

Property Address: 27908 NE 147th PI

Property City, State Zip: Duvall, WA 98019

Worldwide ERC® Relocation Property Assessment

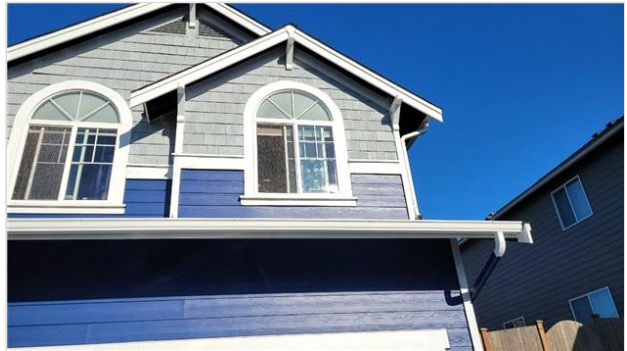
Rotted Trim

Damaged wood ("wood decaying fungi" = moisture damaged wood) was observed at the bottom of the corner trim on the east side of the house and at the horizontal trim board on the south side of the house next to the east second floor window.

PRODUCT / SERVICE	DESCRIPTION	QTY.	UNIT PRICE	TOTAL
Labor	Hourly labor charge Right window over garage - replace bottom trim board Paint only if weather favorable - if we have to return its a 2 hour minimum charge Right side of house - replace lower trim board (splice) and paint Purchase, paint and install new trim boards , caulk all	6	\$95.00	\$570.00
Materials	Rough cut cedar trim boards, caulking, silicone, oscillator blade, door stop, mud, texture, brush, screen, mold inhibitor	1	\$239.08	\$239.08
Fuel surcharge		1	\$14.36	\$14.36
Credit card fee 3.5% (disregard if paying cash or check)		1	\$85.35	\$85.35*

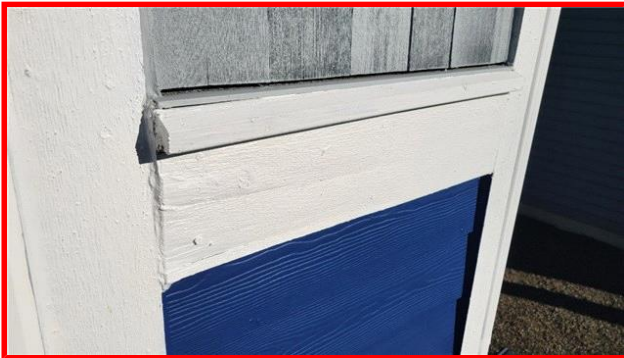
Rotted Trim

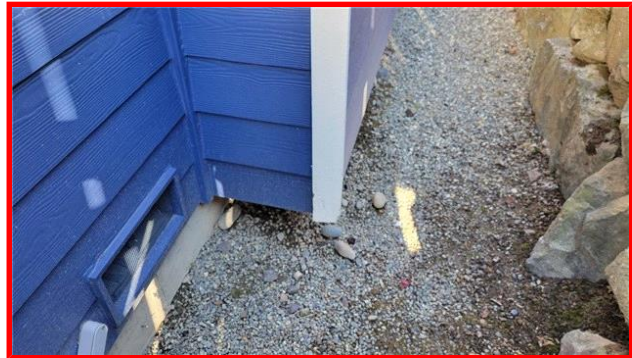
Rotted Trim

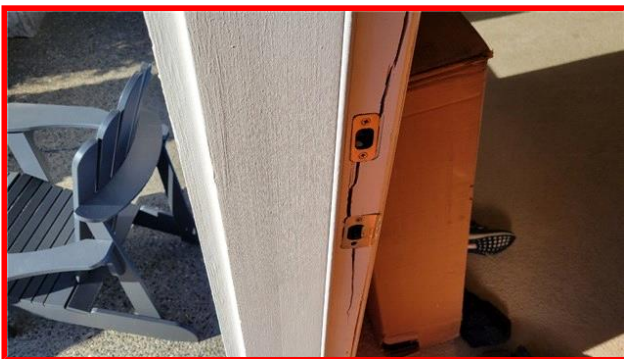
Broken Front Door Jamb

PRODUCT / SERVICE	DESCRIPTION	QTY.	UNIT PRICE	TOTAL
Door Installation	Replace front door - reuse existing trim - new hardware includes - rough opening measurements, ordering, delivery and installation	1	\$955.00	\$955.00
Materials	3' 0" x 6' 8" 3068S818-6P-FG6-CL Smooth Craftsman Fiberglass Door - External Grille 1 - Right Hand Inswing (Note: Image is shown finished, products ship unfinished!) 2-3/8" Backset - Double Bore (2-1/8" Dia. Bore w/Standard 5-1/2" Spacing) w/1" x 2- 1/4" Radius Mortised Edge Latch Preps w/2-1/4" Full Lip - Radius Corner Strike Prep w/Deadbolt 1" x 2-1/4" No Lip - Radius Corner Strike Prep Set of Standard - US15 Satin Nickel Hinges Smooth Composite Frame - 4-9/16" Jamb w/Brickmould Exterior Trim (Loose) White Compression Weatherstrip 1 0.00 \$0.00 Composite Adjustable - Bronze (ships with sill cover) Sill Sill Pan	1	\$1,059.00	\$1,059.00
Disposal	dump fee old door	1	\$85.00	\$85.00

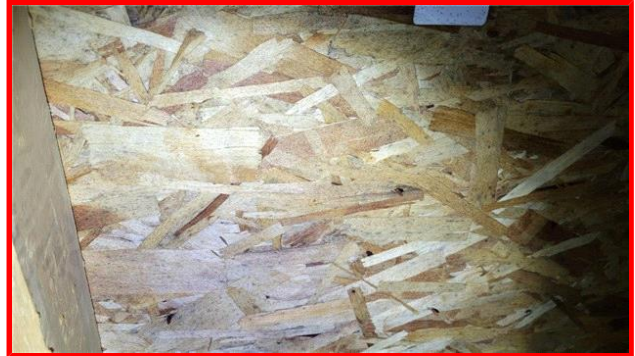
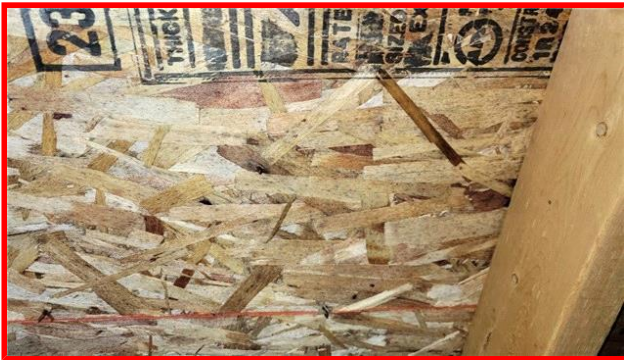
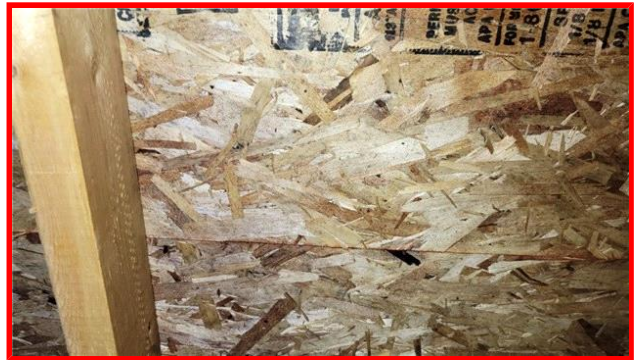
Suspect Mold on Sheathing

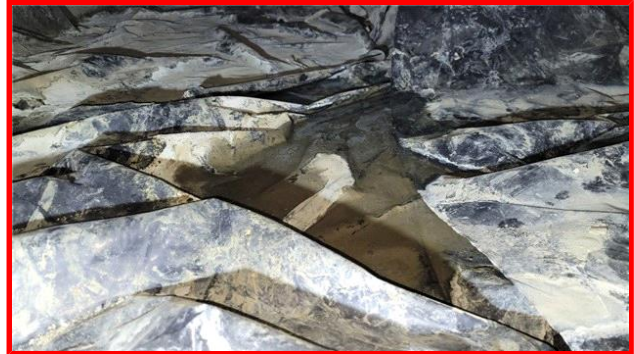
Standing Water in Crawl Space Below Bathroom

Location & SW - The crawlspace has standing water on the vapor barrier. This will increase the moisture level in the

Description	Amount
1. Installed a full crawl space perimeter footing drainage system with perforated pipe 2. Drainage gravel 3. Installed a 1/3 hp sump pump assembly 4. 1 1/2" ABS pipe discharged 5. Cleaned up crawl space and removed debris 6. Replaced and installed a new 6 mil black vapor barrier 7. Replaced all missing or damaged heat duct insulation	\$5,450.00
Subtractions/Discounts/Credits	
Subtotal:	\$5,450.00
Tax:	\$485.00
Total:	\$5,935.00
After 30 Days (Unless Otherwise Stated):	\$6,647.00

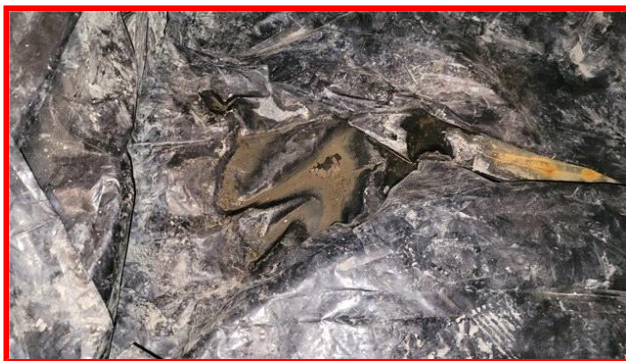
Standing Water in Crawl Space Near Access

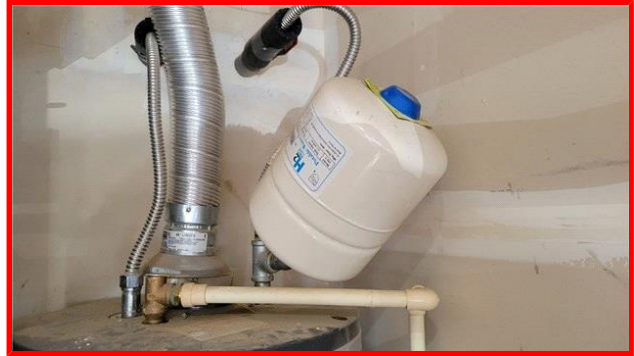
Failed Expansion Tank

PRODUCT / SERVICE	DESCRIPTION	QTY.	UNIT PRICE	TOTAL
Jan 04, 2023				
Plumbing	Replace 40 gallon gas water heater	1	\$950.00	\$950.00
Materials	Rheem 40 gallon 6- year 36,000 BTU gas water heater expansion tank Fittings	1	\$849.55	\$849.55
Disposal		1	\$55.00	\$55.00
Credit card fee 3.5% (disregard if paying cash or check)		1	\$71.78	\$71.78*
