NOTICE TO BUYER: SELLER-PROCURED INSPECTION REPORT

Alexander and Victoria Bogomolny
1384 Greenwich Walk NE
Issaquah, WA, 98029

At your request, a visual inspection of the above referenced property was conducted on 02/15/2023. We have inspected the major structural components, plumbing, heating and electrical systems for signs of significant non-performance, excessive or unusual wear and general state of repair.

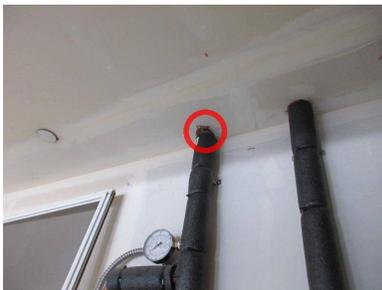
6.4 FIRE SEPARATION

There are voids in the fire resistive barrier between the living space and garage that will allow flames to penetrate. The gypsum barrier slows the spread of a fire from the garage to the structure and/or living space. Patching the voids with a fire retardant caulk is recommended.

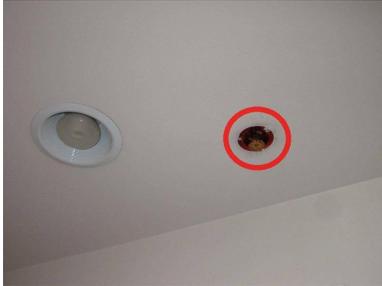
FIRE SUPPRESSION SYSTEM:

The sprinkler head adjacent the garage door has deployed. The sprinkler head should be reset and cover installed as needed.

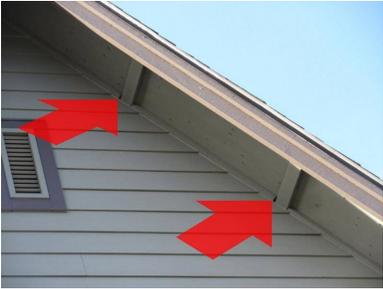
3.4 SOFFITS AND OVERHANGS

There are openings adjacent the ends of the outlook boards under the overhang through which insects and rodents can enter into the attic. These openings should be covered with wood, wire mesh or filled with aerosol foam.

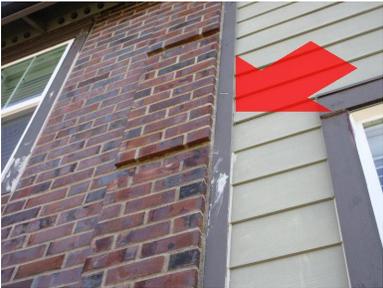
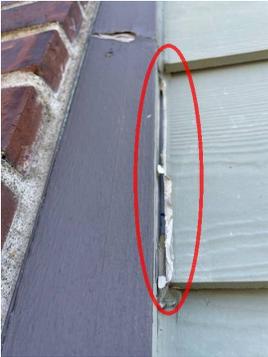
3.6 PAINT

The bottom edge of the lower sections of siding on the exterior are unprotected. Paint protects the siding from moisture absorption and its propensity to hold paint. Painting of the exposed edges is recommended.

The caulking is cracked and deteriorated. Caulking prevents water intrusion into the wall. Removing and replacing deteriorated caulk is recommended.

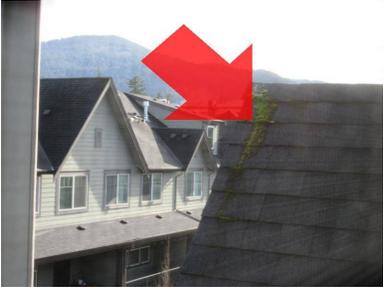
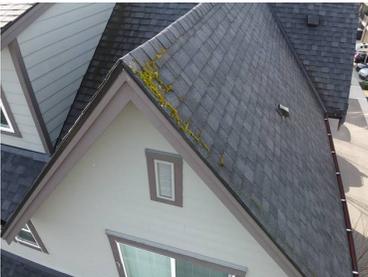
4.5 MAINTENANCE AND REPAIRS

The roof is in need of routine maintenance. The surface should be treated for moss, lichen, and algae growth, then brushed and washed off with a high volume low pressure hose to remove moss and organic debris. Performing this maintenance will improve the appearance and increase the life expectancy of the roof.

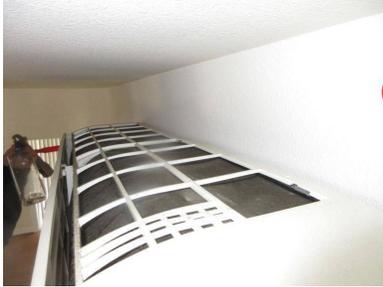
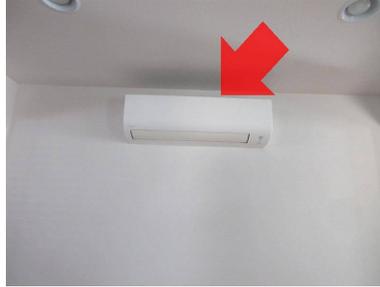
9.5 AIR HANDLER

The ventilation unit was functioning as intended. Servicing the unit is regular replacement and cleaning of the filter(s) integrated in front of the unit. The heat exchanger should be cleaned every 3-4 years depending on how dirty the outside air is. Refer to unit manual for additional servicing tasks.

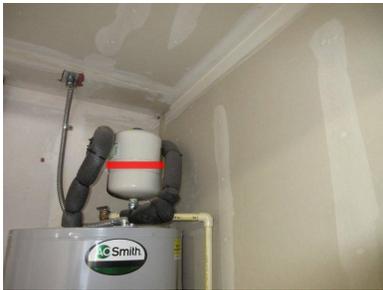
10.6 EXPANSION TANK

The expansion tank is not adequately secured to the wall. As code requirements start to call for engineered expansion tank supports we recommend the installation of seismic restraints to secure the expansion tank instead of allowing it to simply depend on piping connections that could result in damage to the water pipe and leakage during an earthquake.

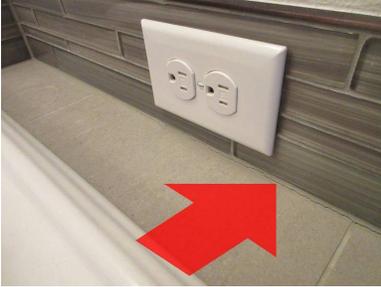
12.10 COUNTERTOP

The backsplash caulking is cracked. Cracking of the caulk allows water to enter the gap and is difficult to clean. Caulking the cracks and/or gaps is recommended.

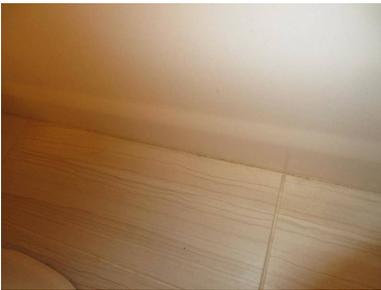
UPPER FLOOR HALLWAY BATHROOM
12.15 FLOORING MATERIAL

The caulking is cracked at the intersection between the tub/shower and floor. This can lead to water damage to the flooring and substrate. Caulking this area with a flexible caulk is recommended.

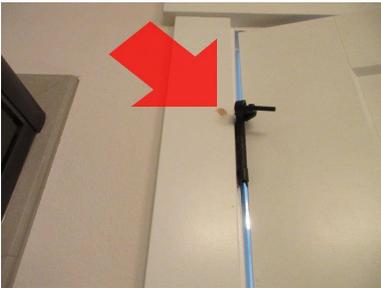
15.5 DOORS

Several of the doors are equipped with hinge mounted door stops. This type of door stop can damage the door skin, tear out hinge screws, and damage the door trim and frame. The removal and replacement with wall or floor mounted door stops is recommended.

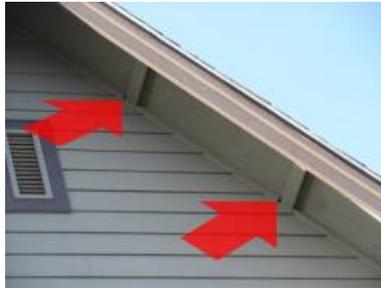
There are openings adjacent the ends of the outlook boards under the overhang through which insects and rodents can enter into the attic. These openings should be covered with wood, wire mesh or filled with aerosol foam.

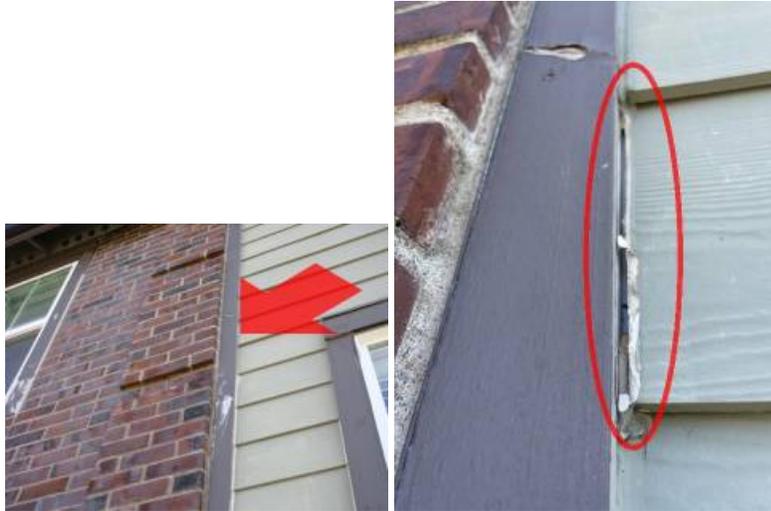
3.6 PAINT

The bottom edge of the lower sections of siding on the exterior are unprotected. Paint protects the siding from moisture absorption and its propensity to hold paint. Painting of the exposed edges is recommended.

The caulking is cracked and deteriorated. Caulking prevents water intrusion into the wall. Removing and replacing deteriorated caulk is recommended.

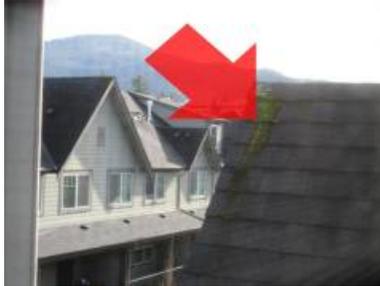
4.5 MAINTENANCE AND REPAIRS

The roof is in need of routine maintenance. The surface should be treated for moss, lichen, and algae growth, then brushed and washed off with a high volume low pressure hose to remove moss and organic debris. Performing this maintenance will improve the appearance and increase the life expectancy of the roof.

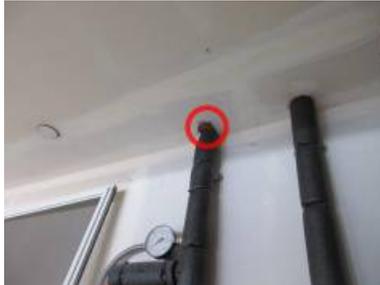
6.4 FIRE SEPARATION

There are voids in the fire resistive barrier between the living space and garage that will allow flames to penetrate. The gypsum barrier slows the spread of a fire from the garage to the structure and/or living space. Patching the voids with a fire retardant caulk is recommended.

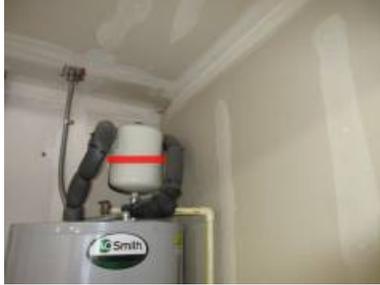
10.6 EXPANSION TANK

The expansion tank is not adequately secured to the wall. As code requirements start to call for engineered expansion tank supports we recommend the installation of seismic restraints to secure the expansion tank instead of allowing it to simply depend on piping connections that could result in damage to the water pipe and leakage during an earthquake.

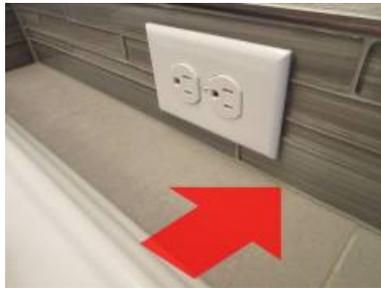
The backsplash caulking is cracked. Cracking of the caulk allows water to enter the gap and is difficult to clean. Caulking the cracks and/or gaps is recommended.

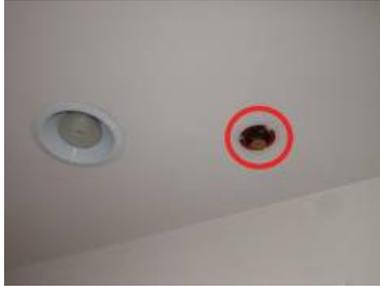
14.12 GENERAL COMMENT**FIRE SUPPRESSION SYSTEM:**

The sprinkler head adjacent the garage door has deployed. The sprinkler head should be reset and cover installed as needed.

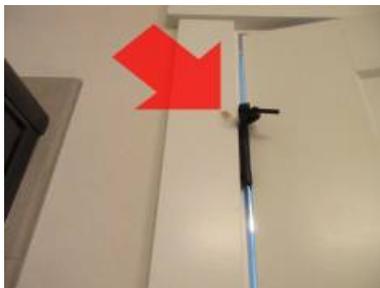
Several of the doors are equipped with hinge mounted door stops. This type of door stop can damage the door skin, tear out hinge screws, and damage the door trim and frame. The removal and replacement with wall or floor mounted door stops is recommended.
