**NOTICE TO BUYER: SELLER-PROCURED INSPECTION REPORT**

The following notice is given with respect to the Purchase and Sale Agreement dated \_\_\_\_\_ between \_\_\_\_\_ (“Buyer”) and **Christina M Matthews** **Luke J Matthews** (“Seller”) concerning **15040 116th PINE** **Kirkland** **WA 98034** (“the Property”).

**Luke & Christina Matthews**  
**15040 116<sup>th</sup> Place NE**  
**Kirkland, WA 98034**

At your request, a visual inspection of the above referenced property was conducted on 02/13/2023. We have inspected the major structural components, plumbing, heating and electrical systems for signs of significant non-performance, excessive or unusual wear and general state of repair.

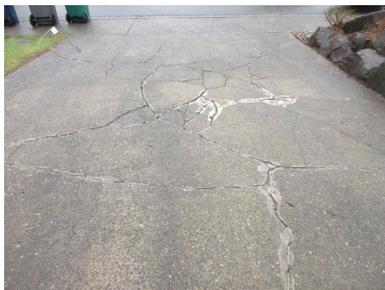
The driveway has cracked and settled differentially. This was probably caused by inadequate preparation of the soil prior to the placement of the concrete. This condition can be repaired by removing and replacing it. The driveway remains functional despite this condition.

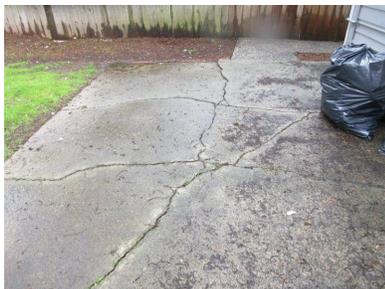
#### *PATIO*

The patio has settled differentially. This was probably caused by inadequate preparation of the soil prior to the placement of the concrete. This condition can be repaired by removing and replacing it. The patio remains functional despite this condition. However, the raised edges of the concrete can be a trip hazard for some people. Repairs should be made as necessary.

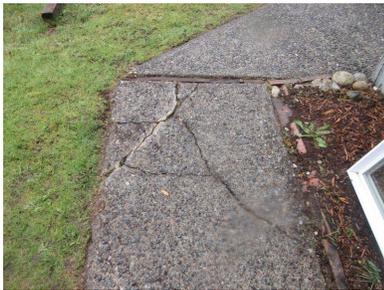
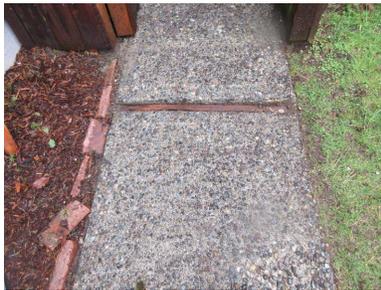
**WALKWAY**

The wooden dividers separating the concrete walkway sections have deteriorated to a point where the gaps are a trip hazard. Replacement with mortar is recommended.

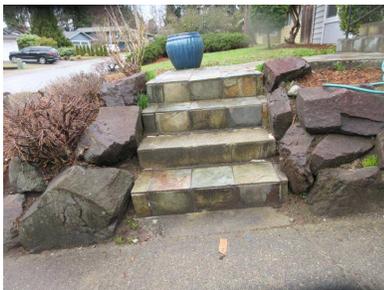
**STEPS**

There is no handrail along the stairs. This is a hazard. The installation of a handrail along the stairs is recommended.

The steps are non-conforming due to the variable and/or excessive rise. Stair design standards require that stair risers do not exceed 8" and that the variation in rise not exceed 3/8" in order to reduce falls from tripping. To increase the margin of safety, consideration should be given to reconfiguring the steps so that rise and run do not vary by more than 3/8". If this proves to be too impractical or expensive, then we recommend exercising caution when using these stairs.

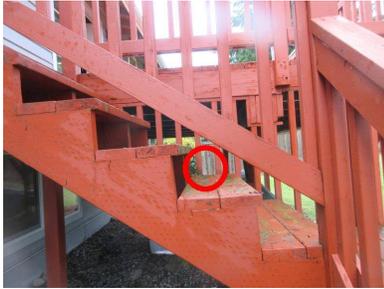
**STAIRS**

The spacing under stair railing is too wide. This is a hazard for small children. The spacing should be reduced

as a safety upgrade. Current standards require that a 4" sphere not pass under the railing.

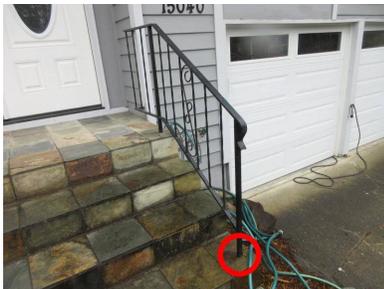
**PORCH RAILING**

The porch railing is loose at the stoop. This is a safety hazard. The installation to present industry standards is recommended.

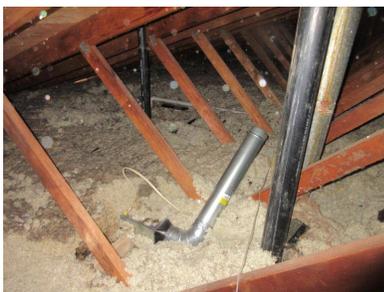
**MECHANICAL VENTILATION SYSTEMS**

The bathroom vent fan discharges in the attic rather than outside. This is an undesirable condition that causes excessive moisture in the attic and can result in mold or fungus growth. A 4" smooth-wall sheet metal duct should be installed to direct the moisture laden air discharged from the fan out of the attic.

An attic fan was installed for whole house ventilation. This fan was tested and was functional. Do not turn the fan on when using the fireplace, as this will cause a back draft and smoke damage.

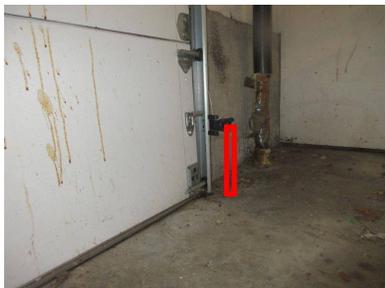
The Photo-eye beam was installed too high above the floor of the garage to adequately offer protection for small children and/or pets. We recommend that the photo-eye be lowered to within 4-6" of the floor.

There was no photo-eye sensor installed for the south garage door to offer protection for small children and/or pets. We recommend that a photo-eye sensor be installed for the garage door at a height of within 4-6" of the floor.

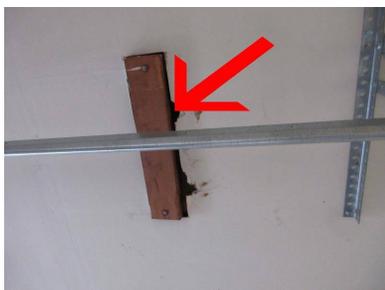
**FIRE SEPARATION**

There are voids in the fire resistive barrier between the living space and garage that will allow flames to penetrate. The gypsum barrier slows the spread of a fire from the garage to the structure and/or living space. Patching the voids with a fire retardant caulk is recommended.

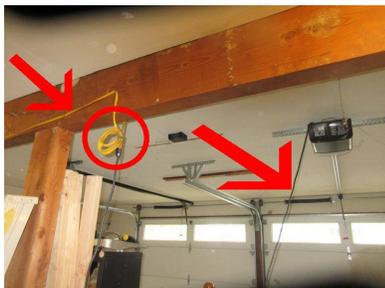
An extension cord is used as a temporary power source for the garage door openers. An extension cord is not suitable as a permanent wiring method. The installation of a receptacle within cords length of the motors is recommended.

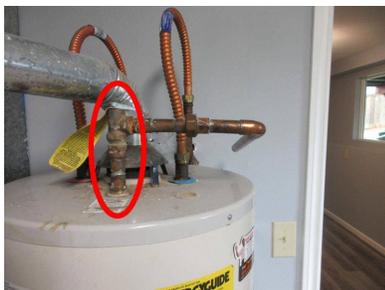
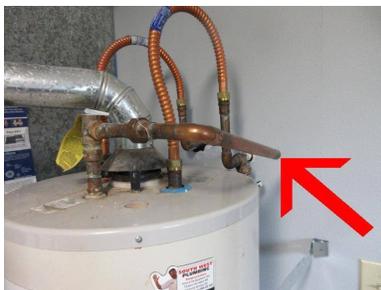
The pressure relief valve is mounted on the external pipe rather than in the water heater. This was a typical installation when this house was built, but is now considered to be non-code compliant in most jurisdictions. The installation of a pressure relief valve on the water heater tank is recommended as a safety upgrade.

The pressure relief valve lacks a drain pipe. This is a scald hazard. The installation of a 3/4" copper, CPVC plastic or galvanized steel drain pipe is recommended. Ideally, the drain should be routed to the exterior. However, running the pipe straight down to the floor eliminates the scald hazard.

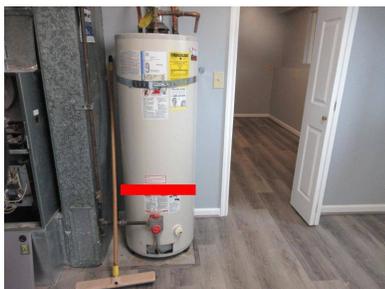
**SEISMIC RESTRAINT**

The seismic restraint for the water heater was minimal. Proper strapping is recommended to adequately secure the tank and provide potable water in the event of an earthquake.

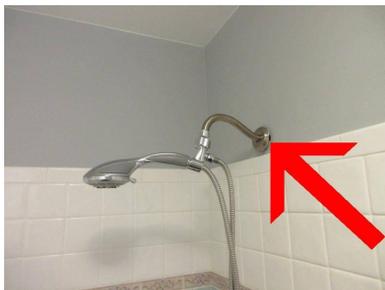
The goose neck is loose inside the wall. This can result in leaks. The goose neck should be secured inside the wall in accordance with industry standards.

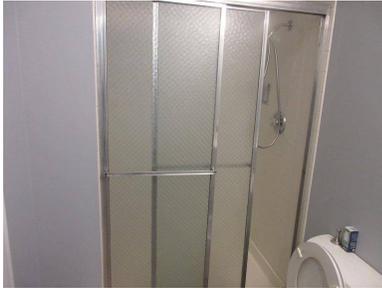
Wire glass has been used in the shower enclosure. Wire glass can be extremely hazardous when broken. As an upgrade, to increase the margin of safety, we recommend installing a tempered safety glass enclosure.

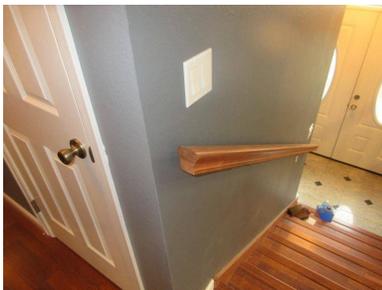
There is no handrail in the lower stairwell. This is a safety hazard. The installation of a graspable handrail that conforms to present industry standards is recommended.

The railing ends in the upper stairwell does not return to the wall. This is a safety hazard. The installation of a continuous handrail should be considered as a safety upgrade.

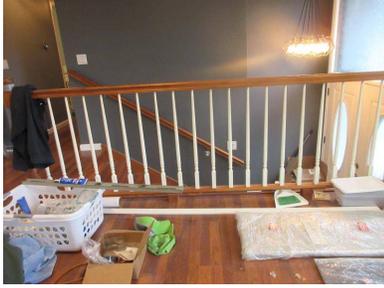
##### *GUARD RAILINGS*

The spacing between the balusters is too wide. This is a hazard to small children. The balusters should be spaced close enough together so that a 4" sphere cannot pass through. Upgrading the guard railing is recommended if small children are present.

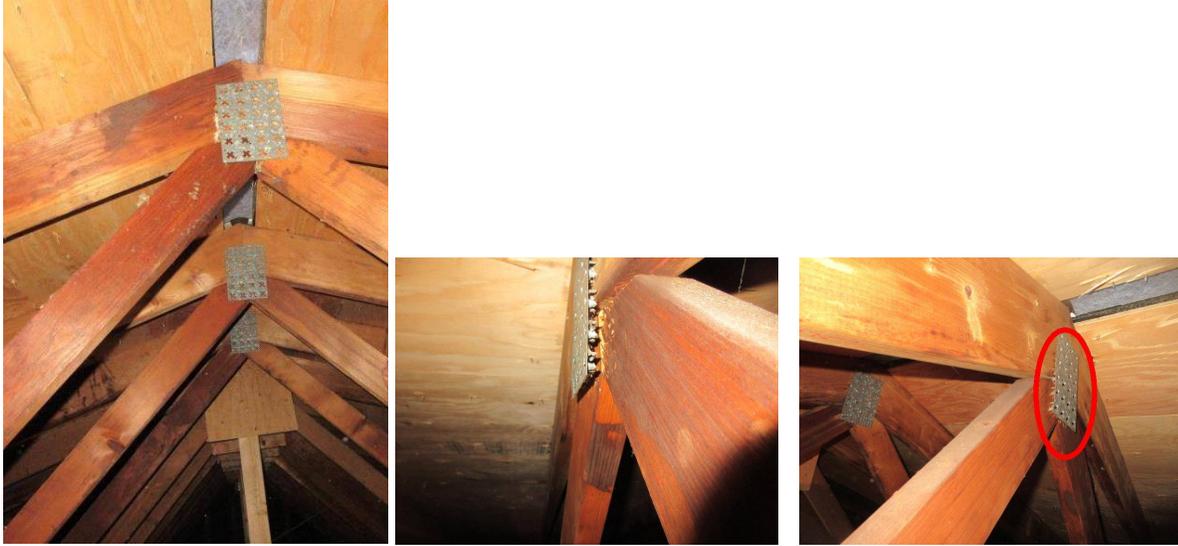
Several of the truss nailing plates are compromised and are inadequately performing their intended function(s). This could cause movement of the roof structure. Repairs are recommended.

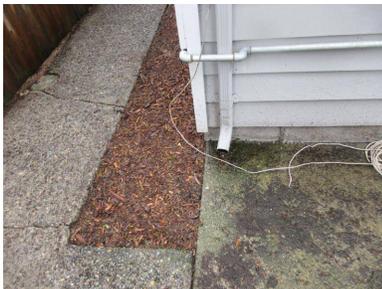
The downspout at the southeast corner of the building discharges on the ground adjacent to the foundation. Roof water discharging on the ground adjacent to the foundation wall and exterior wood door frames is one of the most common causes of water or moisture problems at ground floor occupancies. Clogged downspouts and scuppers also frequently cause or exacerbate moisture or water entry problems. Consideration should be given to diverting water away from the exterior walls, doors and foundation system. Consult with a drain systems specialist for additional information and cost estimates.

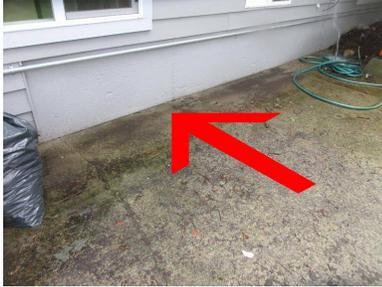
##### *GRADING*

The hardscape surfaces near the building were generally lower than the surrounding grade. This condition does not allow water to drain away from the foundation and building. Accumulated water near the building will cause moisture related damage to the building's components. We recommend a drain systems specialist evaluate the site drainage and determine what type of drainage system or improvements would be beneficial.

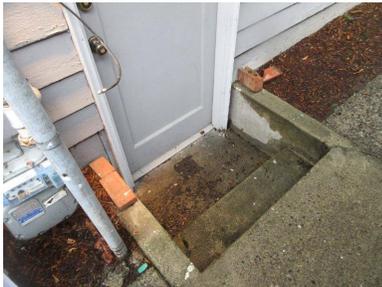
The drain at the bottom of the walkout is clogged. This will result in flooding of the lower level. Steps should be taken to clean the drain and restore its function. This drain should be cleaned regularly.

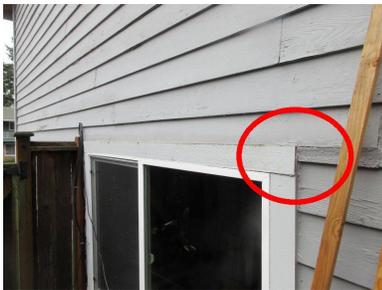
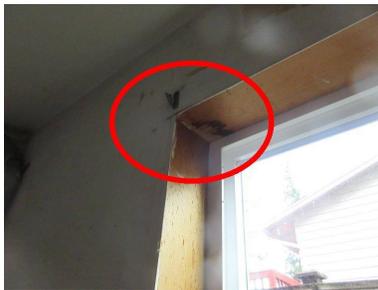
Caulking is used to seal around the exterior of the doors and windows. Exterior wall penetrations sealed with caulking will shrink, crack and eventually will leak. This could result in interior water intrusion. The installation of head flashings is recommended.

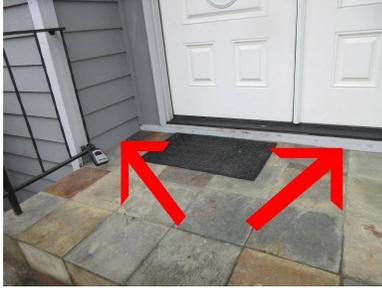
Untreated wood in direct contact with concrete was observed along the front porch stoop. Untreated wood should be raised 1-2" above the concrete. Treating the wood with a preservative sometimes will prevent wood destroy organism damage.

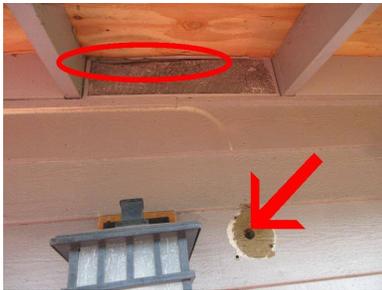
There are openings at the exterior through which birds and rodents can enter into the structure. These openings should be covered with wood, wire mesh or filled with aerosol foam.

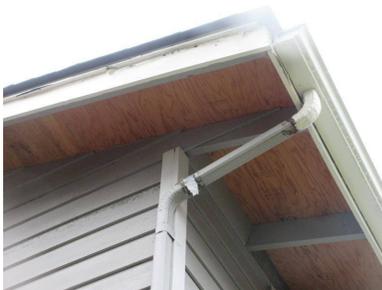
The 2" square downspouts are too small and are more vulnerable to clogging than the larger rectangular ones. Consideration should be given to upgrading the downspouts.

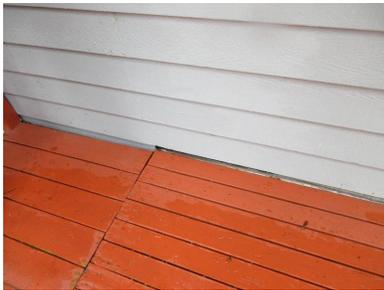
We recommend treatment of exterior decks with a good quality wood preservative/water repellent. Annual treatments will prevent cupping, checking and rotting of the wood and will maximize its service life. Do not use paint on exposed deck surfaces as it will peel and become difficult to maintain. Paint also traps moisture in the wood and will accelerate deterioration.

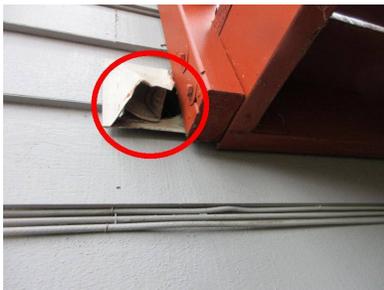
#### **VENT DAMPERS**

The dryer duct back-draft damper is damaged at the termination. The installation of a non-restricted hooded back-draft damper is recommended to prevent entry by rodents, birds insects, etc.

- **Building Exterior, Vent Dampers:** Installation of non-restricted vent - ***Complete***
- **Bathrooms, Hallway Bathroom, Tub Walls:** Clean and replace shower caulk - ***Complete***

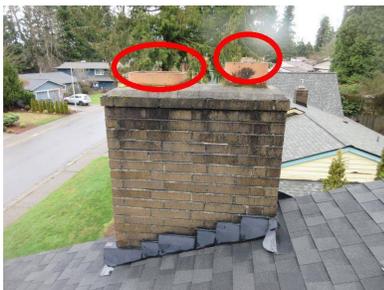
The top of the masonry chimney does not have spark arrestor/rain caps. The installation of a spark arrestor/rain cap for each flue is recommended as a safety upgrade and to prevent moisture damage to the inside of the chimney and fireplace. An additional benefit of a rain cap is that it will keep birds and rodents from entering the house when the damper is left open.

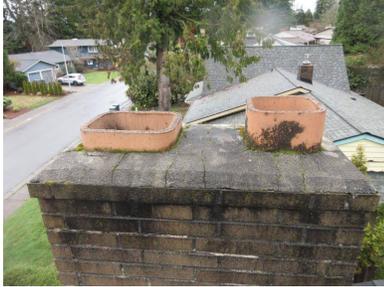
The chimney crown is cracked and deteriorated. The mortar chimney crown prevents water from entering and damaging the masonry. Repairing or replacing the chimney crown will extend the service life of the chimney.

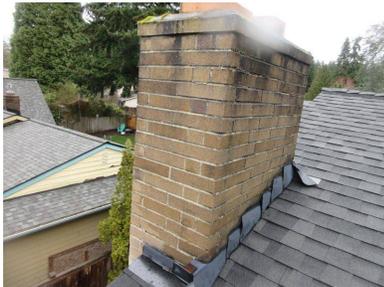
Mortar was missing or deteriorated in numerous areas around the chimney. This has led to accelerated deterioration of the brick masonry. Damaged areas can be repaired by filling in cutout or defective mortar joints with fresh mortar. (Tuck pointing)

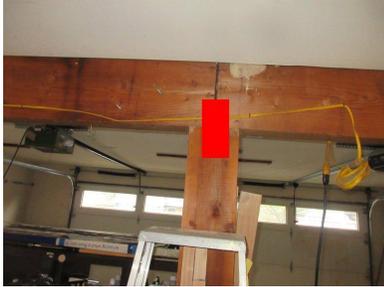
There are no visible positive connections tying the posts and concrete pier footing together. The installation of gusset plates is recommended to reduce the likelihood of damage during an earthquake.

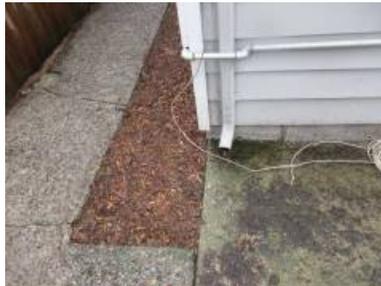
The downspout at the southeast corner of the building discharges on the ground adjacent to the foundation. Roof water discharging on the ground adjacent to the foundation wall and exterior wood door frames is one of the most common causes of water or moisture problems at ground floor occupancies. Clogged downspouts and scuppers also frequently cause or exacerbate moisture or water entry problems. Consideration should be given to diverting water away from the exterior walls, doors and foundation system. Consult with a drain systems specialist for additional information and cost estimates.

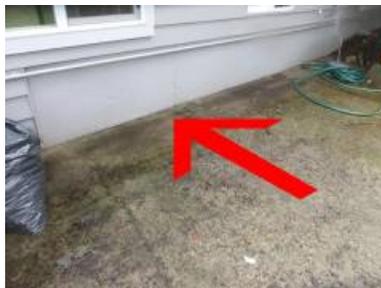
### GRADING

The hardscape surfaces near the building were generally lower than the surrounding grade. This condition does not allow water to drain away from the foundation and building. Accumulated water near the building will cause moisture related damage to the building's components. We recommend a drain systems specialist evaluate the site drainage and determine what type of drainage system or improvements would be beneficial.

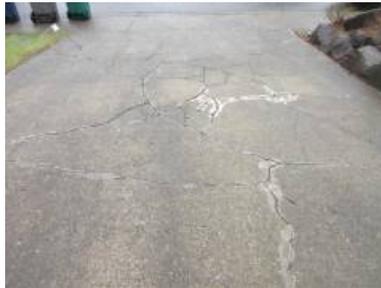
The driveway has cracked and settled differentially. This was probably caused by inadequate preparation of the soil prior to the placement of the concrete. This condition can be repaired by removing and replacing it. The driveway remains functional despite this condition.

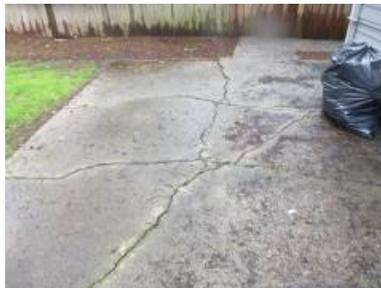
*PATIO*

The patio has settled differentially. This was probably caused by inadequate preparation of the soil prior to the placement of the concrete. This condition can be repaired by removing and replacing it. The patio remains functional despite this condition. However, the raised edges of the concrete can be a trip hazard for some people. Repairs should be made as necessary.

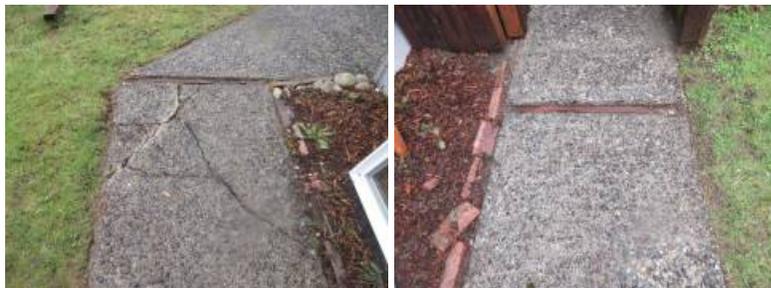
*WALKWAY*

The wooden dividers separating the concrete walkway sections have deteriorated to a point where the gaps are a trip hazard. Replacement with mortar is recommended.

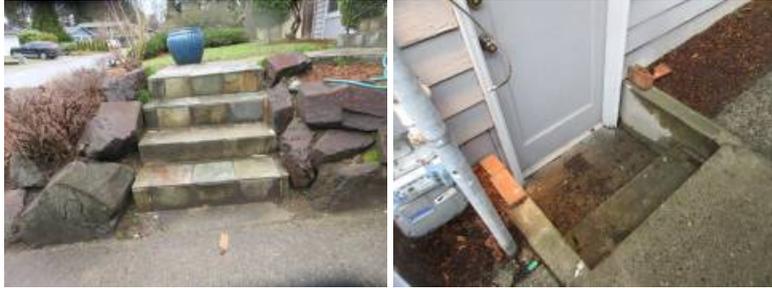
The drain at the bottom of the walkout is clogged. This will result in flooding of the lower level. Steps should be taken to clean the drain and restore its function. This drain should be cleaned regularly.

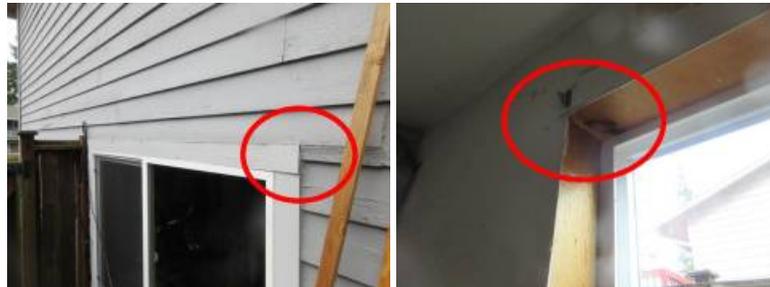
Caulking is used to seal around the exterior of the doors and windows. Exterior wall penetrations sealed with caulking will shrink, crack and eventually will leak. This could result in interior water intrusion. The installation of head flashings is recommended.

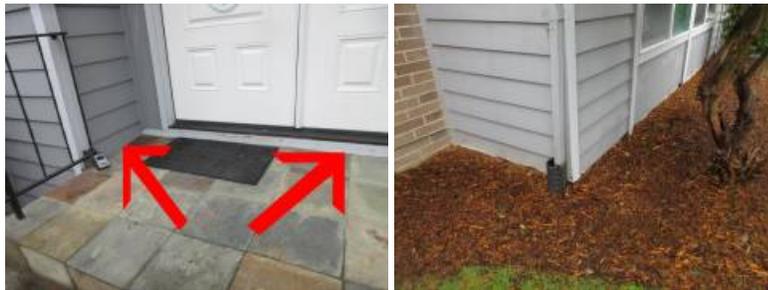
Good building practice requires that foundation walls or pier footings supporting wood frame construction, extend at least 8" above the finish grade with at least a 6" clearance between the top of the soil and the bottom of the wood finish materials. Untreated wood should be raised 1-2" above surrounding flatwork and should have a moisture barrier installed between the concrete and wood. For additional information and treatment options, you should retain the services of a qualified pest control operator.

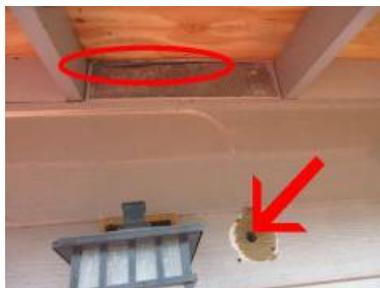
There are openings at the exterior through which birds and rodents can enter into the structure. These openings should be covered with wood, wire mesh or filled with aerosol foam.

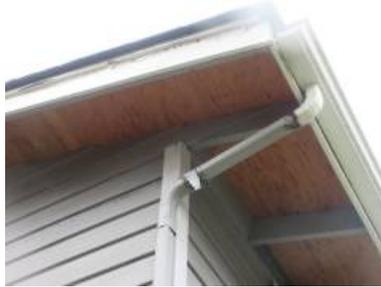
The 2" square downspouts are too small and are more vulnerable to clogging than the larger rectangular ones. Consideration should be given to upgrading the downspouts.

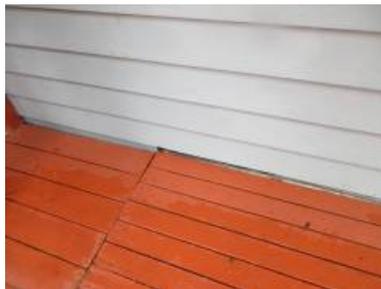
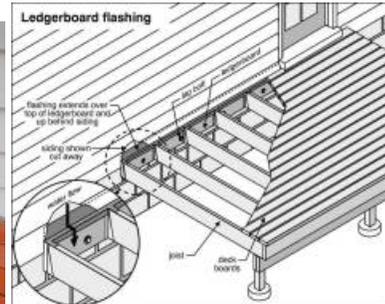
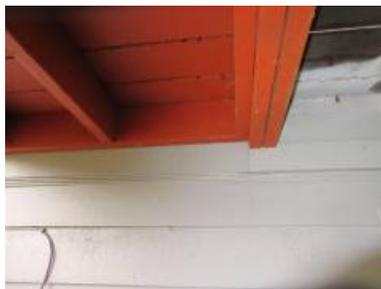
There is no flashing at the intersection between the deck and house. This will allow water to enter behind the siding. The installation of flashing in this area is recommended.

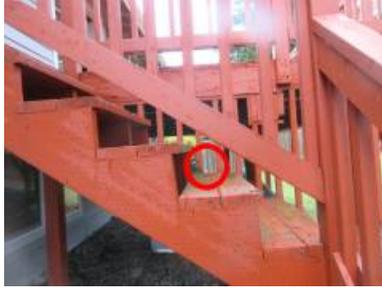
The spacing under stair railing is too wide. This is a hazard for small children. The spacing should be reduced as a safety upgrade. Current standards require that a 4" sphere not pass under the railing.

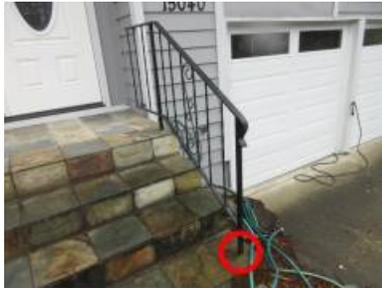
The porch railing is loose at the stoop. This is a safety hazard. The installation to present industry standards is recommended.

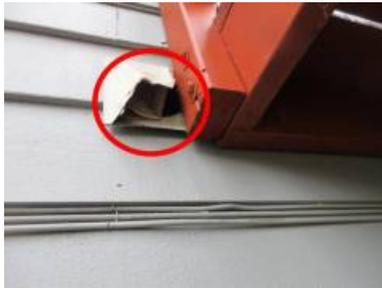
The dryer duct back-draft damper is damaged at the termination. The installation of a non-restricted hooded back-draft damper is recommended to prevent entry by rodents, birds insects, etc.

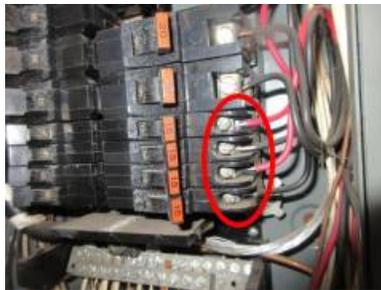
Aluminum wire is used for several of the 120 volt lighting circuits in this building.
