NOTICE TO BUYER: SELLER-PROCURED INSPECTION REPORT

The following notice is given with respect to the Purchase and Sale Agreement dated _____ between _____ (“Buyer”) and **Jennifer Emira** _____ (“Seller”) concerning **17150 NE 140th Ct Redmond WA 98052** (“the Property”).

At your request, a visual inspection of the above referenced property was conducted on 03/14/2023. We have inspected the major structural components, plumbing, heating and electrical systems for signs of significant non-performance, excessive or unusual wear and general state of repair.

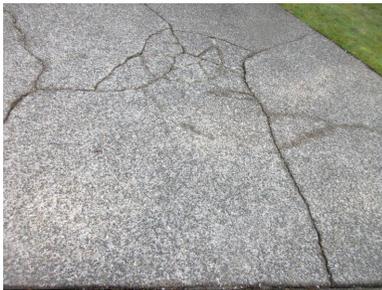
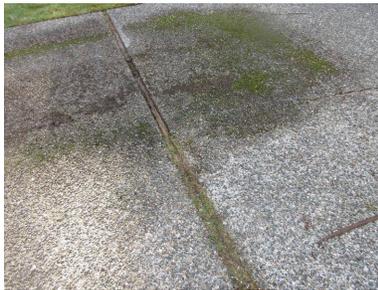
The driveway has cracked and settled differentially. This was probably caused by inadequate preparation of the soil prior to the placement of the concrete. This condition can be repaired by removing and replacing it. The driveway remains functional despite this condition.

The wooden divider separating the concrete driveway sections has deteriorated to a point where it is a trip hazard. Replacement with mortar is recommended.

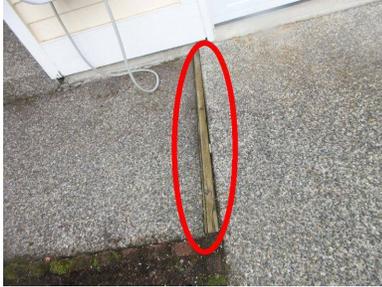
The walkway has cracked and settled differentially. This was probably caused by inadequate preparation of the soil prior to the placement of the concrete. This condition can be repaired by pressure grouting the sunken portion of the walkway or by removing and replacing it. Grinding down the raised edges of the concrete will also mitigate the hazard. The walkway remains functional despite this condition. However, the raised edges of the concrete can be a trip hazard for some people. Repairs should be made as necessary.

One or more of the wooden dividers separating the concrete walkway sections were infested by wood destroying organisms and have deteriorated to a point where they are becoming a trip hazard. Replacement with mortar is recommended.

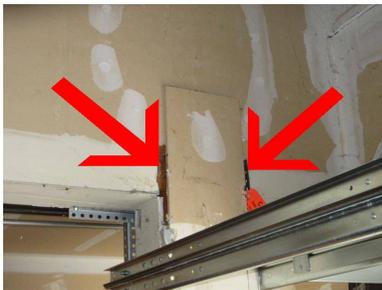
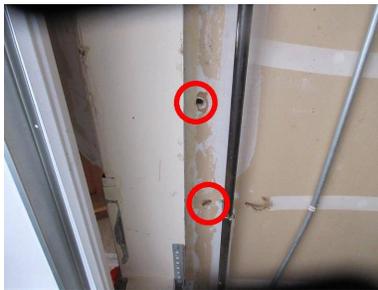
There are voids in the fire resistive barrier between the living space and garage that will allow flames to penetrate. The gypsum barrier slows the spread of a fire from the garage to the structure and/or living space. Patching the voids with a fire retardant caulk is recommended.

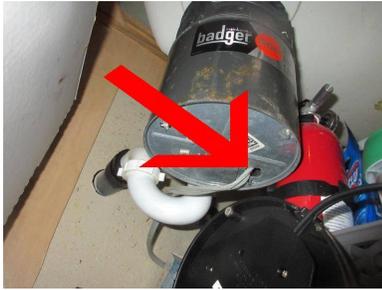
The cord is not clamped where it enters the disposal. This could damage the wires or cause a ground fault. The cord should be clamped in accordance with industry standards.

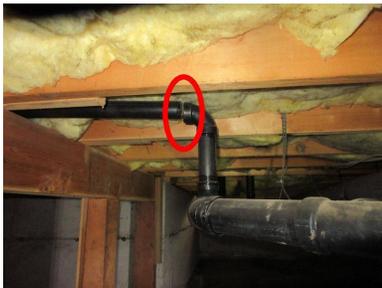
The vertical vent pipe from a waste pipe in the crawlspace is detached. This allows sewer gas to back up into the building and could allow sewage spillage. Repairs are recommended.

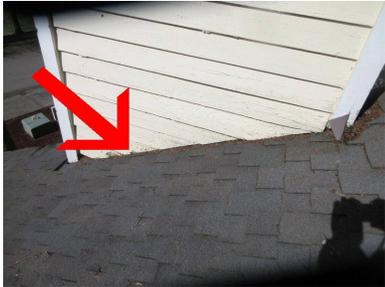
The siding is rot damaged where it has been in contact with the roofing material. The rot damaged siding should be repaired and a minimum of a 2" clearance should be maintained between the top of the roofing and bottom of the siding.

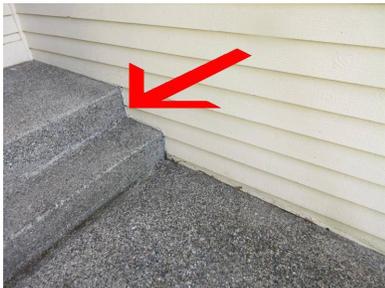
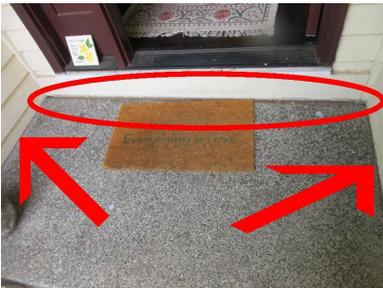
Untreated wood in direct contact with concrete was observed along the stoop. Untreated wood should be raised 1-2" above the concrete. Treating the wood with a preservative sometimes will prevent wood destroy organism damage.

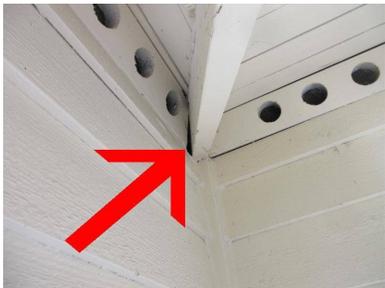
There are large gaps over 1/4" in size adjacent the soffit vent blocks. These gaps allow insects and rodents to enter the attic. Covering the gaps with screening, a strip of wood and/or caulking is recommended.

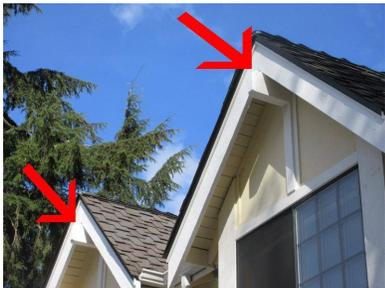
The beams that stick out beyond the drip edge of the roof are vulnerable to rot damage. They should be covered with a metal cap flashing or cut off flush with the edge of the overhang.

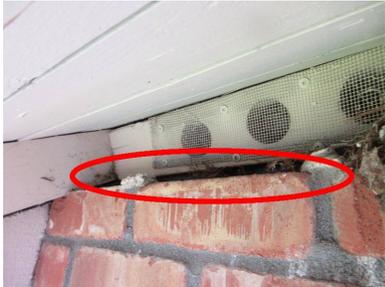
There are openings at the intersection between the vent blocks and the brick cladding through which birds and rodents can enter into the attic. These openings should be covered with wood, wire mesh or filled with aerosol

foam.

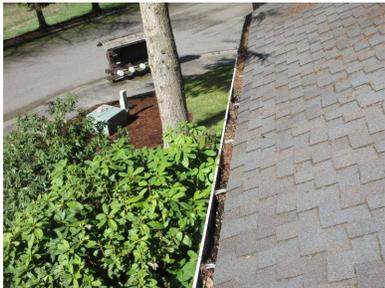
There is a build-up of organic debris inside the gutters. Proper maintenance of gutters and downspouts is essential and should be performed routinely in order to prevent clogging. Maintenance consists primarily of keeping leaves and other organic debris out of the system. Failure to clean the gutters will result in water splash on the building when they overflow. Gutters can be damaged under the weight of the water and organic matter inside the gutter. Gutters should be cleaned as necessary to maintain a free flow of water into the downspouts.

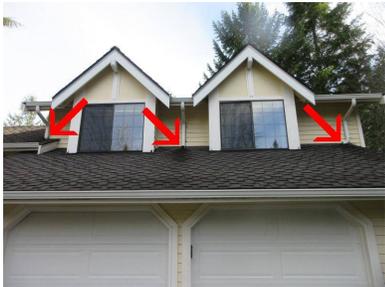
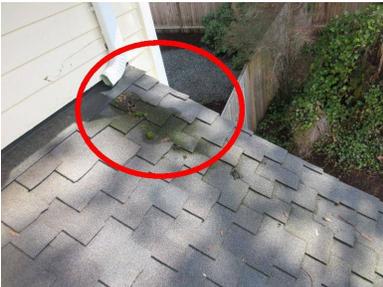
Downspouts draining directly onto the asphalt shingle surface causes excessive wear of the roofing material. Downspout extensions to the lower gutters should be installed to prevent excessive wear and tear of the roofing.

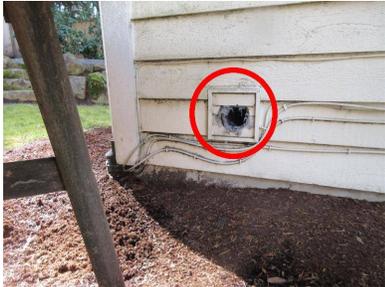
The dryer duct back-draft damper is damaged at the termination. The installation of a hooded back-draft damper is recommended to prevent entry by rodents, birds insects, etc.

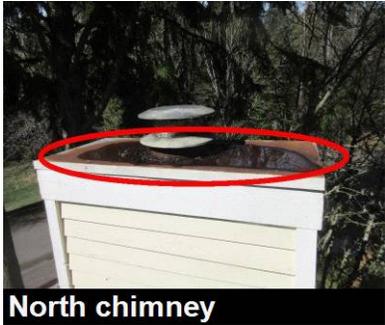
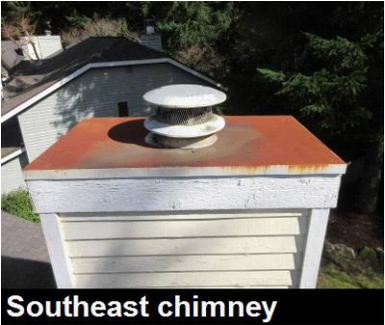
The chase cover for the north fireplace is concave and holds water. This has resulted in corrosion of the sheet metal. When rust holes form the cover will begin to leak. Chase cover replacement is recommended. The new chase cover should be sloped for drainage.

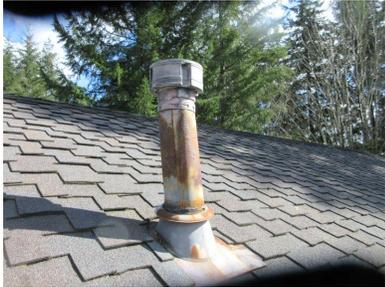
The gas appliance vent is corroded above the roof line. Cleaning and painting the vent will prolong its service life.

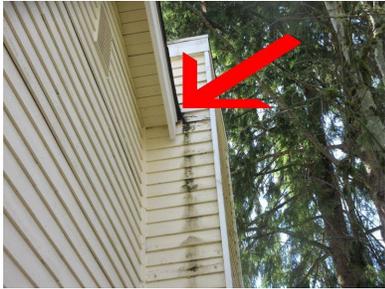
There is no kick out flashing at the roof edge to wall intersection above the gutter. This will allow water to enter the wall behind the siding. The installation of a kick-out flashing is recommended.

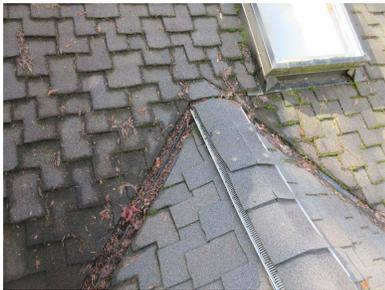
The roof is in need of routine maintenance. The surface should be blown off or washed with a high volume low pressure garden hose to remove moss and organic debris. Performing this maintenance will improve the appearance and increase the life expectancy of the roof.

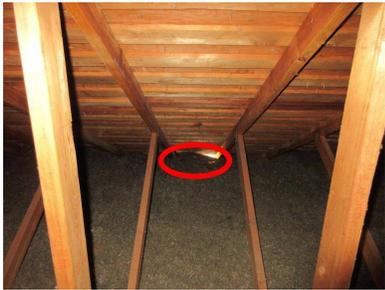
Wind baffles locations are compromised in some areas of the attic. The proper placement of wind baffles in front of all soffit vents is recommended.

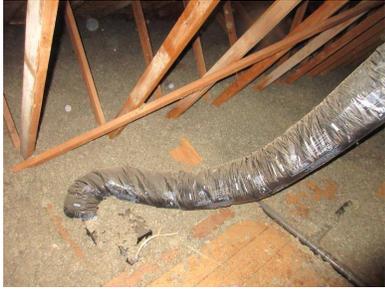
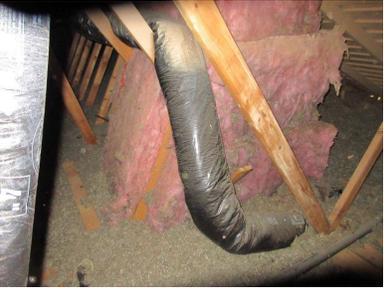
Flexible plastic duct is used to direct air from the vent fans to the exterior. This type of material is unreliable. Replacing the plastic duct with 4" smooth-wall sheet metal duct is recommended.

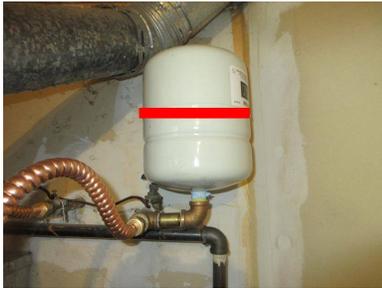
The expansion tank is not adequately secured to the wall. As code requirements start to call for engineered expansion tank supports we recommend the installation of seismic restraints to secure the expansion tank instead of allowing it to simply depend on piping connections that could result in damage to the water pipe and leakage during an earthquake.

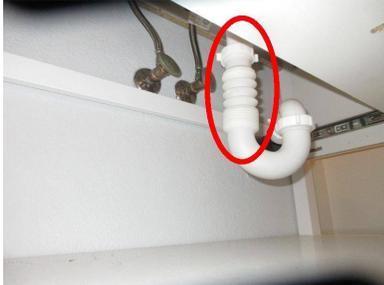
Improper, non-conforming material has been used for the drain pipe fitting. This material will not function reliably. Replacement with industry standard fittings is recommended.

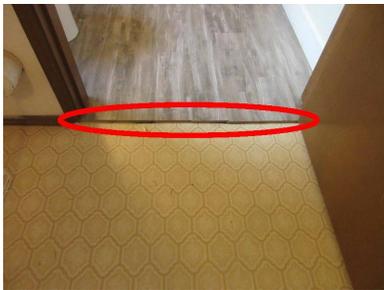
The hard surface flooring lacks a transition strip. The raised edge of the flooring is a hazard. We recommend the installation of a floor edge transition strip.

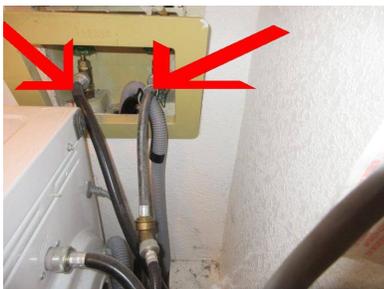
Upgrading the washer connections to high pressure (steel braided) lines is recommended.

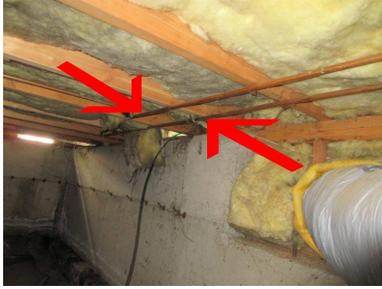
foam pipe insulation on all exposed water pipes is recommended.

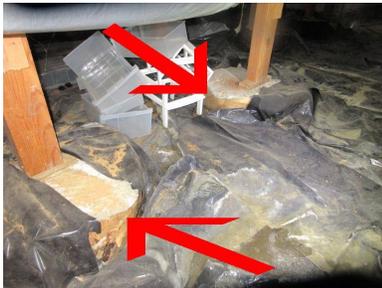
Cellulose forms were left in place on the pier footings. This cellulose is conducive to the infestation of various wood destroying organisms. The removal of the cellulose is recommended.

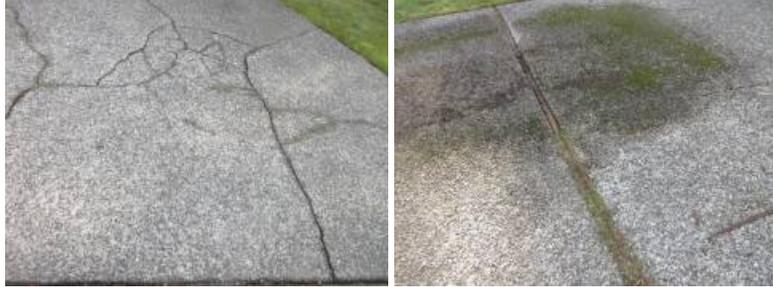
The wooden divider separating the concrete driveway sections has deteriorated to a point where it is a trip hazard. Replacement with mortar is recommended.

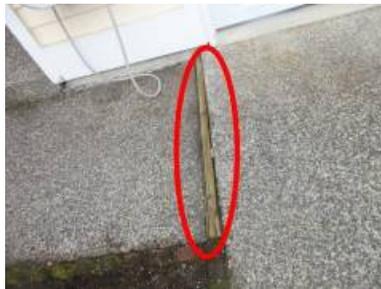
Many legal and public works departments have defined a trip hazard as an irregularity in a walking surface exceeding one inch (1") in height. All walking surfaces should maintain, free of a vertical surface change of 3/4" or more, in the interest of public and personal safety.

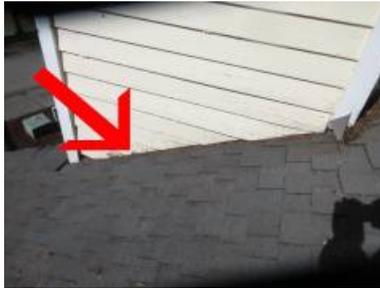
The siding is rot damaged where it has been in contact with the roofing material. The rot damaged siding should be repaired and a minimum of a 2" clearance should be maintained between the top of the roofing and bottom of the siding.

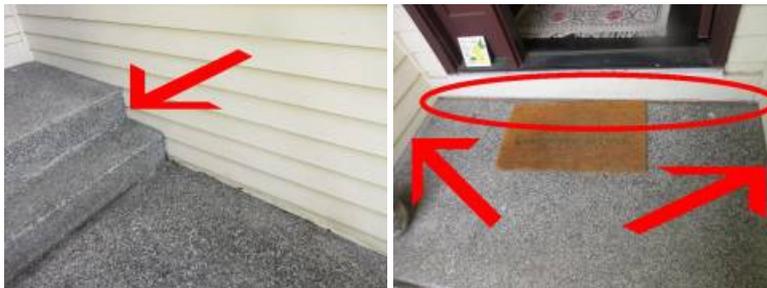
Untreated wood in direct contact with concrete was observed along the stoop. Untreated wood should be raised 1-2" above the concrete. Treating the wood with a preservative sometimes will prevent wood destroy organism damage.

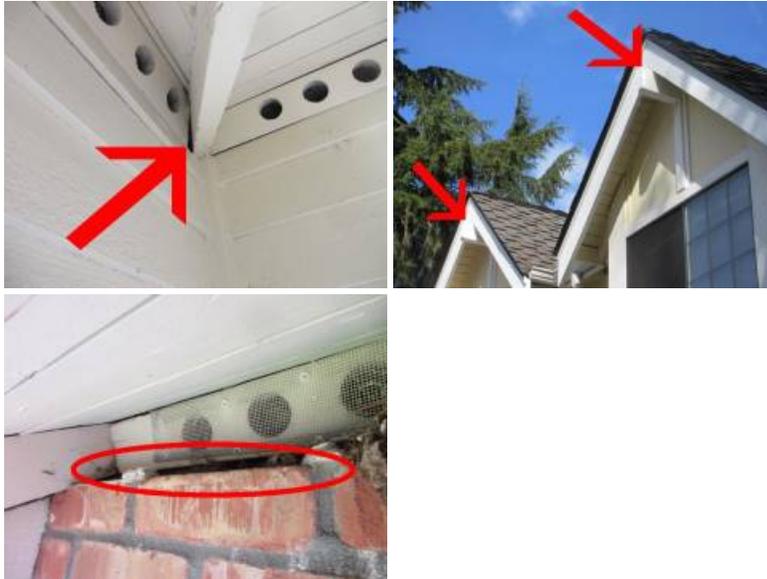
There are openings at the intersection between the vent blocks and the brick cladding through which birds and rodents can enter into the attic. These openings should be covered with wood, wire mesh or filled with aerosol foam.

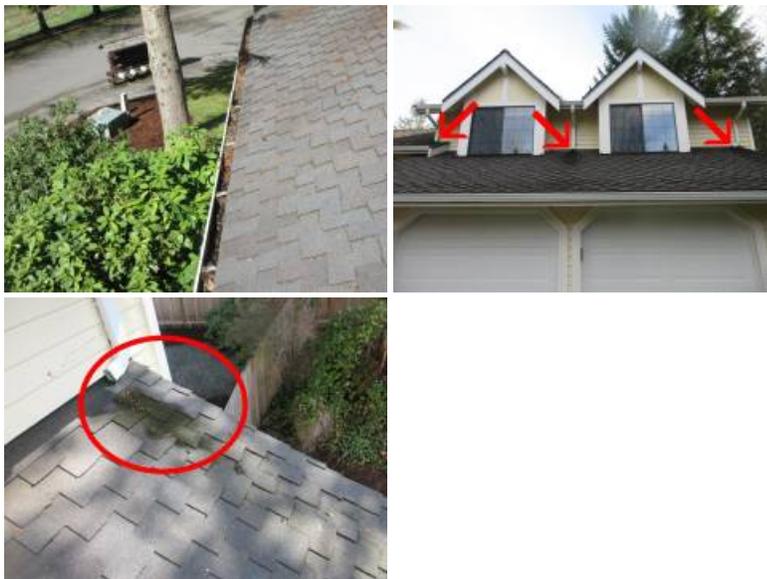
Downspouts draining directly onto the asphalt shingle surface causes excessive wear of the roofing material. Downspout extensions to the lower gutters should be installed to prevent excessive wear and tear of the roofing.

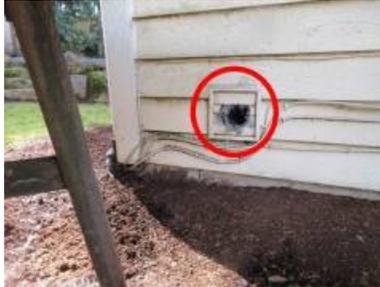
The dryer duct back-draft damper is damaged at the termination. The installation of a hooded back-draft damper is recommended to prevent entry by rodents, birds insects, etc.

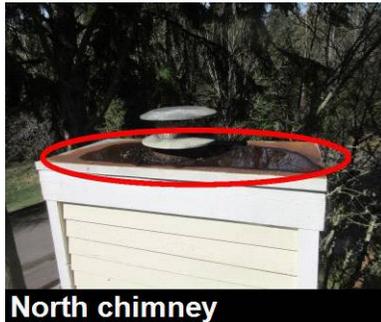
North chimney

The chase cover for the north fireplace is concave and holds water. This has resulted in corrosion of the sheet metal. When rust holes form the cover will begin to leak. Chase cover replacement is recommended. The new chase cover should be sloped for drainage.

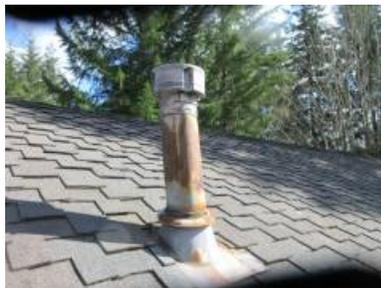
The gas appliance vent is corroded above the roof line. Cleaning and painting the vent will prolong its service life.

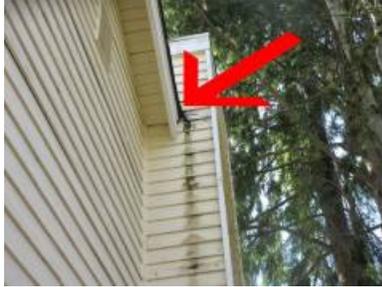
There is no kick out flashing at the roof edge to wall intersection above the gutter. This will allow water to enter the wall behind the siding. The installation of a kick-out flashing is recommended.

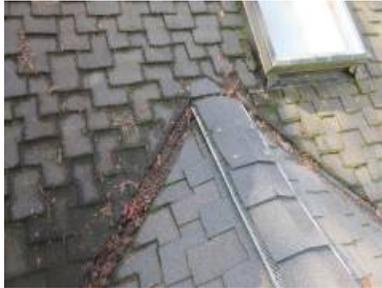
The roof is in need of routine maintenance. The surface should be blown off or washed with a high volume low pressure garden hose to remove moss and organic debris. Performing this maintenance will improve the appearance and increase the life expectancy of the roof.

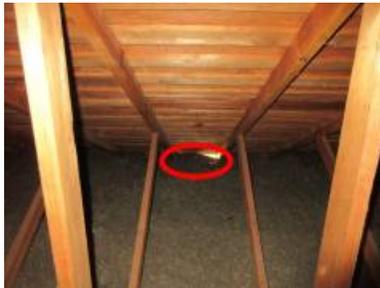
Wind baffles prevent wind from blowing through the soffit vents and pushing the insulation away from the vent opening. The absence of wind baffles will often result in the exposure of large areas of the ceiling to cold temperatures. Wind baffles also prevent insulation from blocking the vents.

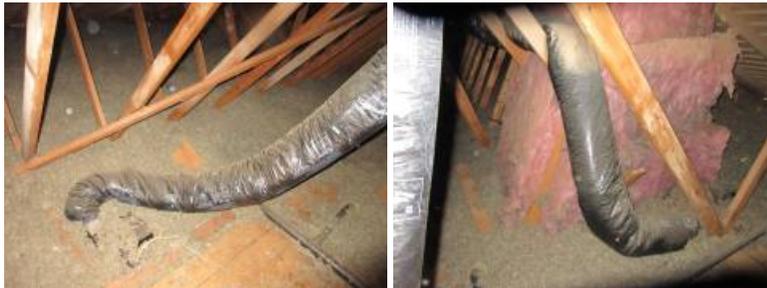
VENTILATION Flexible plastic duct is used to direct air from the vent fans to the exterior. This type of material is unreliable. Replacing the plastic duct with 4" smooth-wall sheet metal duct is recommended.

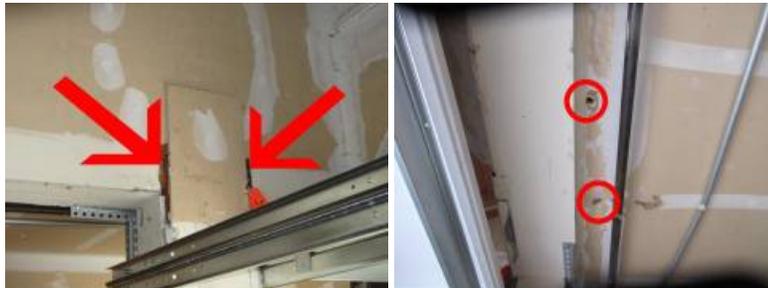
There are voids in the fire resistive barrier between the living space and garage that will allow flames to penetrate. The gypsum barrier slows the spread of a fire from the garage to the structure and/or living space. Patching the voids with a fire retardant caulk is recommended.

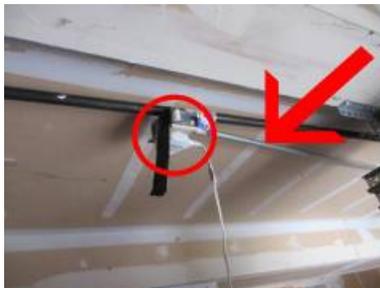
The junction box in the garage is not secured. This is a hazard. The junction box should be attached and secured to the framing.

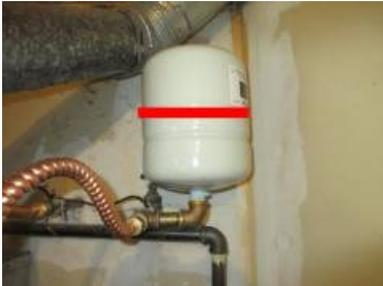
<i>LOCATION OF UNIT</i>	The water heater is located in the garage.
<i>GENERAL INFORMATION</i>	The water heater fuel is natural gas. The capacity of the water heater is 50 gallons. The input rating of the burner is approximately 40,000 BTU. The water heater is approximately 3 years old. Water heaters of this type typically last about 10-15 years.
<i>PRESSURE RELIEF VALVE</i>	The pressure relief valve is properly installed. The valve was not tested, as this could cause the valve to leak.
<i>SHUTOFF VALVE</i>	The shutoff valve for the water supply to the water heater is properly installed and is functioning as intended.
<i>WATER CONNECTIONS AT TANK</i>	The water connections at the tank are properly installed and are performing their intended function.
<i>EXPANSION TANK</i>	The expansion tank is not adequately secured to the wall. As code requirements start to call for engineered expansion tank supports we recommend the installation of seismic restraints to secure the expansion tank instead of allowing it to simply depend on piping connections that could result in damage to the water pipe and leakage during an earthquake.

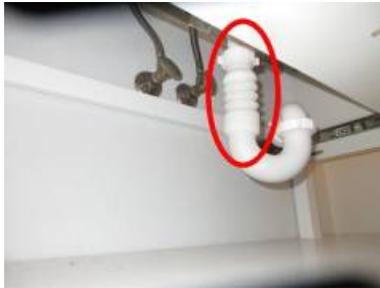
Improper, non-conforming material has been used for the drain pipe fitting. This material will not function reliably. Replacement with industry standard fittings is recommended.

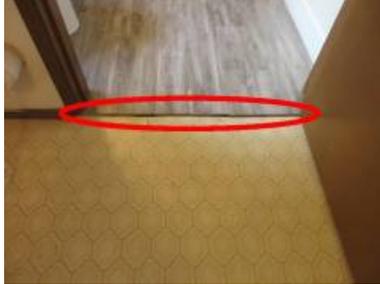
The hard surface flooring lacks a transition strip. The raised edge of the flooring is a hazard. We recommend the installation of a floor edge transition strip.

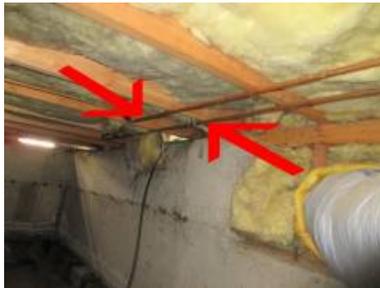
There are water pipes in the crawlspace that are not adequately insulated and could freeze. The installation of foam pipe insulation on all exposed water pipes is recommended.

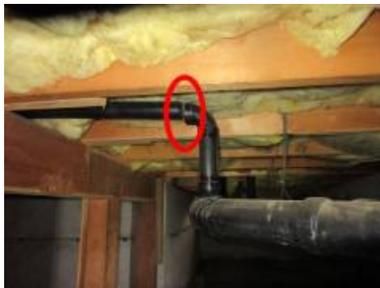
The vertical vent pipe from a waste pipe in the crawlspace is detached. This allows sewer gas to back up into the building and could allow sewage spillage. Repairs are recommended.

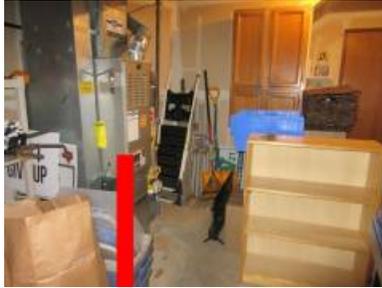
The gas pipes in front of the furnace and water heater are not protected by a bumper stop. A vertical steel pipe, bolted to the floor, is typically installed in front of the water heater to prevent a car bumper from damaging the gas lines.
