NOTICE TO BUYER: SELLER-PROCURED INSPECTION REPORT

**Anzees Khan & Ramiza Saheed
17512 NE 137th St
Redmond, WA 98052**

Per the seller, the following items listed on the pre-sale inspection summary dated 4/11/2023, are being corrected by the seller as part of preparation for sale in good faith.

At your request, a visual inspection of the above referenced property was conducted on 04/10/2023. We have inspected the major structural components, plumbing, heating and electrical systems for signs of significant non-performance, excessive or unusual wear and general state of repair.

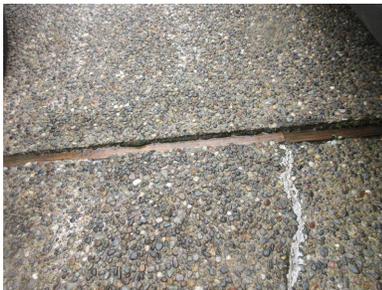
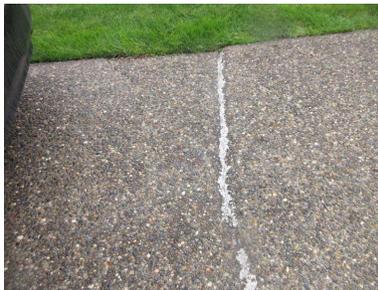
The driveway has cracked and settled differentially. This was probably caused by inadequate preparation of the soil prior to the placement of the concrete. This condition can be repaired by pressure grouting the sunken portion of the driveway or by removing and replacing it. The driveway remains functional despite this condition.

The wooden divider separating the concrete driveway sections has deteriorated to a point where it is a trip hazard. Replacement with mortar is recommended.

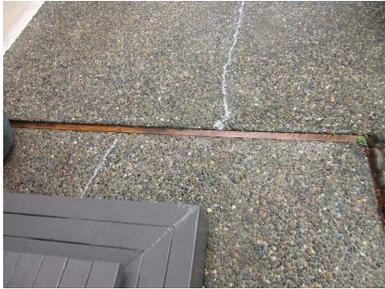
The walkway has cracked and settled differentially. This was probably caused by inadequate preparation of the soil prior to the placement of the concrete. This condition can be repaired by pressure grouting the sunken portion of the walkway or by removing and replacing it. Grinding down the raised edges of the concrete will also mitigate the hazard. The walkway remains functional despite this condition. However, the raised edges of the concrete can be a trip hazard for some people. Repairs should be made as necessary.

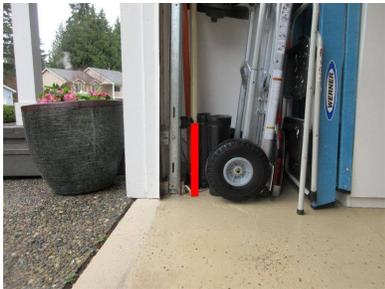
The Photo-eye beam was installed to high above the floor of the garage to adequately offer protection for small children and/or pets. We recommend that the photo-eye be lowered to within 4-6" of the floor.

Garage Door Opener – Photo-eye beam lowered to 4-6”.

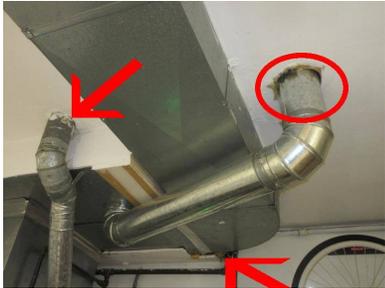
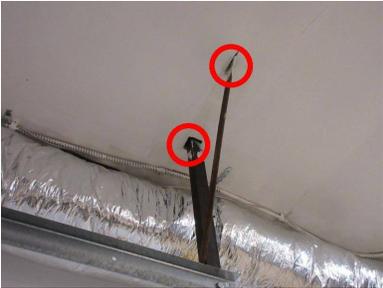
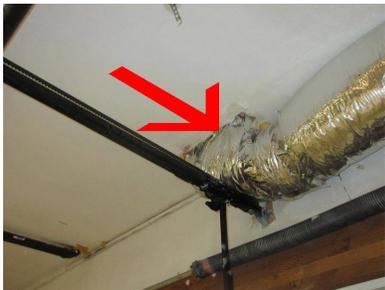
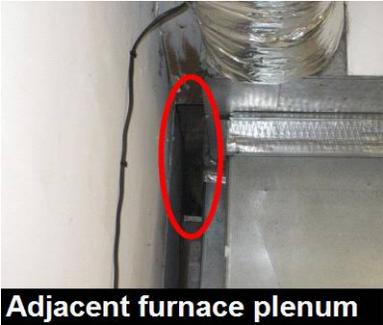
There are voids in the fire resistive barrier between the living space and garage that will allow flames to penetrate. The gypsum barrier slows the spread of a fire from the garage to the structure and/or living space. Patching the voids with a fire retardant caulk is recommended.

The installation of a furnace vent thimble is recommended to prevent flames from spreading to the structure.

Adjacent furnace plenum

Fire Separation – Gypsum Barrier installed in void, Fire Retardant Foam filled in gaps.

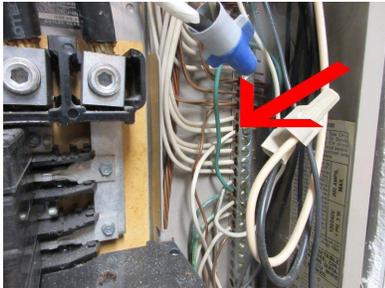
One of the neutral wires is double tapped on the buss bar. Double tapping means that two conductors share a single terminal. Double tapped terminals can loosen and overheat and therefore are not permitted unless the terminal is specifically listed for multiple wires. This defect is easily repaired by connecting the two wires to a "pig tail", securing them with a wire cap, and then inserting the pig tail conductor under the terminal.

Service Panel : Neutral wires separated. Cable clamps installed.

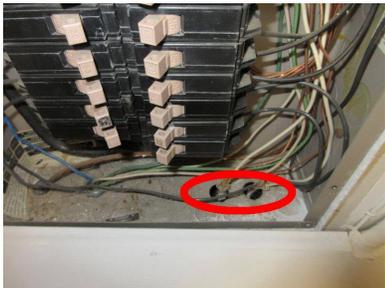
There are electrical cables emanating from the service panel that are not clamped. The sharp edges of the panel box could cut through the wire insulation and cause a short circuit or fire. Clamping the cables to the panel box using approved cable clamps is recommended.

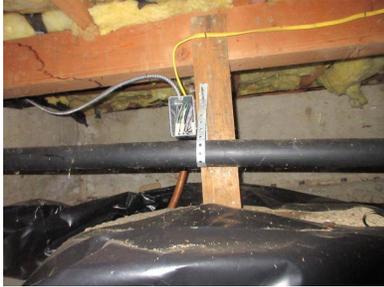
There is a junction box with a missing cover in the crawlspace. This is a fire/shock hazard. Covers should be installed on all junction boxes.

Wiring: Installed cover on junction box in crawlspace. Clamp installed light/fan fixture in attic.

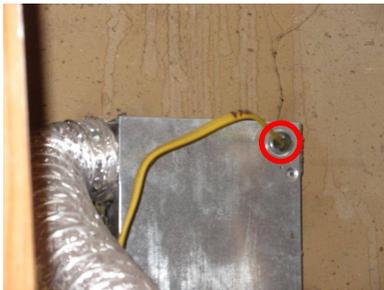
The Romex cable is not clamped where it enters the light/fan fixture chassis in the attic. This could result in a short circuit or fire. A Romex clamp should be installed at the point where the cable enters the fixture.

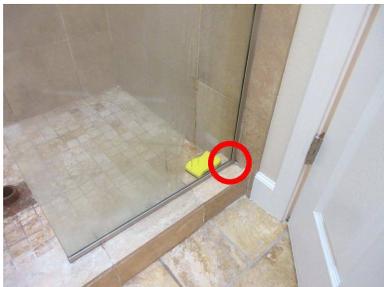
The glass enclosure has been leaking at the lower corner. No damage was visible, but resealing or repairing the enclosure is recommended as preventive maintenance.

Primary Bedroom Room: Glass Enclosure sealed.

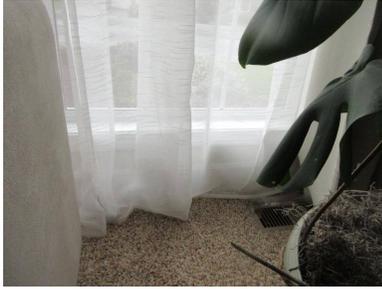
The lower window glass is not labeled as tempered safety glass. The existing glass is nonconforming by current building standards and would be hazardous if broken. The installation of safety glass is recommended as a safety upgrade for all windows less than 18" from the walking surface.

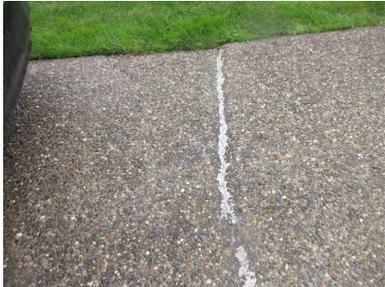
The driveway has cracked and settled differentially. This was probably caused by inadequate preparation of the soil prior to the placement of the concrete. This condition can be repaired by pressure grouting the sunken portion of the driveway or by removing and replacing it. The driveway remains functional despite this condition.

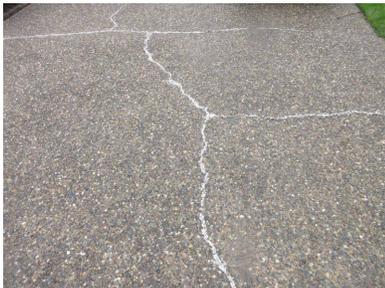
Cracks were observed in the concrete surface of the driveway. Minor cracks can be sealed to minimize moisture entry and further settlement of the concrete. Minor cracks are common and do not affect the serviceability of the concrete.

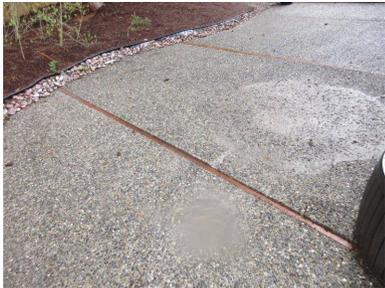
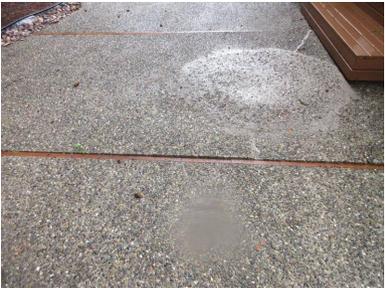
The patio sections have settled differentially. The patio remains functional despite this condition. However, the raised edges of the concrete can be a trip hazard for some people. Grinding down the raised edges of the concrete will mitigate the hazard. Repairs should be made as necessary.

The wooden dividers separating the concrete patio sections will eventually deteriorate to a condition where the gaps would be a trip hazard. Replacement with mortar is recommended.

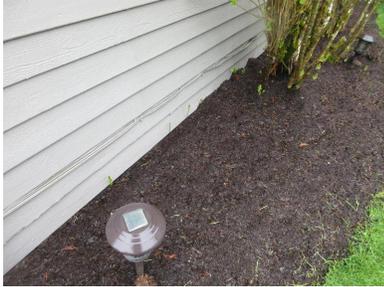
Soil is close to or in contact with siding in some areas around the building exterior. Good building practice requires that foundation walls or pier footings supporting wood frame construction, extend at least 8" above the finish grade with at least a 6" clearance between the top of the soil and the bottom of the wood finish materials. Soil in direct contact with wood creates a hospitable environment for wood destroying organisms. Establishing these minimum clearances is recommended.

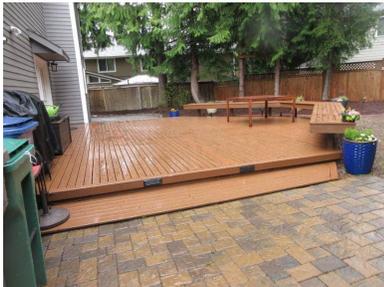
Areas of rot damage and rot fungi was observed around the decks perimeter. Rot weakens the wood and can result in failure of the structure. Rotted portions of the deck should be repaired as necessary.

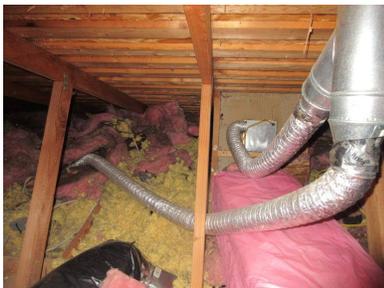
Flexible plastic duct is used to direct air from the vent fans to the exterior. This type of material is unreliable. Replacing the plastic duct with 4" smooth-wall sheet metal duct is recommended.

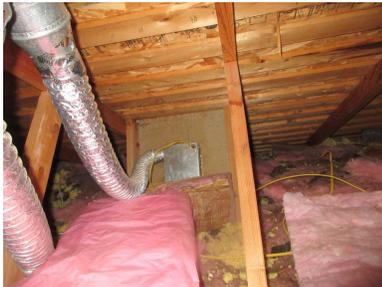
The skylight shaft is not insulated. This condition will result in significant heat loss. The installation of additional attic insulation around the skylight shafts is recommended.

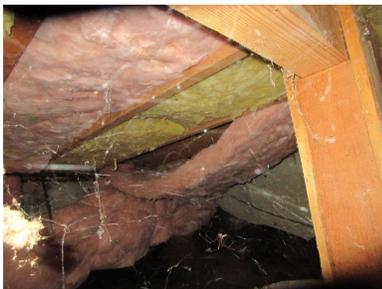
Some of the insulation batts were not properly secured and have falling down. The fallen batts should be reinstalled and secured.

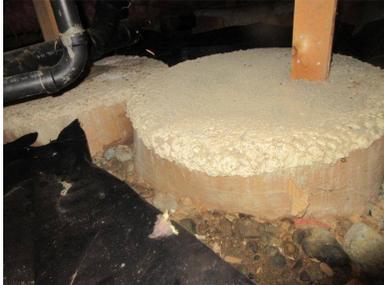
Cellulose forms were left in place on the pier footings. This cellulose is conducive to the infestation of various wood destroying organisms. The removal of the cellulose is recommended.

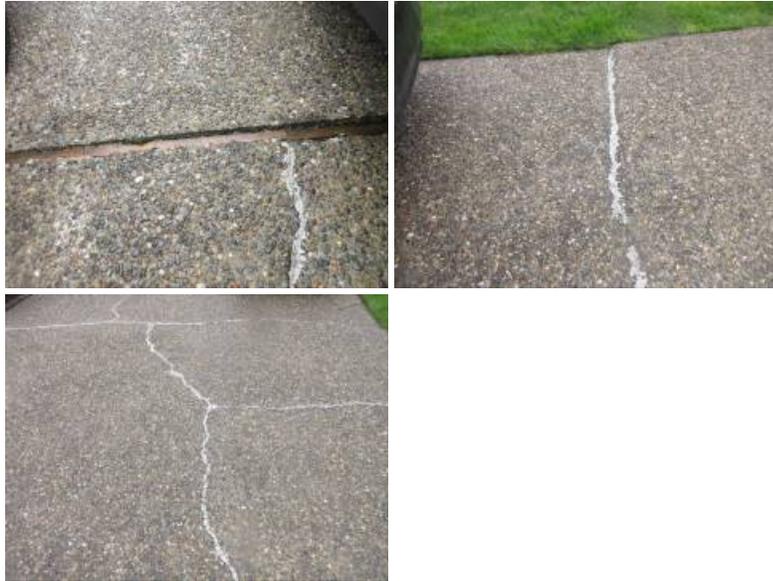
Cracks were observed in the concrete surface of the driveway. Minor cracks can be sealed to minimize moisture entry and further settlement of the concrete. Minor cracks are common and do not affect the serviceability of the concrete.

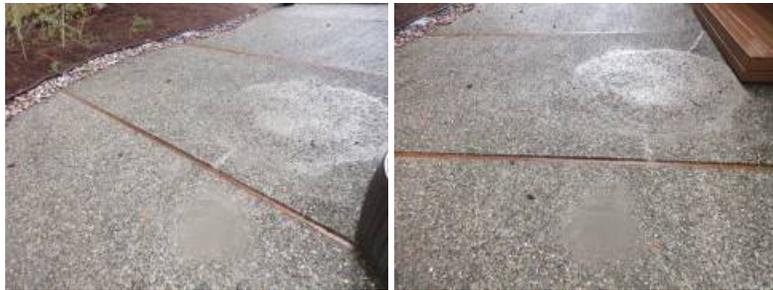
The wooden dividers separating the concrete patio sections will eventually deteriorate to a condition where the gaps would be a trip hazard. Replacement with mortar is recommended.

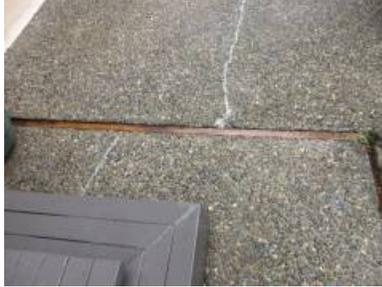
The walkway has cracked and settled differentially. This was probably caused by inadequate preparation of the soil prior to the placement of the concrete. This condition can be repaired by pressure grouting the sunken portion of the walkway or by removing and replacing it. Grinding down the raised edges of the concrete will also mitigate the hazard. The walkway remains functional despite this condition. However, the raised edges of the concrete can be a trip hazard for some people. Repairs should be made as necessary.

Many legal and public works departments have defined a trip hazard as an irregularity in a walking surface exceeding one inch (1") in height. All walking surfaces should maintain, free of a vertical surface change of 3/4" or more, in the interest of public and personal safety.

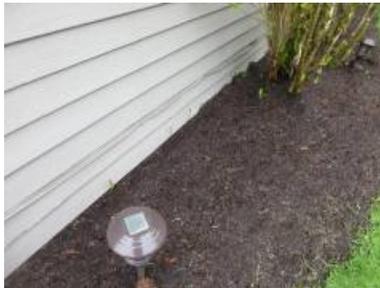
PEST CONTROL Soil is close to or in contact with siding in some areas around the building exterior. Good building practice requires that foundation walls or pier footings supporting wood frame construction, extend at least 8" above the finish grade with at least a 6" clearance between the top of the soil and the bottom of the wood finish materials. Soil in direct contact with wood creates a hospitable environment for wood destroying organisms. Establishing these minimum clearances is recommended.

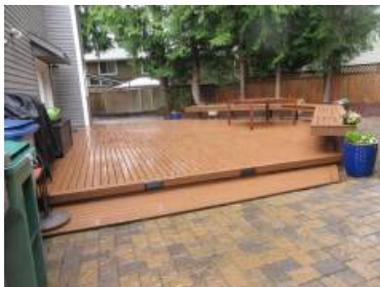
Areas of rot damage and rot fungi was observed around the decks perimeter. Rot weakens the wood and can result in failure of the structure. Rotted portions of the deck should be repaired as necessary.

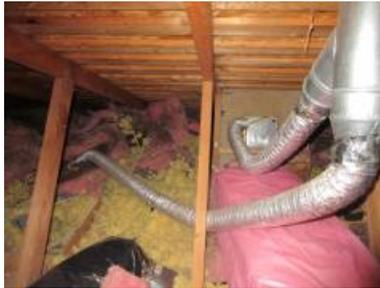
VENTILATION Flexible plastic duct is used to direct air from the vent fans to the exterior. This type of material is unreliable. Replacing the plastic duct with 4" smooth-wall sheet metal duct is recommended.

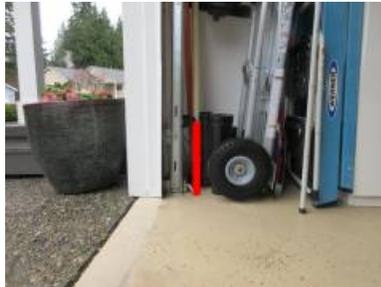
The Photo-eye beam was installed to high above the floor of the garage to adequately offer protection for small children and/or pets. We recommend that the photo-eye be lowered to within 4-6" of the floor.

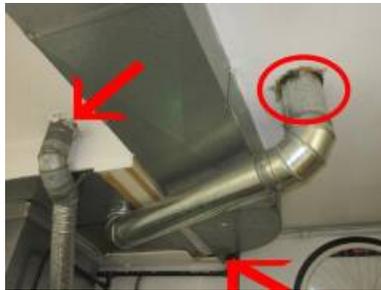
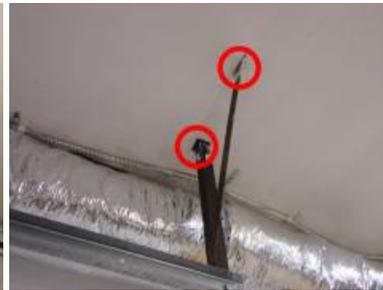
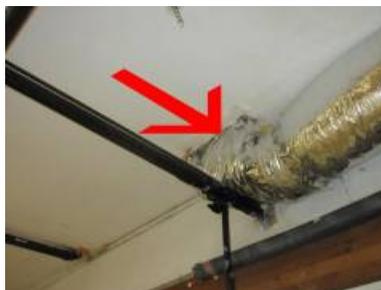
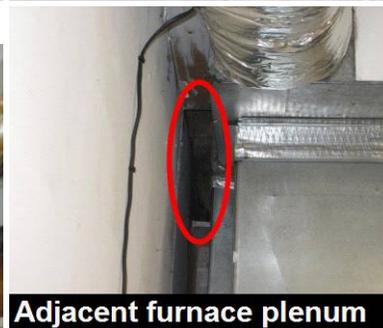
There are voids in the fire resistive barrier between the living space and garage that will allow flames to penetrate. The gypsum barrier slows the spread of a fire from the garage to the structure and/or living space. Patching the voids with a fire retardant caulk is recommended.

The installation of a furnace vent thimble is recommended to prevent flames from spreading to the structure.

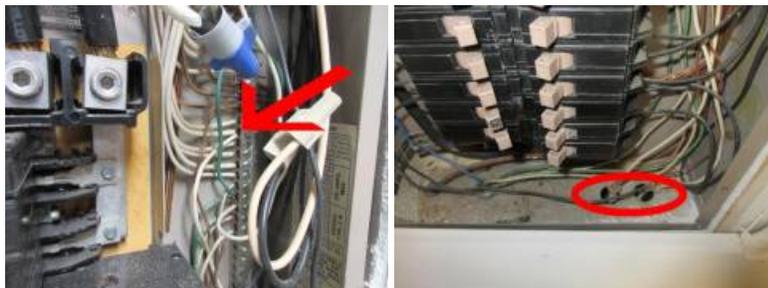
There are electrical cables emanating from the service panel that are not clamped. The sharp edges of the panel box could cut through the wire insulation and cause a short circuit or fire. Clamping the cables to the panel box using approved cable clamps is recommended.

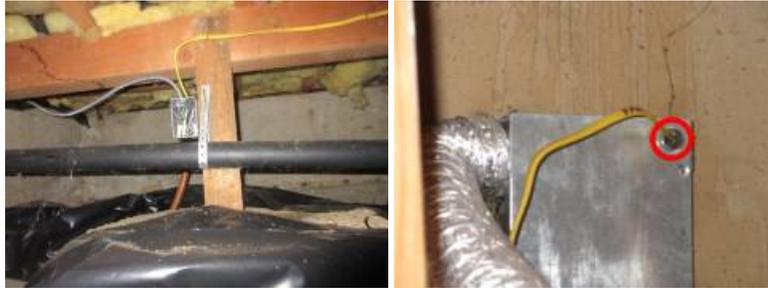
The Romex cable is not clamped where it enters the light/fan fixture chassis in the attic. This could result in a short circuit or fire. A Romex clamp should be installed at the point where the cable enters the fixture.

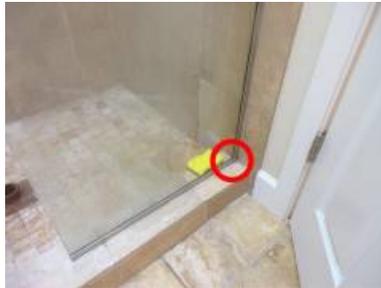
The glass enclosure has been leaking at the lower corner. No damage was visible, but resealing or repairing the enclosure is recommended as preventive maintenance.

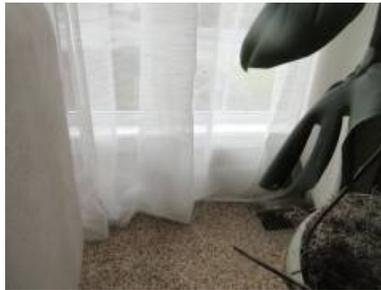
The lower window glass is not labeled as tempered safety glass. The existing glass is nonconforming by current building standards and would be hazardous if broken. The installation of safety glass is recommended as a safety upgrade for all windows less than 18" from the walking surface.

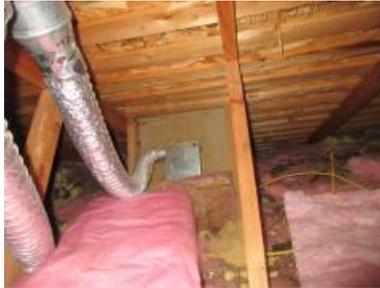
The skylight shaft is not insulated. This condition will result in significant heat loss. The installation of additional attic insulation around the skylight shafts is recommended.

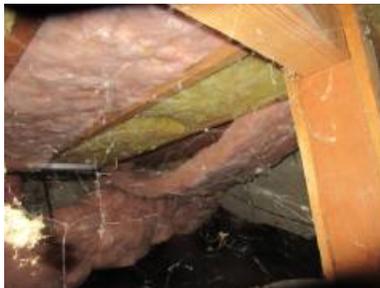
Some of the insulation batts were not properly secured and have falling down. The fallen batts should be reinstalled and secured.

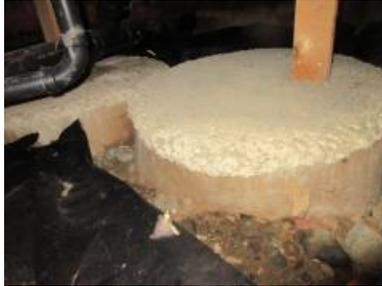
Good building practice requires that foundation walls or pier footings supporting wood frame construction, should extend at least 8" above the finish grade with at least a 6" clearance between the top of the soil and the bottom of the wood finish materials. Untreated wood should be raised 1-2" above surrounding flatwork and should have a moisture barrier such as 30 lb. asphalt impregnated felt installed between the concrete and wood. For additional information and treatment options, you should retain the services of a qualified pest control operator.
