## NOTICE TO BUYER: SELLER-PROCURED INSPECTION REPORT

Estate Of Marcia Joy Palmer  
17130 26th Ave SE  
Bothell, WA 98012

May 30, 2023

**Re: 17130 26th Avenue SE  
Bothell, WA.**

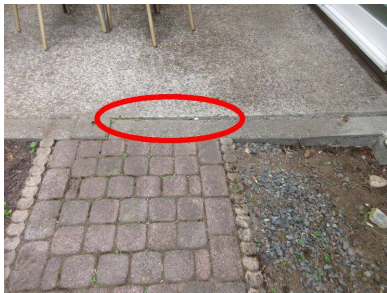
The patio has settled differentially. The patio remains functional despite this condition. However, the raised edges of the concrete can be a trip hazard for some people. Grinding down the raised edges of the concrete will mitigate the hazard. Repairs should be made as necessary.

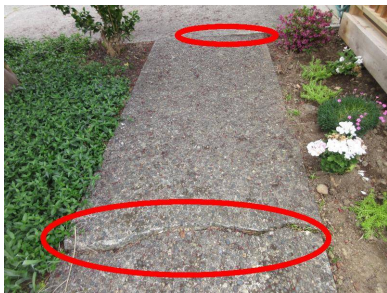
The walkway has cracked and settled differentially. This was probably caused by inadequate preparation of the soil prior to the placement of the concrete. This condition can be repaired by pressure grouting the sunken portion of the walkway or by removing and replacing it. Grinding down the raised edges of the concrete will also mitigate the hazard. The walkway remains functional despite this condition. However, the raised edges of the concrete can be a trip hazard for some people. Repairs should be made as necessary.

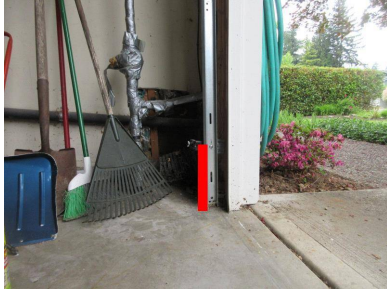
The Photo-eye beam was installed to high above the floor of the garage to adequately offer protection for small children and/or pets. We recommend that the photo-eye be lowered to within 4-6" of the floor.

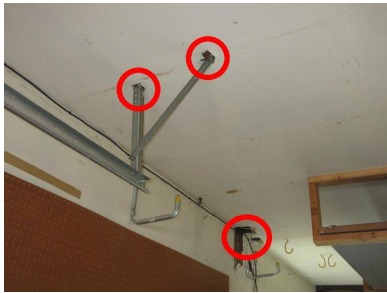
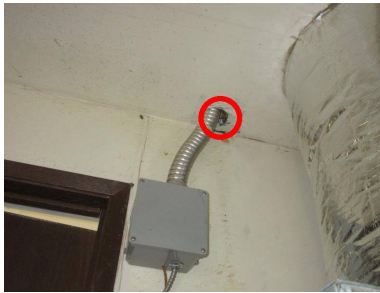
There are voids (adjacent the overhead door brackets) in the fire resistive barrier between the living space and garage that will allow flames to penetrate. The gypsum barrier slows the spread of a fire from the garage to the structure and/or living space. Patching the voids with a fire retardant caulk is recommended.

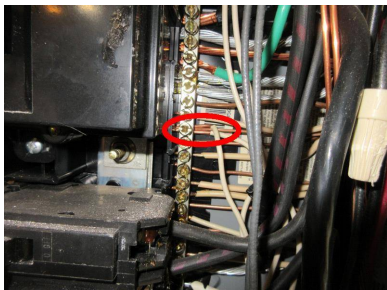
One of the neutral wires is double tapped on the buss bar. Double tapping means that two conductors share a single terminal. Double tapped terminals can loosen and overheat and therefore are not permitted unless the terminal is specifically listed for multiple wires. This defect is easily repaired by connecting the two wires to a "pig tail", securing them with a wire cap, and then inserting the pig tail conductor under the terminal.

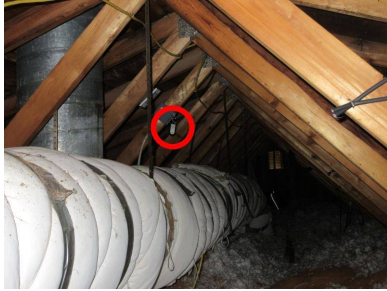
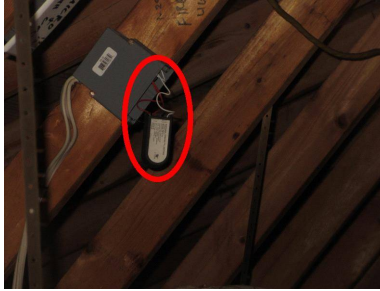
The transformer in the attic is detached and is hanging from its wires. This is a hazard. The transformer should be attached and secured to the junction box.

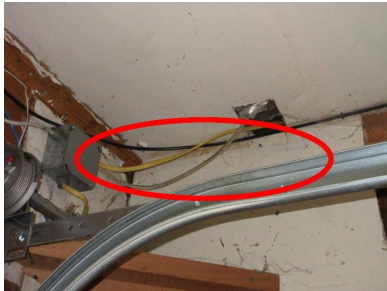
Loose electrical cables were observed in the garage. Loose cables are vulnerable to damage. All loose cables should be secured at 4' intervals using approved cable staples.

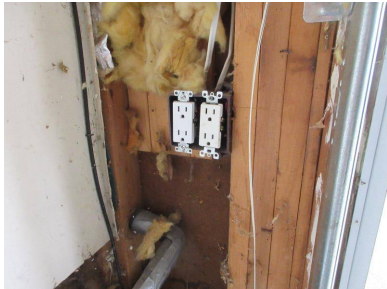
The cover plate is missing from a receptacle in the garage. This is a shock and fire hazard. The installation of a cover plate is recommended.

Switch plate cover on garage Outlets replaced  
Power to Outlets in Primary Bedroom restored  
Clothes Washer in Garage Serviced  
Orkin Pest Control verified droppings in Attic are old and not recent activity  
Verified SPA feature of tub works when plugged in

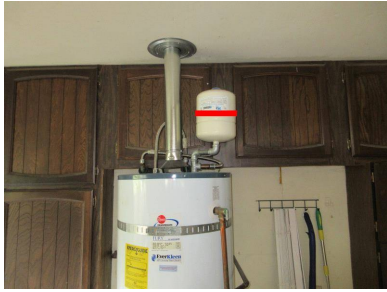
The expansion tank is not adequately secured to the wall. As code requirements start to call for engineered expansion tank supports we recommend the installation of seismic restraints to secure the expansion tank instead of allowing it to simply depend on piping connections that could result in damage to the water pipe and leakage during an earthquake.

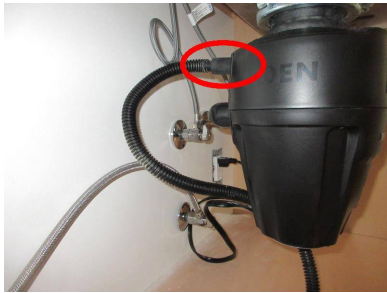
The dishwasher drain lacks an air gap. The dishwasher will function without one, but there is a risk of contamination of the inside of the dishwasher by waste water. The installation of an air gap above the flood rim of the sink is recommended.

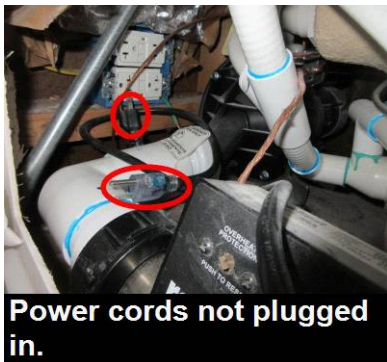
The hydromassage tub was filled to the overflow, however the hydromassage tub circulation system was not connected to a power source. Its function was not verified.

**Power cords not plugged in.**

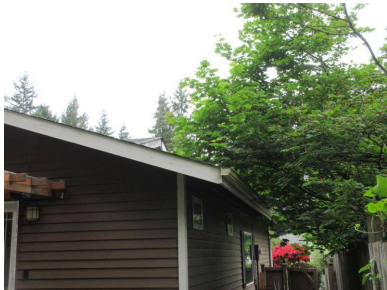
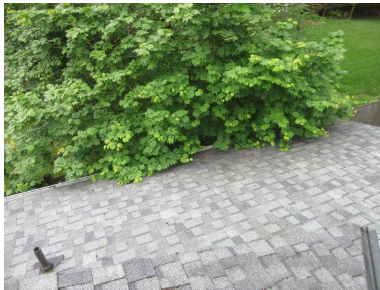
Trees are touching the building on the south side. Low hanging tree branches can damage the roof, gutters, siding, doors and/or windows. Tree branches should be trimmed back where necessary.

Repair Pilot light for Fireplace  
Repair sheetrock penetrations into the attic or living areas from the Garage  
Repair Loose Toilet  
Trim branches away from roof  
Paint boards that are missing paint above the roof line

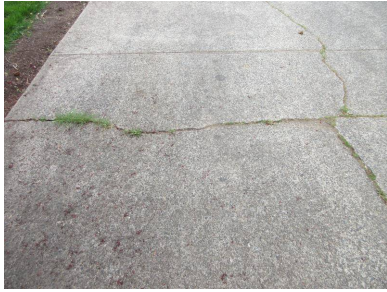
Cracks were observed in the concrete surface of the driveway. Minor cracks can be sealed to minimize moisture entry and further settlement of the concrete. Minor cracks are common and do not affect the serviceability of the concrete.

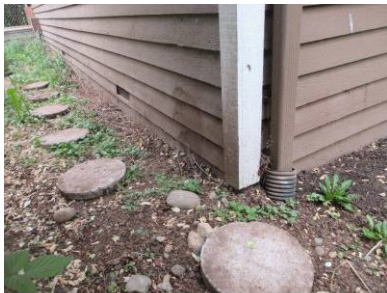
**Northwest corner**

Soil is close to or in contact with siding in some areas around the building exterior. Good building practice requires that foundation walls or pier footings supporting wood frame construction, extend at least 8" above the finish grade with at least a 6" clearance between the top of the soil and the bottom of the wood finish materials. Soil in direct contact with wood creates a hospitable environment for wood destroying organisms. Establishing these minimum clearances is recommended.

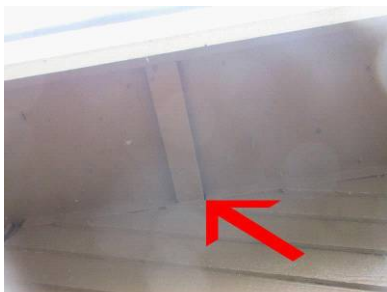
**Northeast corner**

There are openings adjacent the ends of the outlook boards under the overhang through which insects and rodents can enter into the attic. These openings should be covered with wood, wire mesh or filled with aerosol foam.

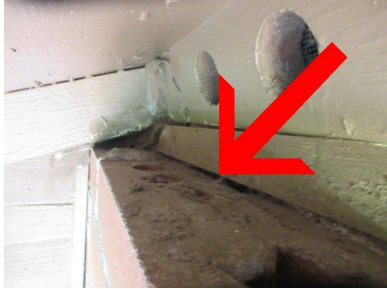
Gaps over 1/4" in size adjacent the brick cladding and soffit vent blocks will allow insects and rodents to enter the structure. Covering any gaps with screening, a strip of trim and/or caulking is recommended.

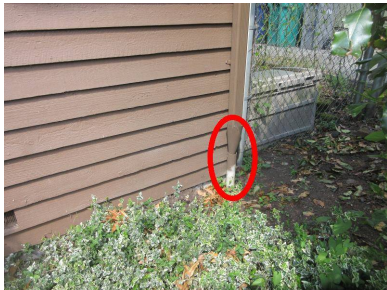
The 2" round downspout is too small and is more vulnerable to clogging than the larger rectangular ones. Consideration should be given to upgrading the drain line size.

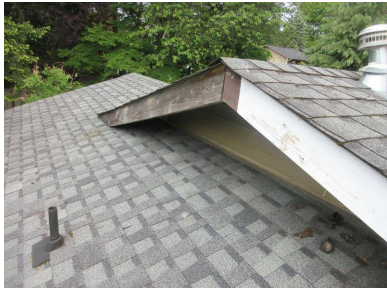
Localized areas of needed paint were noted on trim boards above the roof line. Paint protects the wood from cupping, checking, warping and rot. These areas should be scraped, primed and repainted.

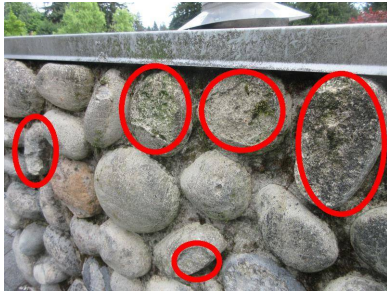
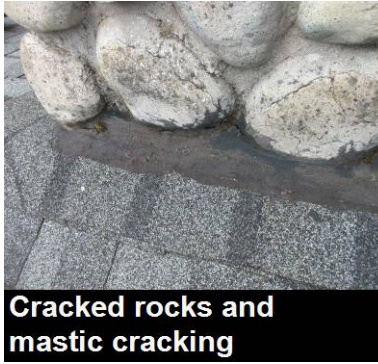
The rock is spalling on the exposed portion of the chimney. Spalling occurs during the winter when the surface of the stone absorbs moisture and freezes. The water expands as it freezes causing the surface of the stone to flake off. Spalling can be prevented by applying a sealer to the surface of the stone. For maximum protection, the sealer should be reapplied every 2-3 years.

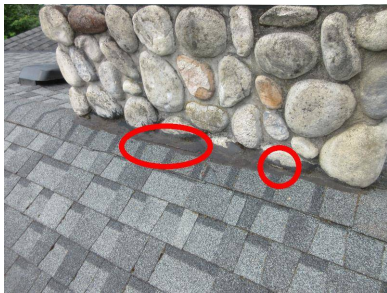
Built up mastic is used to seal around the chimney to roof intersections. These intersections sealed with roofing mastic will shrink, crack and eventually leak, resealing the flashings with mastic will extend their service life.

Counter flashings are missing around the chimney. This may allow leakage to occur. The installation of counter flashings is recommended.

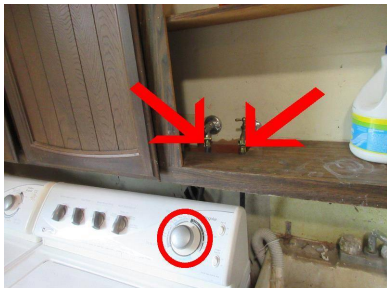
The washer cycle timer is very noisy. We recommend that it be serviced or replaced to restore quiet operation.

Upgrading the washer connections to high pressure (steel braided) lines is recommended.

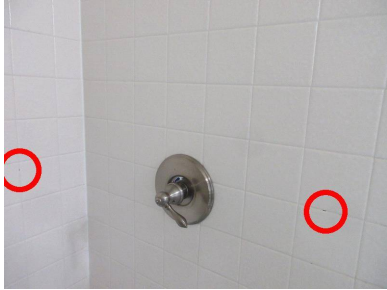
Grout is missing from between some of the wall tiles. This can allow water to enter through the tile and can damage the walls. Regrouting the wall tile is recommended.

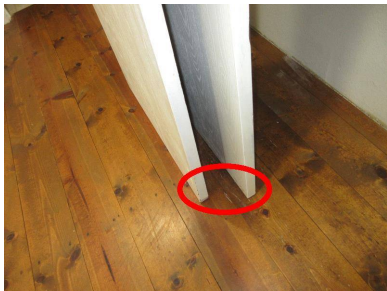
The floor guides are missing from the bypass closet doors in the hallway. Missing floor guides could result in damage to the doors. The installation of floor guides is recommended.

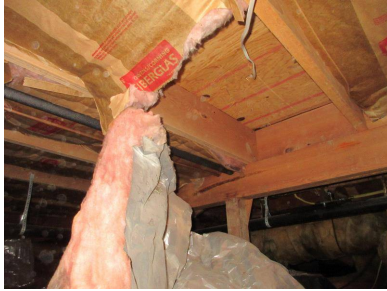
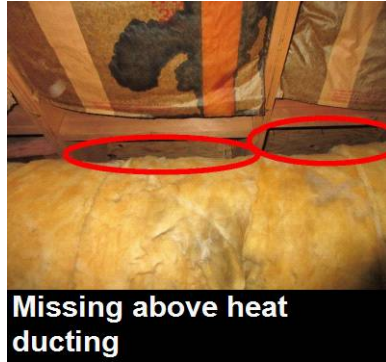
**Missing above heat ducting**

Several insulation batts are missing and numerous were not properly secured and have falling down. The fallen

batts should be reinstalled and secured. The missing batts should be replaced.

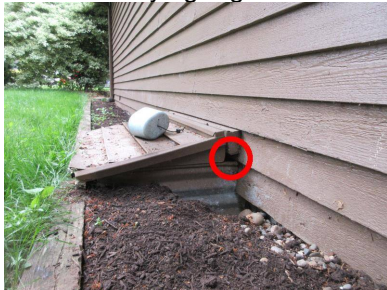
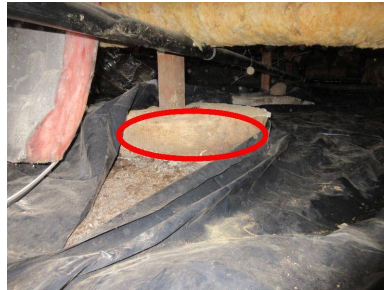
Cellulose forms were left in place on the pier footings. This cellulose is conducive to the infestation of various wood destroying organisms. The removal of the cellulose is recommended.

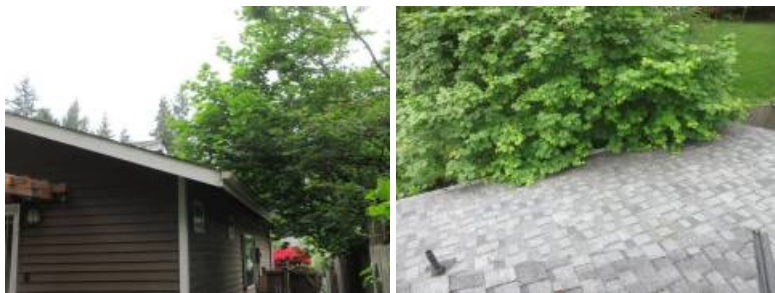
Trees are touching the building on the south side. Low hanging tree branches can damage the roof, gutters, siding, doors and/or windows. Tree branches should be trimmed back where necessary.

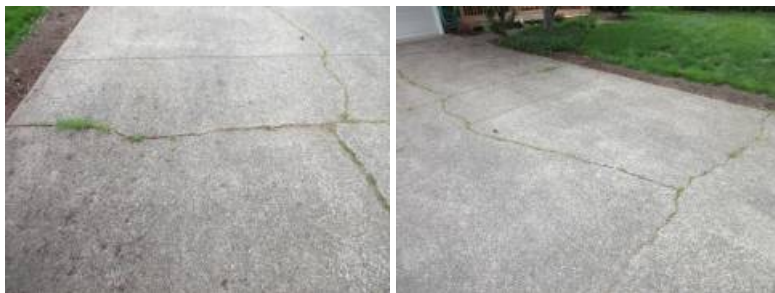
Cracks were observed in the concrete surface of the driveway. Minor cracks can be sealed to minimize moisture entry and further settlement of the concrete. Minor cracks are common and do not affect the serviceability of the concrete.

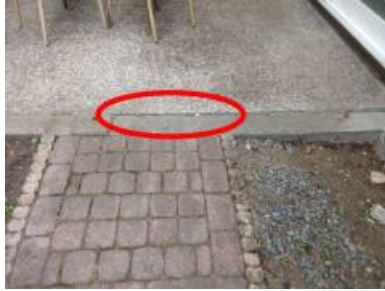
However, the raised edges of the concrete can be a trip hazard for some people. Grinding down the raised edges of the concrete will mitigate the hazard. Repairs should be made as necessary.

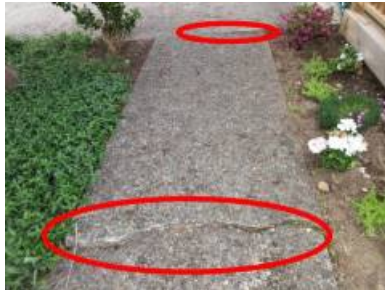
Many legal and public works departments have defined a trip hazard as an irregularity in a walking surface exceeding one inch (1") in height. All walking surfaces should maintain, free of a vertical surface change of 3/4" or more, in the interest of public and personal safety.

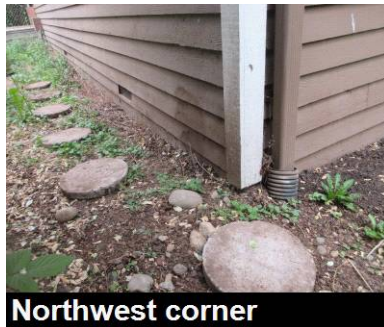
Soil is close to or in contact with siding in some areas around the building exterior. Good building practice requires that foundation walls or pier footings supporting wood frame construction, extend at least 8" above the finish grade with at least a 6" clearance between the top of the soil and the bottom of the wood finish materials. Soil in direct contact with wood creates a hospitable environment for wood destroying organisms. Establishing these minimum clearances is recommended.

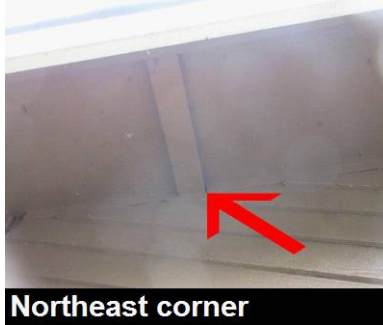
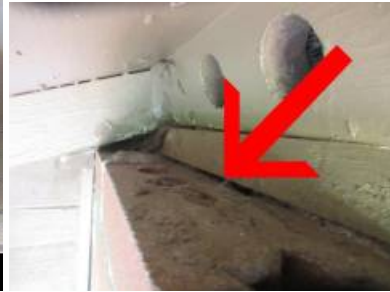
Gaps over 1/4" in size adjacent the brick cladding and soffit vent blocks will allow insects and rodents to enter the structure. Covering any gaps with screening, a strip of trim and/or caulking is recommended.

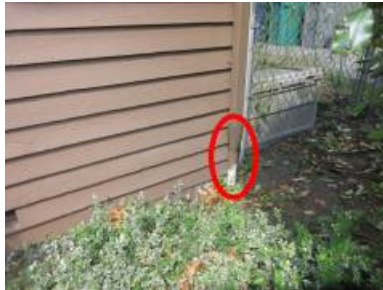
The 2" round downspout is too small and is more vulnerable to clogging than the larger rectangular ones. Consideration should be given to upgrading the drain line size.

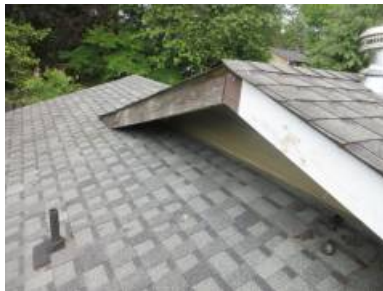
Localized areas of needed paint were noted on trim boards above the roof line. Paint protects the wood from cupping, checking, warping and rot. These areas should be scraped, primed and repainted.

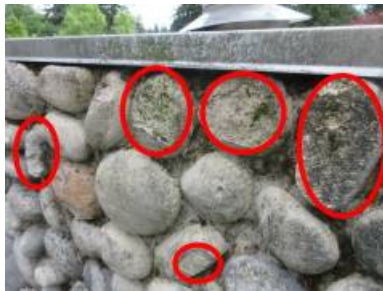
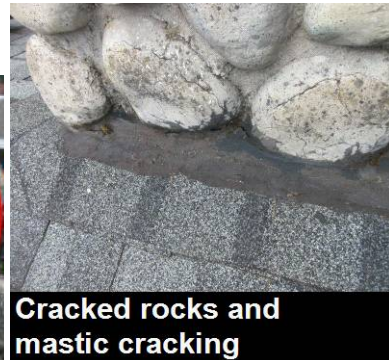
The rock is spalling on the exposed portion of the chimney. Spalling occurs during the winter when the surface of the stone absorbs moisture and freezes. The water expands as it freezes causing the surface of the stone to flake off. Spalling can be prevented by applying a sealer to the surface of the stone. For maximum protection, the sealer should be reapplied every 2-3 years.

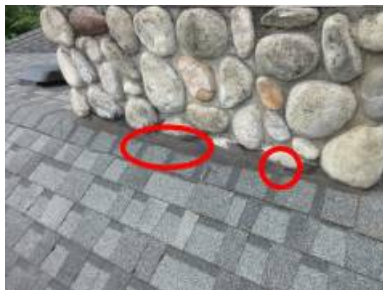
Counter flashings are missing around the chimney. This may allow leakage to occur. The installation of counter flashings is recommended.

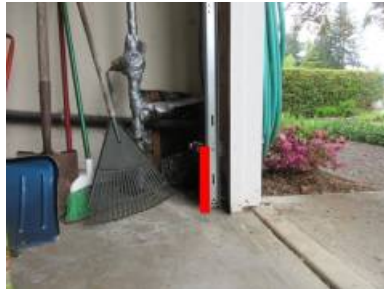
The Photo-eye beam was installed to high above the floor of the garage to adequately offer protection for small children and/or pets. We recommend that the photo-eye be lowered to within 4-6" of the floor.

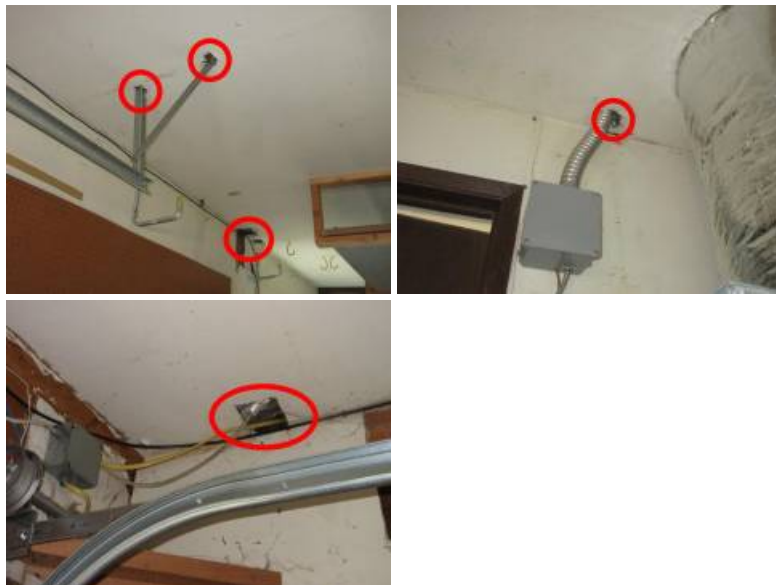
There are voids (adjacent the overhead door brackets) in the fire resistive barrier between the living space and garage that will allow flames to penetrate. The gypsum barrier slows the spread of a fire from the garage to the structure and/or living space. Patching the voids with a fire retardant caulk is recommended.

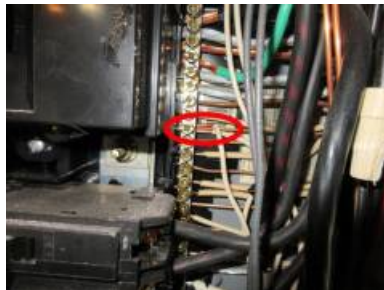
One of the neutral wires is double tapped on the buss bar. Double tapping means that two conductors share a single terminal. Double tapped terminals can loosen and overheat and therefore are not permitted unless the terminal is specifically listed for multiple wires. This defect is easily repaired by connecting the two wires to a "pig tail", securing them with a wire cap, and then inserting the pig tail conductor under the terminal.

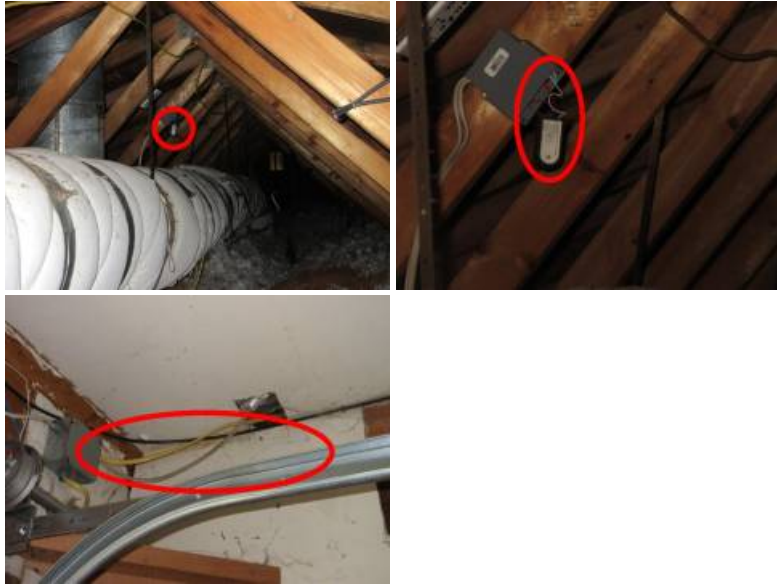
damage. All loose cables should be secured at 4' intervals using approved cable staples.

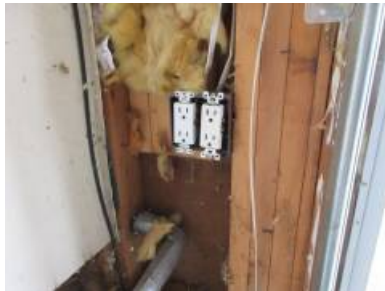
The cover plate is missing from a receptacle in the garage. This is a shock and fire hazard. The installation of a cover plate is recommended.

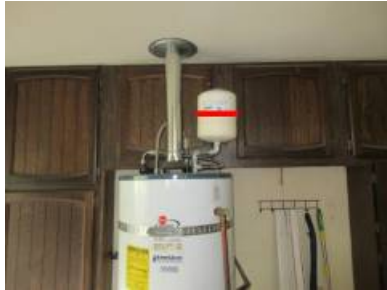
LOCATION OF UNIT	The water heater is located in the garage.
GENERAL INFORMATION	The water heater fuel is natural gas. The capacity of the water heater is 50 gallons. The input rating of the burner is approximately 40,000 BTU. The water heater is approximately 16 years old. Water heaters of this type typically last about 10-15 years.
PRESSURE RELIEF VALVE	The pressure relief valve is properly installed. The valve was not tested, as this could cause the valve to leak.
SHUTOFF VALVE	The shutoff valve for the water supply to the water heater is properly installed and is functioning as intended.
WATER CONNECTIONS AT TANK	The water connections at the tank are properly installed and are performing their intended function.
EXPANSION TANK	The expansion tank is not adequately secured to the wall. As code requirements start to call for engineered expansion tank supports we recommend the installation of seismic restraints to secure the expansion tank instead of allowing it to simply depend on piping connections that could result in damage to the water pipe and leakage during an earthquake.

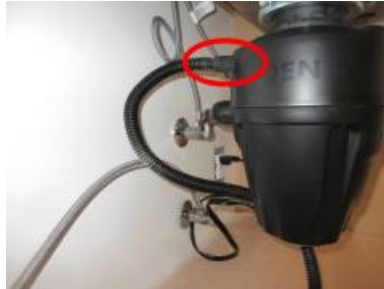
The dishwasher drain lacks an air gap. The dishwasher will function without one, but there is a risk of contamination of the inside of the dishwasher by waste water. The installation of an air gap above the flood rim of the sink is recommended.

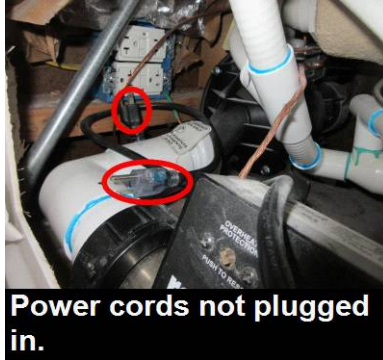
The hydromassage tub was filled to the overflow, however the hydromassage tub circulation system was not connected to a power source. Its function was not verified.

**Power cords not plugged in.**

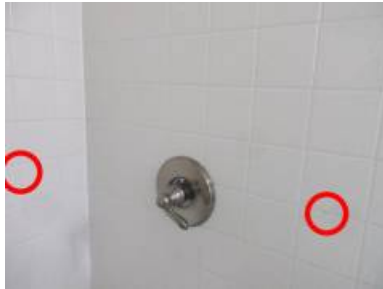
Grout is missing from between some of the wall tiles. This can allow water to enter through the tile and can damage the walls. Regrouting the wall tile is recommended.

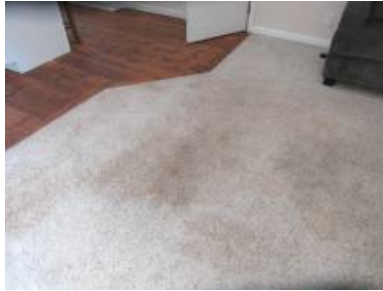
Carpet is worn and dirty. Carpet replacement should be considered.

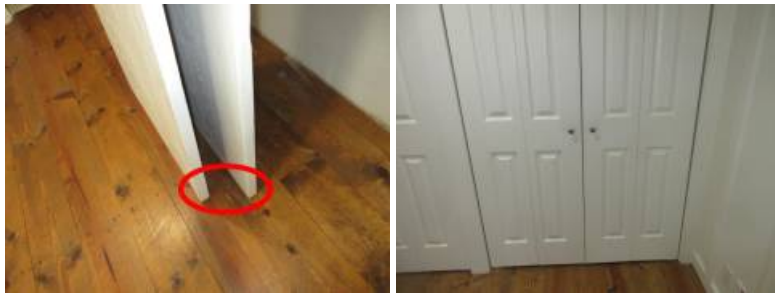
The closet door pulls in the primary bedroom are offset and do not allow the closet doors to open easily. This could result in damage to the doors. Consideration should be given to relocating of the door pulls.
