## NOTICE TO BUYER: SELLER-PROCURED INSPECTION REPORT

17614 NE 138<sup>th</sup> St

At your request, a visual inspection of the above referenced property was conducted on 07/11/2023. We have inspected the major structural components, plumbing, heating and electrical systems for signs of significant non-performance, excessive or unusual wear and general state of repair.

DATE OF INSPECTION: 7/11/2023.  
 INSPECTOR'S NAME: Terry Clark.  
 CLIENT NAME: Mr. & Mrs. Zach & Tessa Holmes.  
 MAILING ADDRESS: 17614 NE 138th St.  
 Redmond WA.  
 CLIENT E-MAIL ADDRESS: tessa.m.holmes73@gmail.com; [zach.holmes275@gmail.com](mailto:zach.holmes275@gmail.com).  
 ADDRESS OF PROPERTY INSPECTED: 17614 NE 138th St.  
 Redmond WA.

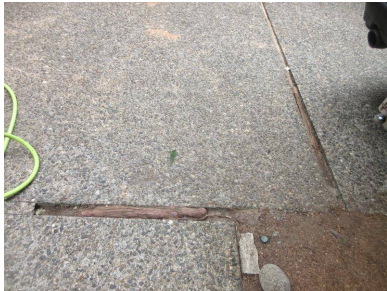
One or more of the wooden dividers separating the concrete driveway sections were infested by wood destroying organisms and have deteriorated to a point where they are becoming a trip hazard. Replacement with mortar is recommended.

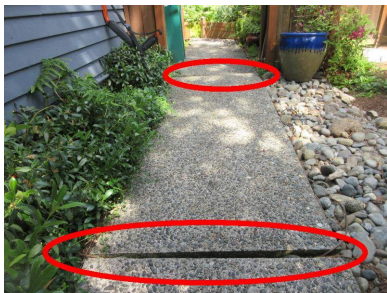
The walkway has cracked and settled differentially. This was probably caused by inadequate preparation of the soil prior to the placement of the concrete. This condition can be repaired by pressure grouting the sunken portion of the walkway or by removing and replacing it. Grinding down the raised edges of the concrete will also mitigate the hazard. The walkway remains functional despite this condition. However, the raised edges of the concrete can be a trip hazard for some people. Repairs should be made as necessary.

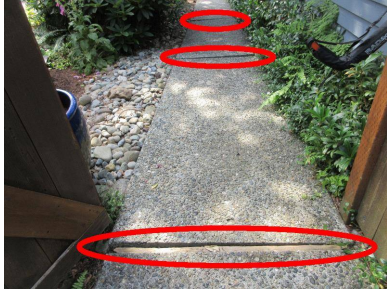
The wooden dividers separating the concrete walkway sections have deteriorated to a point where the gaps are

a trip hazard. Replacement with mortar is recommended.

Cracks were observed in the concrete walkway. Minor cracks can be sealed to minimize moisture entry and further settlement of the concrete.

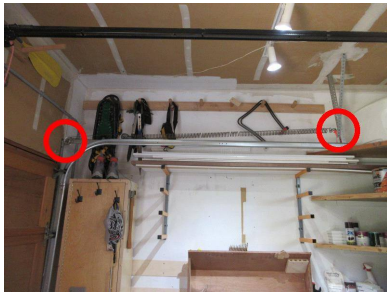
Safeties are cables run through the center of the garage door springs that prevent broken springs from becoming projectiles that can cause injury. There are no safeties installed. The installation of safeties is recommended.

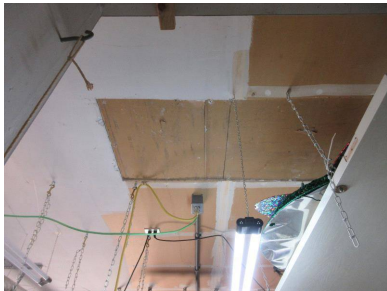
The fire resistive barrier between the garage and the living space is properly installed and in good condition, however, several of the joints are not taped. Consideration should be given to completely "fire taping" the drywall as a safety upgrade.

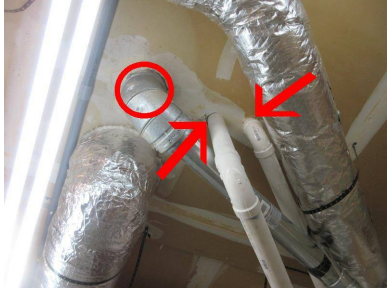
The installation of a water heater vent thimble is recommended to prevent flames from spreading to the structure.

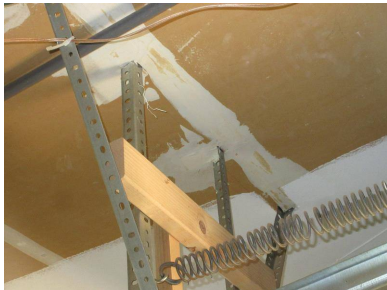
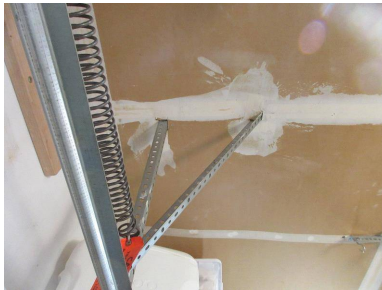
There are voids (adjacent the overhead door brackets) in the fire resistive barrier between the living space and garage that will allow flames to penetrate. The gypsum barrier slows the spread of a fire from the garage to the structure and/or living space. Patching the voids with a fire retardant caulk is recommended.

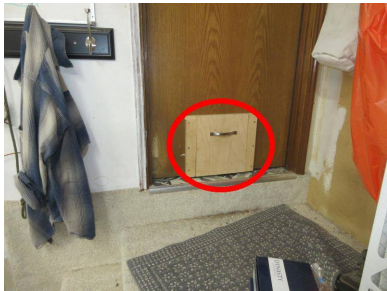
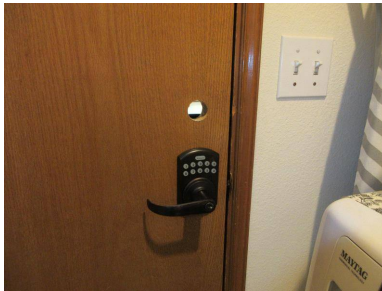
The door between the garage and living space is a solid core door with a self closing hinge. The door is properly installed and is in good condition. However, there is a pet door at the bottom which nullifies the fire rating of the door. Patching the hole in the door is recommended as a safety upgrade.

Hardware is missing from the rated door. Replacement of the missing hardware is recommended.

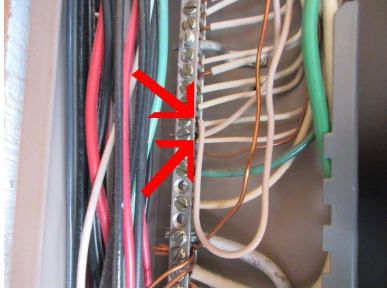
Several of the neutral wires are double tapped on the buss bar. Double tapping means that two conductors share a single terminal. Double tapped terminals can loosen and overheat and therefore are not permitted unless the terminal is specifically listed for multiple wires. This defect is easily repaired by connecting the two wires to a "pig tail", securing them with a wire cap, and then inserting the pig tail conductor under the terminal.

Screws that secure the panel cover to the panel box are the wrong type. This is a potential hazard. Screws should be replaced with the original style blunt end screws.

- Service Panel
  - neutral wires – FIXED
  - screws – FIXED
- Wiring
  - Extension cord for garage opener – FIXED
- Receptacles
  - Open grounds – FIXED
  - Loose plates – FIXED
  - Cover plates - FIXED

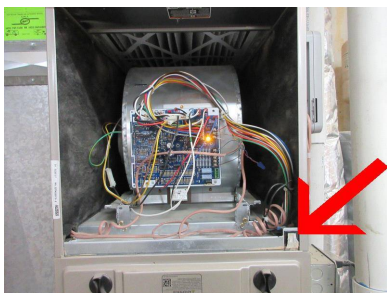
The blower door cut-out switch has been disabled. This is a potential hazard. The cut-out switch should be not be restricted.

- Forced Air System
  - Blower door cutout switch – FIXED

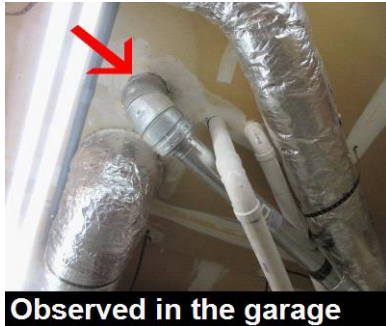
Observed in the garage

The water heater vent connector is too close to combustible material. The minimum clearance of 6" is required between the single wall vent connector and the combustible surface. The double wall type B vent requires only 1" of clearance.

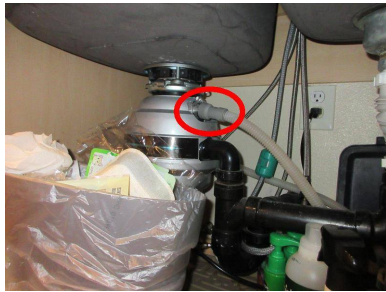
The dishwasher drain lacks an air gap. The dishwasher will function without one, but there is a risk of contamination of the inside of the dishwasher by waste water. The installation of an air gap above the flood rim of the sink is recommended.

- Dishwasher air-gap – FIXED

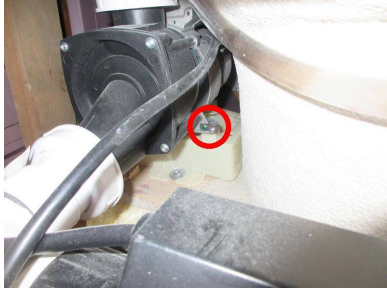
The pump motor is not bonded. This is a safety concern. The installation of a bonding wire between the motor chassis and water pipes is recommended.

- Toilets (all 3)
  - Loose fitting – FIXED
- Main Bath
  - Bonding – FIXED

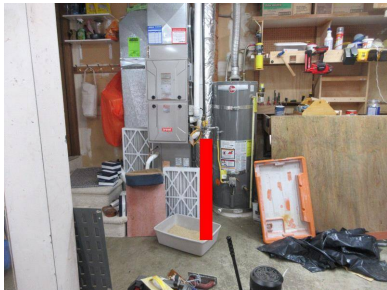
The gas pipes in front of the furnace and water heater are not protected by a bumper stop. A vertical steel pipe, bolted to the floor, is typically installed in front of the water heater to prevent a car bumper from damaging the gas lines.

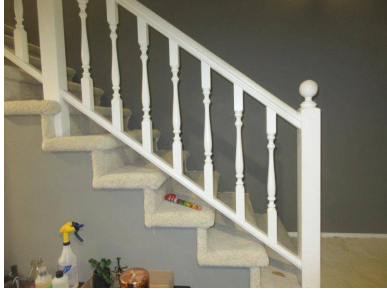
The stair railing baluster spacing is too wide. This is a hazard for small children. The baluster spacing should be reduced as a safety upgrade. Current standards require that a 4-3/8" sphere not pass through the railing.

The stair railing spacing at the stair treads is too wide. This is a hazard for small children. The railing spacing should be reduced as a safety upgrade. Current standards require that a 6" sphere not pass through or under the railing.

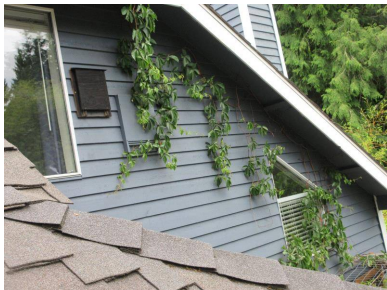
Vines are touching the east side of the building. Vines can damage the roof, windows and other exterior building components. Consideration should be given to removing vines that are attached to the house. Vines could be trellised away from the structure to allow for air flow.

3. Vegetation
  - a. Vines removed – FIXED
4. Soffit/Overhangs
  - a. Gaps caulked – FIXED
5. Vent damper
  - a. Screen replaced – FIXED

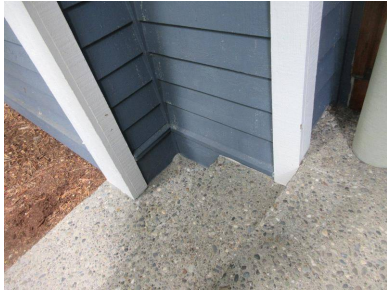
Untreated wood in direct contact with concrete was observed along the front stoop. Untreated wood should be raised 1-2" above the concrete. Treating the wood with a preservative sometimes will prevent wood destroy

organism damage.

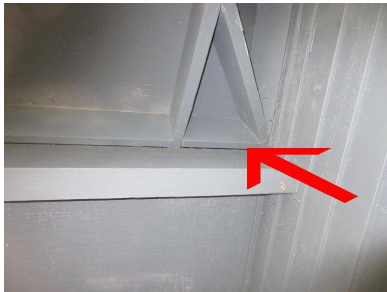
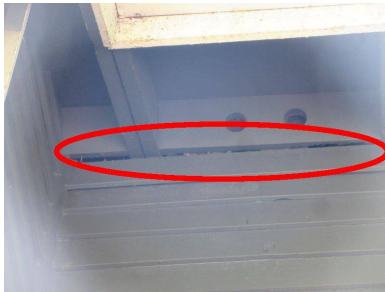
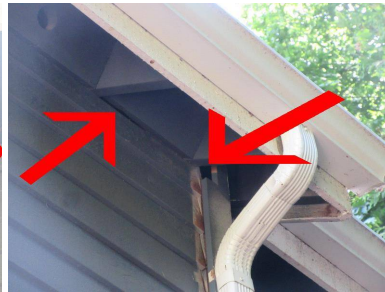
Gaps over 1/4" in size adjacent the soffit vent blocks will allow insects and rodents to enter the attic. Covering any gaps with screening, a strip of wood and/or caulking is recommended.

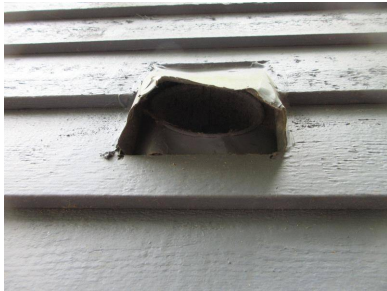
The fireplace vent is missing a screen at the termination. The installation of a screen is recommended to prevent entry by rodents, bird's, insects, etc.

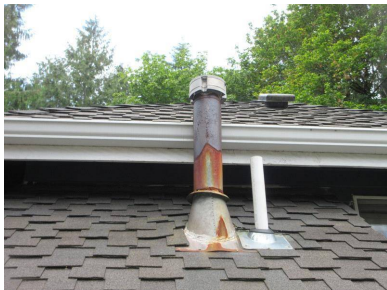
The gas appliance vent is corroded above the roof line. Cleaning and painting the vent will prolong its life.

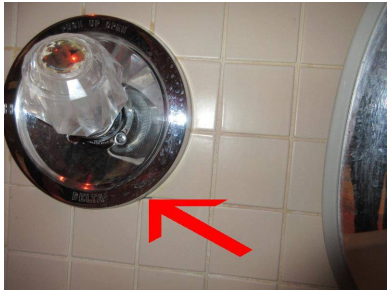
Caulking is missing at the intersection between the tub/shower and floor. This can lead to water damage to the flooring and substrate. Caulking this area is recommended.

Grout is missing from between some of the wall tiles. This can allow water to enter through the tile and can damage the walls. Regrouting the wall tile is recommended.

2. Bathrooms
  - a. Caulk at tub-line – FIXED
  - b. Missing grout – FIXED
  - c. Sink drain stop - FIXED

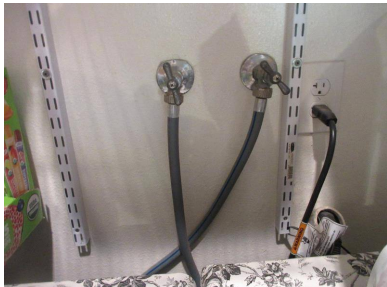
Upgrading the washer connections to high pressure (steel braided) lines is recommended.

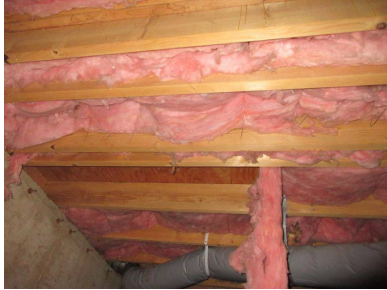
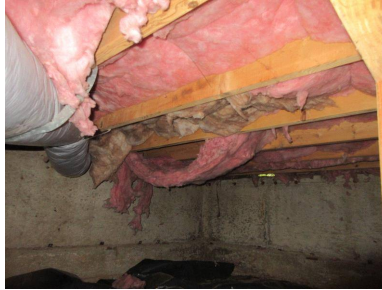
Some of the insulation batts were not properly secured and have falling down. The fallen batts should be reinstalled and secured.

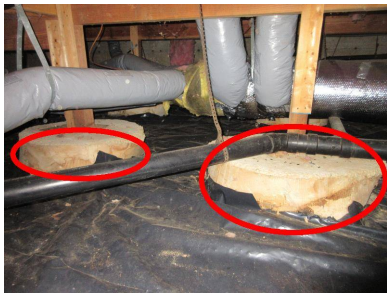
Cellulose forms were left in place on the pier footings. This cellulose is conducive to the infestation of various wood destroying organisms. The removal of the cellulose is recommended.

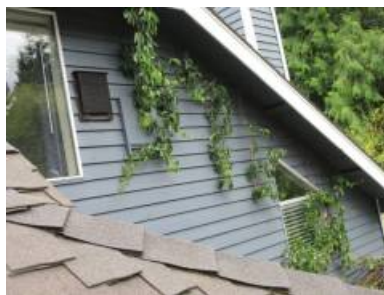
Vines are touching the east side of the building. Vines can damage the roof, windows and other exterior building components. Consideration should be given to removing vines that are attached to the house. Vines could be trellised away from the structure to allow for air flow.

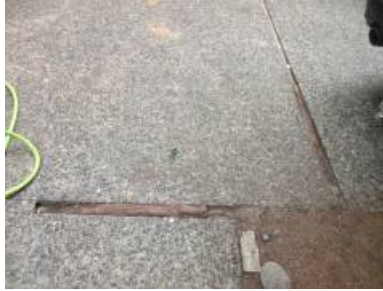
One or more of the wooden dividers separating the concrete driveway sections were infested by wood destroying organisms and have deteriorated to a point where they are becoming a trip hazard. Replacement with mortar is recommended.

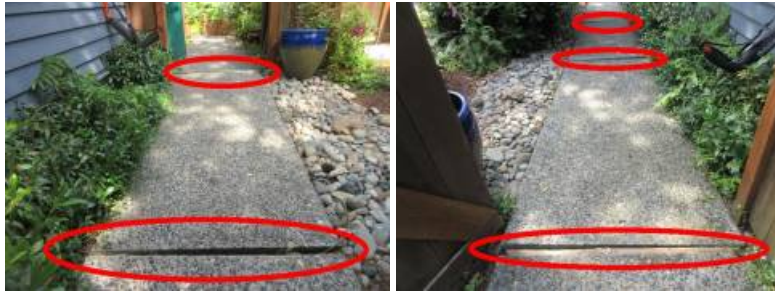
Many legal and public works departments have defined a trip hazard as an irregularity in a walking surface exceeding one inch (1") in height. All walking surfaces should maintain, free of a vertical surface change of 3/4" or more, in the interest of public and personal safety.

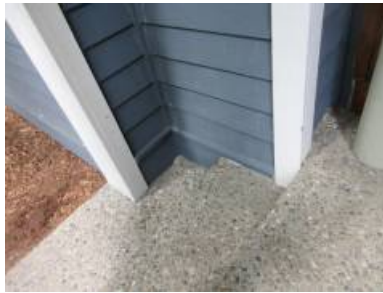
Untreated wood in direct contact with concrete was observed along the front stoop. Untreated wood should be raised 1-2" above the concrete. Treating the wood with a preservative sometimes will prevent wood destroy organism damage.

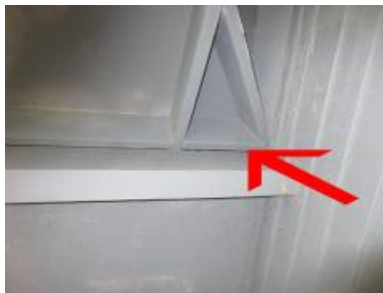
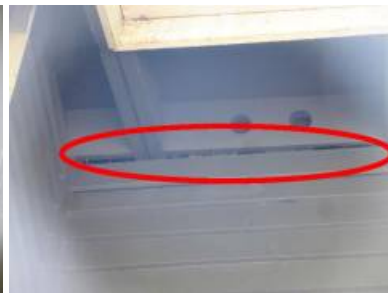
Gaps over 1/4" in size adjacent the soffit vent blocks will allow insects and rodents to enter the attic. Covering any gaps with screening, a strip of wood and/or caulking is recommended.

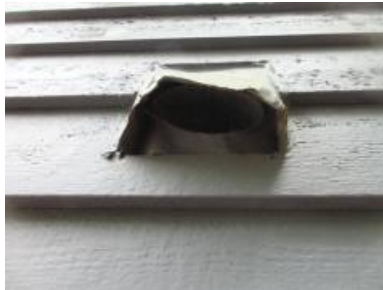
**VENT DAMPERS** The fireplace vent is missing a screen at the termination. The installation of a screen is recommended to prevent entry by rodents, bird's, insects, etc.

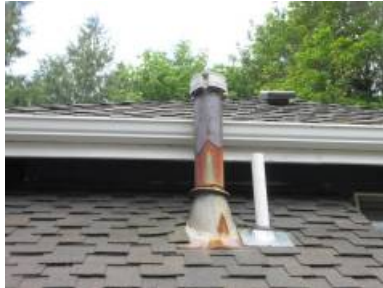
The gas appliance vent is corroded above the roof line. Cleaning and painting the vent will prolong its life.

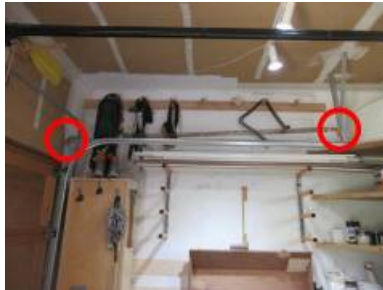
Safeties are cables run through the center of the garage door springs that prevent broken springs from becoming projectiles that can cause injury. There are no safeties installed. The installation of safeties is recommended.

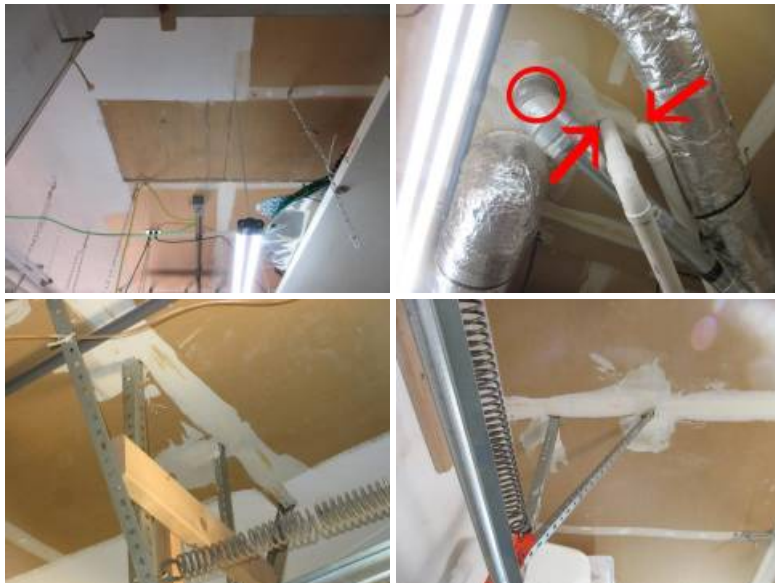
There are voids (adjacent the overhead door brackets) in the fire resistive barrier between the living space and garage that will allow flames to penetrate. The gypsum barrier slows the spread of a fire from the garage to the structure and/or living space. Patching the voids with a fire retardant caulk is recommended.

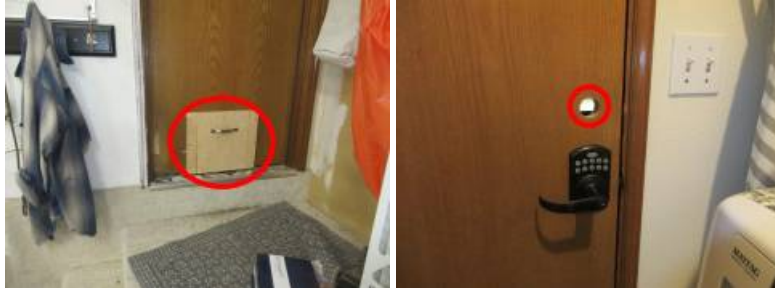
Hardware is missing from the rated door. Replacement of the missing hardware is recommended.

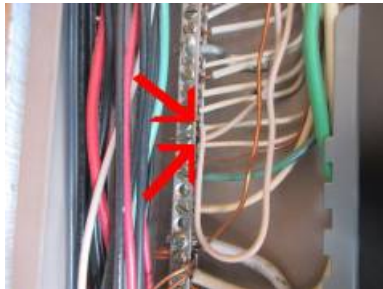
Screws that secure the panel cover to the panel box are the wrong type. This is a potential hazard. Screws should be replaced with the original style blunt end screws.

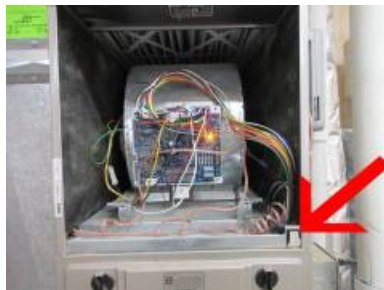
The blower door cut-out switch has been disabled. This is a potential hazard. The cut-out switch should be not be restricted.

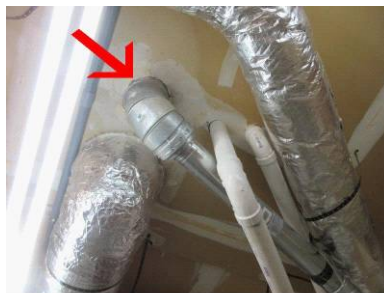
**Observed in the garage**

The water heater vent connector is too close to combustible material. The minimum clearance of 6" is required between the single wall vent connector and the combustible surface. The double wall type B vent requires only 1" of clearance.

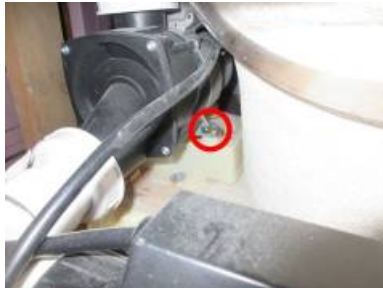
LOCATION	Primary Bedroom.
BATHTUB	<p>The hydromassage tub was filled to the overflow. It was run for several minutes and functioned as intended.</p> <p>Failure to follow proper cleaning and maintenance procedures for the hydromassage tub circulation system can result in the growth and transmission of infectious bacteria. The circulation system should be flushed regularly.</p> <p>The pump motor is not bonded. This is a safety concern. The installation of a bonding wire between the motor chassis and water pipes is recommended.</p>

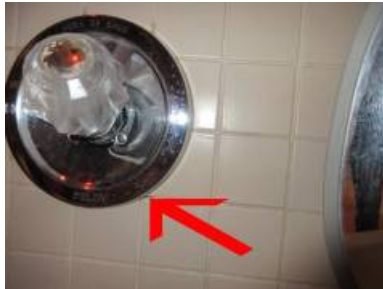
<i>LOCATION</i>	Upper Floor Hallway.
<i>BATHTUB</i>	The bathtub is properly installed and is in good condition.
<i>TUB WALLS</i>	The tub walls are properly installed and are in serviceable condition. Most ceramic tile is applied directly over gypsum board rather than on a concrete board such as "Durock" or "Wonder Board". Where the tile is applied directly over the gypsum board, it is critical that the tile grout be maintained to prevent water intrusion behind the tile. Missing or cracked grout should be repaired. Inside corners, and penetrations in the tile should be kept sealed with a high quality caulk.
	Grout is missing from between some of the wall tiles. This can allow water to enter through the tile and can damage the walls. Regrouting the wall tile is recommended.

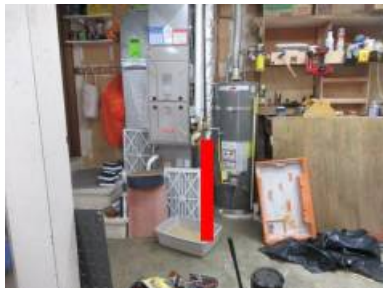
The gas pipes in front of the furnace and water heater are not protected by a bumper stop. A vertical steel pipe, bolted to the floor, is typically installed in front of the water heater to prevent a car bumper from damaging the gas lines.

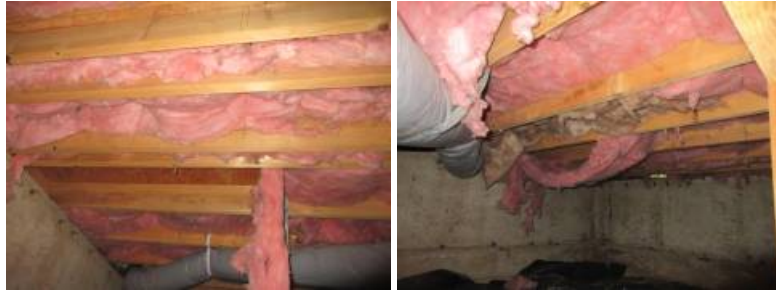
Some of the insulation batts were not properly secured and have falling down. The fallen batts should be reinstalled and secured.
