## NOTICE TO BUYER: SELLER-PROCURED INSPECTION REPORT

The following notice is given with respect to the Purchase and Sale Agreement dated \_\_\_\_\_  
between \_\_\_\_\_ ("Buyer")  
and **Stephanie Meyer** **Shane Meyer** ("Seller")  
concerning **13620 178th Ave NE Redmond WA 98052** ("the Property").

DATE OF INSPECTION: 7/24/2023.  
 INSPECTOR'S NAME: Terry Clark.  
 CLIENT NAME: Mr. & Mrs. Shane & Stephanie Meyer.  
 MAILING ADDRESS: 13620 178th Ave. NE  
 Redmond WA.  
 CLIENT E-MAIL ADDRESS janeite75@gmail.com; [sdm292@gmail.com](mailto:sdm292@gmail.com).  
 ADDRESS OF PROPERTY 13620 178th Ave. NE  
 INSPECTED Redmond WA.

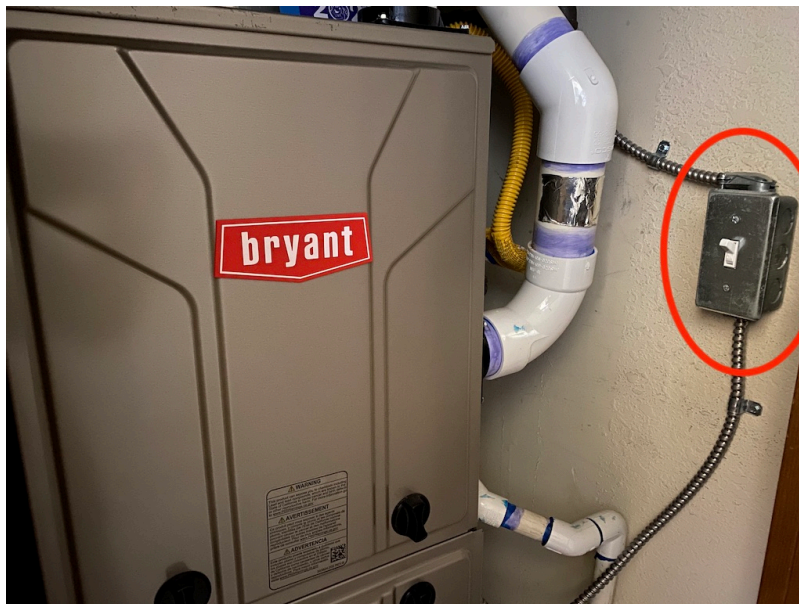
- All loose electrical receptacles have been tightened.
- Tree branches have been trimmed back to avoid potential contact with the roof.
- The roof has been brushed and cleaned to remove moss.
- The furnace was installed by All Climate in February of 2020 and passed the subsequent inspection by King County. All Climate installed a local power switch to the unit (see attached photo) to meet code. No changes have been made.

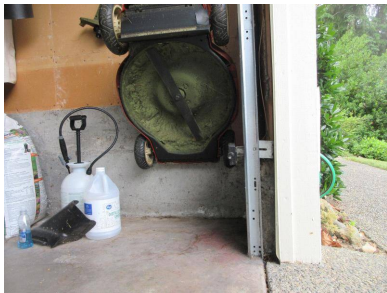
The Photo-eye beam was installed to high above the floor of the garage to adequately offer protection for small children and/or pets. We recommend that the photo-eye be lowered to within 4-6" of the floor.

- The lowering of the garage door photo-eye beam.

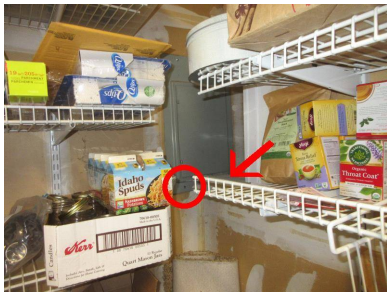
Screws that secure the panel cover to the panel box are missing. This is a potential hazard. Missing screws should be replaced with the original style blunt end screws.

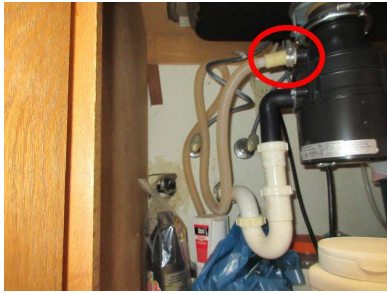
The dishwasher drain lacks an air gap. The dishwasher will function without one, but there is a risk of contamination of the inside of the dishwasher by waste water. The installation of an air gap above the flood rim of the sink is recommended.

- The grounding of the receptacle in the living room.
- The installation of an air gap for the dishwasher drain.

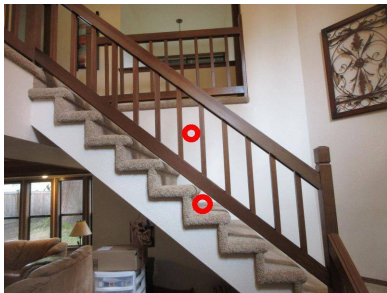
The stair railing baluster spacing is too wide. This is a hazard for small children. The baluster spacing should be reduced as a safety upgrade. Current standards require that a 4-3/8" sphere not pass through the railing.

The stair railing spacing at the stair treads is too wide. This is a hazard for small children. The railing spacing should be reduced as a safety upgrade. Current standards require that a 6" sphere not pass through or under the railing.

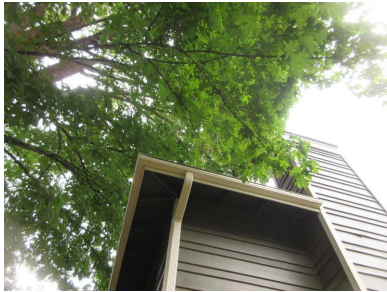
Trees are nearly touching the building on the northeast corner. Low hanging tree branches can damage the roof, siding, doors and windows. Tree branches should be trimmed back where necessary.

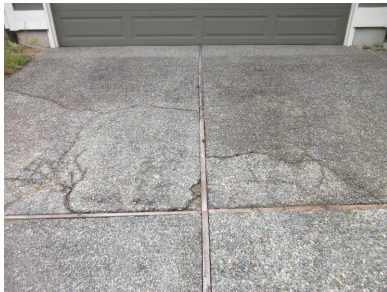
The driveway has cracked and settled differentially. This was probably caused by inadequate preparation of the soil prior to the placement of the concrete. This condition can be repaired by pressure grouting the sunken portion of the driveway or by removing and replacing it. The driveway remains functional despite this condition.

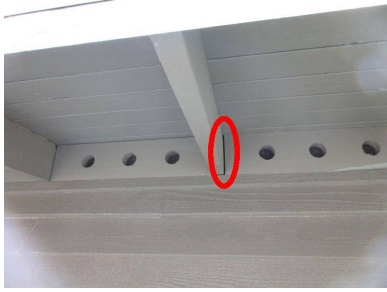
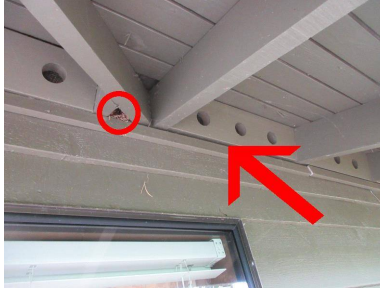
enter the attic. Covering the gaps with screening, a strip of wood and/or caulking is recommended.

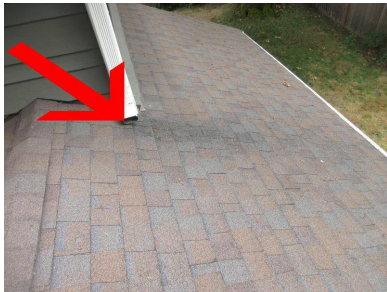
Downspouts draining directly onto the asphalt shingle surface causes excessive wear of the roofing material. Downspout extensions to the lower gutters should be installed to prevent excessive wear and tear of the roofing.

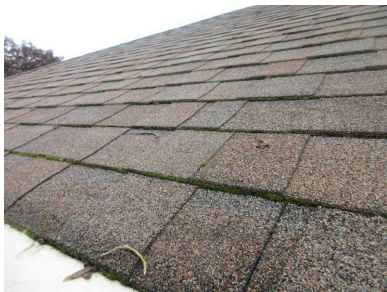
The roof is in need of routine maintenance. The surface should be treated for moss, lichen, and algae growth, then brushed and washed off with a high volume low pressure hose to remove moss and organic debris. Performing this maintenance will improve the appearance and increase the life expectancy of the roof.

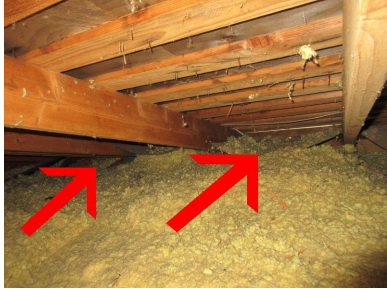
Wind baffles locations are compromised in some areas of the attic. The proper placement of wind baffles in front of all soffit vents is recommended.

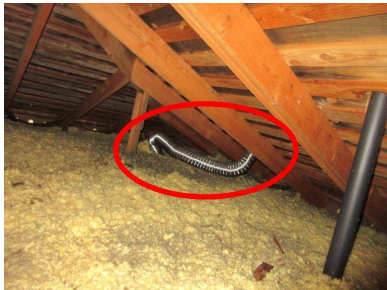
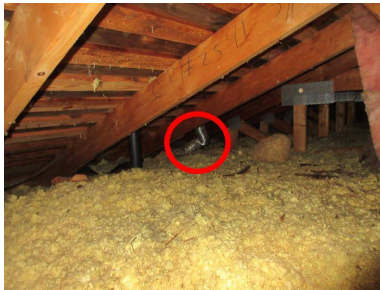
Flexible plastic duct is used to direct air from the vent fans to the exterior. This type of material is unreliable. Replacing the plastic duct with 4" smooth-wall sheet metal duct is recommended.

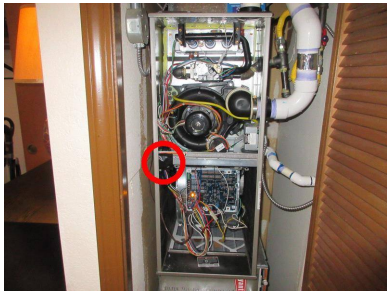
The blower door cut-out switch has been disabled. This is a potential hazard. The cut-out switch should be not be restricted.

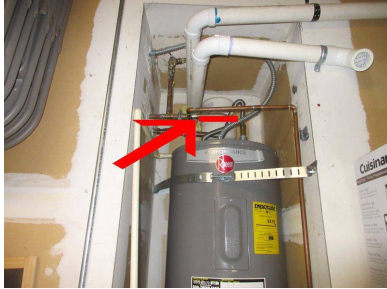
The expansion tank is not adequately secured to the wall. As code requirements start to call for engineered expansion tank supports we recommend the installation of seismic restraints to secure the expansion tank instead of allowing it to simply depend on piping connections that could result in damage to the water pipe and leakage during an earthquake.

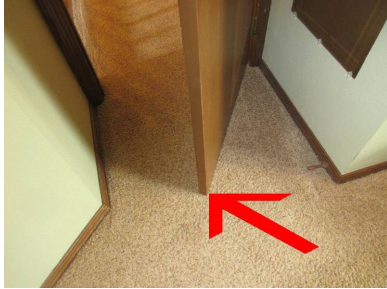
One of the bedroom doors rubs on the carpeting. This can damage the carpet and prevents air circulation under the door. Doors should be undercut 3/4".

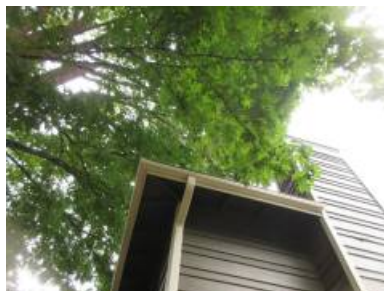
Trees are nearly touching the building on the northeast corner. Low hanging tree branches can damage the roof, siding, doors and windows. Tree branches should be trimmed back where necessary.

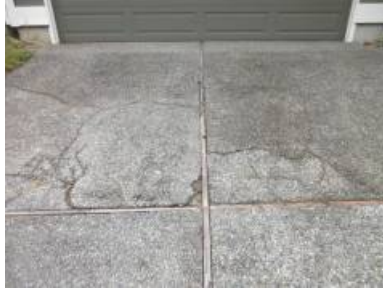
The driveway has cracked and settled differentially. This was probably caused by inadequate preparation of the soil prior to the placement of the concrete. This condition can be repaired by pressure grouting the sunken portion of the driveway or by removing and replacing it. The driveway remains functional despite this condition.

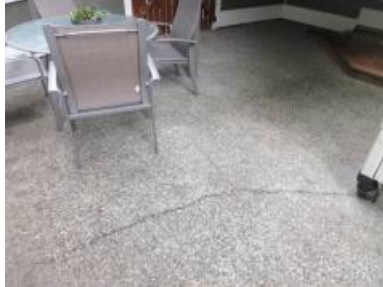
Cracks were observed in the concrete surface of the patio. Minor cracks can be sealed to minimize moisture entry and further settlement of the concrete.

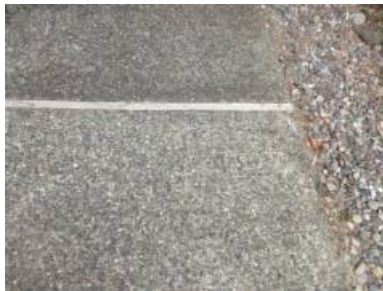
When the wooden dividers separating the concrete walkway sections have deteriorated to a point where they become a trip hazard. Replacement with mortar is recommended.

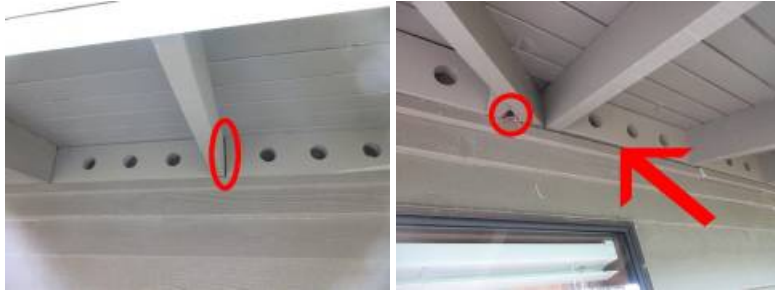
There are large gaps over 1/4" in size adjacent the soffit vent blocks. These gaps allow insects and rodents to enter the attic. Covering the gaps with screening, a strip of wood and/or caulking is recommended.

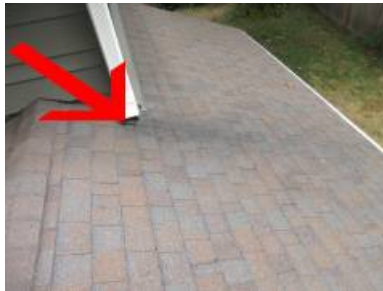
Downspouts draining directly onto the asphalt shingle surface causes excessive wear of the roofing material. Downspout extensions to the lower gutters should be installed to prevent excessive wear and tear of the roofing.

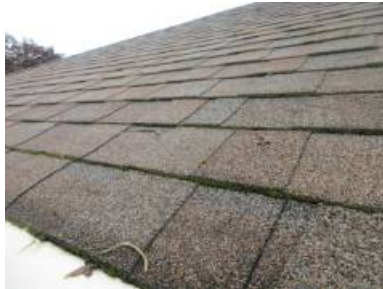
The roof is in need of routine maintenance. The surface should be treated for moss, lichen, and algae growth, then brushed and washed off with a high volume low pressure hose to remove moss and organic debris. Performing this maintenance will improve the appearance and increase the life expectancy of the roof.

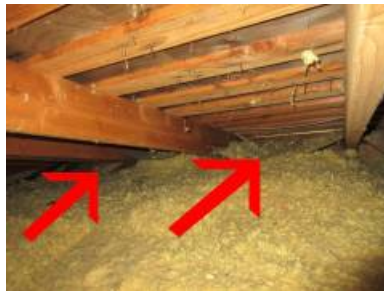
Wind baffles locations are compromised in some areas of the attic. The proper placement of wind baffles in front of all soffit vents is recommended.

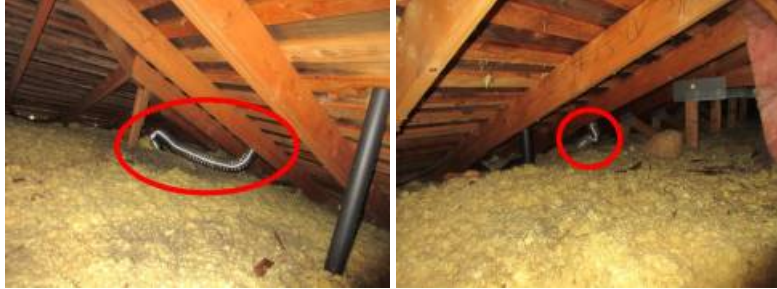
Flexible plastic duct is used to direct air from the vent fans to the exterior. This type of material is unreliable. Replacing the plastic duct with 4" smooth-wall sheet metal duct is recommended.

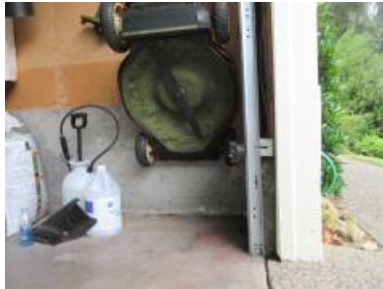
The Photo-eye beam was installed to high above the floor of the garage to adequately offer protection for small children and/or pets. We recommend that the photo-eye be lowered to within 4-6" of the floor.

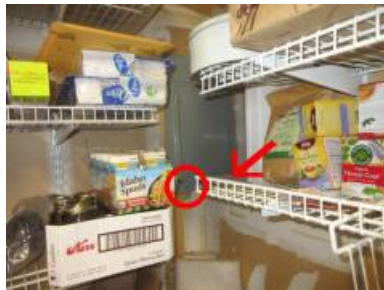
Screws that secure the panel cover to the panel box are missing. This is a potential hazard. Missing screws should be replaced with the original style blunt end screws.

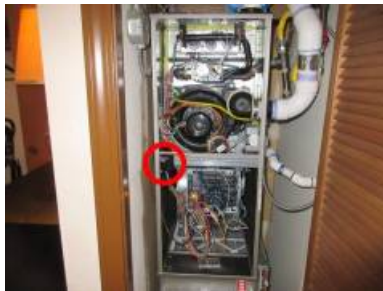
The blower door cut-out switch has been disabled. This is a potential hazard. The cut-out switch should be not be restricted.

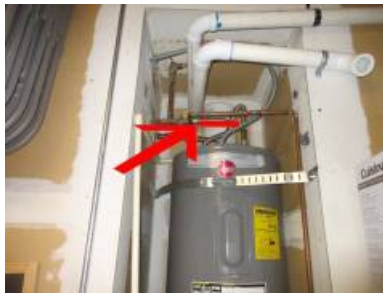
LOCATION OF UNIT	The water heater is located in the garage.
GENERAL INFORMATION	The water heater is electric. The capacity of the water heater is 50 gallons. The water heater is approximately 3 years old. Water heaters of this type typically last about 10-15 years.
PRESSURE RELIEF VALVE	The pressure relief valve is properly installed. The valve was not tested, as this could cause the valve to leak.
SHUTOFF VALVE	The shutoff valve for the water supply to the water heater is properly installed and is functioning as intended.
WATER CONNECTIONS TANK	AT The water connections at the tank are properly installed and are performing their intended function.
EXPANSION TANK	The expansion tank is not adequately secured to the wall. As code requirements start to call for engineered expansion tank supports we recommend the installation of seismic restraints to secure the expansion tank instead of allowing it to simply depend on piping connections that could result in damage to the water pipe and leakage during an earthquake.

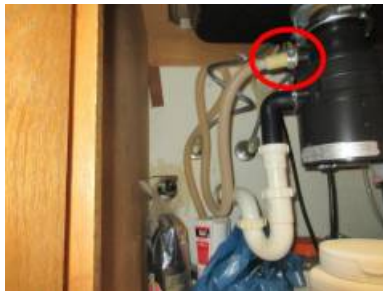
The dishwasher drain lacks an air gap. The dishwasher will function without one, but there is a risk of contamination of the inside of the dishwasher by waste water. The installation of an air gap above the flood rim of the sink is recommended.

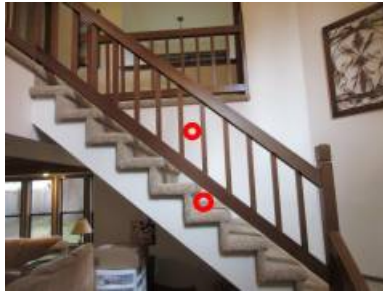
The stair railing spacing at the stair treads is too wide. This is a hazard for small children. The railing spacing should be reduced as a safety upgrade. Current standards require that a 6" sphere not pass through or under the railing.

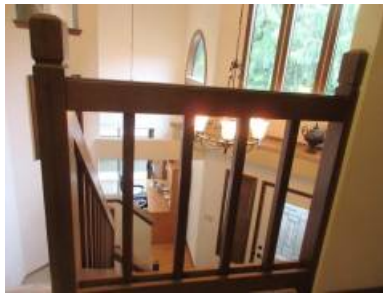
The spacing between the balusters is too wide. This is a hazard to small children. The balusters should be spaced close enough together so that a 4" sphere cannot pass through. Upgrading the guard railing is recommended if small children are present.

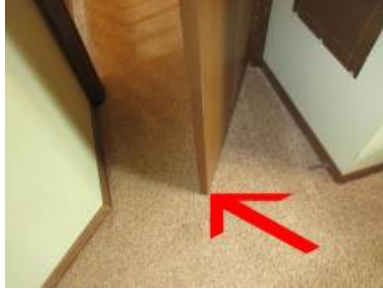
One of the bedroom doors rubs on the carpeting. This can damage the carpet and prevents air circulation under the door. Doors should be undercut 3/4".

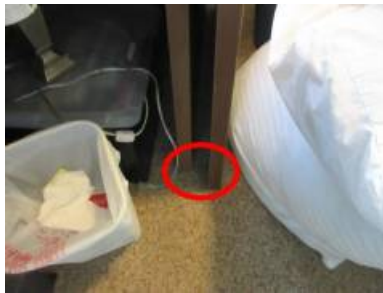
The floor guides are missing from the bypass closet doors in the bedrooms. Missing floor guides could result in damage to the doors. The installation of floor guides is recommended.
